Development at West Kowloon Cultural District

Monthly Environmental Monitoring and Audit
(EM&A) Report for August 2017

September 2017

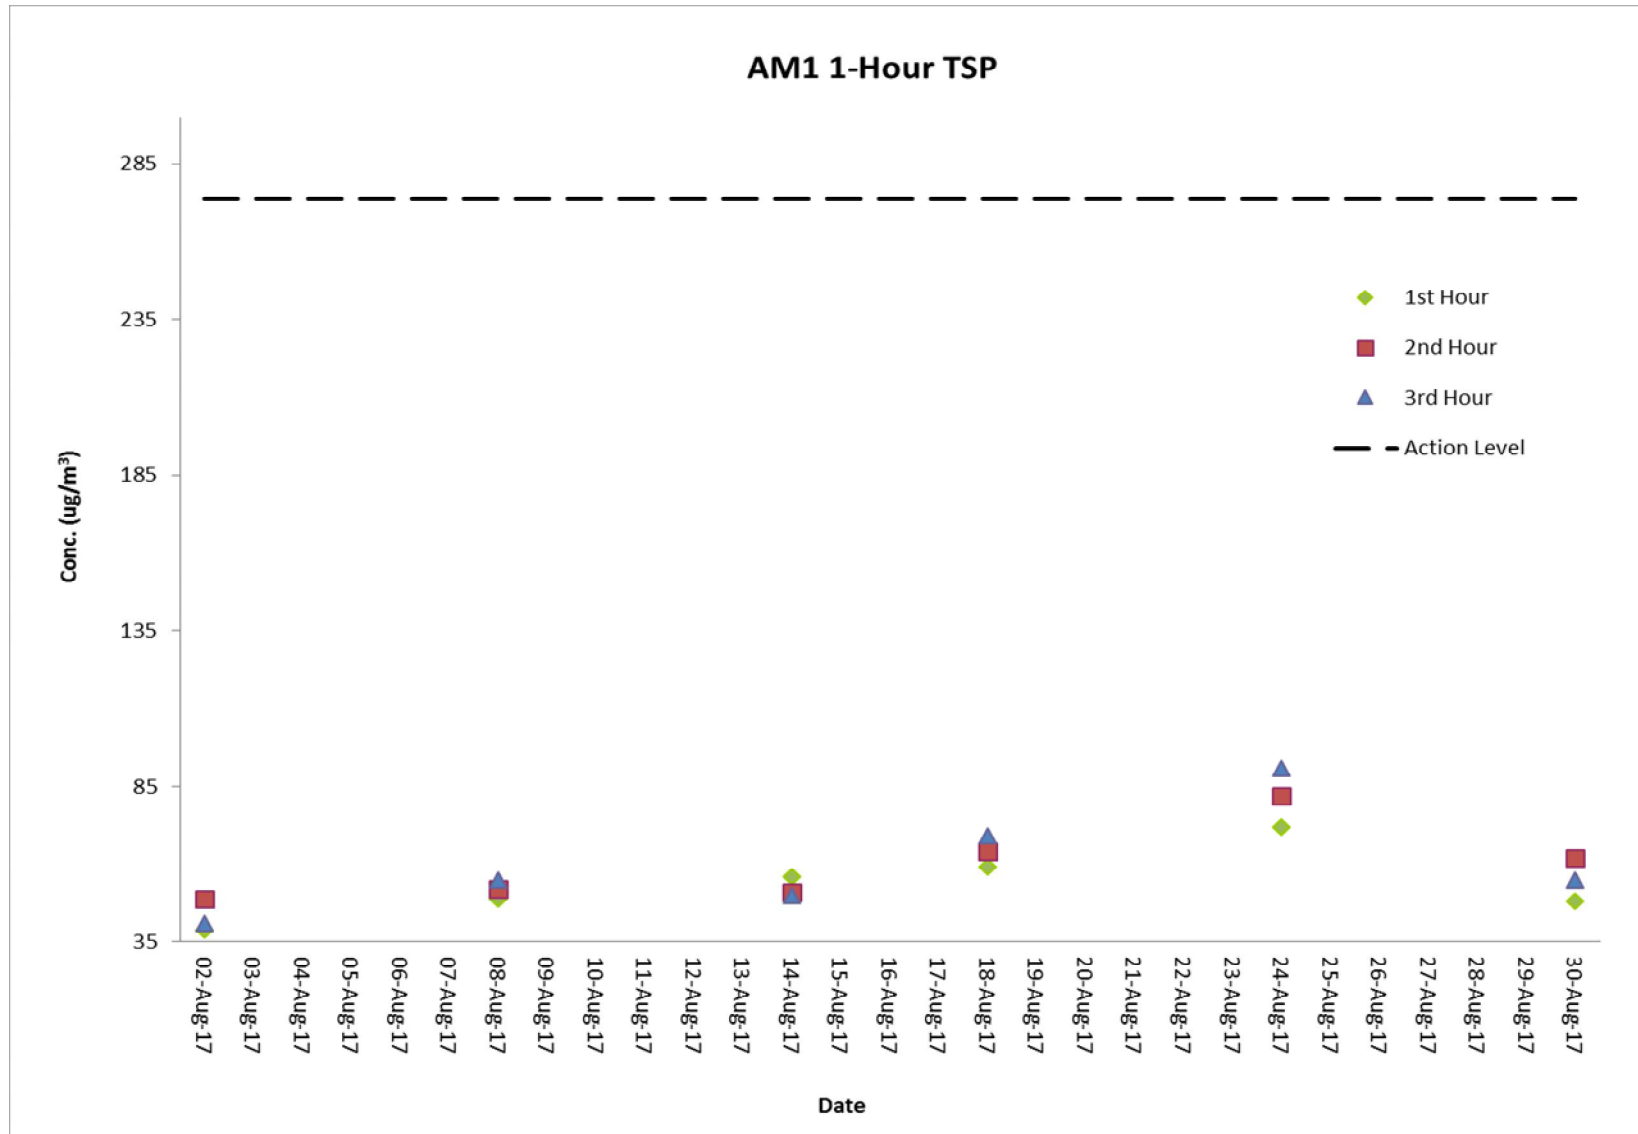
Graphical Presentation of Air Quality Monitoring Result at Station AM1 (1-hour TSP)

Date	Weather Condition	Time	Conc. ($\mu\text{g}/\text{m}^3$)			Action Level ($\mu\text{g}/\text{m}^3$)	Limit Level ($\mu\text{g}/\text{m}^3$)
			1 st Hour	2 nd Hour	3 rd Hour		
02-Aug-17	Cloudy	10:42 - 16:00	39	49	41	273.7	500
08-Aug-17	Fine	10:50 - 16:00	49	52	55	273.7	500
14-Aug-17	Sunny	10:40 - 16:00	56	51	50	273.7	500
18-Aug-17	Sunny	8:02 - 11:02	59	64	69	273.7	500
24-Aug-17	Fine	10:40 - 16:00	72	82	91	273.7	500
30-Aug-17	Fine	10:38 - 16:00	48	62	55	273.7	500

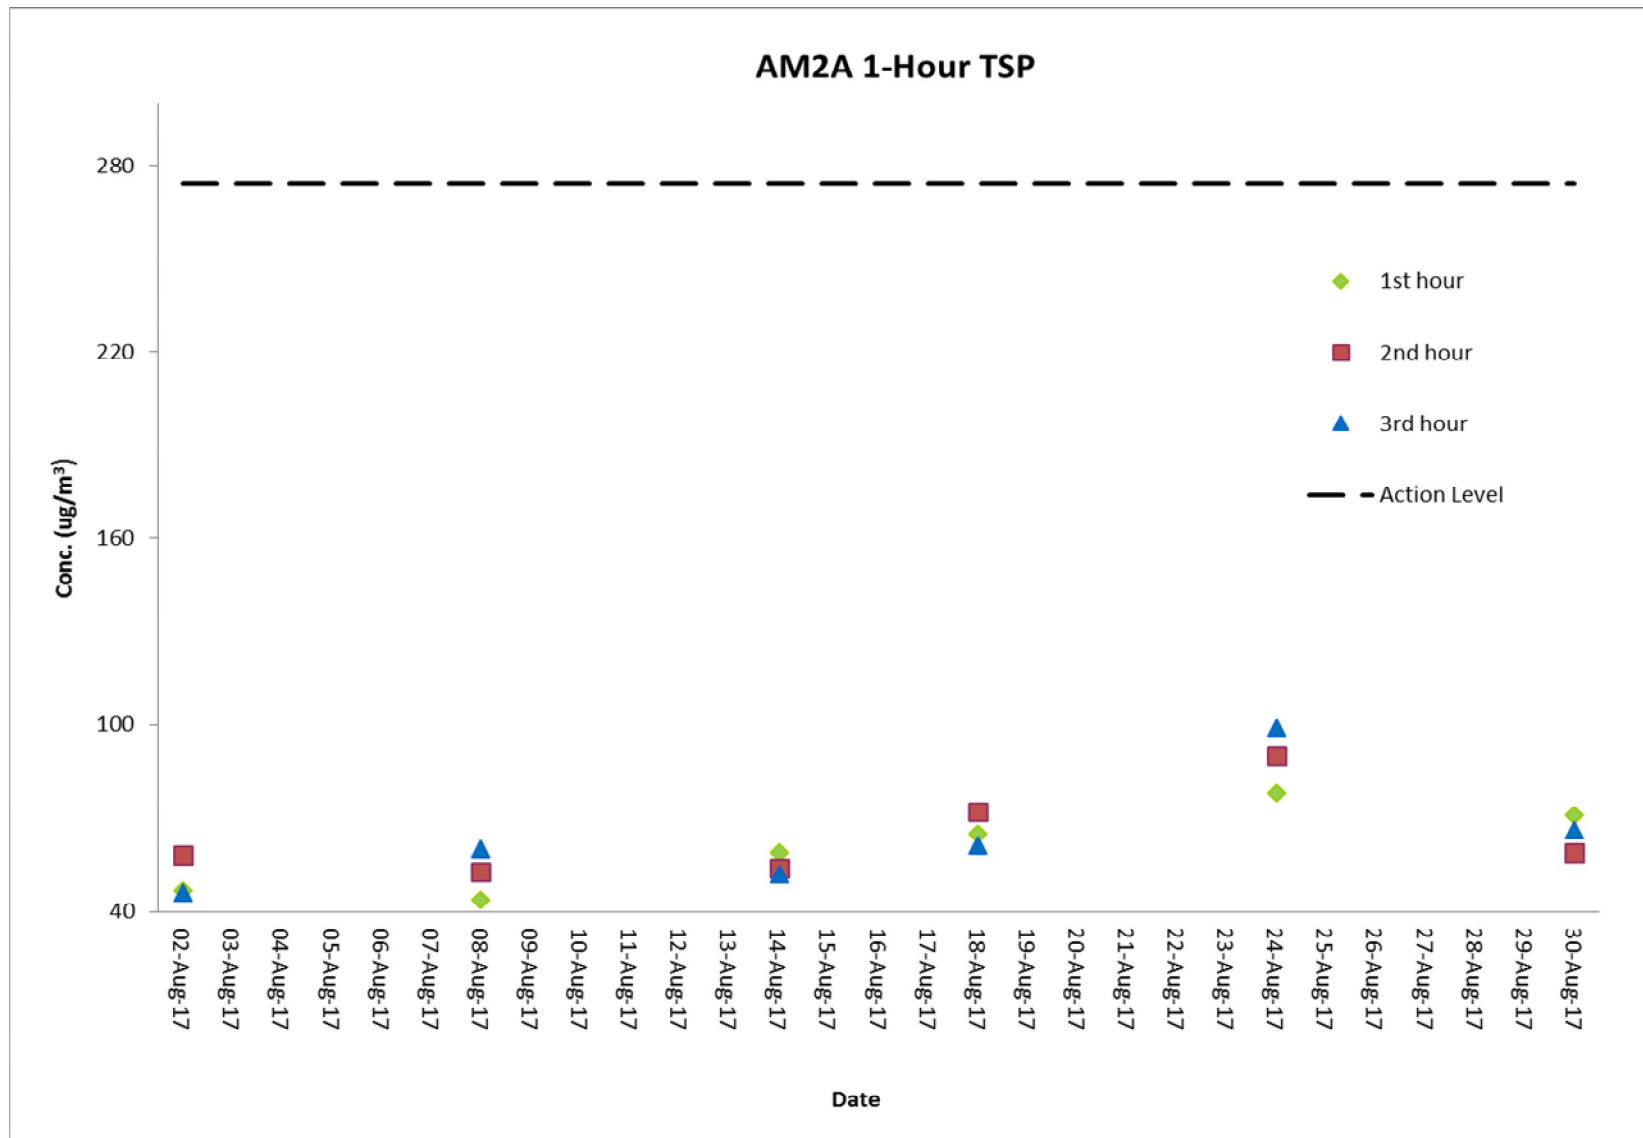
Graphical Presentation of Air Quality Monitoring Result at Station AM2A (1-hour TSP)

Date	Weather Condition	Time	Conc. ($\mu\text{g}/\text{m}^3$)			Action Level ($\mu\text{g}/\text{m}^3$)	Limit Level ($\mu\text{g}/\text{m}^3$)
			1 st Hour	2 nd Hour	3 rd Hour		
02-Aug-17	Cloudy	10:54 - 16:10	47	58	46	274.2	500
08-Aug-17	Fine	11:02 - 16:10	44	53	60	274.2	500
14-Aug-17	Sunny	10:52 - 16:10	59	54	52	274.2	500
18-Aug-17	Sunny	8:14 - 11:14	65	72	61	274.2	500
24-Aug-17	Fine	10:54 - 16:10	78	90	99	274.2	500
30-Aug-17	Fine	10:52 - 16:10	71	59	66	274.2	500

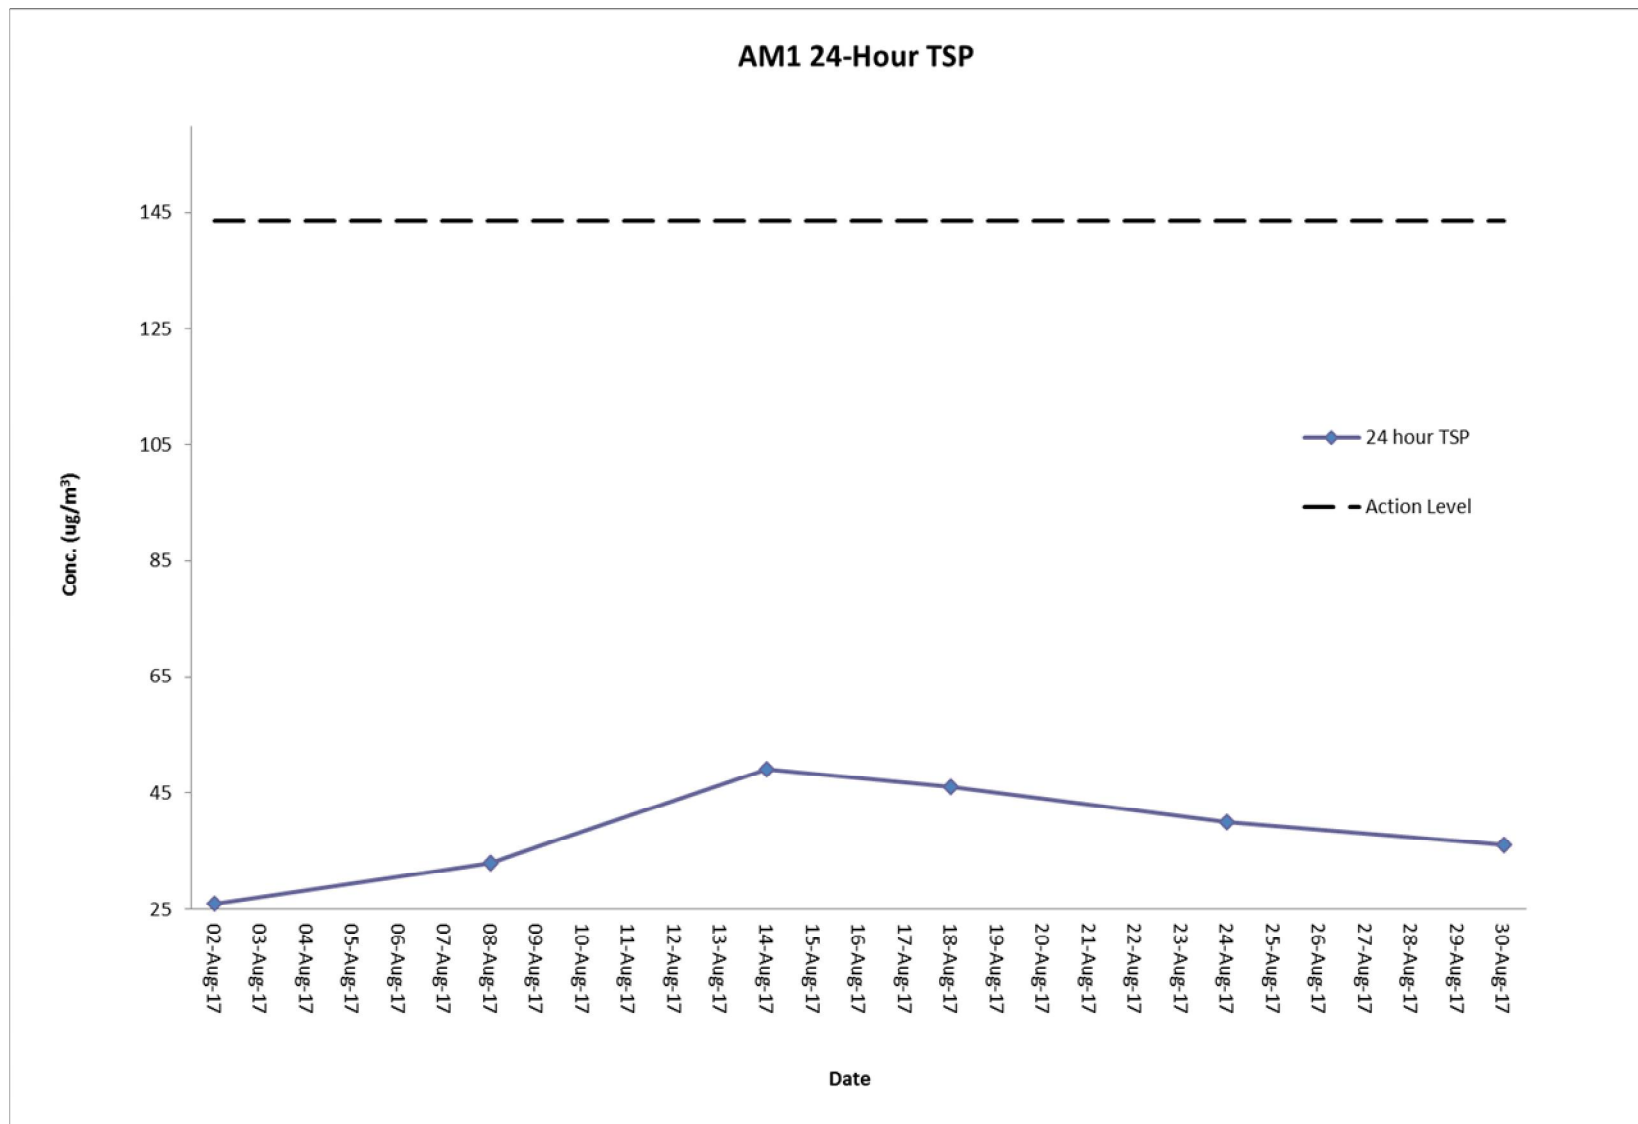
Graphical Presentation of Air Quality Monitoring Result at Station AM1 (24-hour TSP)

Start		Finish		Filter Weight (g)		Elapsed Time Reading		Sampling Time (hrs)	Flow Rate (m ³ /min)			Conc. (µg/m ³)	Weather Condition	Action Level	Limit Level
Date	Time	Date	Time	Initial	Final	Initial	Final		Initial	Final	Average				
02-Aug-17	10:40	03-Aug-17	10:40	2.6397	2.6855	21384.38	21408.38	24	1.23	1.23	1.23	26	Cloudy	143.6	260
08-Aug-17	10:48	09-Aug-17	10:48	2.678	2.7365	21408.38	21432.38	24	1.23	1.23	1.23	33	Fine	143.6	260
14-Aug-17	10:38	15-Aug-17	10:38	2.7124	2.7991	21432.38	21456.38	24	1.23	1.23	1.23	49	Sunny	143.6	260
18-Aug-17	08:00	19-Aug-17	08:00	2.718	2.7998	21456.38	21480.38	24	1.23	1.23	1.23	46	Sunny	143.6	260
24-Aug-17	10:42	25-Aug-17	10:42	2.7219	2.7929	21480.38	21504.38	24	1.23	1.23	1.23	40	Fine	143.6	260
30-Aug-17	10:40	31-Aug-17	10:40	2.6819	2.745	21504.38	21528.38	24	1.23	1.23	1.23	36	Fine	143.6	260

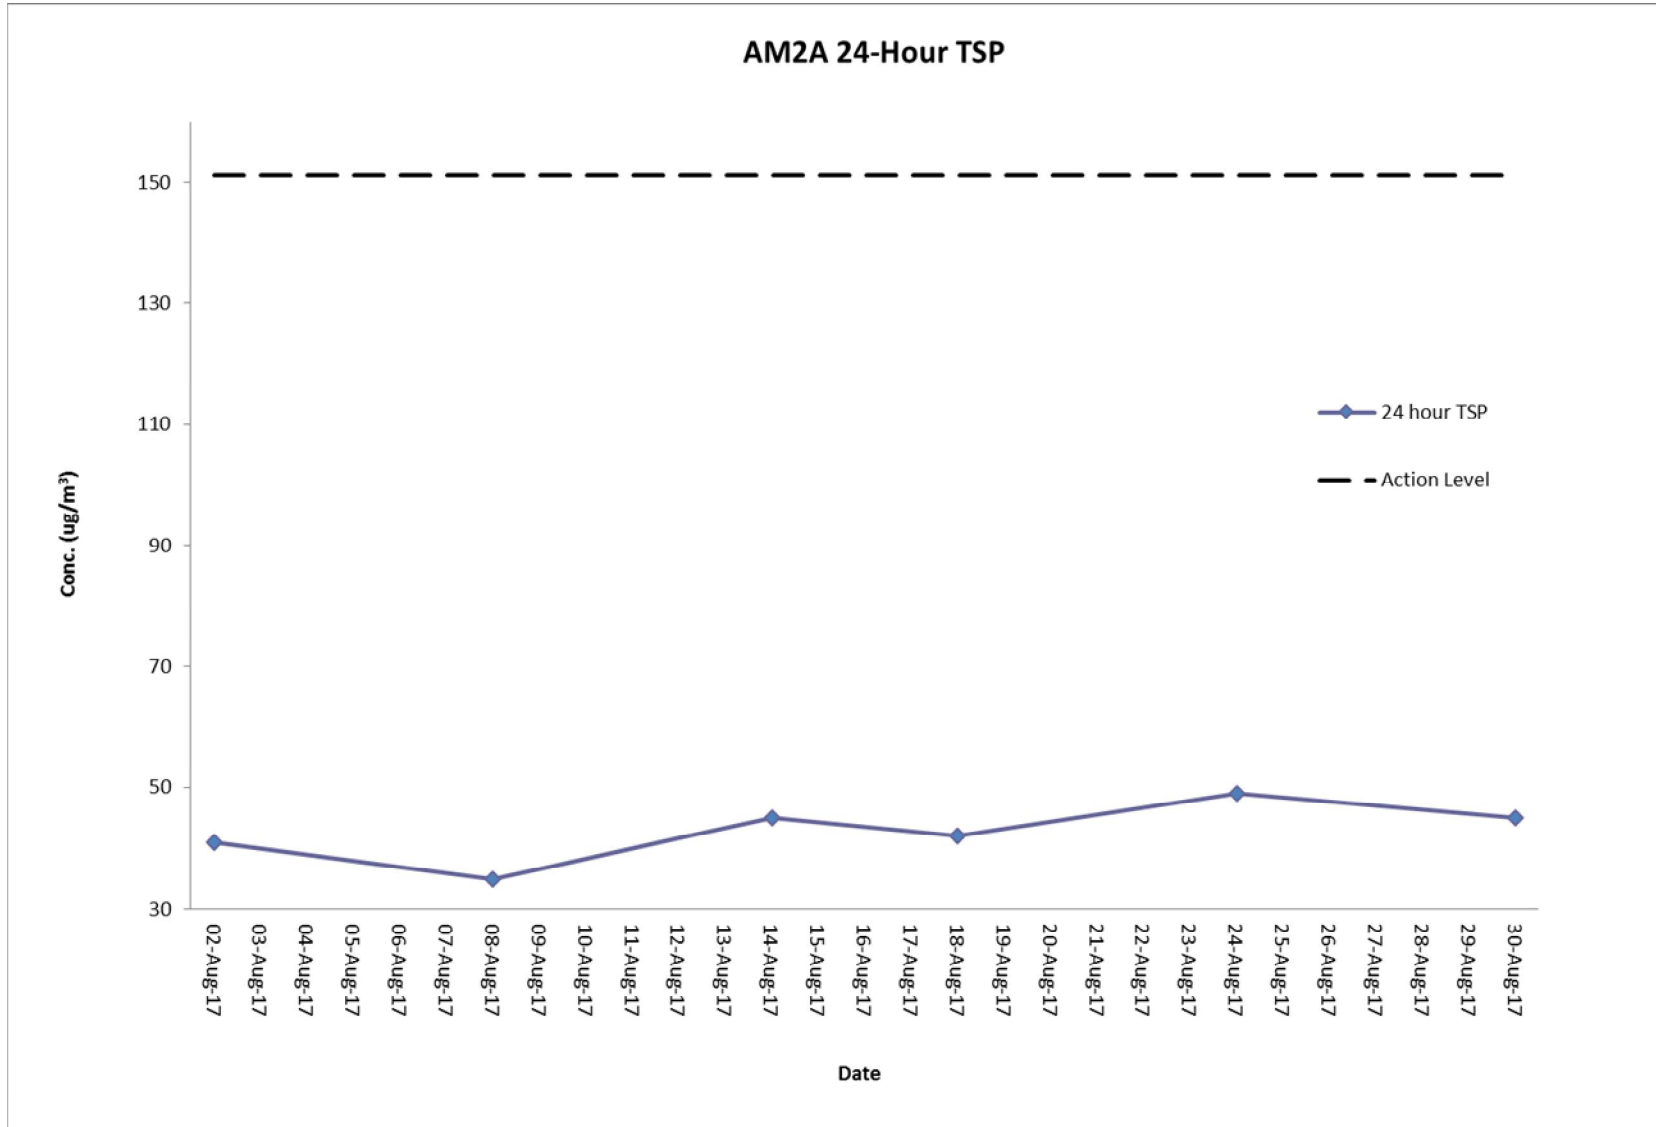
Graphical Presentation of Air Quality Monitoring Result at Station AM2A (24-hour TSP)

Start		Finish		Filter Weight (g)		Elapsed Time Reading		Sampling Time (hrs)	Flow Rate (m ³ /min)			Conc. (µg/m ³)	Weather Condition	Action Level	Limit Level
Date	Time	Date	Time	Initial	Final	Initial	Final		Initial	Final	Average				
02-Aug-17	10:52	03-Aug-17	10:52	2.6180	2.6934	17039.59	17063.59	24	1.27	1.27	1.27	41	Cloudy	151.1	260
08-Aug-17	11:00	09-Aug-17	11:00	2.6790	2.7427	17063.59	17087.59	24	1.27	1.27	1.27	35	Fine	151.1	260
14-Aug-17	10:50	15-Aug-17	10:50	2.7037	2.7841	17087.59	17111.59	24	1.24	1.24	1.24	45	Sunny	151.1	260
18-Aug-17	08:12	19-Aug-17	08:12	2.6664	2.7419	17111.59	17135.59	24	1.24	1.24	1.24	42	Sunny	151.1	260
24-Aug-17	10:52	25-Aug-17	10:52	2.6840	2.7710	17135.59	17159.59	24	1.24	1.24	1.24	49	Fine	151.1	260
30-Aug-17	10:50	31-Aug-17	10:50	2.6858	2.7659	17159.59	17183.59	24	1.24	1.24	1.24	45	Fine	151.1	260

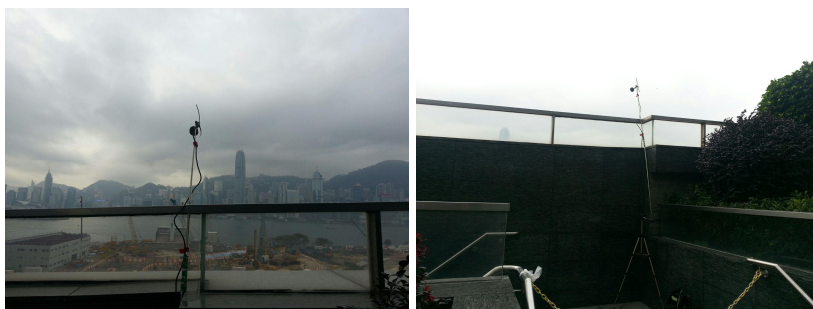
+3dB (A) correction was applied to free-field measurement.

The station set-up of a free-field measurement at Station NM1A.

- The microphone of the Sound Level Meter was set at least 1.2 m above the ground.
- Free Field measurement was made at the monitoring locations.
- The battery condition was checked to ensure the correct functioning of the meter.

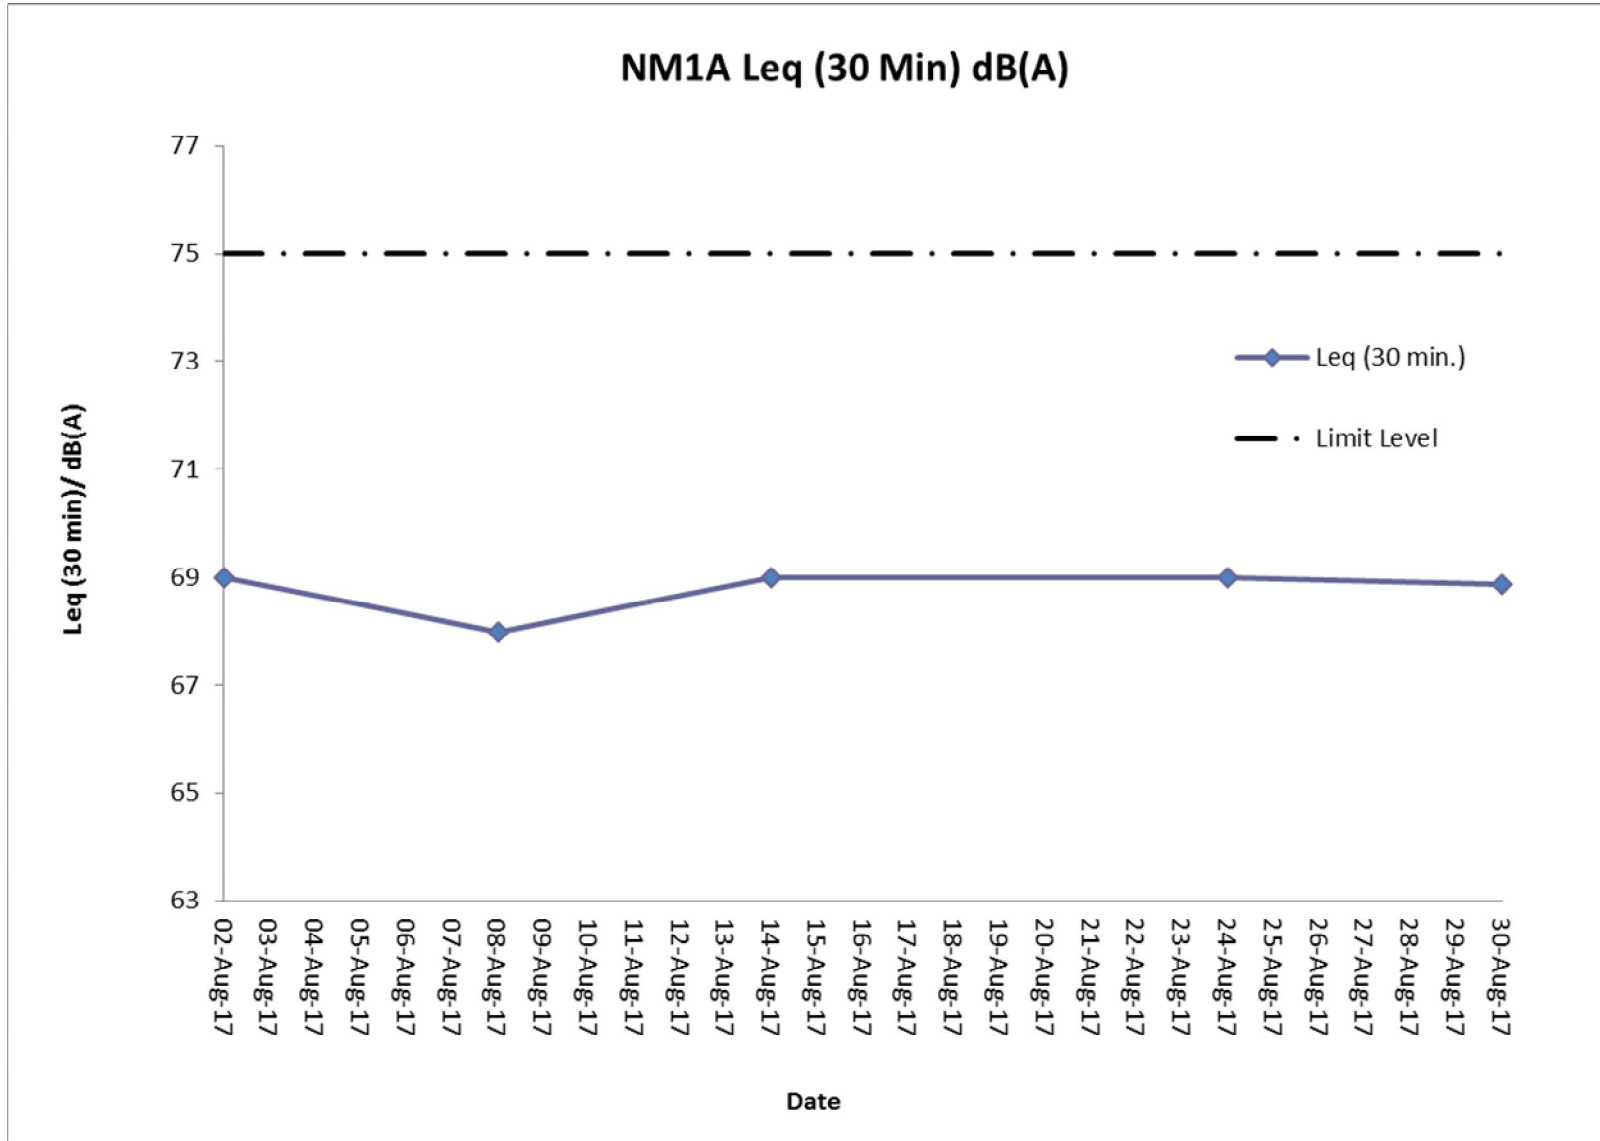
Graphical Presentation Noise Monitoring Result at Station NM1A

Date	Time	Measured L ₁₀ dB(A)	Measured L ₉₀ dB(A)	L _{eq} (30 min.) dB(A)
02-Aug-17	16:00	68.9	63.1	69
02-Aug-17	16:05	67.9	62.9	
02-Aug-17	16:10	69.0	64.1	
02-Aug-17	16:15	67.7	63.9	
02-Aug-17	16:20	68.4	64.1	
02-Aug-17	16:25	68.0	63.9	
08-Aug-17	14:00	67.1	62.1	68
08-Aug-17	14:05	68.0	63.1	
08-Aug-17	14:10	67.9	62.9	
08-Aug-17	14:15	66.7	60.9	
08-Aug-17	14:20	66.4	61.7	
08-Aug-17	14:25	67.0	63.1	
14-Aug-17	14:00	68.0	63.1	69
14-Aug-17	14:05	67.1	62.1	
14-Aug-17	14:10	67.9	63.9	
14-Aug-17	14:15	68.8	64.0	
14-Aug-17	14:20	67.0	63.1	
14-Aug-17	14:25	67.4	63.4	
24-Aug-17	14:00	68.0	63.9	69
24-Aug-17	14:05	69.4	64.7	
24-Aug-17	14:10	67.7	63.2	
24-Aug-17	14:15	67.9	63.4	
24-Aug-17	14:20	68.2	64.0	
24-Aug-17	14:25	68.8	63.9	
30-Aug-17	14:00	67.9	62.1	69
30-Aug-17	14:05	68.8	63.4	
30-Aug-17	14:10	69.0	63.7	
30-Aug-17	14:15	67.0	62.8	
30-Aug-17	14:20	67.4	63.7	
30-Aug-17	14:25	67.9	63.9
