Development at West Kowloon Cultural District

Quarterly Environmental Monitoring and Audit
(EM&A) Report (November 2018 - January 2019)

March 2019

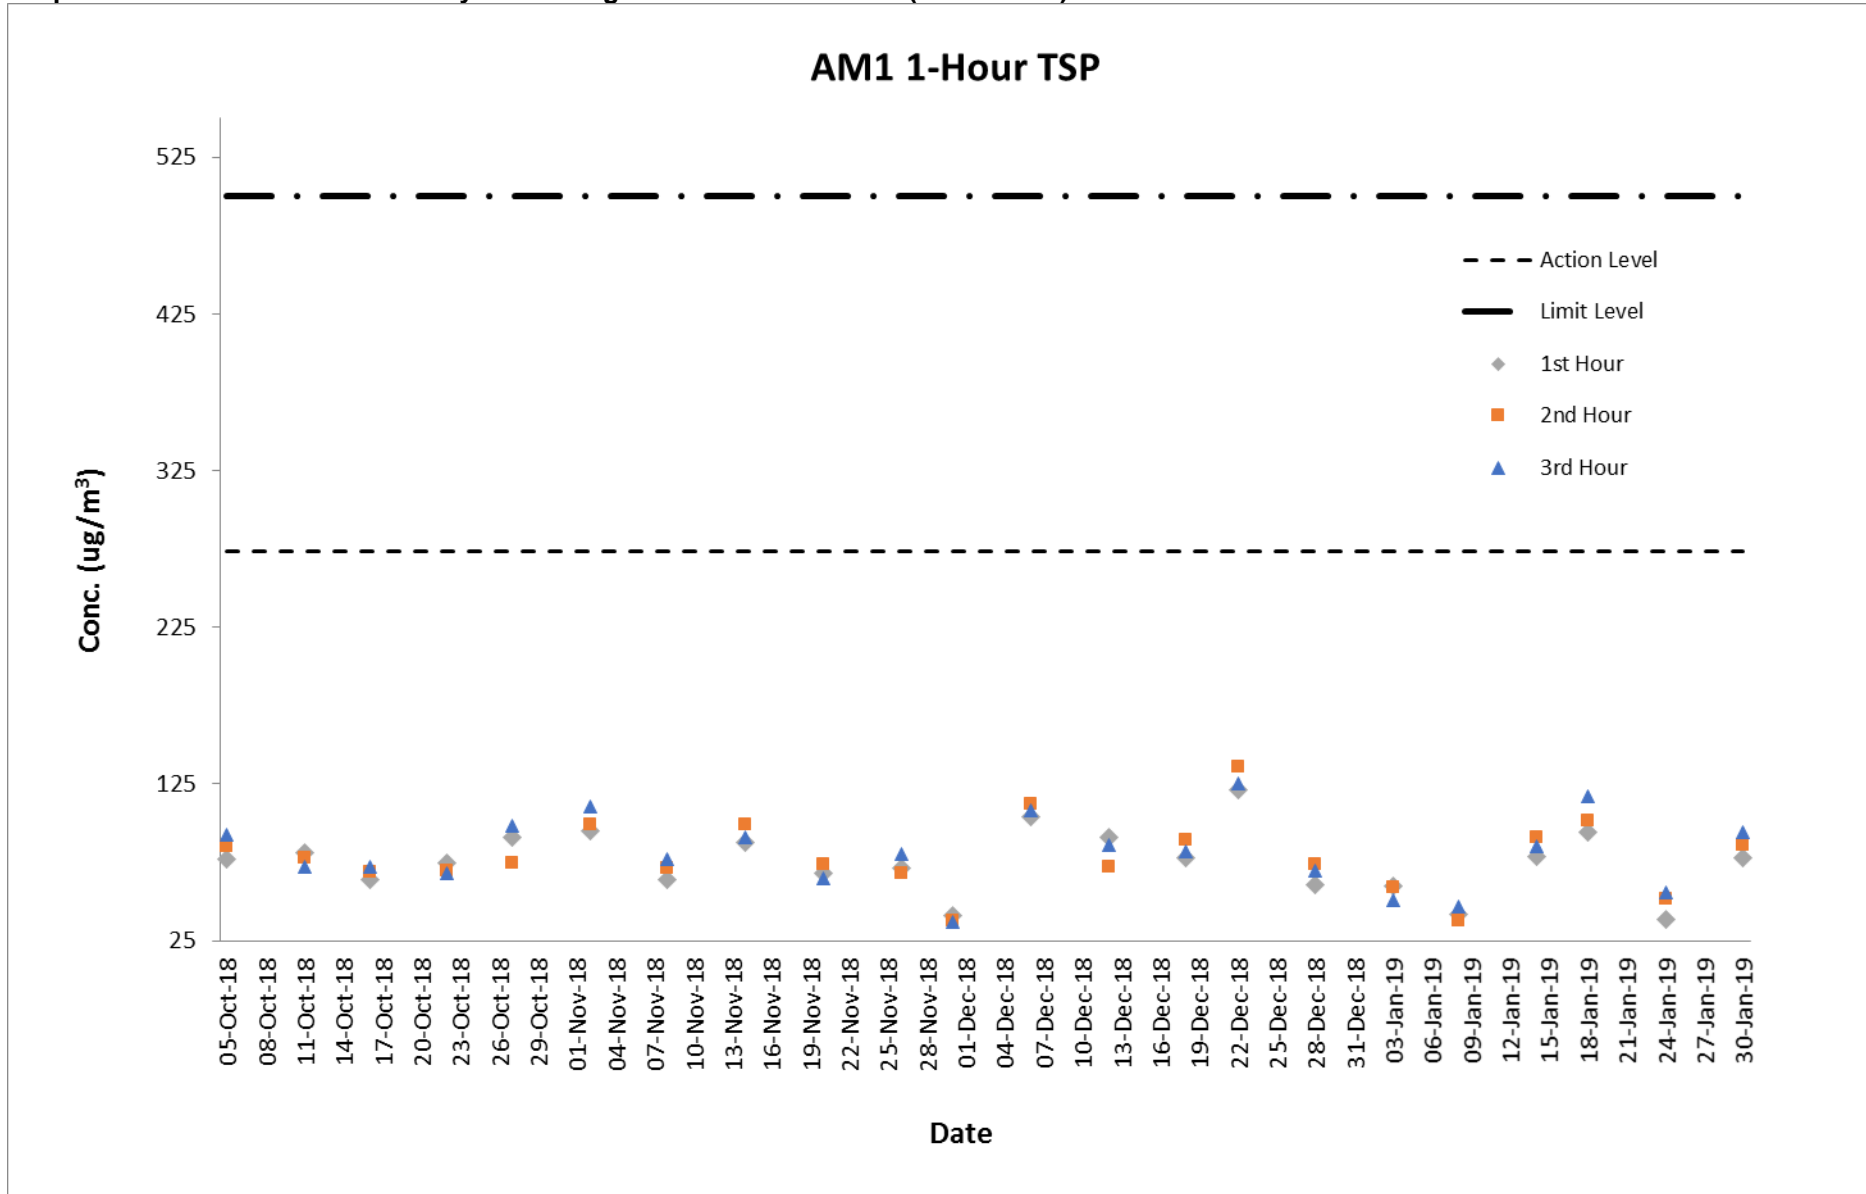
Graphical Presentation of Air Quality Monitoring Result at Station AM1 (1-hour TSP)

Air Quality Monitoring Result at Station AM1 (1-hour TSP)

Date	Weather Condition	Time	Conc. ($\mu\text{g}/\text{m}^3$)			Action Level ($\mu\text{g}/\text{m}^3$)	Limit Level ($\mu\text{g}/\text{m}^3$)
			1 st Hour	2 nd Hour	3 rd Hour		
02-Nov-18	Cloudy	8:04 - 11:04	95	99	111	273.7	500
08-Nov-18	Fine	7:58 - 10:58	64	71	77	273.7	500
14-Nov-18	Fine	7:50 - 10:50	88	99	91	273.7	500
20-Nov-18	Cloudy	7:50 - 10:50	68	74	65	273.7	500
26-Nov-18	Cloudy	7:52 - 10:52	71	68	80	273.7	500
30-Nov-18	Sunny	8:02 - 11:02	41	38	37	273.7	500
06-Dec-18	Cloudy	8:03 - 11:03	104	112	108	273.7	500
12-Dec-18	Cloudy	7:52 - 10:52	91	72	86	273.7	500
18-Dec-18	Sunny	7:50 - 10:50	78	89	82	273.7	500
22-Dec-18	Sunny	8:02 - 11:02	121	136	125	273.7	500
28-Dec-18	Sunny	7:50 - 10:50	61	74	70	273.7	500
03-Jan-19	Cloudy	7:50 - 10:50	60	59	51	273.7	500
08-Jan-19	Cloudy	7:52 - 10:52	42	38	47	273.7	500
14-Jan-19	Cloudy	8:02 - 11:02	79	91	85	273.7	500
18-Jan-19	Cloudy	8:12 - 11:12	94	102	117	273.7	500
24-Jan-19	Sunny	8:05 - 11:05	39	52	56	273.7	500

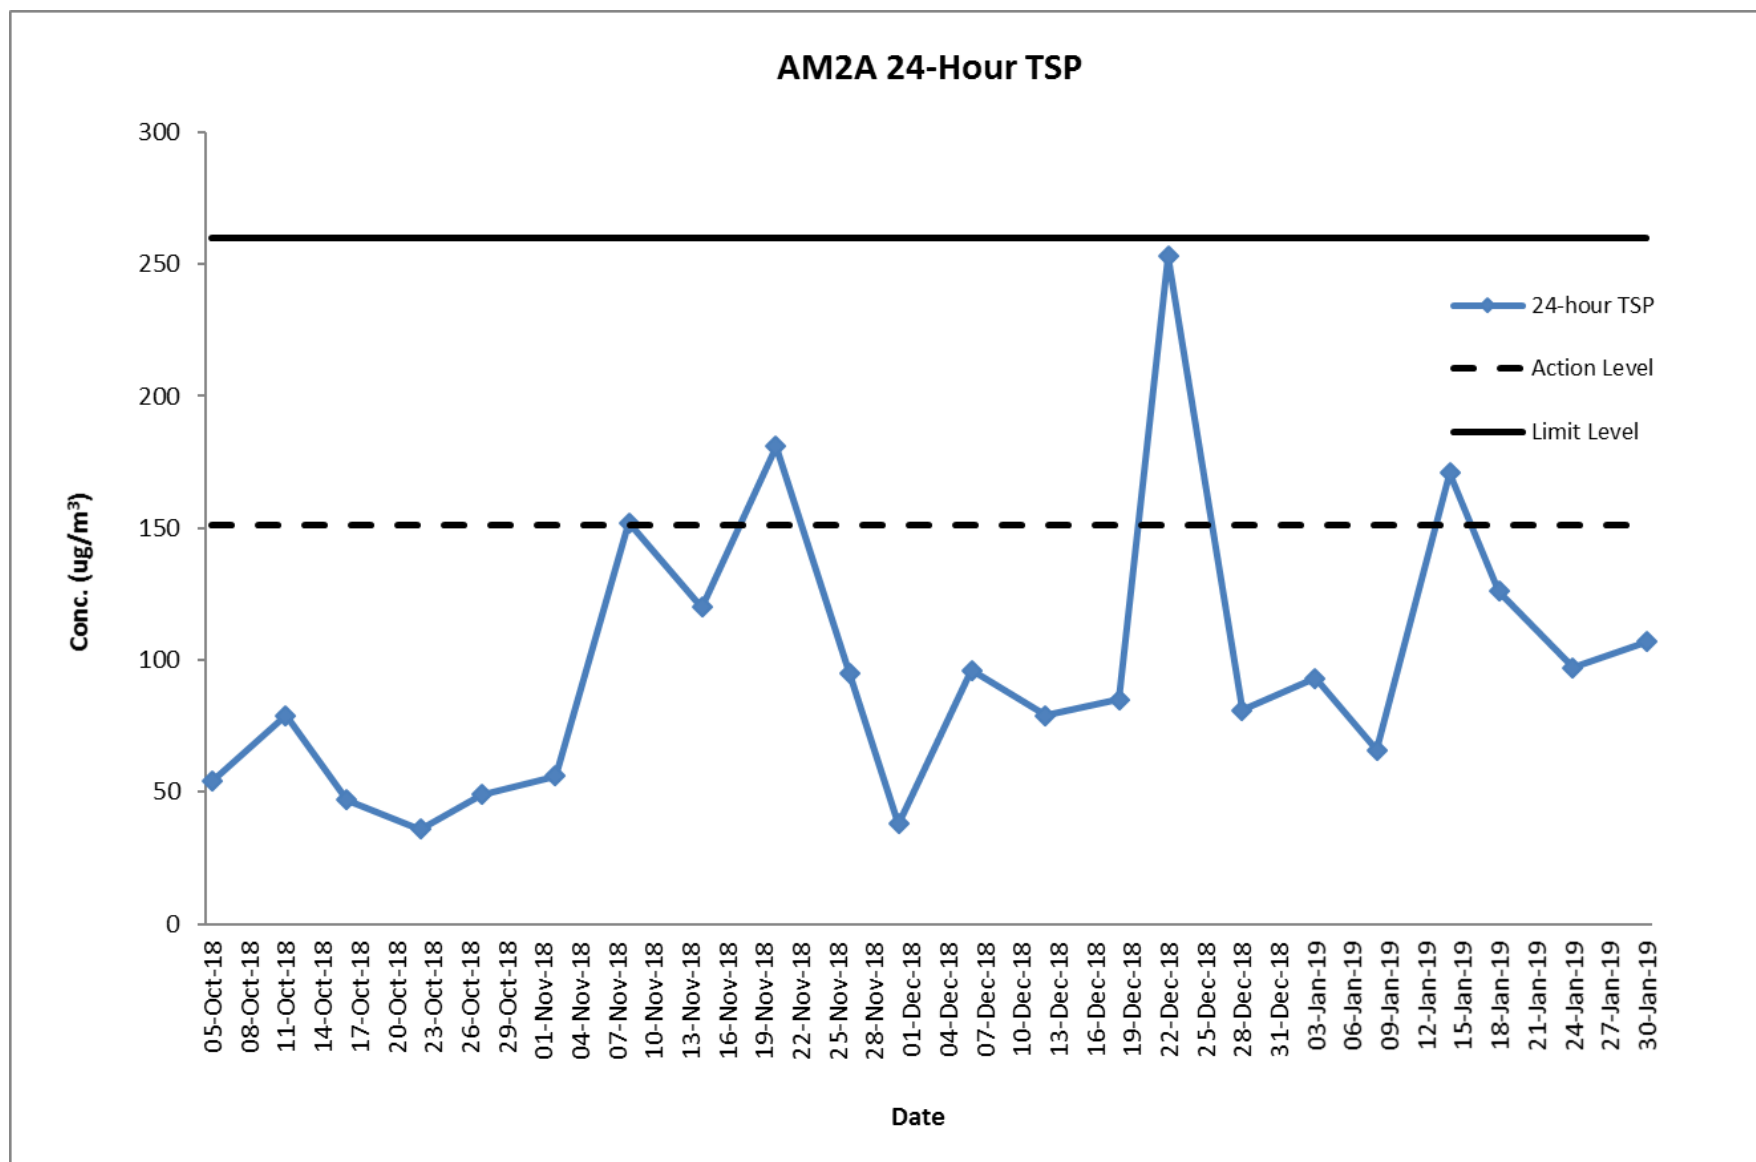
Graphical Presentation of Air Quality Monitoring Result at Station AM2A (24-hour TSP)

While on 22 Dec 2018 and 14 Jan 2019, the measured level was at 253 $\mu\text{g}/\text{m}^3$ and 171 $\mu\text{g}/\text{m}^3$ respectively. It is revealed that the contractors have already implemented dust mitigation measures to reduce the dust impact from their construction works. Uncovered debris was found on 19 Dec 2018 during weekly site inspection, but it was no longer found on site on 22 Dec 2018. Therefore, it is deemed that the contribution from the uncovered debris to the exceedance on 22 Dec 2018 was minor. Moreover, it should be noted that there have been construction works carried out by another contractor at Austin Road West during the concerned monitoring period with no dust mitigation measures provided. This may also have contributed to the 24-hr TSP exceedance during the concerned monitoring period.

Air Quality Monitoring Result at Station AM2A (24-hour TSP)

Start		Finish		Filter Weight (g)		Reading		Sampling Time (hrs)	Flow Rate (m ³ /min)			Conc. (µg/m ³)	Weather Condition	Action Level	Limit Level
Date	Time	Date	Time	Initial	Final	Initial	Final		Initial	Final	Average				
02-Nov-18	08:15	03-Nov-18	08:15	2.6846	2.7895	19031.59	19055.59	24	1.29	1.29	1.29	56	Cloudy	151.1	260
08-Nov-18	08:08	09-Nov-18	08:08	2.6924	2.9701	19055.59	19079.59	24	1.27	1.27	1.27	152	Fine	151.1	260
14-Nov-18	08:03	15-Nov-18	08:03	2.6749	2.8950	19079.59	19103.59	24	1.27	1.27	1.27	120	Fine	151.1	260
20-Nov-18	08:02	21-Nov-18	08:02	2.6708	3.0077	19103.59	19127.59	24	1.29	1.29	1.29	181	Cloudy	151.1	260
26-Nov-18	08:02	27-Nov-18	08:02	2.6881	2.8623	19127.05	19151.05	24	1.27	1.27	1.27	95	Cloudy	151.1	260
30-Nov-18	08:12	01-Dec-18	08:12	2.6610	2.7297	19151.05	19175.05	24	1.27	1.27	1.27	38	Sunny	151.1	260
06-Dec-18	08:13	07-Dec-18	08:13	2.6569	2.8310	19175.05	19199.05	24	1.26	1.26	1.26	96	Cloudy	151.1	260

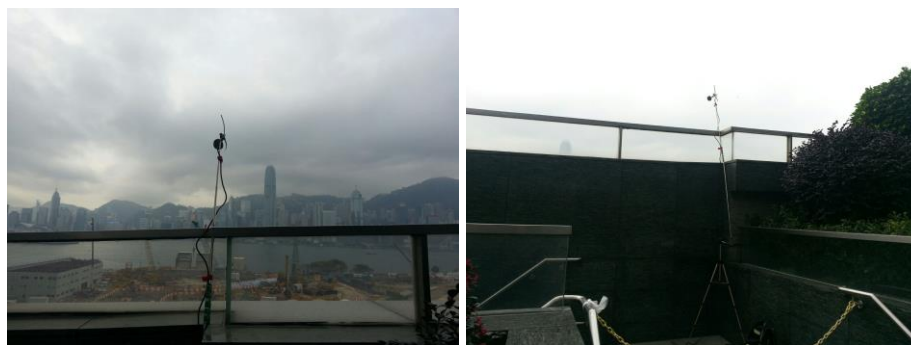
+3dB (A) correction was applied to free-field measurement.

The station set-up of a free-field measurement at Station NM1A.
