Development at West Kowloon Cultural District

Monthly Environmental Monitoring and Audit
(EM&A) Report for April 2019

May 2019

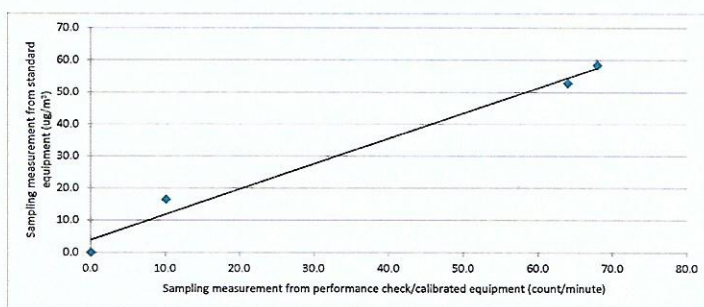
Linear Regression of Y on X

Slope (K- factor) : 0.8
 Correlation Coefficient : 0.9916
 Validity of Performance Check / Calibration Record : 28/4/2019

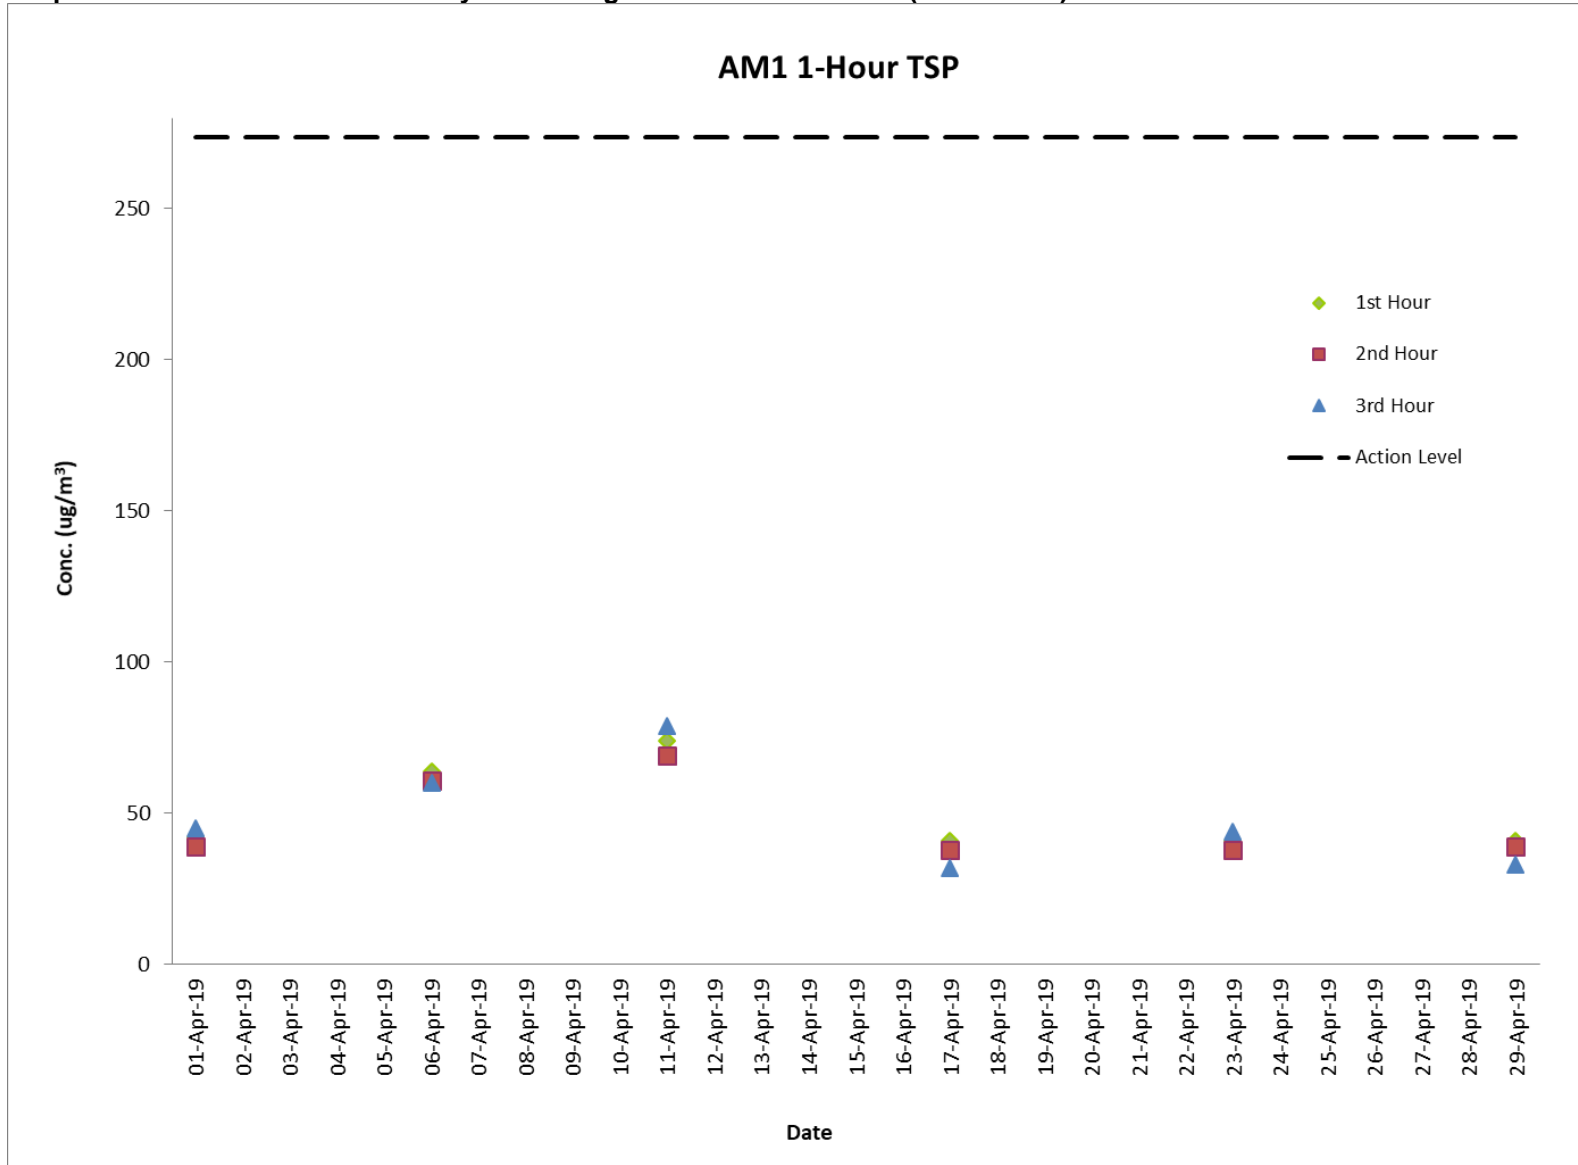
Graphical Presentation of Air Quality Monitoring Result at Station AM1 (1-hour TSP)

Date	Weather Condition	Time	Conc. ($\mu\text{g}/\text{m}^3$)			Action Level ($\mu\text{g}/\text{m}^3$)	Limit Level ($\mu\text{g}/\text{m}^3$)
			1 st Hour	2 nd Hour	3 rd Hour		
1-Apr-19	Cloudy	8:00 - 11:00	42	39	45	273.7	500
6-Apr-19	Sunny	8:02 - 11:02	64	61	60	273.7	500
11-Apr-19	Fine	7:50 - 10:50	74	69	79	273.7	500
17-Apr-19	Cloudy	7:52 - 10:52	41	38	32	273.7	500
23-Apr-19	Fine	7:53 - 10:53	41	38	44	273.7	500
29-Apr-19	Fine	7:52 - 10:52	41	39	33	273.7	500

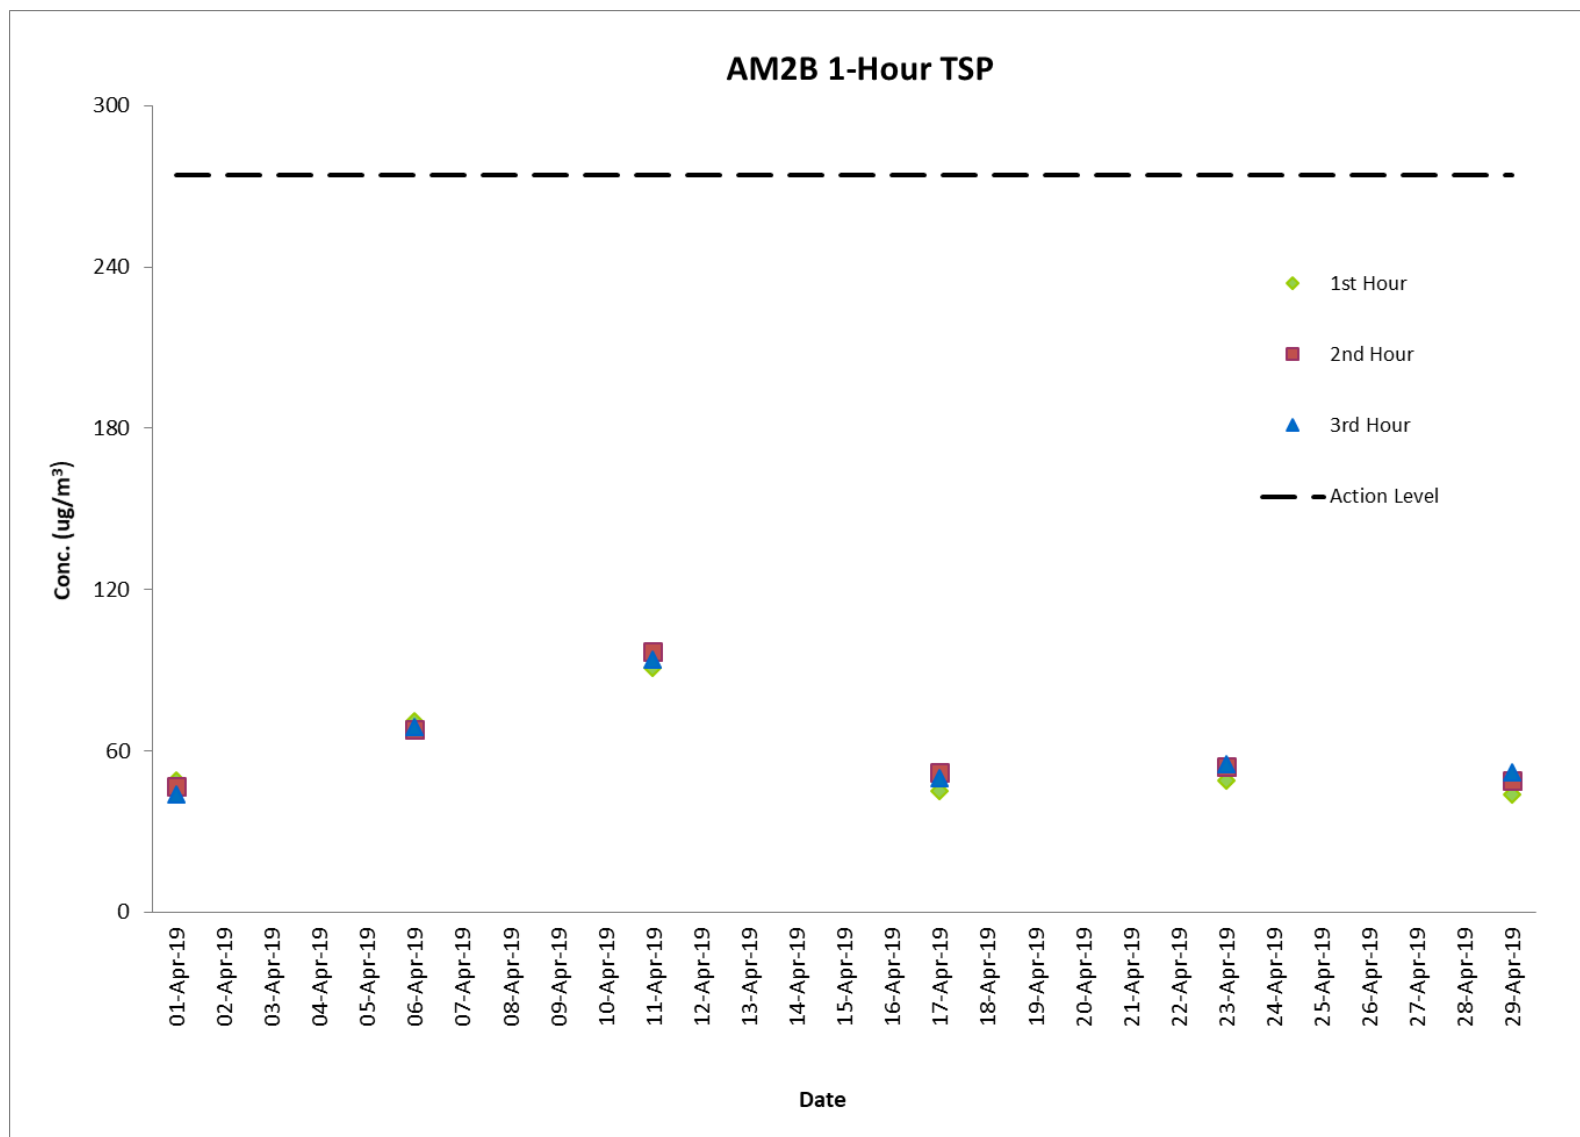
Graphical Presentation of Air Quality Monitoring Result at Station AM2B (1-hour TSP)

Date	Weather Condition	Time	Conc. ($\mu\text{g}/\text{m}^3$)			Action Level ($\mu\text{g}/\text{m}^3$)	Limit Level ($\mu\text{g}/\text{m}^3$)
			1 st Hour	2 nd Hour	3 rd Hour		
1-Apr-19	Cloudy	8:17 - 11:17	49	47	44	274.2	500
6-Apr-19	Sunny	8:16 - 11:16	71	68	69	274.2	500
11-Apr-19	Fine	8:07 - 11:07	91	97	94	274.2	500
17-Apr-19	Cloudy	8:07 - 11:07	45	52	50	274.2	500
23-Apr-19	Fine	8:07 - 11:07	49	54	55	274.2	500
29-Apr-19	Fine	8:07 - 11:07	44	49	52	274.2	500

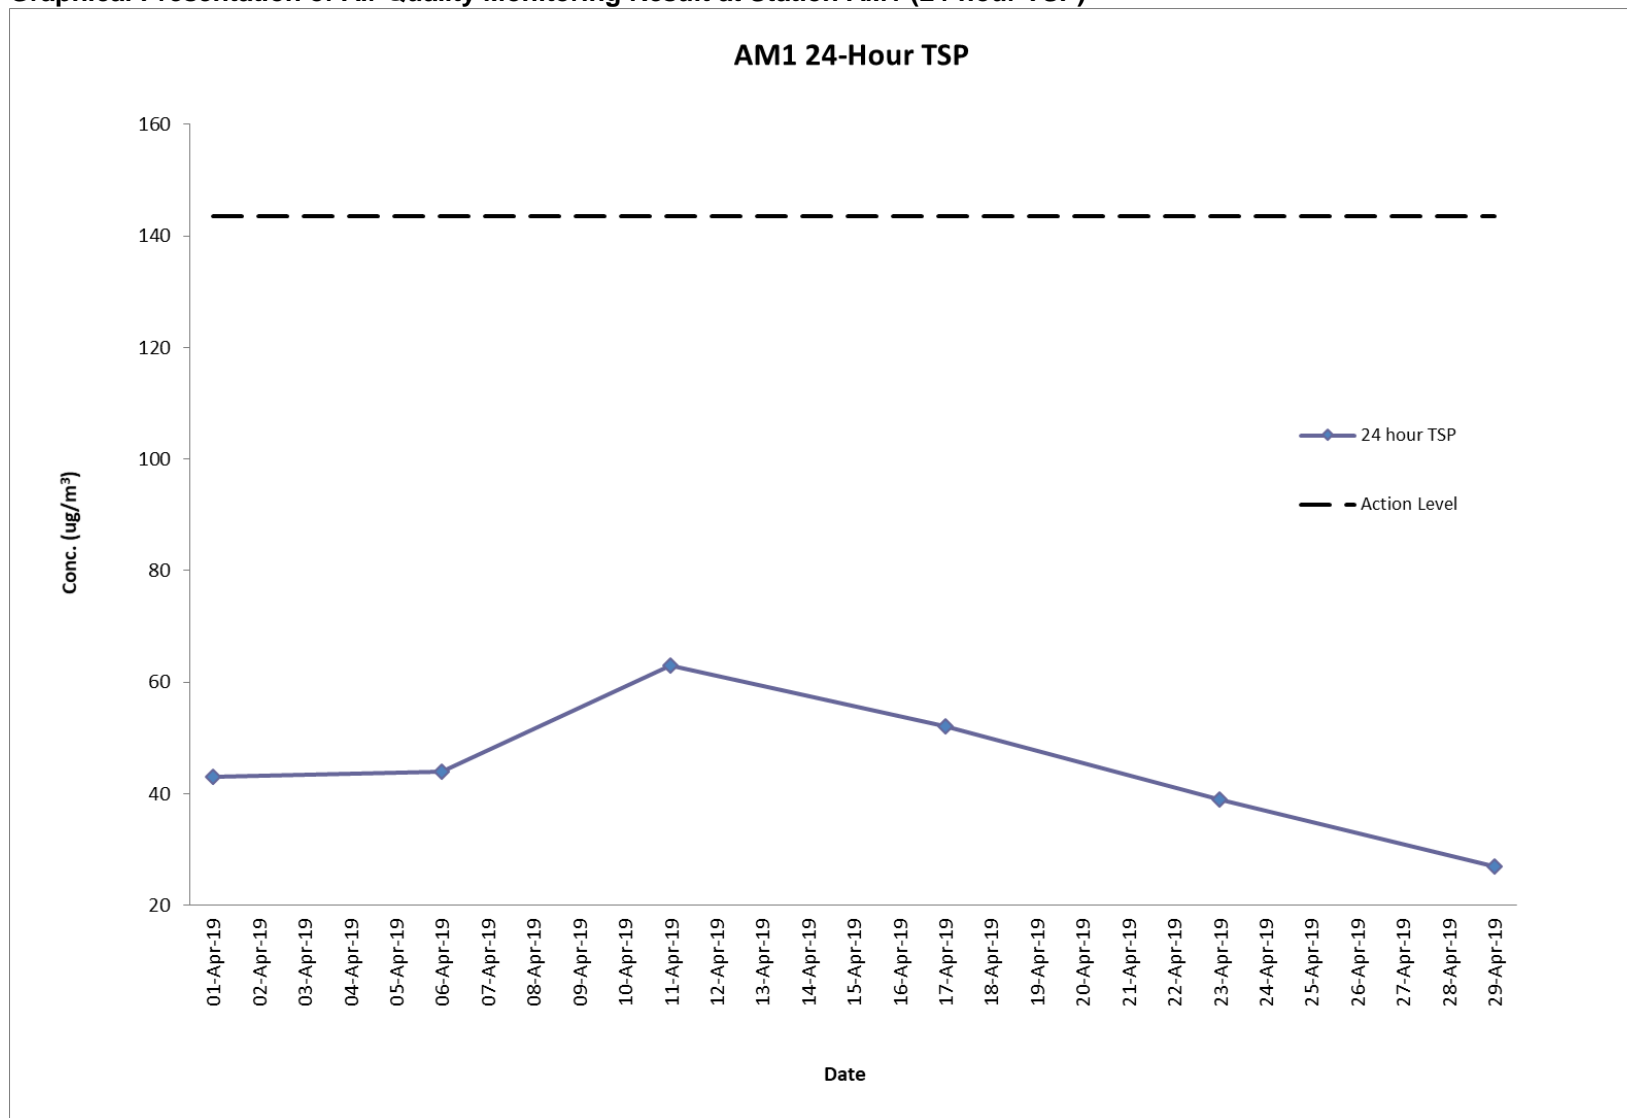
Graphical Presentation of Air Quality Monitoring Result at Station AM1 (24-hour TSP)

Start		Finish		Filter Weight (g)		Elapsed Time Reading		Sampling Time (hrs)	Flow Rate (m ³ /min)			Conc. (µg/m ³)	Weather Condition	Action Level	Limit Level
Date	Time	Date	Time	Initial	Final	Initial	Final		Initial	Final	Average				
1-Apr-19	8:02	2-Apr-19	8:02	2.637	2.7135	24024.38	24048.38	24	1.24	1.24	1.24	43	Cloudy	143.6	260
6-Apr-19	8:00	7-Apr-19	8:00	2.6376	2.7167	24048.38	24072.38	24	1.24	1.24	1.24	44	Sunny	143.6	260
11-Apr-19	7:52	12-Apr-19	7:52	2.6228	2.735	24072.38	24096.38	24	1.24	1.24	1.24	63	Fine	143.6	260
17-Apr-19	7:50	18-Apr-19	7:50	2.6411	2.7332	24096.38	24120.38	24	1.24	1.24	1.24	52	Cloudy	143.6	260
23-Apr-19	10:20	24-Apr-19	10:20	2.6705	2.7397	24120.38	24144.38	24	1.24	1.24	1.24	39	Fine	143.6	260
29-Apr-19	7:50	30-Apr-19	7:50	2.7111	2.7592	24144.38	24168.38	24	1.24	1.24	1.24	27	Fine	143.6	260

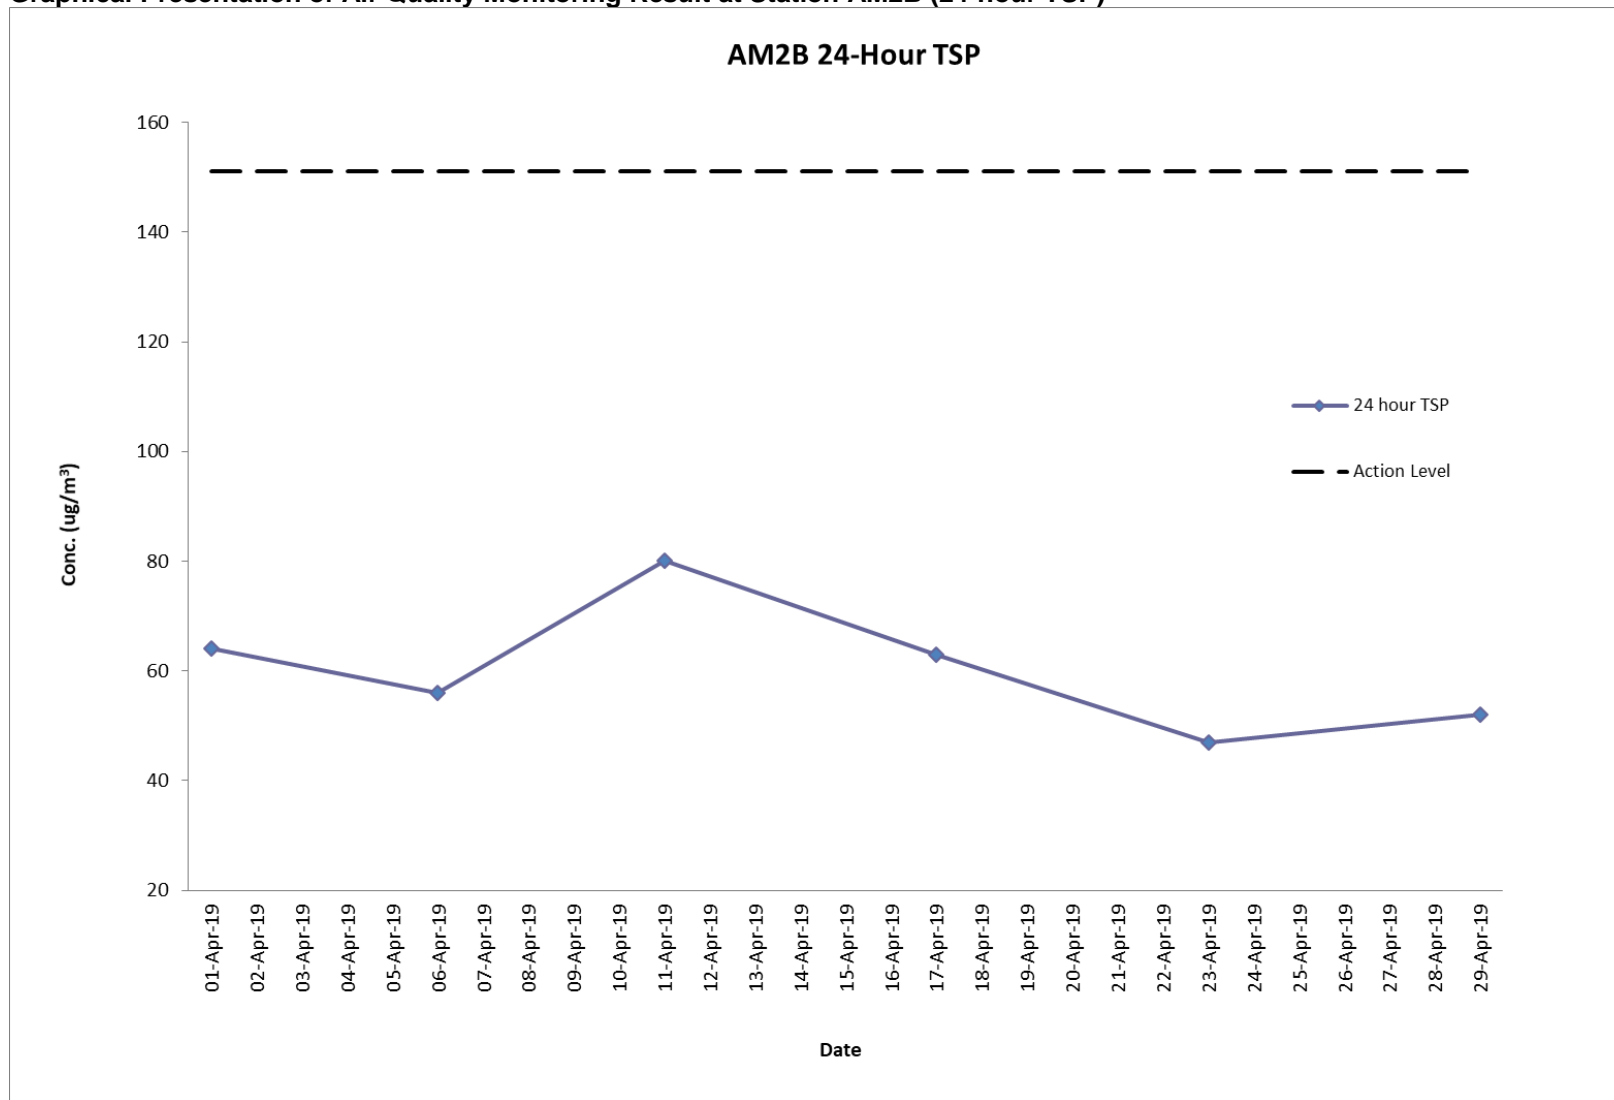
Graphical Presentation of Air Quality Monitoring Result at Station AM2B (24-hour TSP)

Start		Finish		Filter Weight (g)		Elapsed Time Reading		Sampling Time (hrs)	Flow Rate (m ³ /min)			Conc. (µg/m ³)	Weather Condition	Action Level	Limit Level
Date	Time	Date	Time	Initial	Final	Initial	Final		Initial	Final	Average				
1-Apr-19	8:15	2-Apr-19	8:15	2.6444	2.7520	19679.05	19703.05	24	1.17	1.17	1.17	64	Cloudy	151.1	260
6-Apr-19	8:14	7-Apr-19	8:14	2.6298	2.7248	19703.05	19727.05	24	1.17	1.17	1.17	56	Sunny	151.1	260
11-Apr-19	8:05	12-Apr-19	8:05	2.6124	2.7474	19727.05	19751.05	24	1.17	1.17	1.17	80	Fine	151.1	260
17-Apr-19	8:05	18-Apr-19	8:05	2.7039	2.8092	19751.05	19775.05	24	1.17	1.17	1.17	63	Cloudy	151.1	260
23-Apr-19	8:05	24-Apr-19	8:05	2.7053	2.7848	19775.05	19799.05	24	1.17	1.17	1.17	47	Fine	151.1	260
29-Apr-19	8:05	30-Apr-19	8:05	2.6970	2.7852	19799.05	19823.05	24	1.17	1.17	1.17	52	Fine	151.1	260

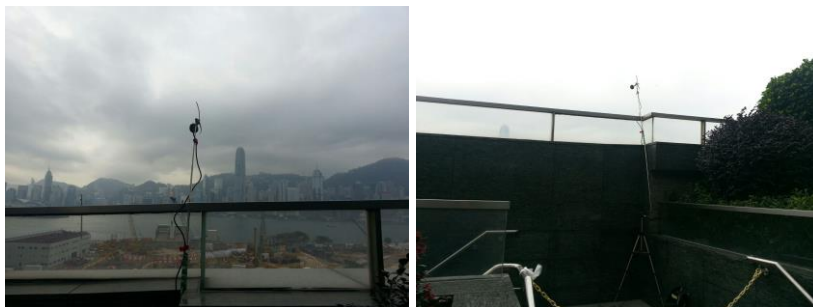
The station set-up of a free-field measurement at Station NM1A.

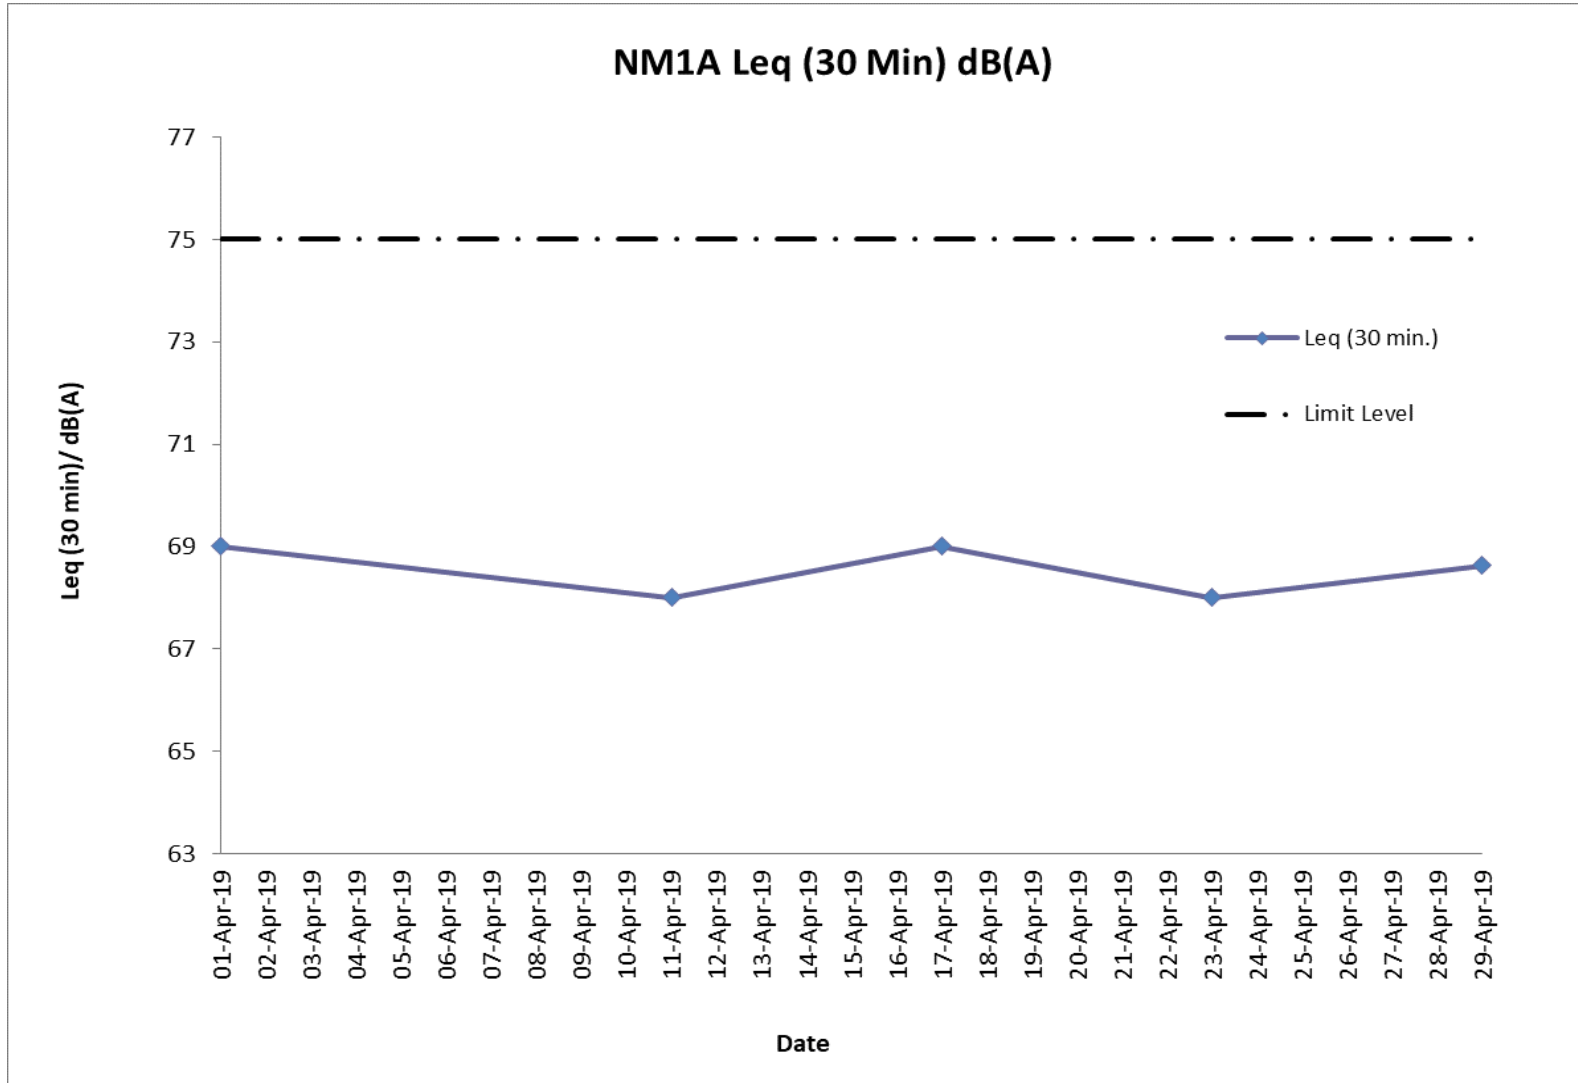
Graphical Presentation Noise Monitoring Result at Station NM1A

Date	Time	Measured L ₁₀ , dB(A)	Measured L ₉₀ , dB(A)	L _{eq} (30 min.)*, dB(A)
1-Apr-19	10:24	68.6	64.1	69
1-Apr-19	10:29	66.4	62.0	
1-Apr-19	10:34	67.5	63.3	
1-Apr-19	10:39	68.3	64.1	
1-Apr-19	10:44	66.1	62.7	
1-Apr-19	10:49	67.5	63.3	
11-Apr-19	10:14	66.5	62.3	68
11-Apr-19	10:19	67.4	63.1	
11-Apr-19	10:24	66.6	62.5	
11-Apr-19	10:29	67.3	63.4	
11-Apr-19	10:34	66.7	62.6	
11-Apr-19	10:39	66.5	62.3	
17-Apr-19	10:14	67.8	63.7	69
17-Apr-19	10:19	68.6	64.2	
17-Apr-19	10:24	69.5	65.6	
17-Apr-19	10:29	67.9	63.5	
17-Apr-19	10:34	66.2	62.6	
17-Apr-19	10:39	67.3	63.3	
23-Apr-19	10:10	66.0	62.7	68
23-Apr-19	10:15	68.3	64.1	
23-Apr-19	10:20	68.9	64.5	
23-Apr-19	10:25	67.6	63.2	
23-Apr-19	10:30	66.4	63.0	
23-Apr-19	10:35	66.5	62.5	
29-Apr-19	10:12	66.4	62.2	69
29-Apr-19	10:17	67.9	63.5	
29-Apr-19	10:22	68.0	64.1	
29-Apr-19	10:27	69.3	65.5	
29-Apr-19	10:32	66.5	62.3	
29-Apr-19	10:37	67.7	63.4

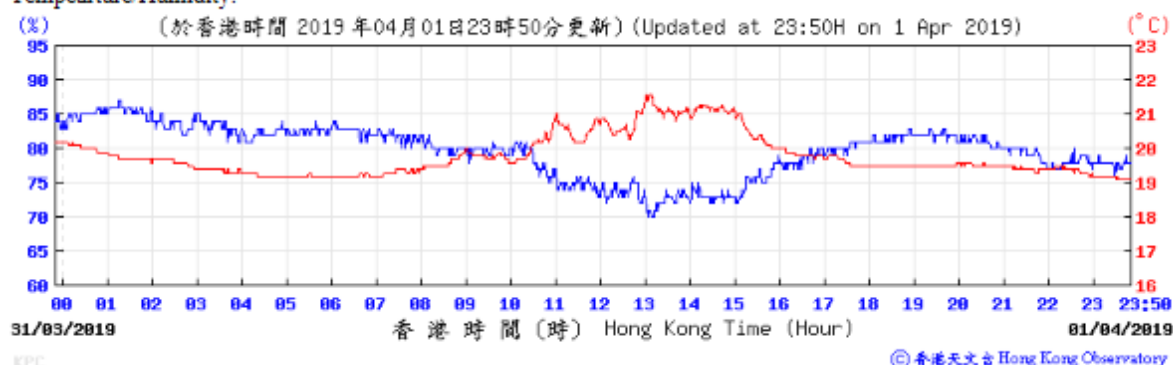
Temperature/Humidity:

Extract of Meteorological Observations for King's Park Automatic Weather Station, April 2019
