Development at West Kowloon Cultural District

Quarterly Environmental Monitoring and Audit
(EM&A) Report (May 2019 - July 2019)

August 2019

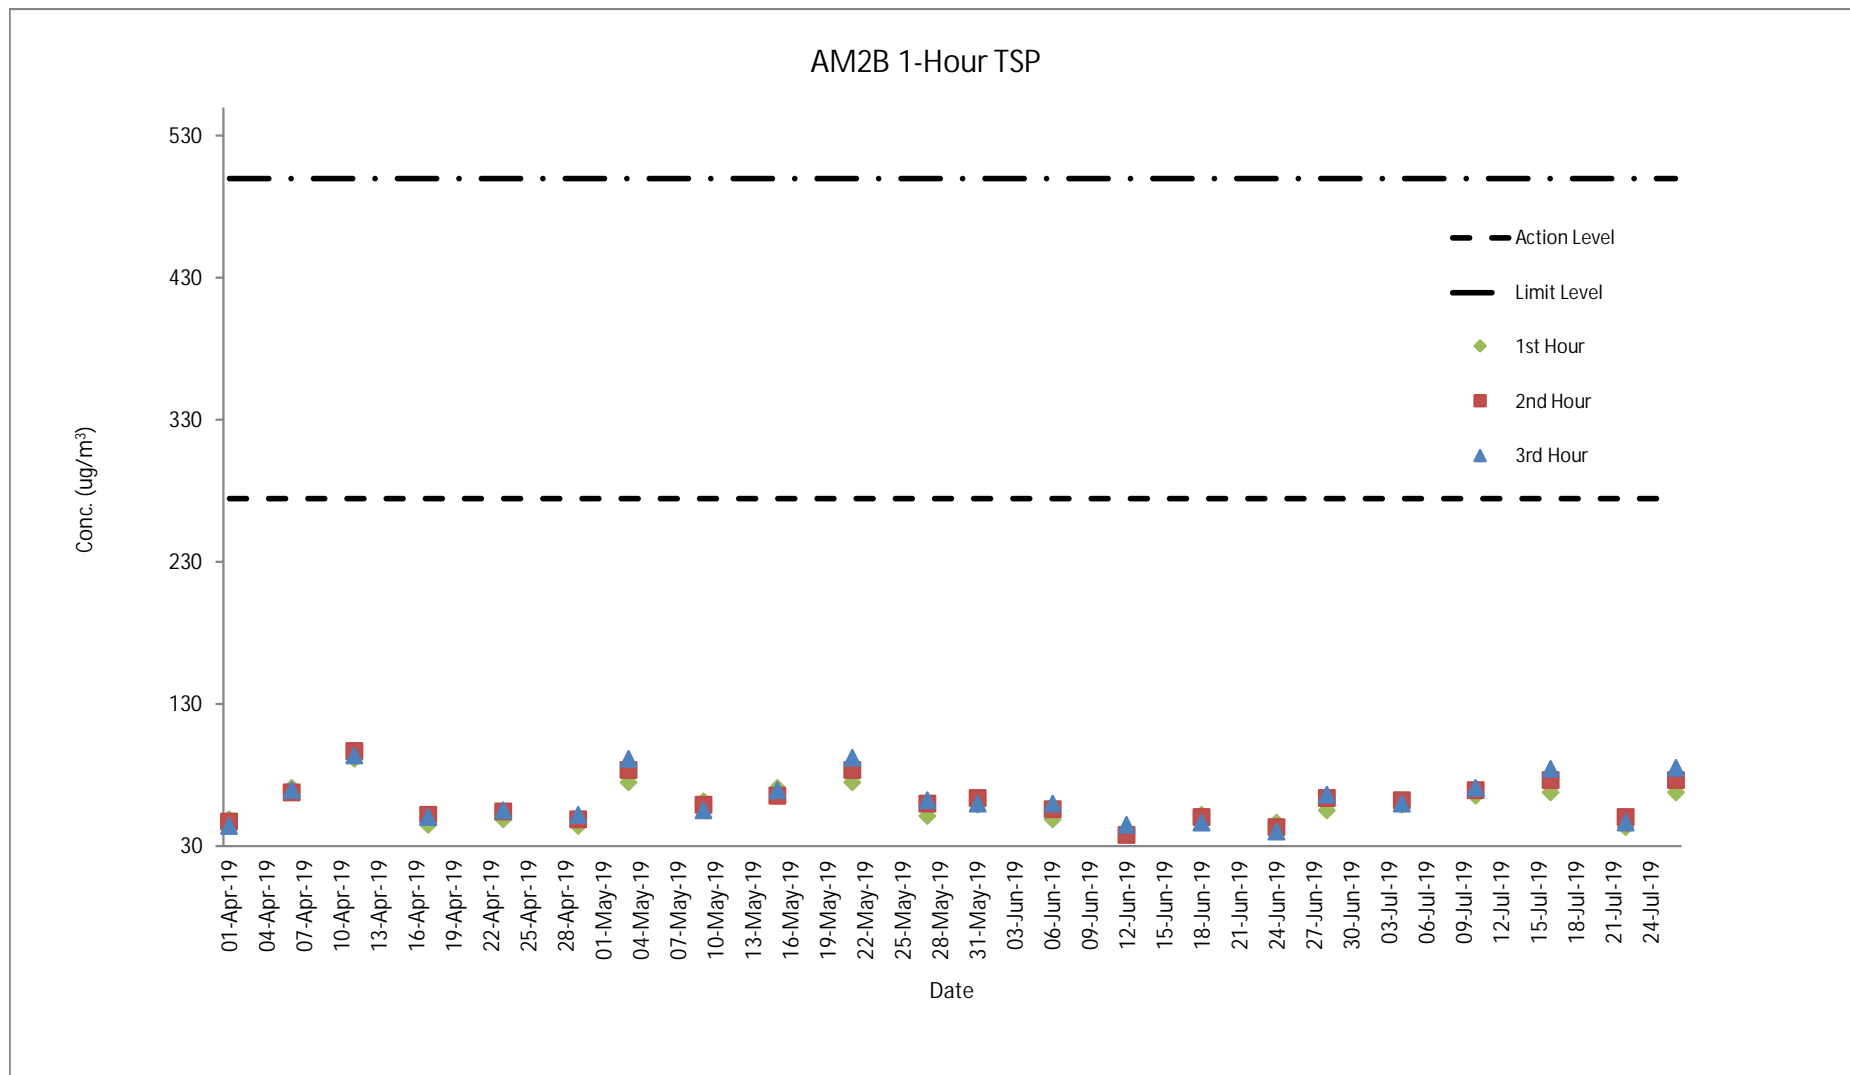
Graphical Presentation of Air Quality Monitoring Result at Station AM2B (1-hour TSP)

Date	Weather Condition	Time	Conc. ($\mu\text{g}/\text{m}^3$)			Action Level ($\mu\text{g}/\text{m}^3$)	Limit Level ($\mu\text{g}/\text{m}^3$)
			1 st Hour	2 nd Hour	3 rd Hour		
03-May-19	Cloudy	8:17 - 11:17	75	83	91	274.2	500
09-May-19	Cloudy	8:22 - 11:22	61	59	55	274.2	500
15-May-19	Fine	8:16 - 11:16	71	65	69	274.2	500
21-May-19	Cloudy	8:18 - 11:18	75	83	92	274.2	500
27-May-19	Cloudy	8:22 - 11:22	51	60	62	274.2	500
31-May-19	Cloudy	8:25 - 11:25	59	64	60	274.2	500
06-Jun-19	Cloudy	8:04 - 11:04	49	56	60	274.2	500
12-Jun-19	Cloudy	8:07 - 11:07	41	38	45	274.2	500
18-Jun-19	Cloudy	13:10 - 16:10	52	50	46	274.2	500
24-Jun-19	Cloudy	8:17 - 11:17	46	43	40	274.2	500
28-Jun-19	Fine	8:38 - 11:38	55	64	66	274.2	500
04-Jul-19	Cloudy	8:32 - 11:32	59	62	60	274.2	500
10-Jul-19	Cloudy	8:38 - 11:38	65	69	71	274.2	500
16-Jul-19	Sunny	8:25 - 11:25	68	76	84	274.2	500
22-Jul-19	Cloudy	8:38 - 11:38	43	50	46	274.2	500
26-Jul-19	Fine	13:17 - 16:17	68	76	85	274.2	500

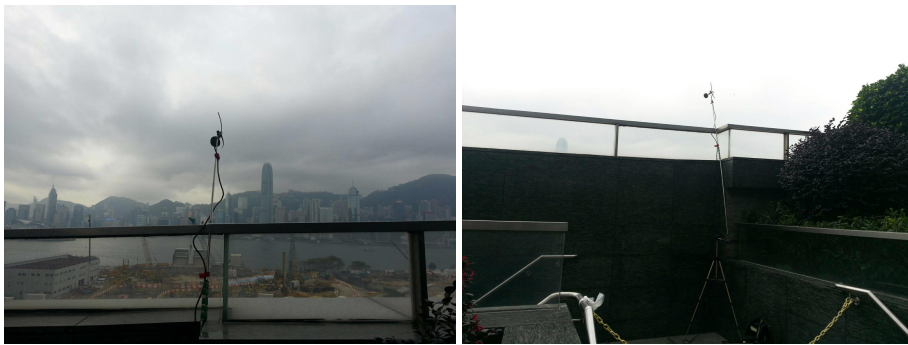
+3dB (A) correction was applied to free-field measurement.

The station set-up of a free-field measurement at Station NM1A.
