# **Development at West Kowloon Cultural District**

Monthly Environmental Monitoring and Audit (EM&A) Report for July 2019

August 2019

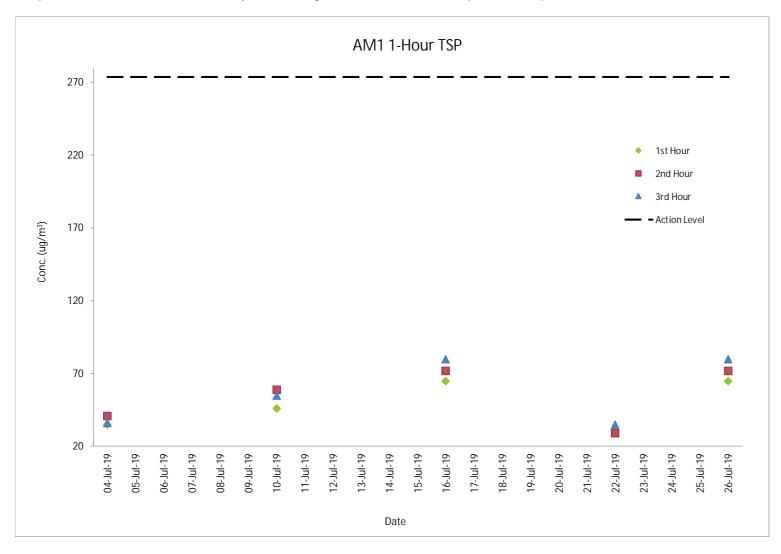
## **Graphical Presentation of Air Quality Monitoring Result at Station AM1 (1-hour TSP)**

Conc. (µg/m³	)	Action	Limit
Date	Weather Condition	Time	1 <sup>st</sup> Hour	2 <sup>nd</sup> Hour	3 <sup>rd</sup> Hour	Level ( <b>μ</b> g/m³)	Level ( <b>µ</b> g/m³)
04-Jul-19	Cloudy	8:17 - 11:17	35	41	36	273.7	500
10-Jul-19	Cloudy	8:24 - 11:24	46	59	55	273.7	500
16-Jul-19	Sunny	8:08 - 11:08	65	72	80	273.7	500
22-Jul-19	Cloudy	8:22 - 11:22	31	29	35	273.7	500
26-Jul-19	Fine	13:02 - 16:02	65	72	80	273.7	500

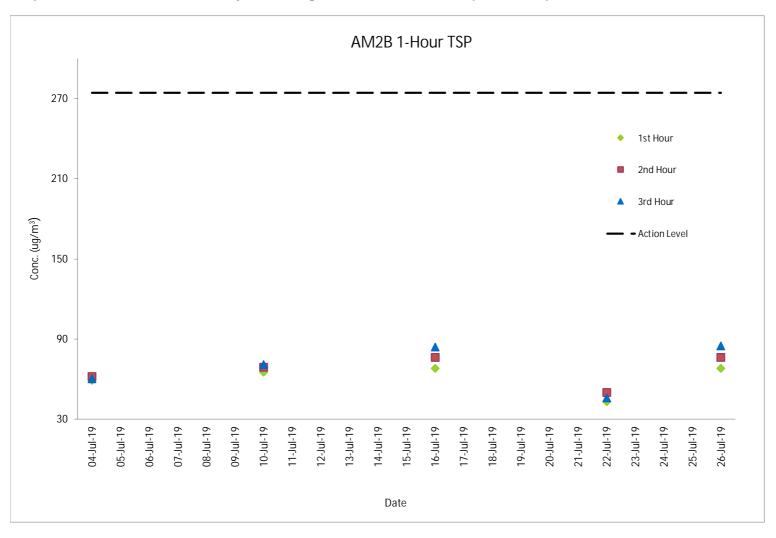
## **Graphical Presentation of Air Quality Monitoring Result at Station AM2B (1-hour TSP)**

Conc. (µg/m³)	)	Action	Limit
Date	Weather Condition	Time	1 <sup>st</sup> Hour	2 <sup>nd</sup> Hour	3 <sup>rd</sup> Hour	Level (μg/m³)	Level ( <b>µ</b> g/m³)
04-Jul-19	Cloudy	8:32 - 11:32	59	62	60	274.2	500
10-Jul-19	Cloudy	8:38 - 11:38	65	69	71	274.2	500
16-Jul-19	Sunny	8:25 - 11:25	68	76	84	274.2	500
22-Jul-19	Cloudy	8:38 - 11:38	43	50	46	274.2	500
26-Jul-19	Fine	13:17 - 16:17	68	76	85	274.2	500

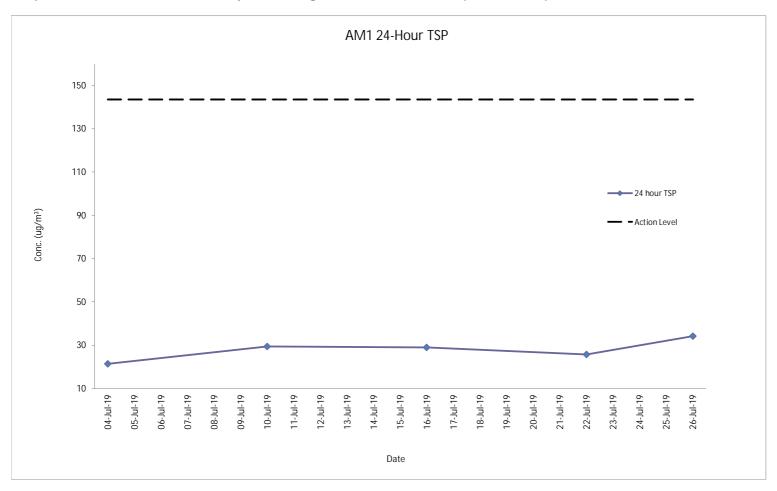
## **Graphical Presentation of Air Quality Monitoring Result at Station AM1 (24-hour TSP)**

Elapsed Tir	me Reading							Action	Limit
Stai	rt	Finis	sh	Filter W	eight (g)	(h	rs)	Sampling Time Flow Rate (m³/min)		Conc.	Weather	Level	Level		
Date	Time	Date	Time	Initial	Final	Initial	Final	(hrs)	Initial	Final	Average	$(\mu g/m^3)$	Condition	(µg/m³)	(µg/m³)
04-Jul-19	08:15	05-Jul-19	08:15	2.6735	2.7094	24432.38	24456.38	24	1.17	1.17	1.17	21	Cloudy	143.6	260
10-Jul-19	08:22	11-Jul-19	08:22	2.6909	2.7404	24456.38	24480.38	24	1.17	1.17	1.17	29	Cloudy	143.6	260
16-Jul-19	08:10	17-Jul-19	08:10	2.6885	2.7373	24480.38	24504.38	24	1.17	1.17	1.17	29	Sunny	143.6	260
22-Jul-19	08:20	23-Jul-19	08:20	2.6954	2.7388	24504.38	24528.38	24	1.17	1.17	1.17	26	Cloudy	143.6	260
26-Jul-19	08:00	27-Jul-19	08:00	2.6616	2.719	24528.38	24552.38	24	1.17	1.17	1.17	34	Fine	143.6	260

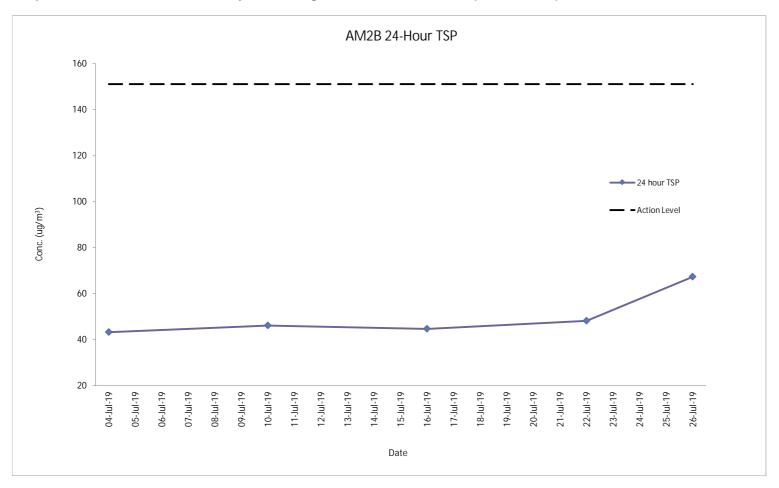
## **Graphical Presentation of Air Quality Monitoring Result at Station AM2B (24-hour TSP)**

Elapsed Tir	ne Reading							Action	Limit
Stai	rt	Finis	sh	Filter W	e <b>ight (g)</b>	(h	rs)	Sampling Time	Flov	v Rate (m³/	min)	Conc.	Weather	Level	Level
Date	Time	Date	Time	Initial	Final	Initial	Final	(hrs)	Initial	Final	Average	$(\mu g/m^3)$	Condition	(µg/m³)	(µg/m³)
04-Jul-19	08:30	05-Jul-19	08:30	2.6636	2.7389	20087.05	20111.05	24	1.21	1.21	1.21	43	Cloudy	151.1	260
10-Jul-19	08:36	11-Jul-19	08:36	2.7106	2.7908	20111.05	20135.05	24	1.21	1.21	1.21	46	Cloudy	151.1	260
16-Jul-19	08:23	17-Jul-19	08:23	2.6727	2.7506	20135.05	20159.05	24	1.21	1.21	1.21	45	Sunny	151.1	260
22-Jul-19	08:36	23-Jul-19	08:36	2.7017	2.7855	20159.05	20183.05	24	1.21	1.21	1.21	48	Cloudy	151.1	260
26-Jul-19	08:15	27-Jul-19	08:15	2.6868	2.8070	20183.05	20207.05	24	1.24	1.24	1.24	67	Fine	151.1	260

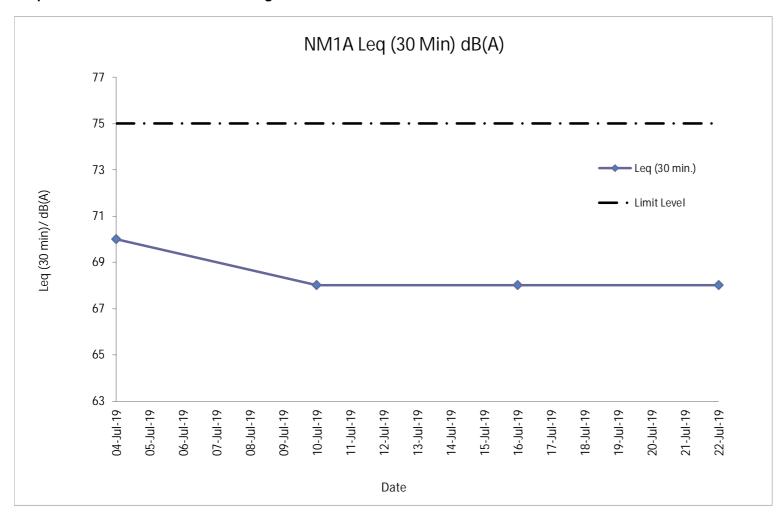
## **Graphical Presentation Noise Monitoring Result at Station NM1A**

Date	Time	Measured L <sub>10</sub> , dB(A)	Measured L <sub>90</sub> , dB(A)	L <sub>eq</sub> (30 min.)*, dB(A)
04-Jul-19	10:35	68.4	64.1	
04-Jul-19	10:40	69.1	65.0	
04-Jul-19	10:45	67.1	63.1	/0/
04-Jul-19	10:50	68.2	64.0	69.6
04-Jul-19	10:55	69.1	65.7	
04-Jul-19	11:00	67.0	63.2	
10-Jul-19	10:15	66.9	62.4	
10-Jul-19	10:20	67.5	63.0	
10-Jul-19	10:25	68.5	64.7	40.0
10-Jul-19	10:30	68.8	64.3	68.0
10-Jul-19	10:35	66.7	62.5	
10-Jul-19	10:40	66.9	63.6	
16-Jul-19	10:33	66.5	62.7	
16-Jul-19	10:38	67.8	63.6	
16-Jul-19	10:43	66.3	62.7	68.3
16-Jul-19	10:48	68.4	64.4	08.3
16-Jul-19	10:53	67.2	63.9	
16-Jul-19	10:58	66.3	62.7	
22-Jul-19	10:44	66.0	62.7	
22-Jul-19	10:49	68.4	64.4	
22-Jul-19	10:54	67.5	63.4	40.2
22-Jul-19	10:59	66.7	62.8	68.3
22-Jul-19	11:04	67.9	63.6	
22-Jul-19	11:09	66.2	62.3
