Development at West Kowloon Cultural District

Monthly Environmental Monitoring and Audit
(EM&A) Report for August 2019

September 2019

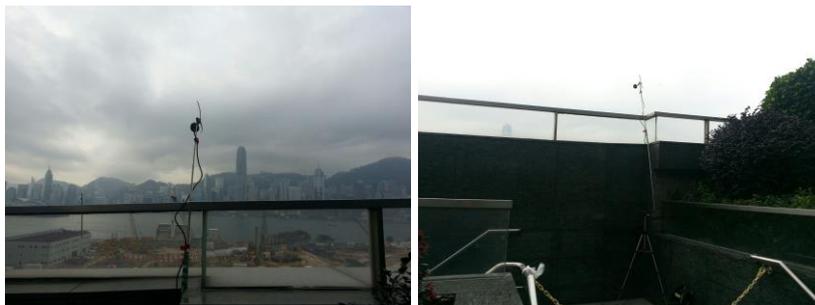
The station set-up of a free-field measurement at Station NM1A
