# **Development at West Kowloon Cultural District**

Monthly Environmental Monitoring and Audit  
(EM&A) Report for October 2019

November 2019

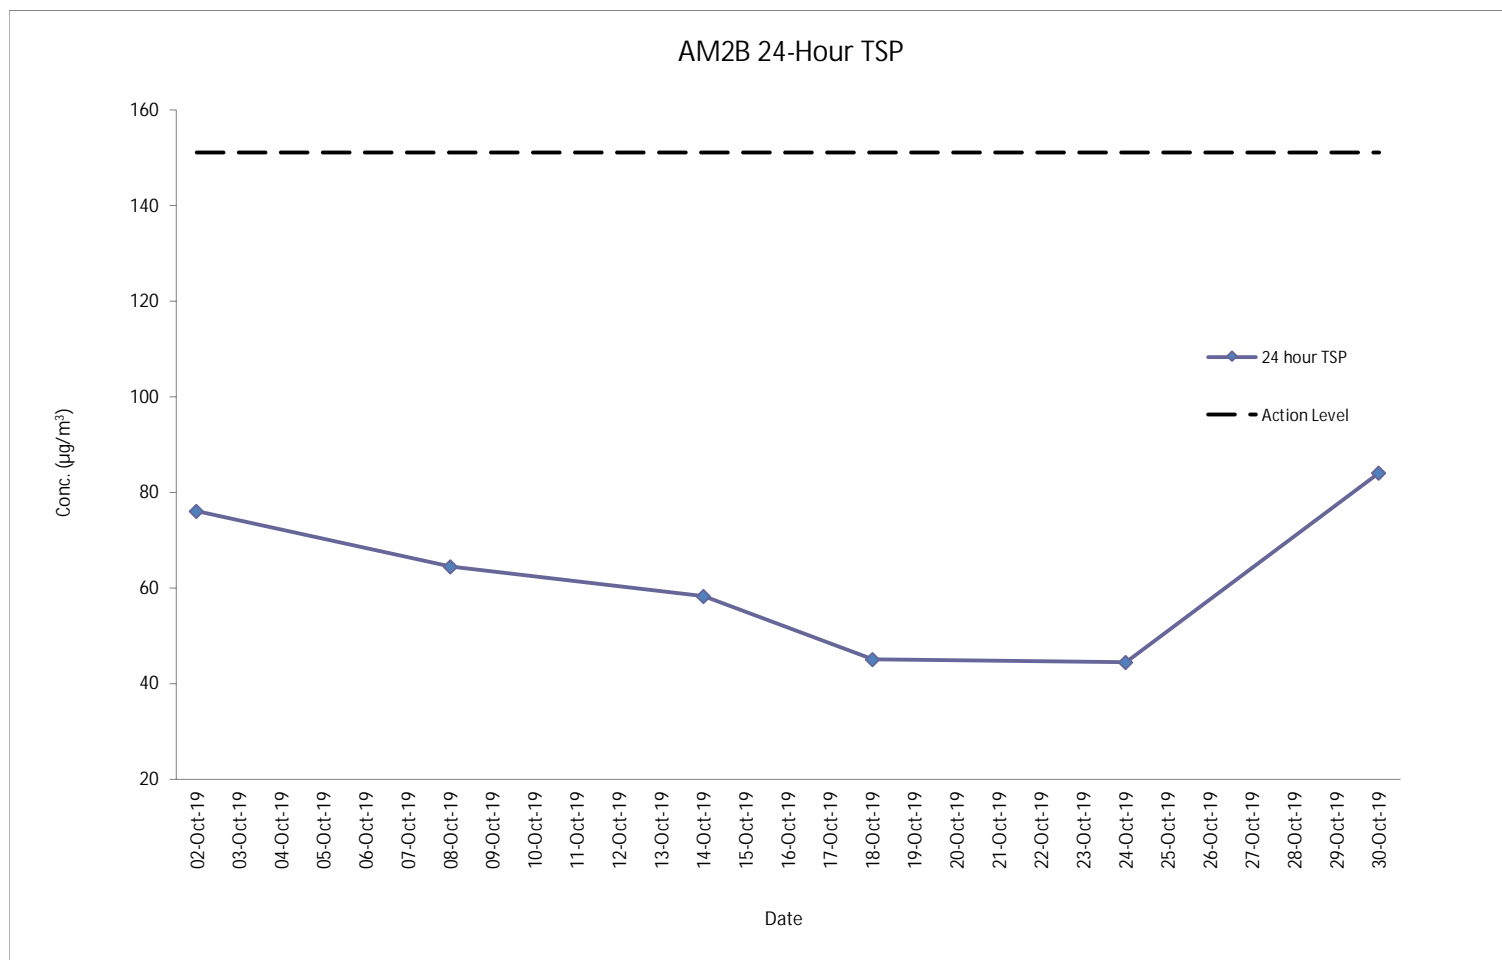
### Graphical Presentation of Air Quality Monitoring Result at Station AM2B (24-hour TSP)

Start		Finish		Filter Weight (g)		Elapsed Time Reading (hrs)		Sampling Time (hrs)	Flow Rate (m <sup>3</sup> /min)			Conc. (µg/m <sup>3</sup> )	Weather Condition	Action Level (µg/m <sup>3</sup> )	Limit Level (µg/m <sup>3</sup> )
Date	Time	Date	Time	Initial	Final	Initial	Final		Initial	Final	Average				
02-Oct-19	08:20	03-Oct-19	08:20	2.7055	2.8457	20371.05	20395.05	24	1.28	1.28	1.28	76	Sunny	151.1	260
08-Oct-19	08:22	09-Oct-19	08:22	2.7240	2.8428	20395.05	20419.05	24	1.28	1.28	1.28	64	Fine	151.1	260
14-Oct-19	08:20	15-Oct-19	08:20	2.7236	2.8312	20419.05	20443.05	24	1.28	1.28	1.28	58	Cloudy	151.1	260
18-Oct-19	08:20	19-Oct-19	08:20	2.7145	2.7975	20443.05	20467.05	24	1.28	1.28	1.28	45	Fine	151.1	260
24-Oct-19	08:22	25-Oct-19	08:22	2.7056	2.7875	20467.05	20491.05	24	1.28	1.28	1.28	44	Sunny	151.1	260
30-Oct-19	08:18	31-Oct-19	08:18	2.6729	2.8276	20491.05	20515.05	24	1.28	1.28	1.28	84	Fine	151.1	260

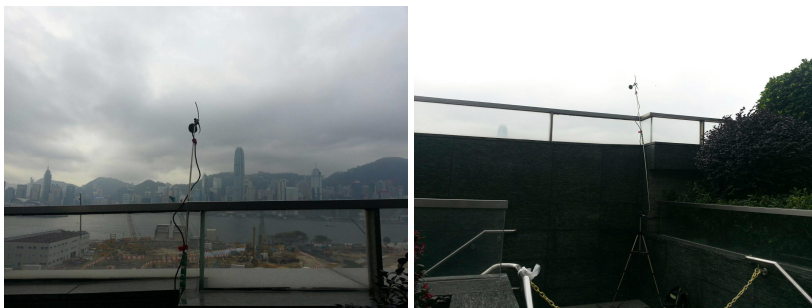
The station set-up of a free-field measurement at Station NM1A.

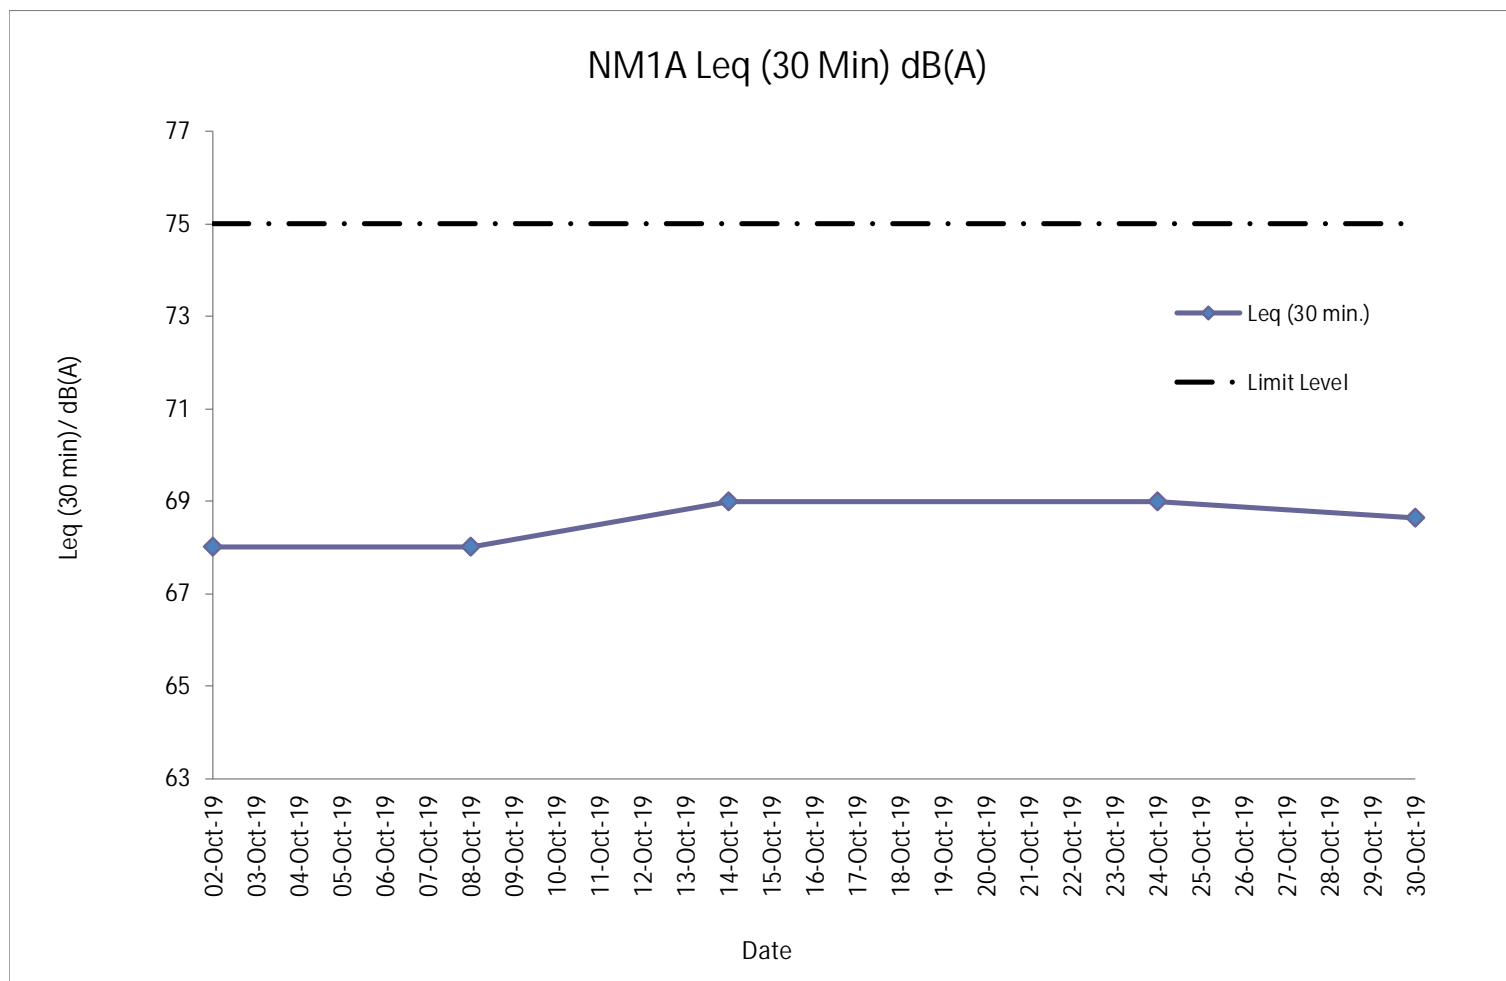
### Graphical Presentation Noise Monitoring Result at Station NM1A

Date	Time	Measured L <sub>10</sub> , dB(A)	Measured L <sub>90</sub> , dB(A)	L <sub>eq</sub> (30 min.)*, dB(A)
02-Oct-19	10:28	66.4	62.7	68.2
02-Oct-19	10:33	67.9	63.1	
02-Oct-19	10:38	68.0	63.9	
02-Oct-19	10:43	66.4	62.9	
02-Oct-19	10:48	66.7	62.7	
02-Oct-19	10:53	68.2	64.5	
08-Oct-19	10:30	66.4	62.1	68.5
08-Oct-19	10:35	67.9	63.4	
08-Oct-19	10:40	67.8	63.9	
08-Oct-19	10:45	66.5	62.4	
08-Oct-19	10:50	67.6	63.4	
08-Oct-19	10:55	68.0	64.0	
14-Oct-19	10:28	68.4	64.5	69.5
14-Oct-19	10:33	67.5	63.2	
14-Oct-19	10:38	69.7	65.2	
14-Oct-19	10:43	69.6	65.8	
14-Oct-19	10:48	68.7	64.9	
14-Oct-19	10:53	67.7	63.5	
24-Oct-19	10:30	68.3	63.1	69.0
24-Oct-19	10:35	67.5	62.7	
24-Oct-19	10:40	67.9	62.9	
24-Oct-19	10:45	68.0	63.4	
24-Oct-19	10:50	68.4	63.9	
24-Oct-19	10:55	67.2	62.7	
30-Oct-19	10:26	66.9	62.7	68.6
30-Oct-19	10:31	67.4	63.4	
30-Oct-19	10:36	68.7	64.2	
30-Oct-19	10:41	66.7	62.7	
30-Oct-19	10:46	68.4	64.5	
30-Oct-19	10:51	67.1	63.2

\* +3dB (A) correction was applied to free-field measurement.
