Development at West Kowloon Cultural District

Monthly Environmental Monitoring and Audit
(EM&A) Report for August 2020

4 September 2020

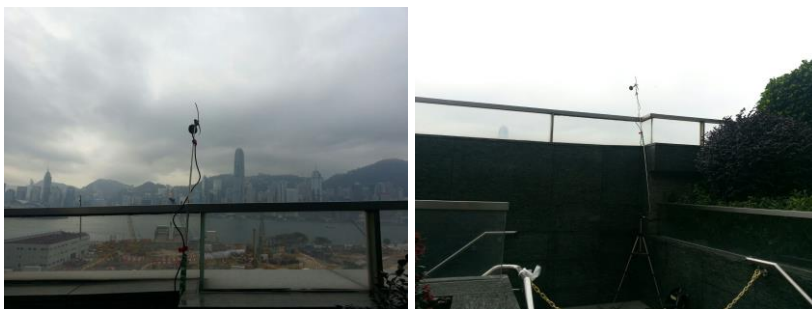
The station set-up of a free-field measurement at Station NM1A.
