Development at West Kowloon Cultural District

Monthly Environmental Monitoring and Audit
(EM&A) Report for September 2020

9 October 2020

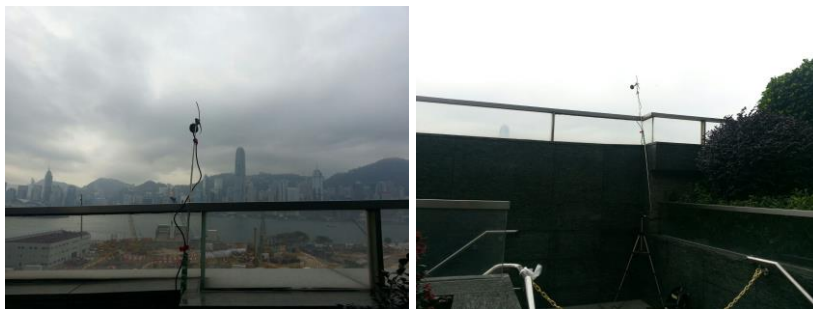
* +3dB (A) correction was applied to free-field measurement.

The station set-up of a free-field measurement at Station NM1A.
