# Development at West Kowloon Cultural District

Monthly Environmental Monitoring and Audit (EM&A) Report  
for September 2021

08 October 2021

**Part-1: EM&A at Lyric Theatre Complex**

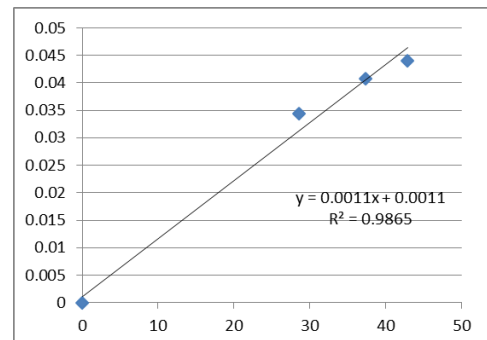
Slope (K-factor): 0.0011  
Correlation Coefficient 0.9932  
Date of Issue 30 November 2020

1. **Strong** Correlation ( $R > 0.8$ )
  2. Factor 0.0011 should be applied for TSP monitoring
- \*If  $R < 0.5$ , repair or re-verification is required for the equipment

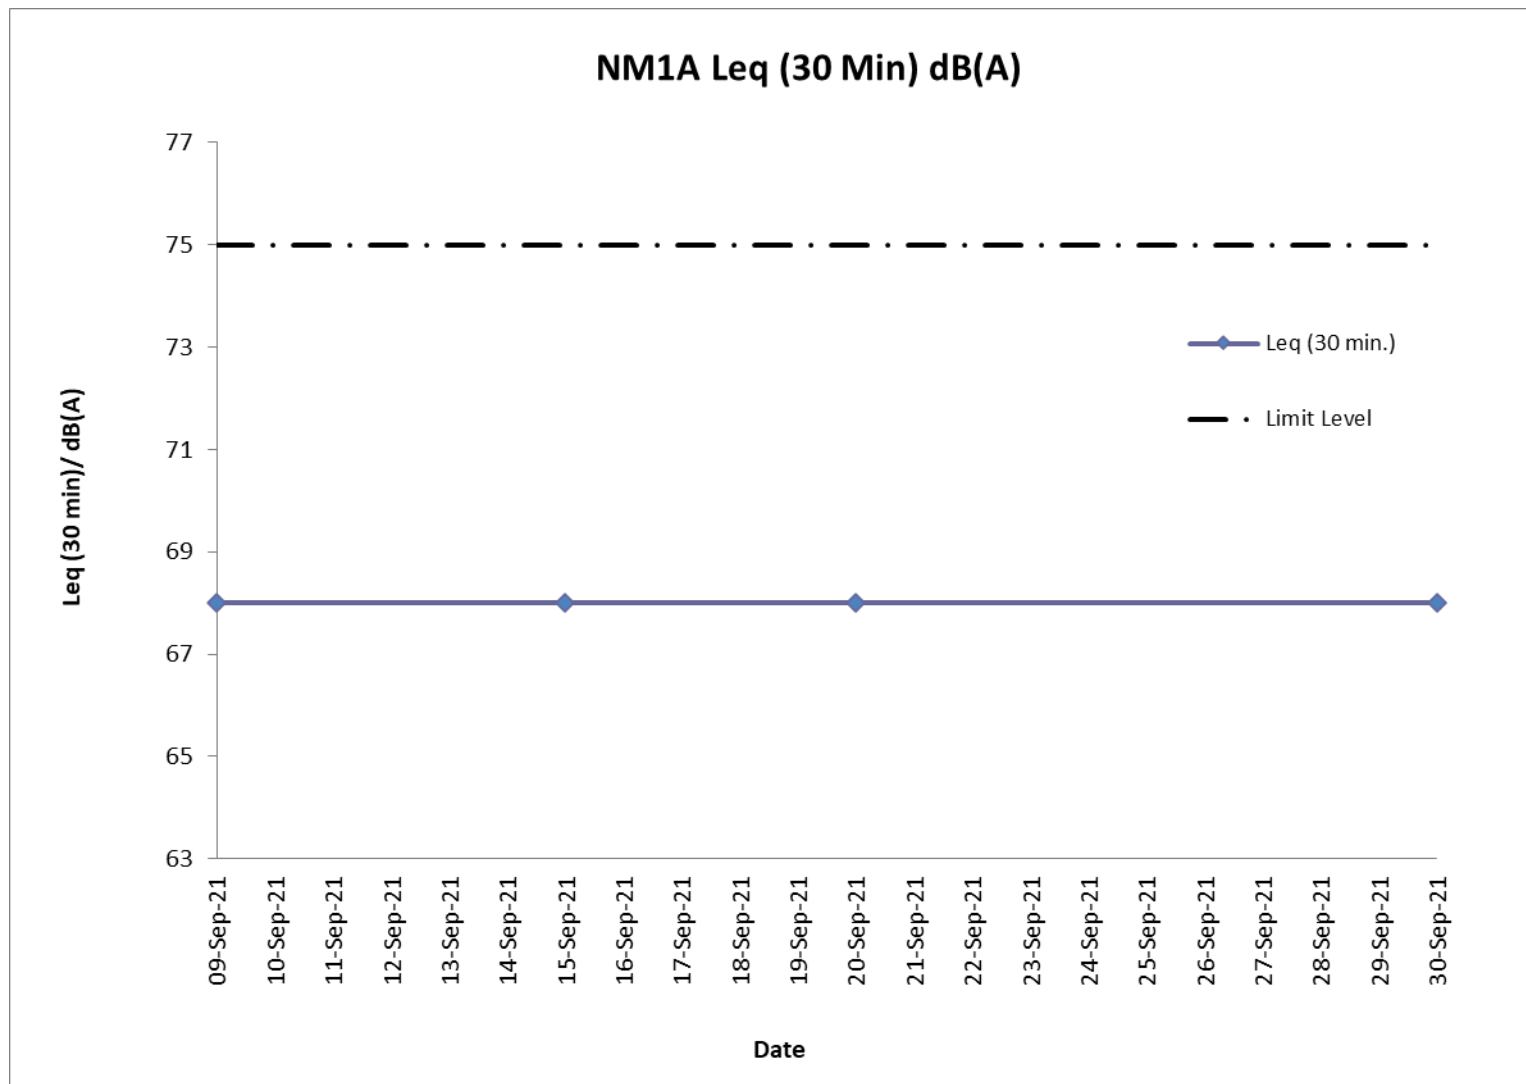
### Graphical Presentation Noise Monitoring Result at Station NM1A

The station set-up of a free-field measurement at Station NM1A.
