Development at West Kowloon Cultural District

Monthly Environmental Monitoring and Audit (EM&A) Report

for May 2022

Part-1: EM&A at Lyric Theatre Complex

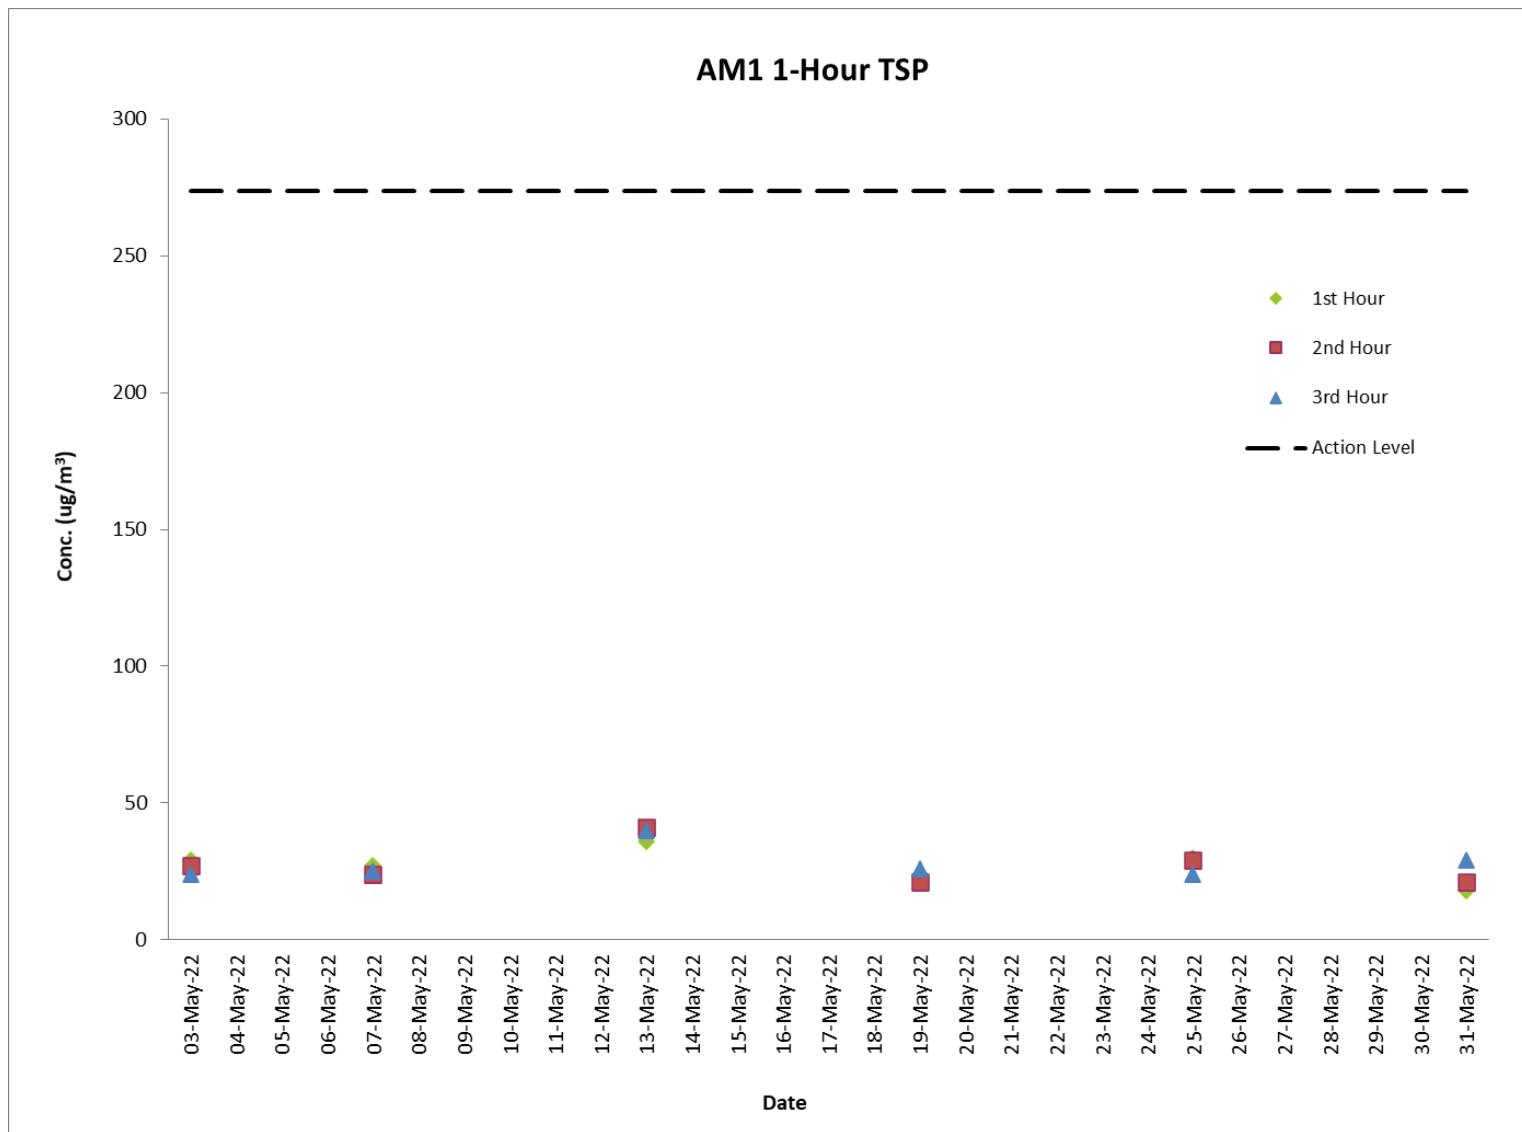
Graphical Presentation of Air Quality Monitoring Result at Station AM1 (1-hour TSP)

Date	Weather Condition	Time	Conc. ($\mu\text{g}/\text{m}^3$)			Action Level ($\mu\text{g}/\text{m}^3$)	Limit Level ($\mu\text{g}/\text{m}^3$)
			1 st Hour	2 nd Hour	3 rd Hour		
03-May-22	Sunny	8:27 - 11:27	29	27	24	273.7	500
07-May-22	Fine	8:32 - 11:32	27	24	25	273.7	500
13-May-22	Cloudy	8:24 - 11:24	36	41	40	273.7	500
19-May-22	Cloudy	8:22 - 11:22	24	21	26	273.7	500
25-May-22	Cloudy	8:32 - 11:32	30	29	24	273.7	500
31-May-22	Fine	8:22 - 11:22	18	21	29	273.7	500

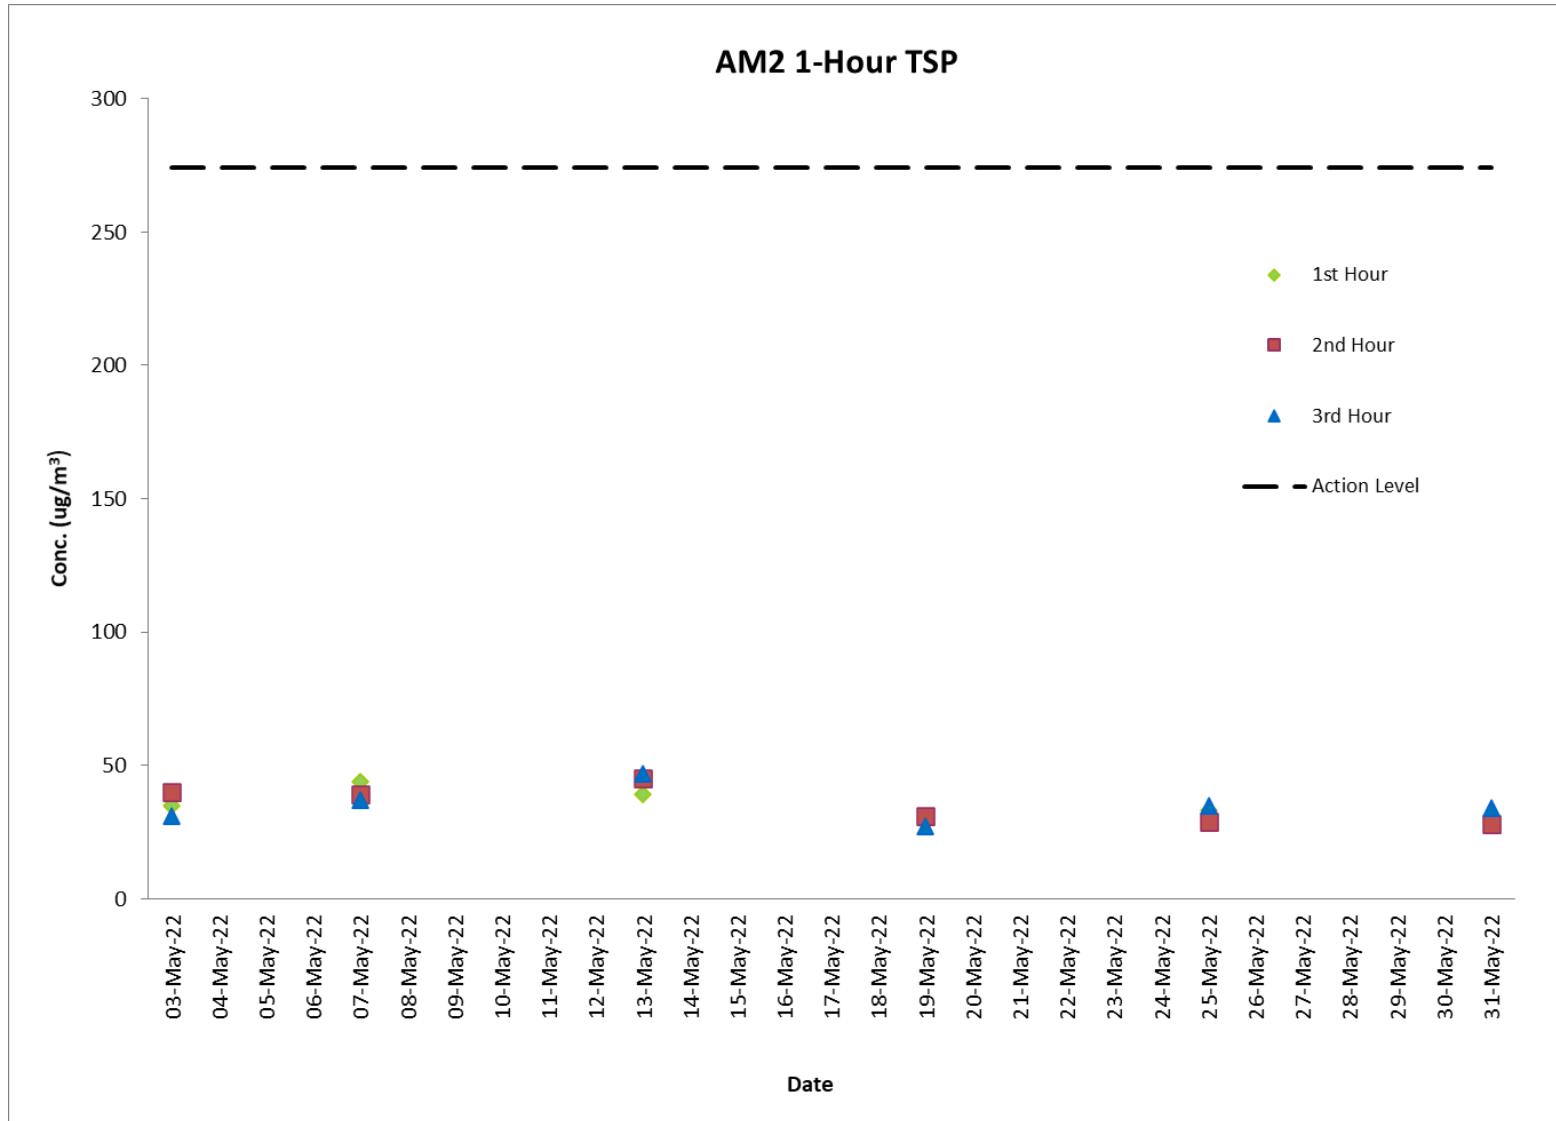
Graphical Presentation of Air Quality Monitoring Result at Station AM2 (1-hour TSP)

Date	Weather Condition	Time	Conc. ($\mu\text{g}/\text{m}^3$)			Action Level ($\mu\text{g}/\text{m}^3$)	Limit Level ($\mu\text{g}/\text{m}^3$)
			1 st Hour	2 nd Hour	3 rd Hour		
03-May-22	Sunny	8:39 - 11:39	35	40	31	274.2	500
07-May-22	Fine	8:45 - 11:45	44	39	37	274.2	500
13-May-22	Cloudy	8:37 - 11:37	39	45	47	274.2	500
19-May-22	Cloudy	8:36 - 11:36	29	31	27	274.2	500
25-May-22	Cloudy	8:46 - 11:46	33	29	35	274.2	500
31-May-22	Fine	8:36 - 11:36	30	28	34	274.2	500

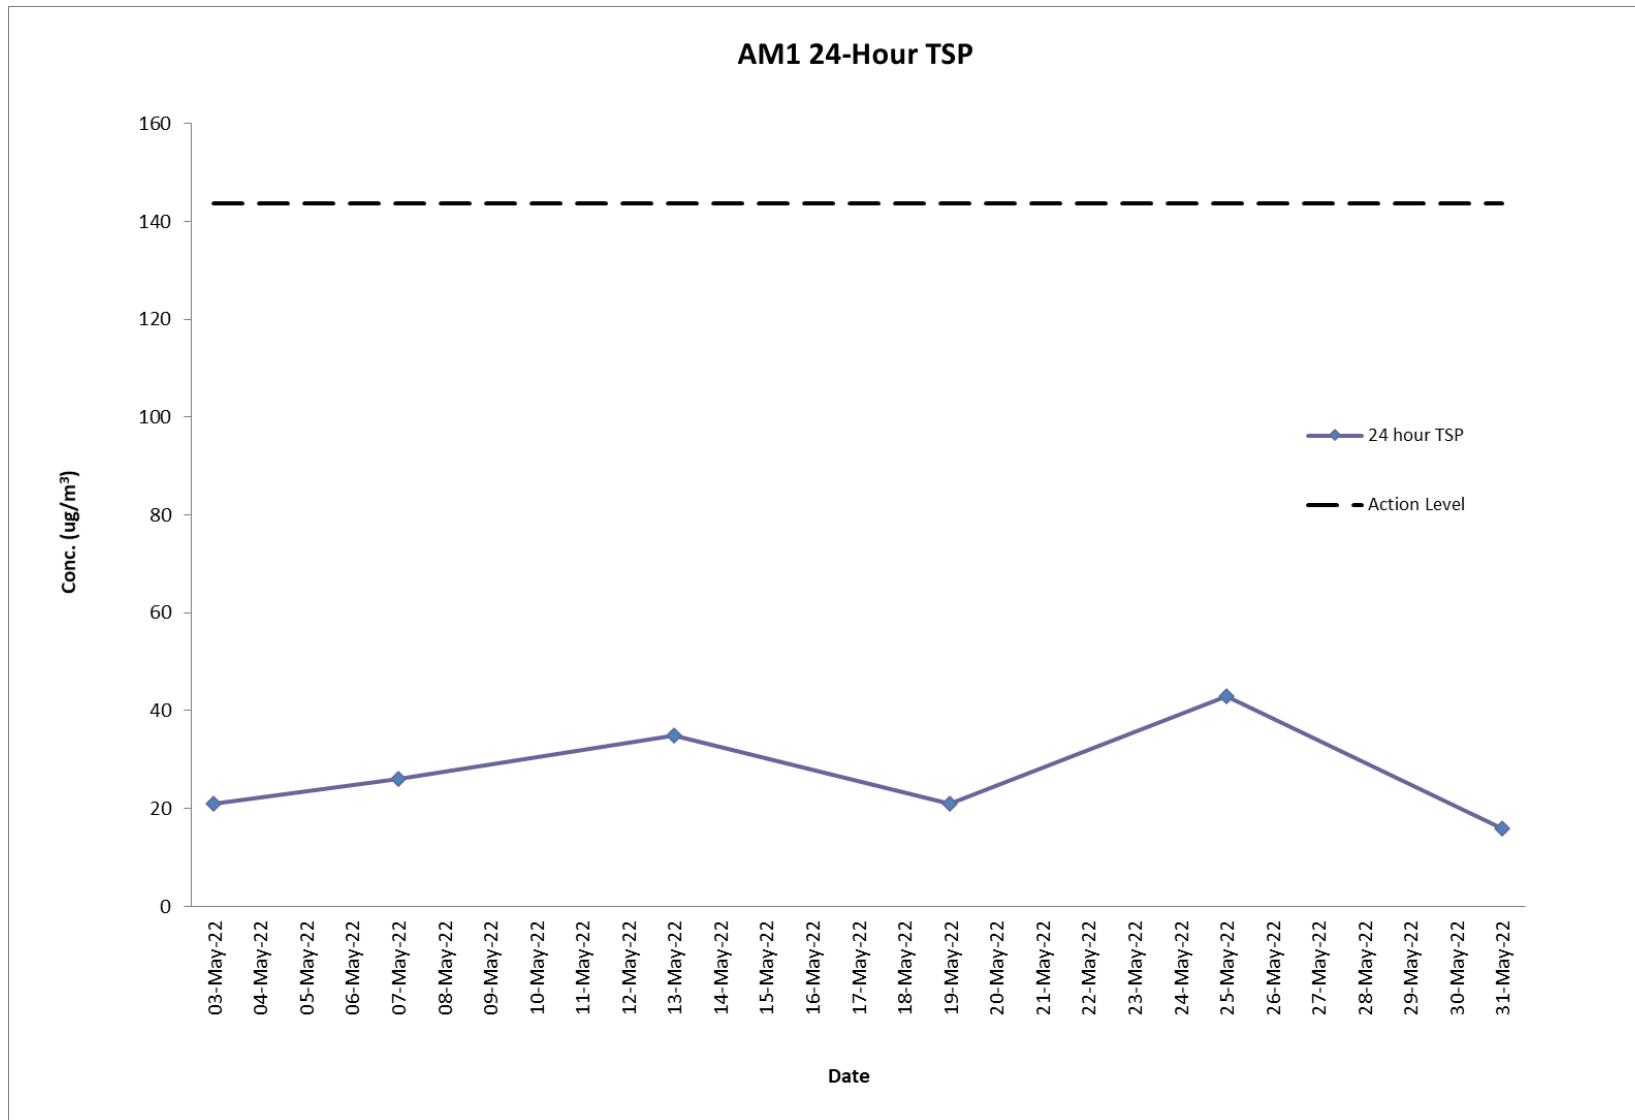
Graphical Presentation of Air Quality Monitoring Result at Station AM1 (24-hour TSP)

Start		Finish		Filter Weight (g)		Elapsed Time Reading		Sampling Time (hrs)	Flow Rate (m ³ /min)			Conc. (µg/m ³)	Weather Condition	Action Level	Limit Level
Date	Time	Date	Time	Initial	Final	Initial	Final		Initial	Final	Average				
03-May-22	08:25	04-May-22	08:25	2.7664	2.8038	24896.38	24920.38	24	1.26	1.26	1.26	21	Sunny	143.6	260
07-May-22	08:30	08-May-22	08:30	2.7564	2.8039	24920.38	24944.38	24	1.26	1.26	1.26	26	Fine	143.6	260
13-May-22	08:22	14-May-22	08:22	2.7549	2.8182	24944.38	24968.38	24	1.26	1.26	1.26	35	Cloudy	143.6	260
19-May-22	08:20	20-May-22	08:20	2.7642	2.8008	24968.38	24992.38	24	1.22	1.22	1.22	21	Cloudy	143.6	260
25-May-22	08:30	26-May-22	08:30	2.7595	2.8357	24992.38	25016.38	24	1.22	1.22	1.22	43	Cloudy	143.6	260
31-May-22	08:20	01-Jun-22	08:20	2.7509	2.7784	24016.38	24040.38	24	1.22	1.22	1.22	16	Fine	143.6	260

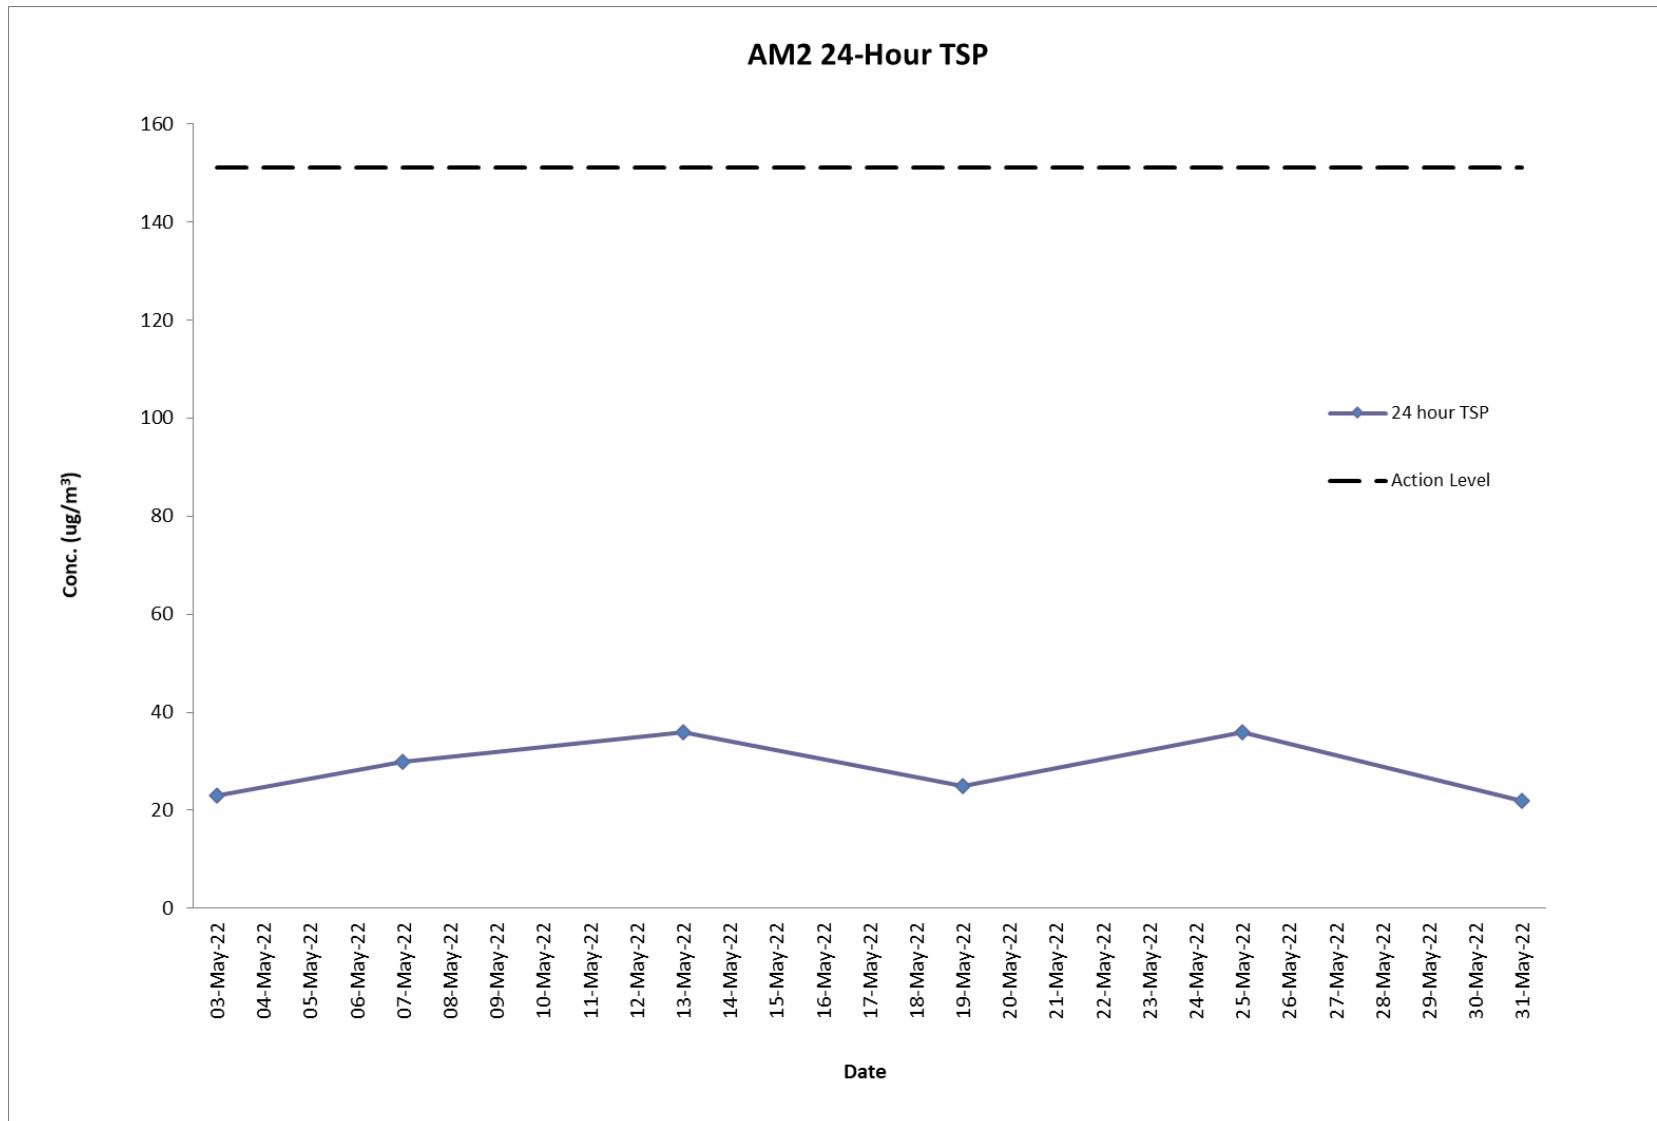
Graphical Presentation of Air Quality Monitoring Result at Station AM2 (24-hour TSP)

Start		Finish		Sampling Time (hrs)	Conc. ($\mu\text{g}/\text{m}^3$)	Weather Condition	Action Level	Limit Level
Date	Time	Date	Time					
03-May-22	08:37	04-May-22	08:37	24	23	Sunny	151.1	260
07-May-22	08:43	08-May-22	08:43	24	30	Fine	151.1	260
13-May-22	08:35	14-May-22	08:35	24	36	Cloudy	151.1	260
19-May-22	08:34	20-May-22	08:34	24	25	Cloudy	151.1	260
25-May-22	08:44	26-May-22	08:44	24	36	Cloudy	151.1	260
31-May-22	08:34	01-Jun-22	08:34	24	22	Fine	151.1	260

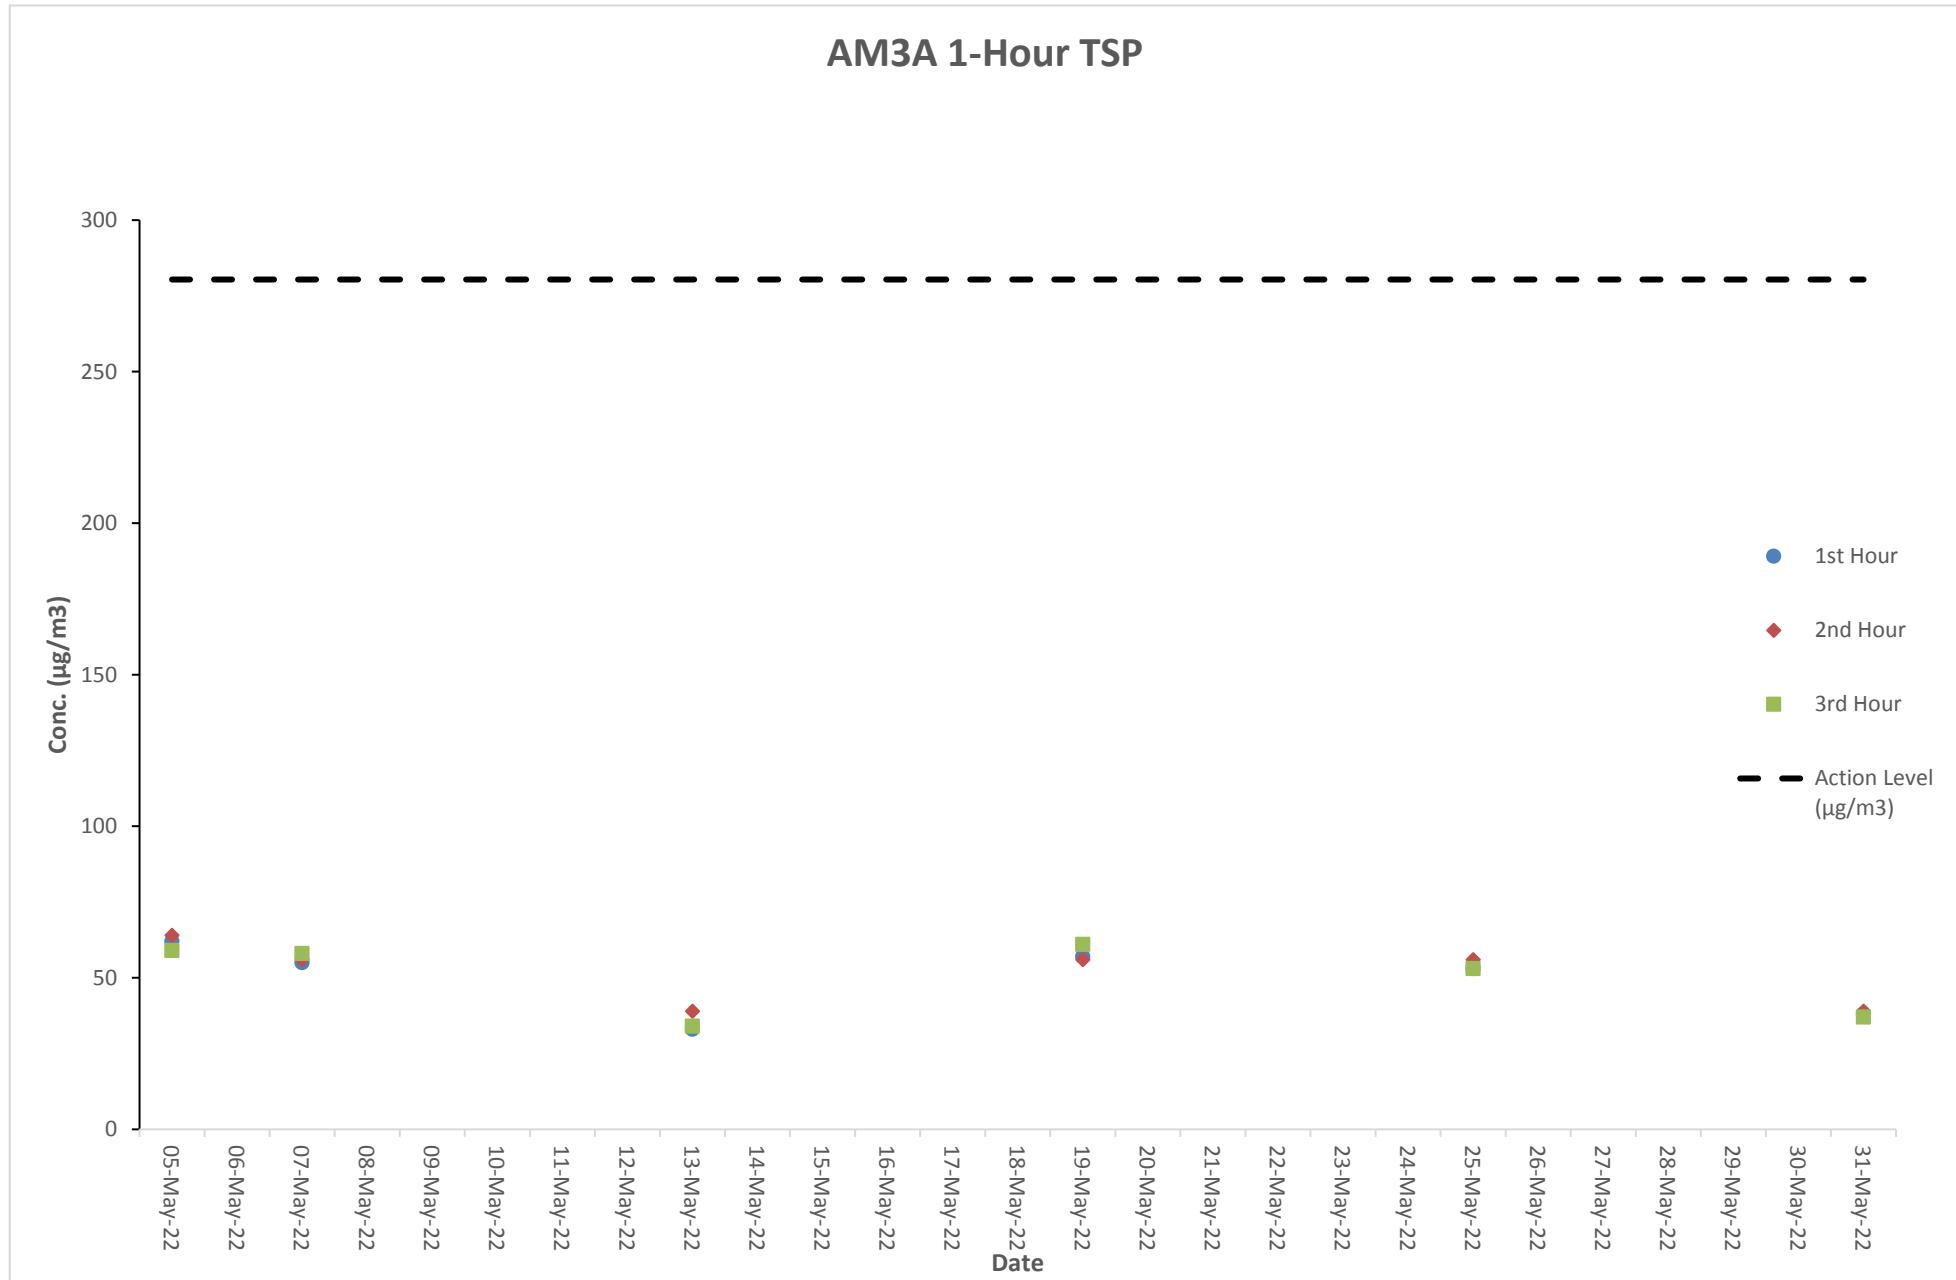
Graphical Presentation of Air Quality Monitoring Result at Station AM3A (1-hour TSP)

Date	Weather Condition	Time		Conc. (µg/m³)			Action Level	Limit Level
		Start	Finish	1st Hour	2nd Hour	3rd Hour		
05-May-22	Fine	8:06	11:06	62	64	59	280.4	500
07-May-22	Cloudy	14:01	17:01	55	56	58	280.4	500
13-May-22	Cloudy	8:09	11:09	33	39	34	280.4	500
19-May-22	Fine	14:05	17:05	57	56	61	280.4	500
25-May-22	Cloudy	8:13	11:13	53	56	53	280.4	500
31-May-22	Cloudy	14:04	17:04	38	39	37	280.4	500

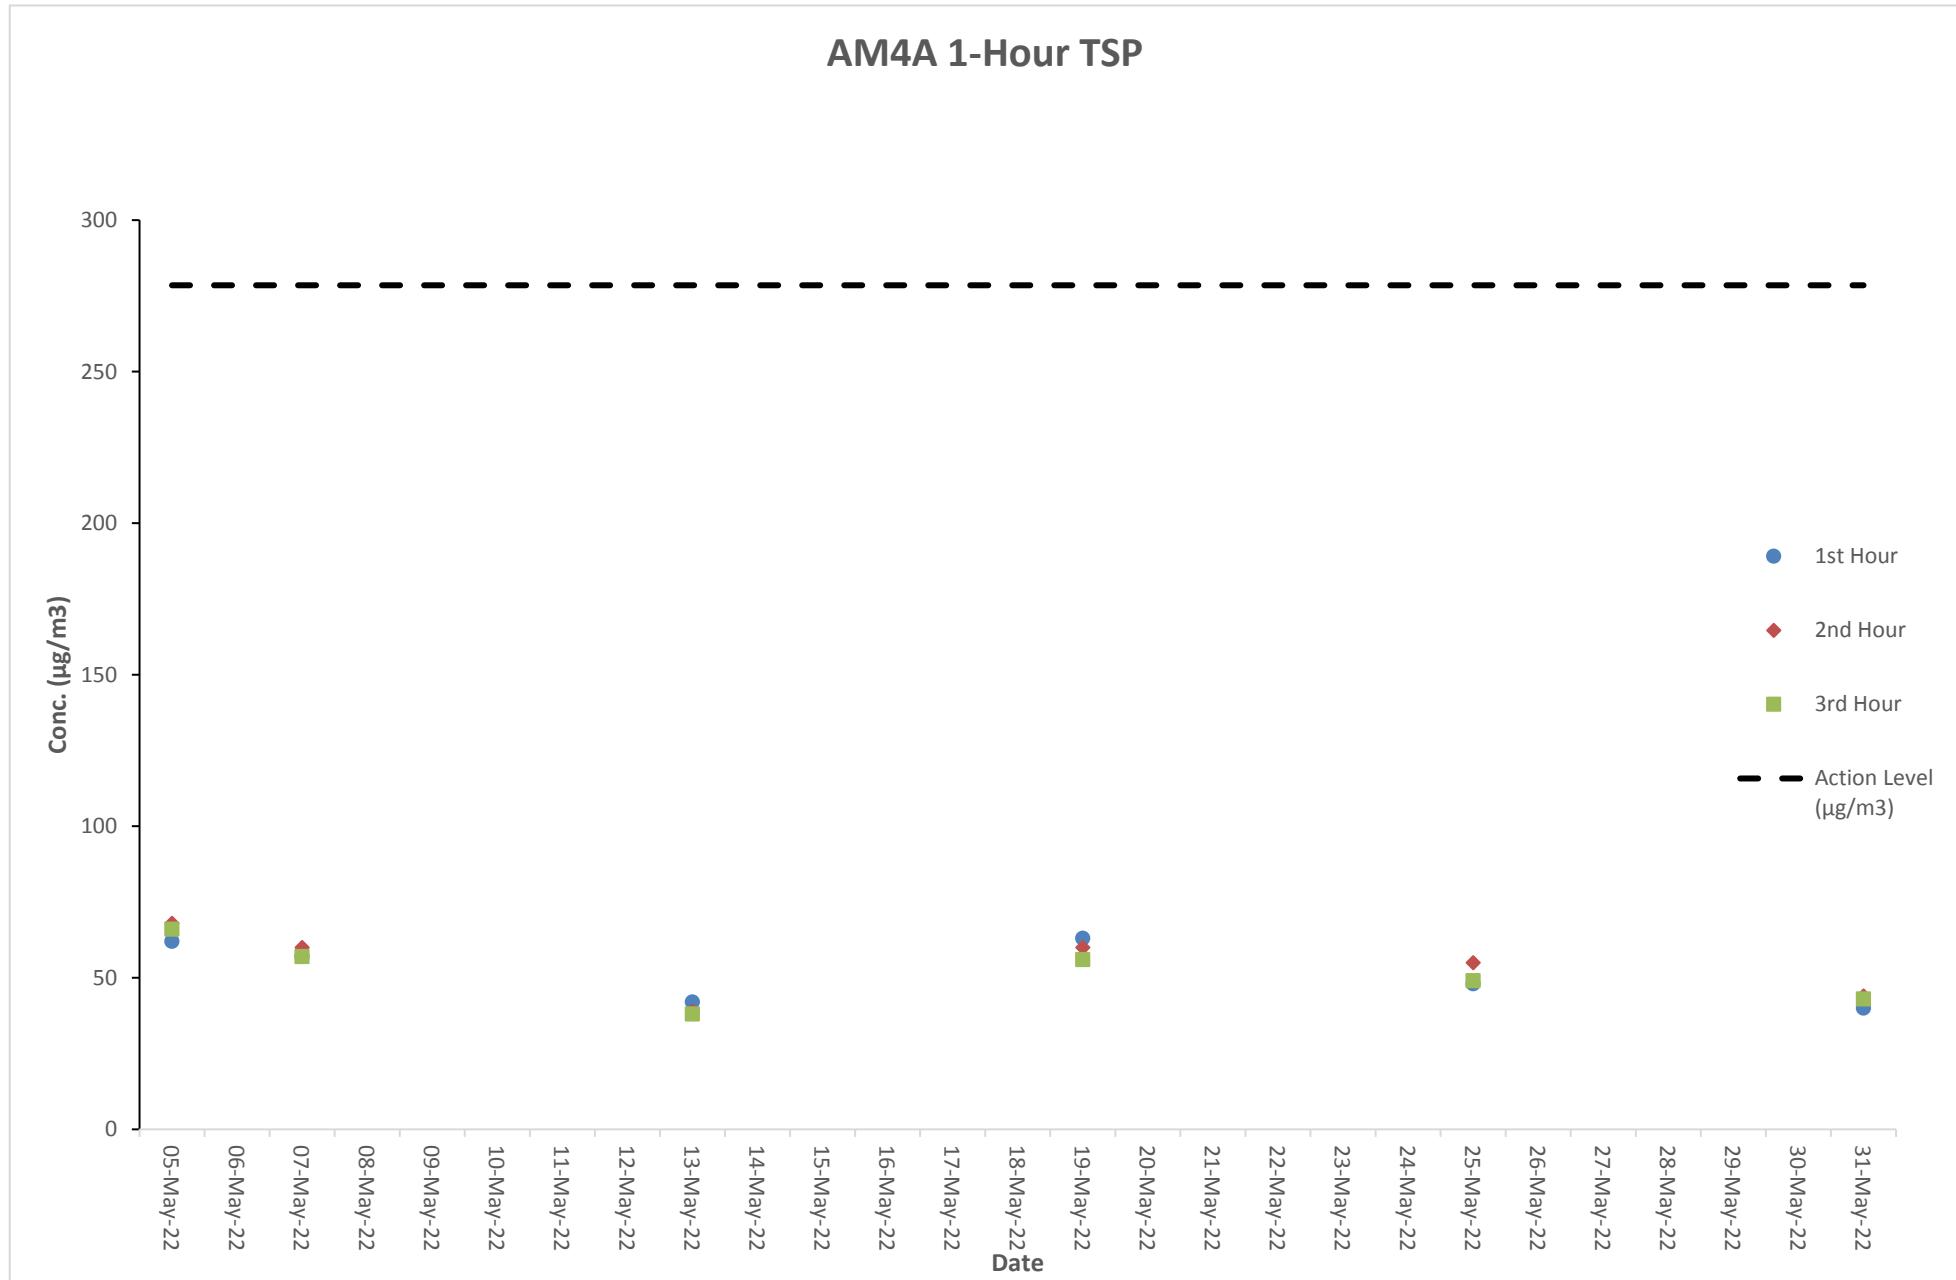
Graphical Presentation of Air Quality Monitoring Result at Station AM4A (1-hour TSP)

Date	Weather Condition	Time		Conc. (µg/m³)			Action Level	Limit Level
		Start	Finish	1st Hour	2nd Hour	3rd Hour		
05-May-22	Fine	8:14	11:14	62	68	66	278.5	500
07-May-22	Cloudy	14:09	17:09	57	60	57	278.5	500
13-May-22	Cloudy	8:17	11:17	42	39	38	278.5	500
19-May-22	Fine	14:13	17:13	63	60	56	278.5	500
25-May-22	Cloudy	8:21	11:21	48	55	49	278.5	500
31-May-22	Cloudy	14:12	17:12	40	44	43	278.5	500

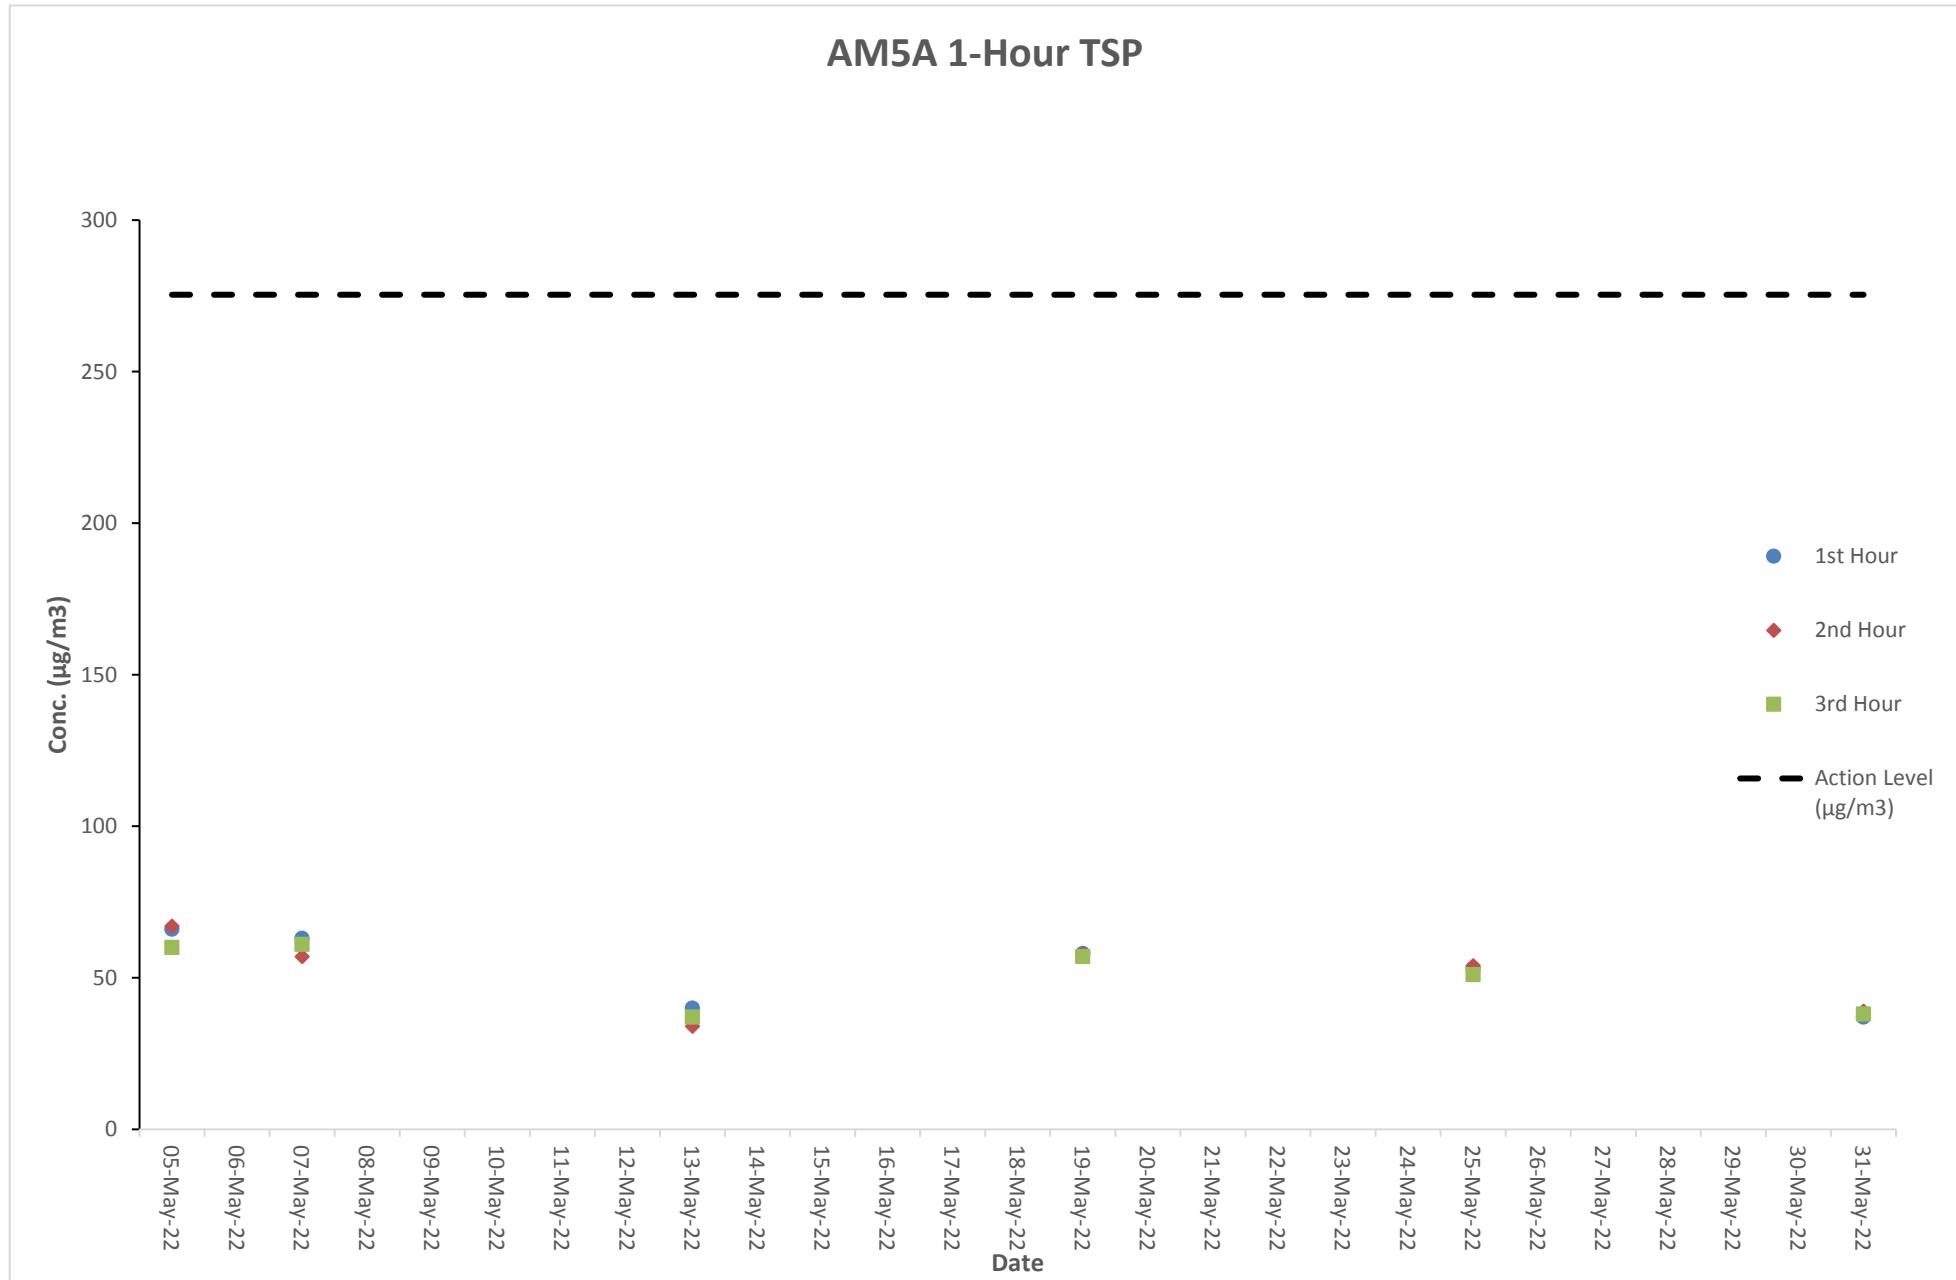
Graphical Presentation of Air Quality Monitoring Result at Station AM5A (1-hour TSP)

Date	Weather Condition	Time		Conc. (µg/m³)			Action Level	Limit Level
		Start	Finish	1st Hour	2nd Hour	3rd Hour		
05-May-22	Fine	8:29	11:29	66	67	60	275.4	500
07-May-22	Cloudy	14:26	17:26	63	57	61	275.4	500
13-May-22	Cloudy	8:32	11:32	40	34	37	275.4	500
19-May-22	Fine	14:30	17:30	58	58	57	275.4	500
25-May-22	Cloudy	8:36	11:36	53	54	51	275.4	500
31-May-22	Cloudy	14:20	17:20	37	39	38	275.4	500

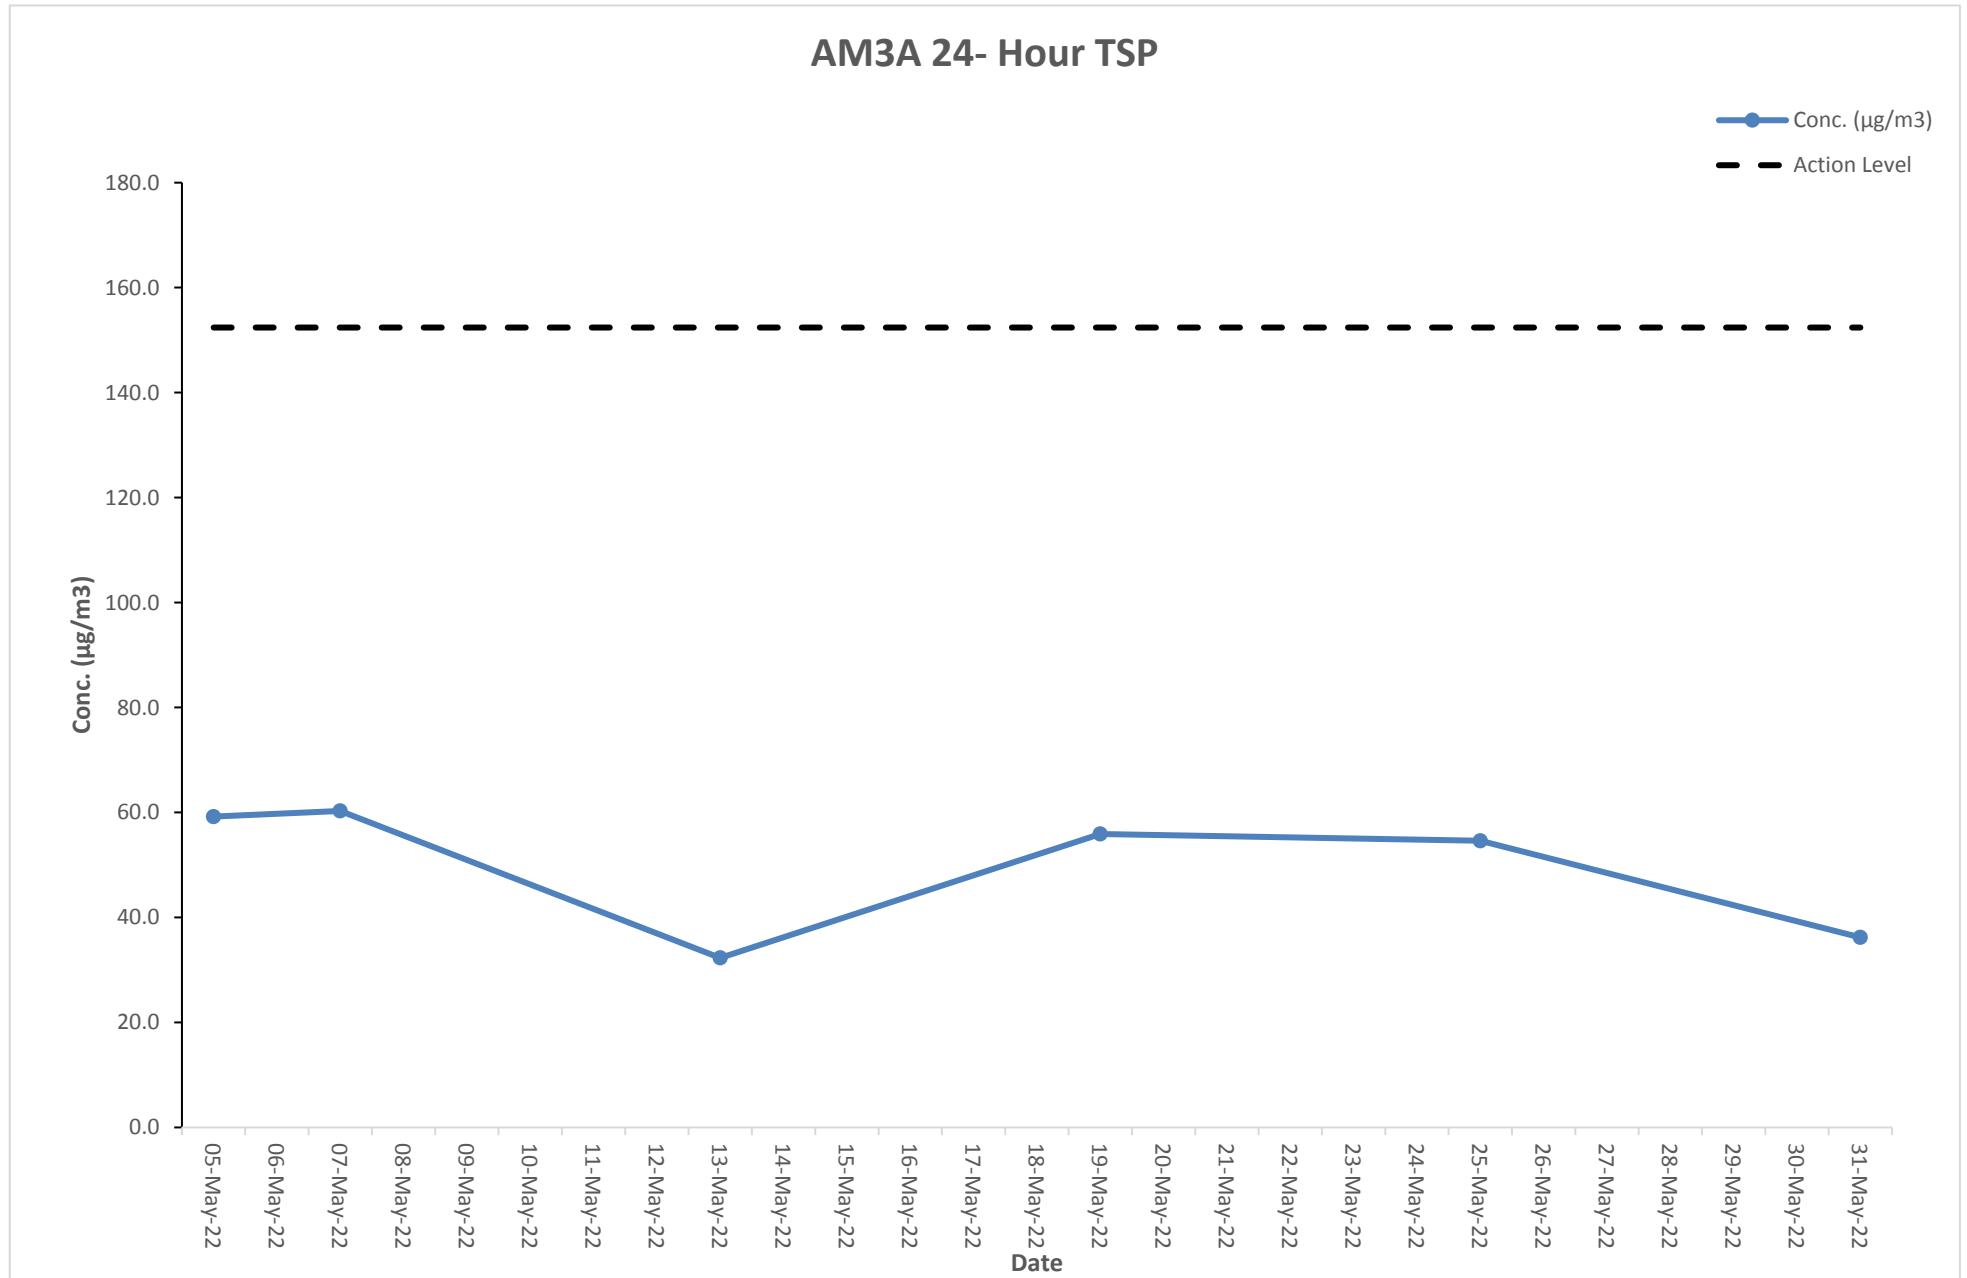
Graphical Presentation of Air Quality Monitoring Result at Station AM3A (24-hour TSP)

Start		Finish		Filter Weight (g)		Elapsed Time Reading		Sampling Time (hrs)	Flow Rate (m³/min)			Conc. (µg/m³)	Weather Condition	Action Level	Limit Level
Date	Time	Date	Time	Initial	Final	Initial	Final		Initial	Final	Average				
05-May-22	10:00AM	06-May-22	10:00AM	2.8051	2.9005	3529.8	3553.8	24	1.12	1.12	1.12	59.2	Sunny	152.4	260
07-May-22	10:00AM	08-May-22	10:00AM	2.8047	2.9017	3553.8	3577.8	24	1.12	1.12	1.12	60.3	Rainy	152.4	260
13-May-22	10:00AM	14-May-22	10:00AM	2.8085	2.8604	3577.8	3601.8	24	1.12	1.12	1.12	32.3	Rainy	152.4	260
19-May-22	10:00AM	20-May-22	10:00AM	2.8069	2.8969	3601.8	3625.8	24	1.12	1.12	1.12	55.9	Sunny	152.4	260
25-May-22	10:00AM	26-May-22	10:00AM	2.8042	2.8921	3625.8	3649.8	24	1.12	1.12	1.12	54.6	Rainy	152.4	260
31-May-22	10:00AM	01-Jun-22	10:00AM	2.8056	2.8639	3649.8	3673.8	24	1.12	1.12	1.12	36.2	Cloudy	152.4	260

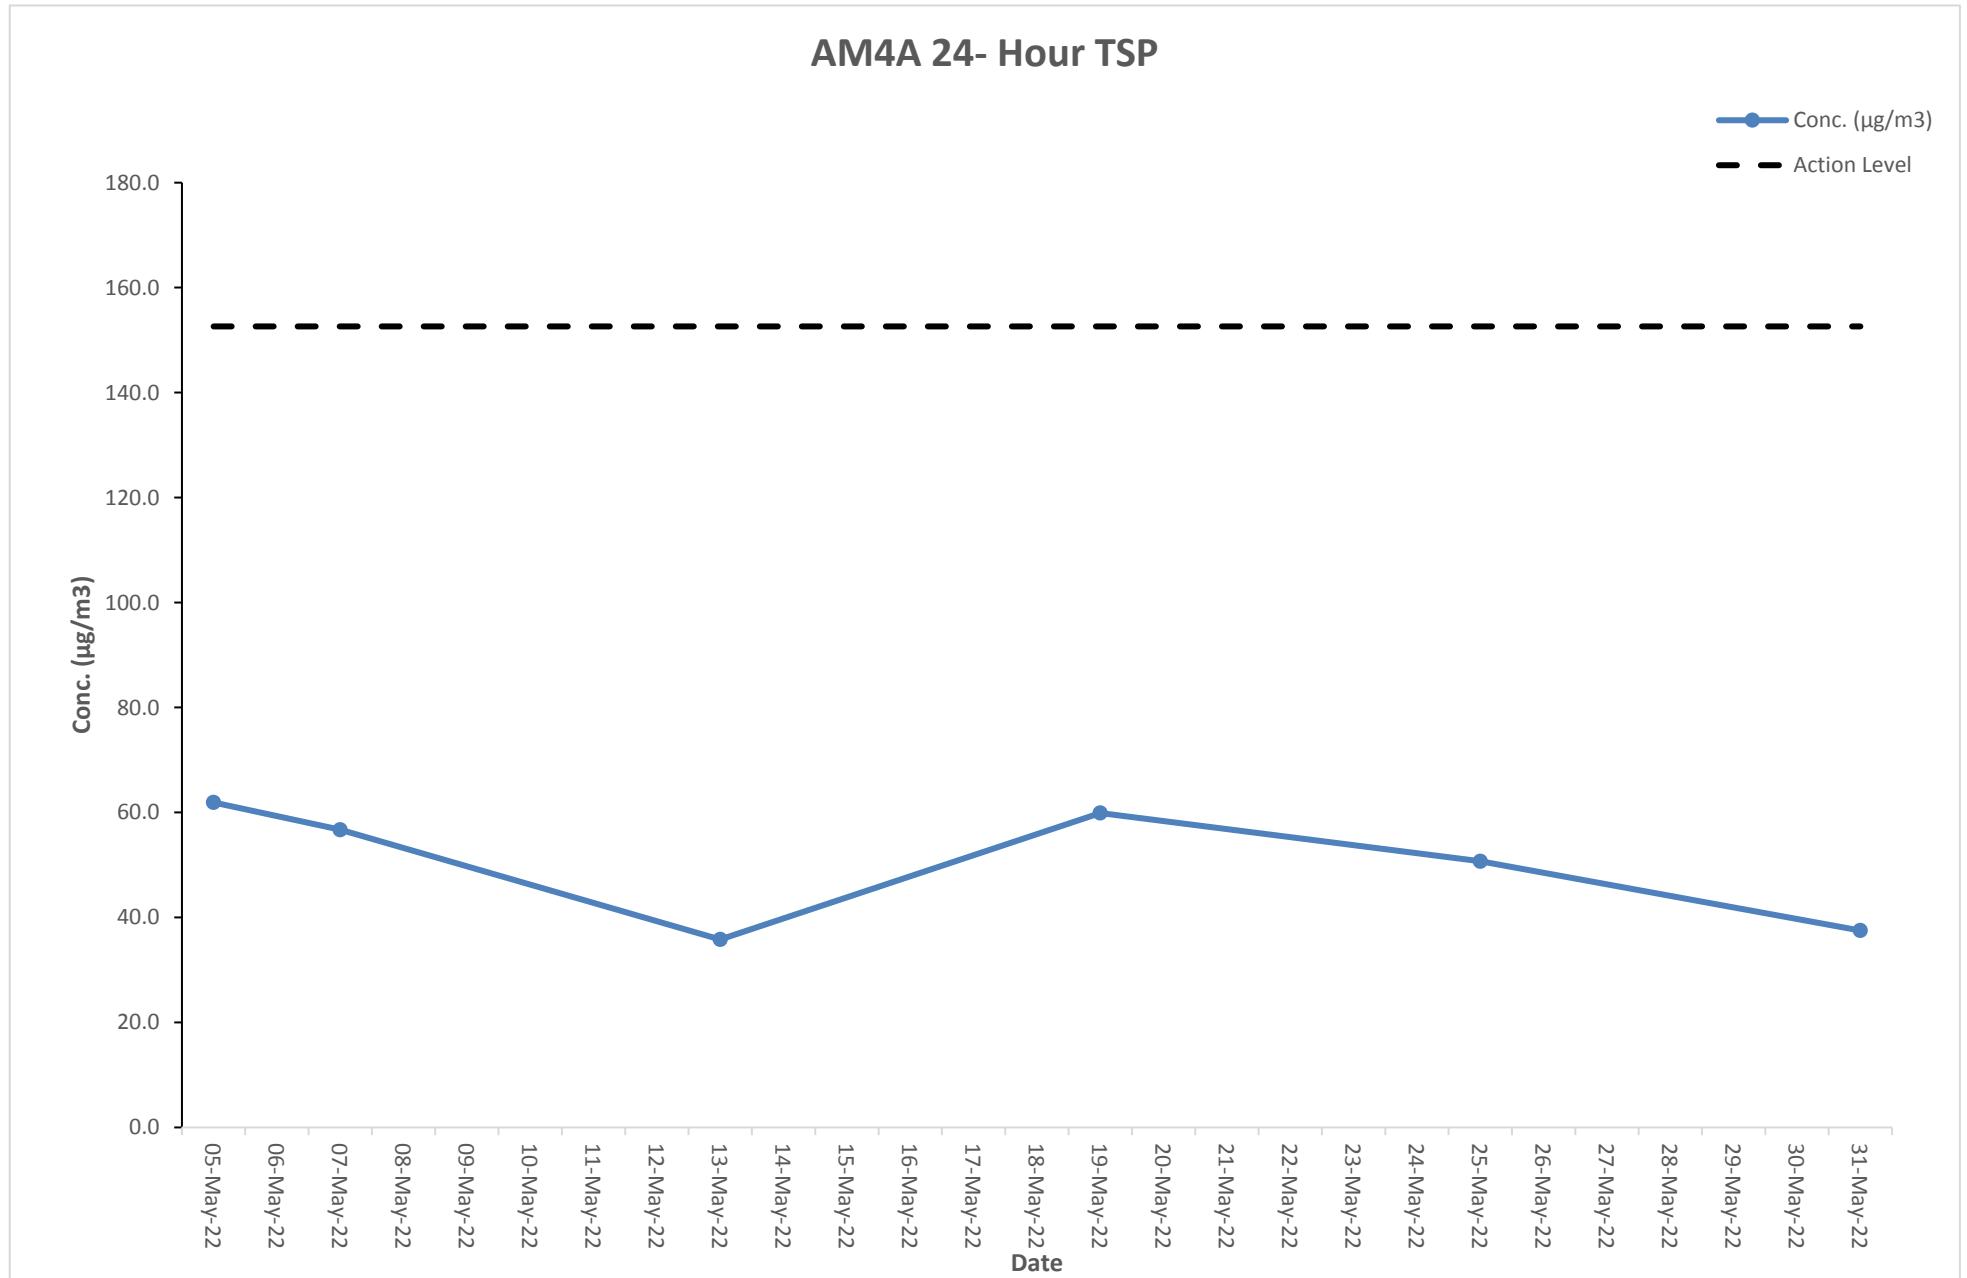
Graphical Presentation of Air Quality Monitoring Result at Station AM4A (24-hour TSP)

Start		Finish		Filter Weight (g)		Elapsed Time Reading		Sampling Time (hrs)	Flow Rate (m³/min)			Conc. (µg/m³)	Weather Condition	Action Level	Limit Level
Date	Time	Date	Time	Initial	Final	Initial	Final		Initial	Final	Average				
05-May-22	10:00AM	06-May-22	10:00AM	2.8028	2.9025	3949.4	3973.4	24	1.12	1.12	1.12	61.9	Sunny	152.6	260
07-May-22	10:00AM	08-May-22	10:00AM	2.8035	2.8947	3973.4	3997.4	24	1.12	1.12	1.12	56.7	Rainy	152.6	260
13-May-22	10:00AM	14-May-22	10:00AM	2.8033	2.8610	3997.4	4021.4	24	1.12	1.12	1.12	35.8	Rainy	152.6	260
19-May-22	10:00AM	20-May-22	10:00AM	2.8044	2.9008	4021.4	4045.4	24	1.12	1.12	1.12	59.9	Sunny	152.6	260
25-May-22	10:00AM	26-May-22	10:00AM	2.8051	2.8867	4045.4	4069.4	24	1.12	1.12	1.12	50.7	Rainy	152.6	260
31-May-22	10:00AM	01-Jun-22	10:00AM	2.8027	2.8631	4069.4	4093.4	24	1.12	1.12	1.12	37.5	Cloudy	152.6	260
