Development at West Kowloon Cultural District

Monthly Environmental Monitoring and Audit (EM&A) Report

for May 2022

Part-1: EM&A at Lyric Theatre Complex

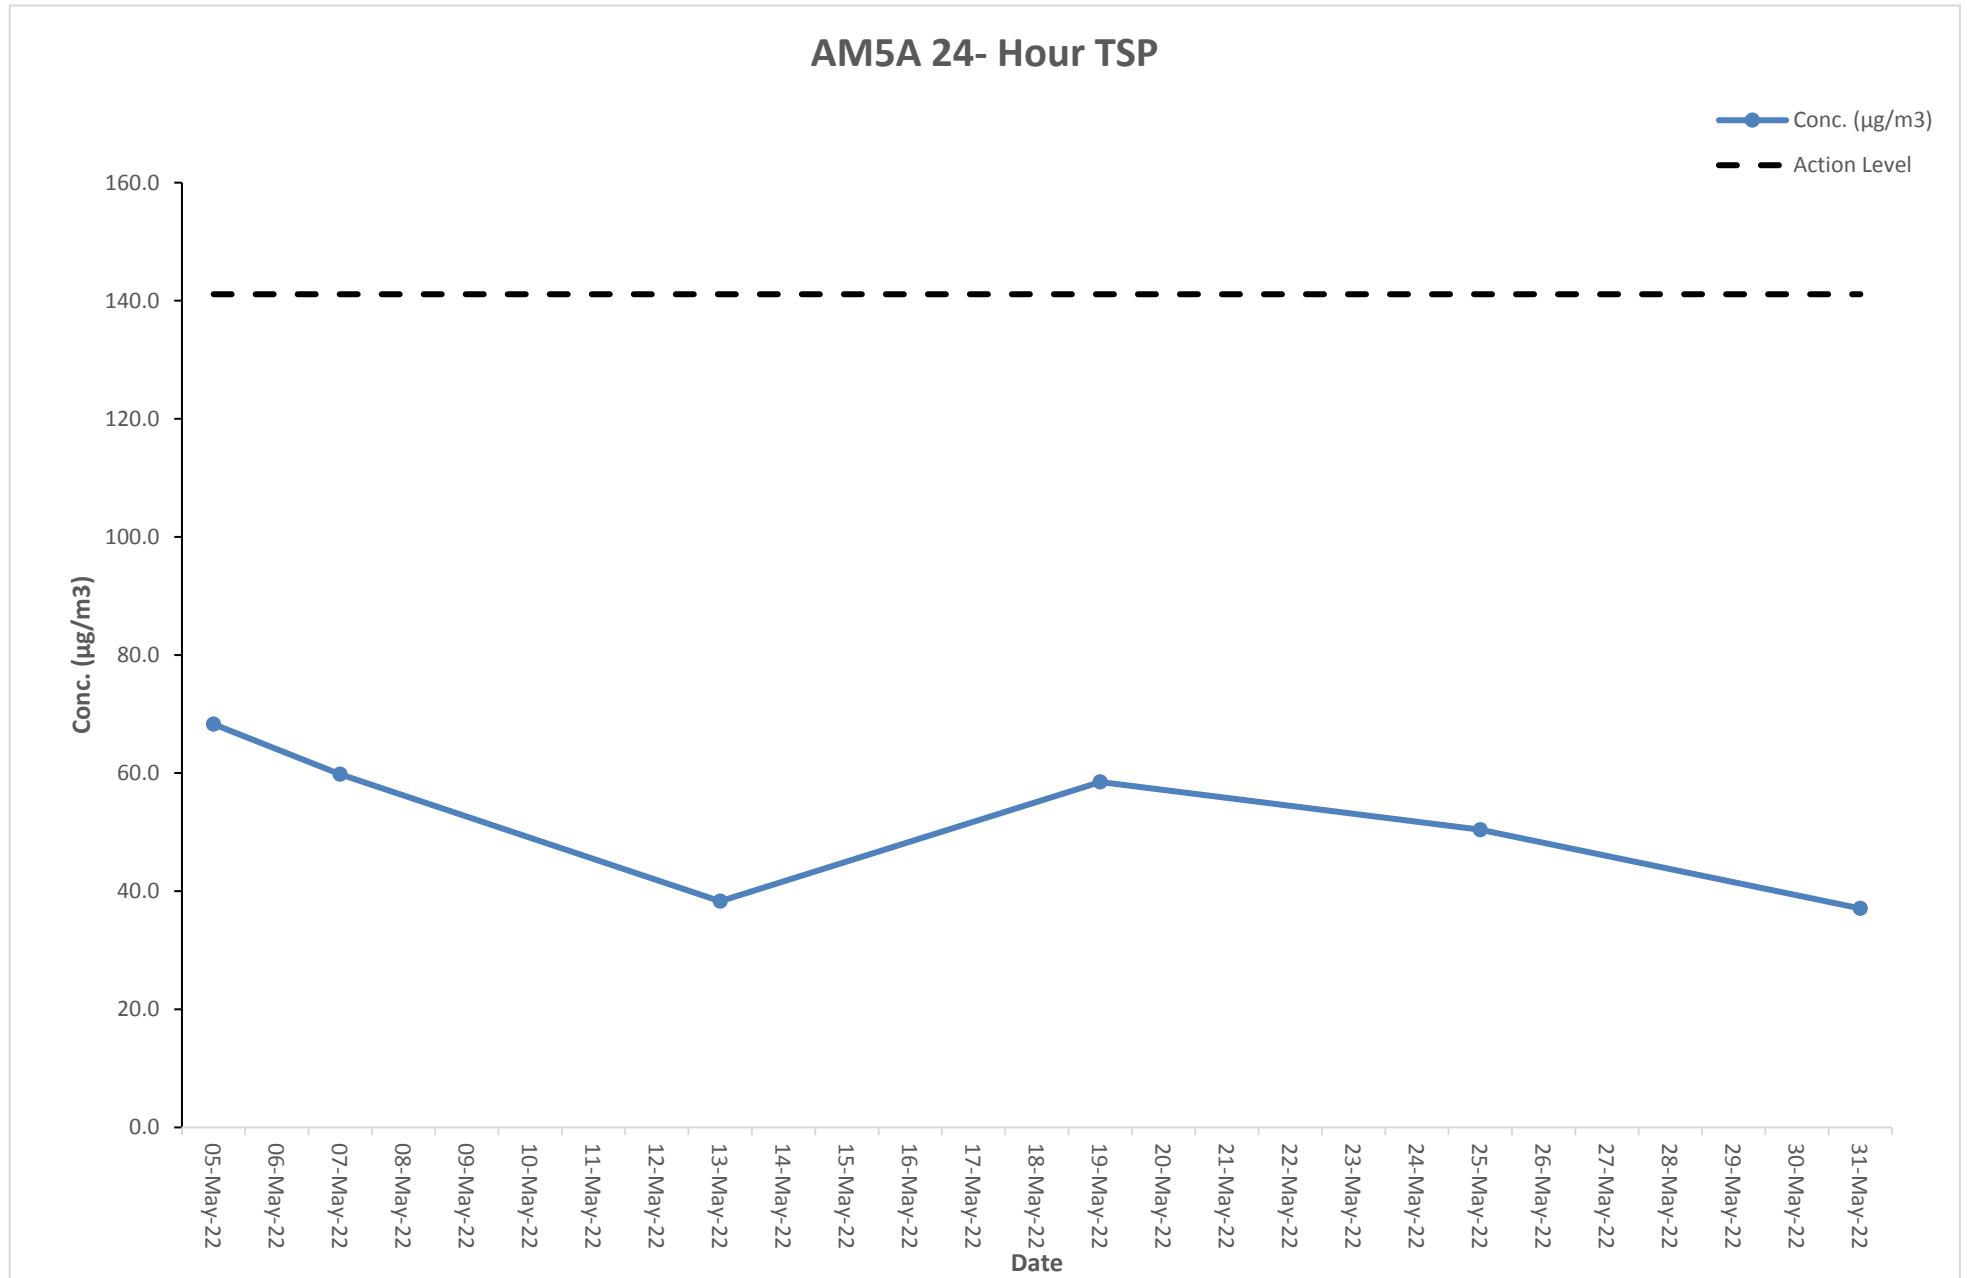
Graphical Presentation of Air Quality Monitoring Result at Station AM5A (24-hour TSP)

Start		Finish		Filter Weight (g)		Elapsed Time Reading		Sampling Time (hrs)	Flow Rate (m³/min)			Conc. (µg/m³)	Weather Condition	Action Level	Limit Level
Date	Time	Date	Time	Initial	Final	Initial	Final		Initial	Final	Average				
05-May-22	10:00AM	06-May-22	10:00AM	2.8022	2.9122	4089.6	4113.6	24	1.12	1.12	1.12	68.3	Sunny	141.1	260
07-May-22	10:00AM	08-May-22	10:00AM	2.8041	2.9004	4113.6	4137.6	24	1.12	1.12	1.12	59.8	Rainy	141.1	260
13-May-22	10:00AM	14-May-22	10:00AM	2.8055	2.8671	4137.6	4161.6	24	1.12	1.12	1.12	38.3	Rainy	141.1	260
19-May-22	10:00AM	20-May-22	10:00AM	2.8024	2.8966	4161.6	4185.6	24	1.12	1.12	1.12	58.5	Sunny	141.1	260
25-May-22	10:00AM	26-May-22	10:00AM	2.8025	2.8837	4185.6	4209.6	24	1.12	1.12	1.12	50.4	Rainy	141.1	260
31-May-22	10:00AM	01-Jun-22	10:00AM	2.8075	2.8673	4209.6	4233.6	24	1.12	1.12	1.12	37.1	Cloudy	141.1	260
