Development at West Kowloon Cultural District

**Monthly Environmental Monitoring and Audit (EM&A) Report
for September 2022**

**Part-2: EM&A for Foundation and ELS
Works in Zones 2A, 2B & 2C**

Part-1: EM&A at Lyric Theatre Complex

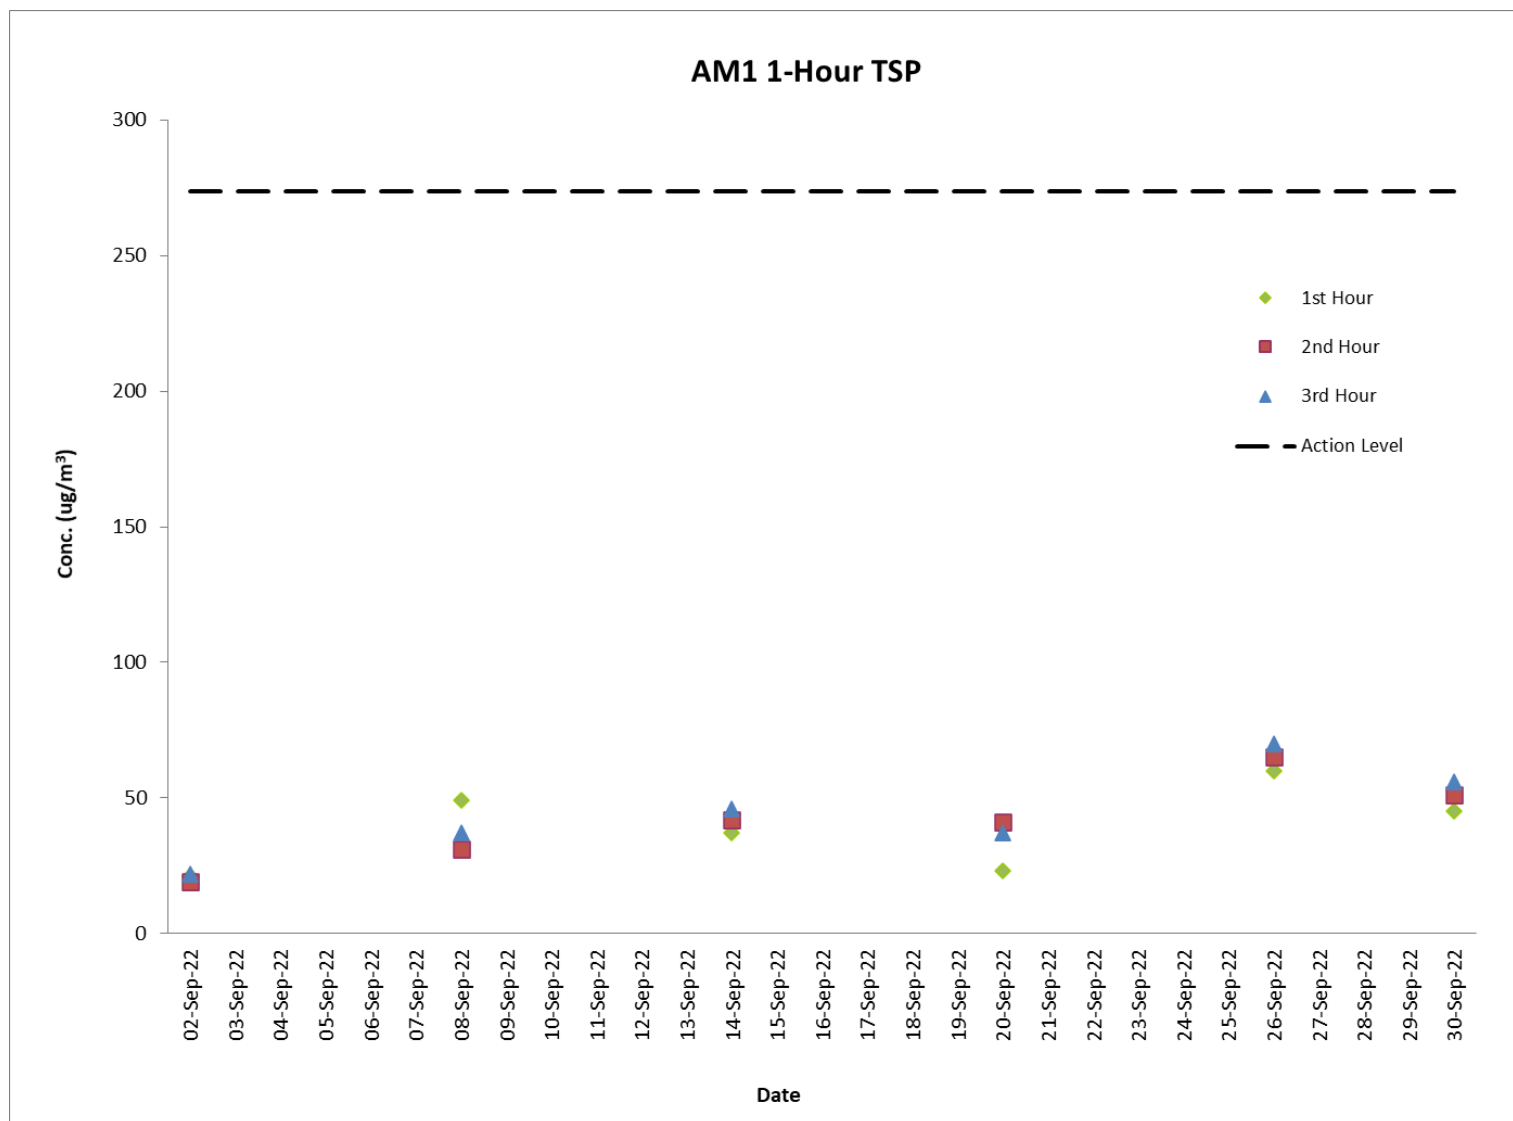
Graphical Presentation of Air Quality Monitoring Result at Station AM1 (1-hour TSP)

| Date | Weather Condition | Time | Conc. ($\mu\text{g}/\text{m}^3$) | | | Action Level ($\mu\text{g}/\text{m}^3$) | Limit Level ($\mu\text{g}/\text{m}^3$) |
|---|---|---|---|---|---|---|--|
| 30-Sep-22 | Cloudy | 8:22 - 11:22 | 45 | 51 | 56 | 273.7 | 500 |

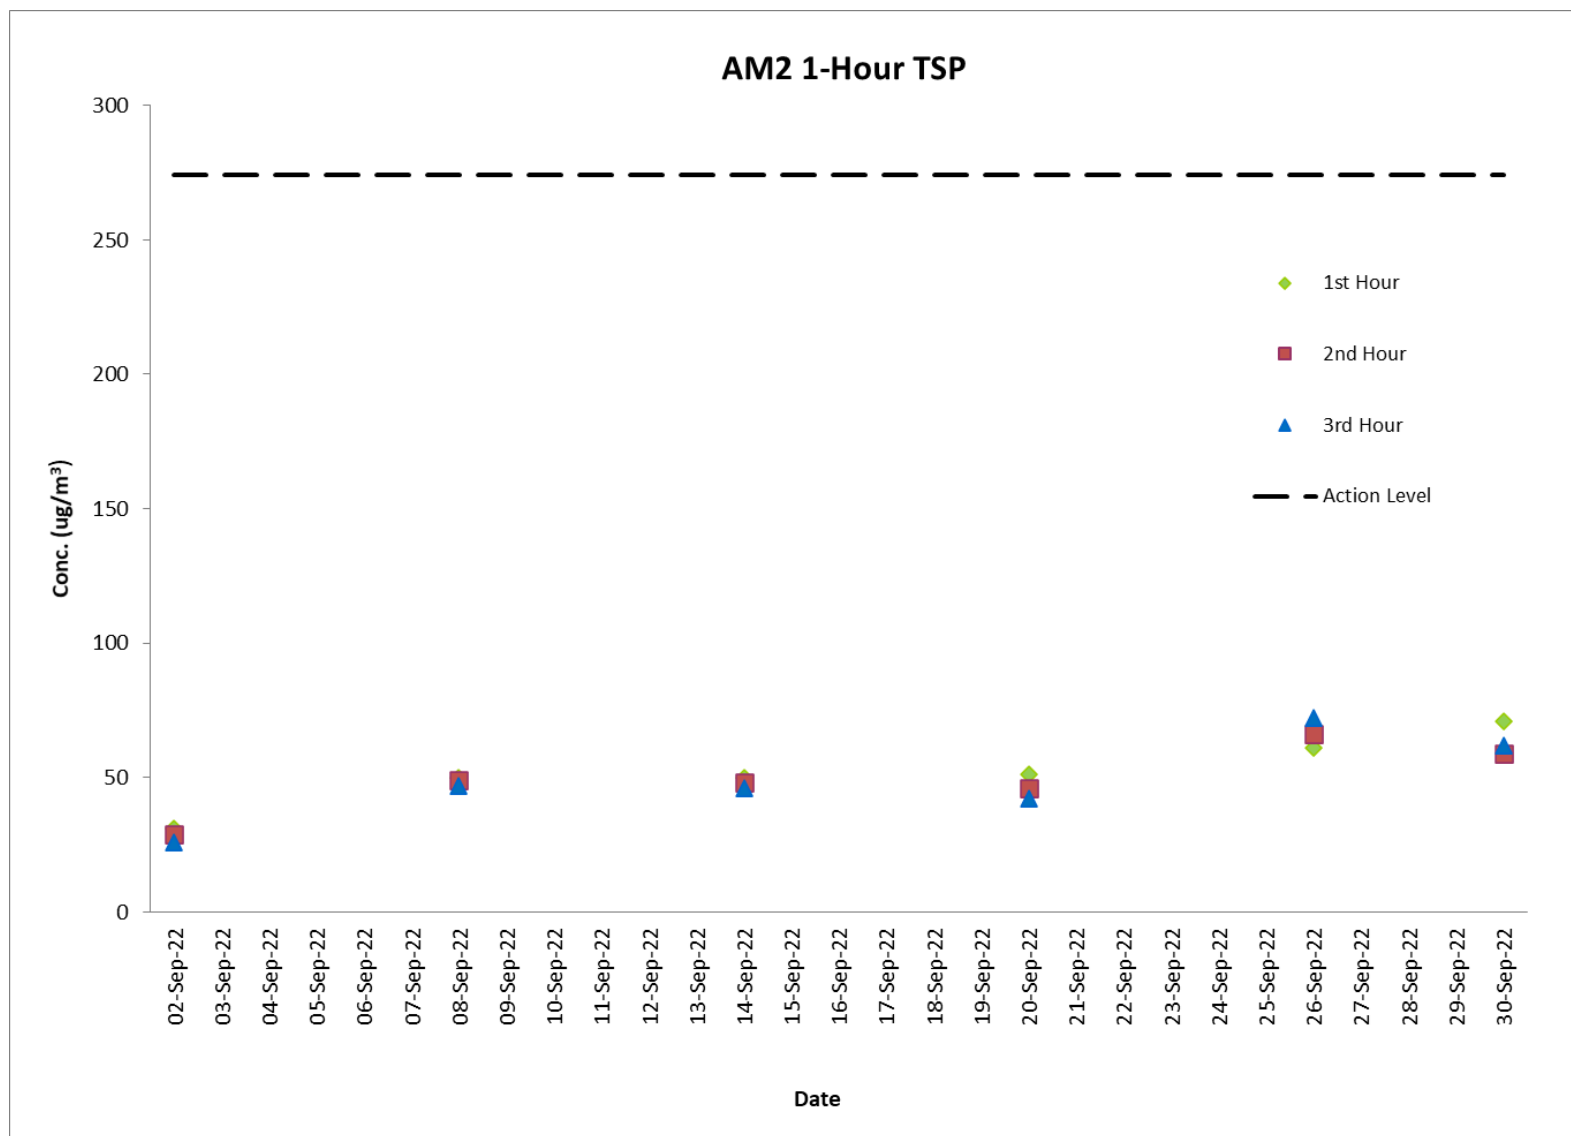
Graphical Presentation of Air Quality Monitoring Result at Station AM2 (1-hour TSP)

| Date | Weather Condition | Time | Conc. ($\mu\text{g}/\text{m}^3$) | | | Action Level ($\mu\text{g}/\text{m}^3$) | Limit Level ($\mu\text{g}/\text{m}^3$) |
|---|---|---|---|---|---|---|--|
| 30-Sep-22 | Cloudy | 8:36 - 11:36 | 71 | 59 | 62 | 274.2 | 500 |

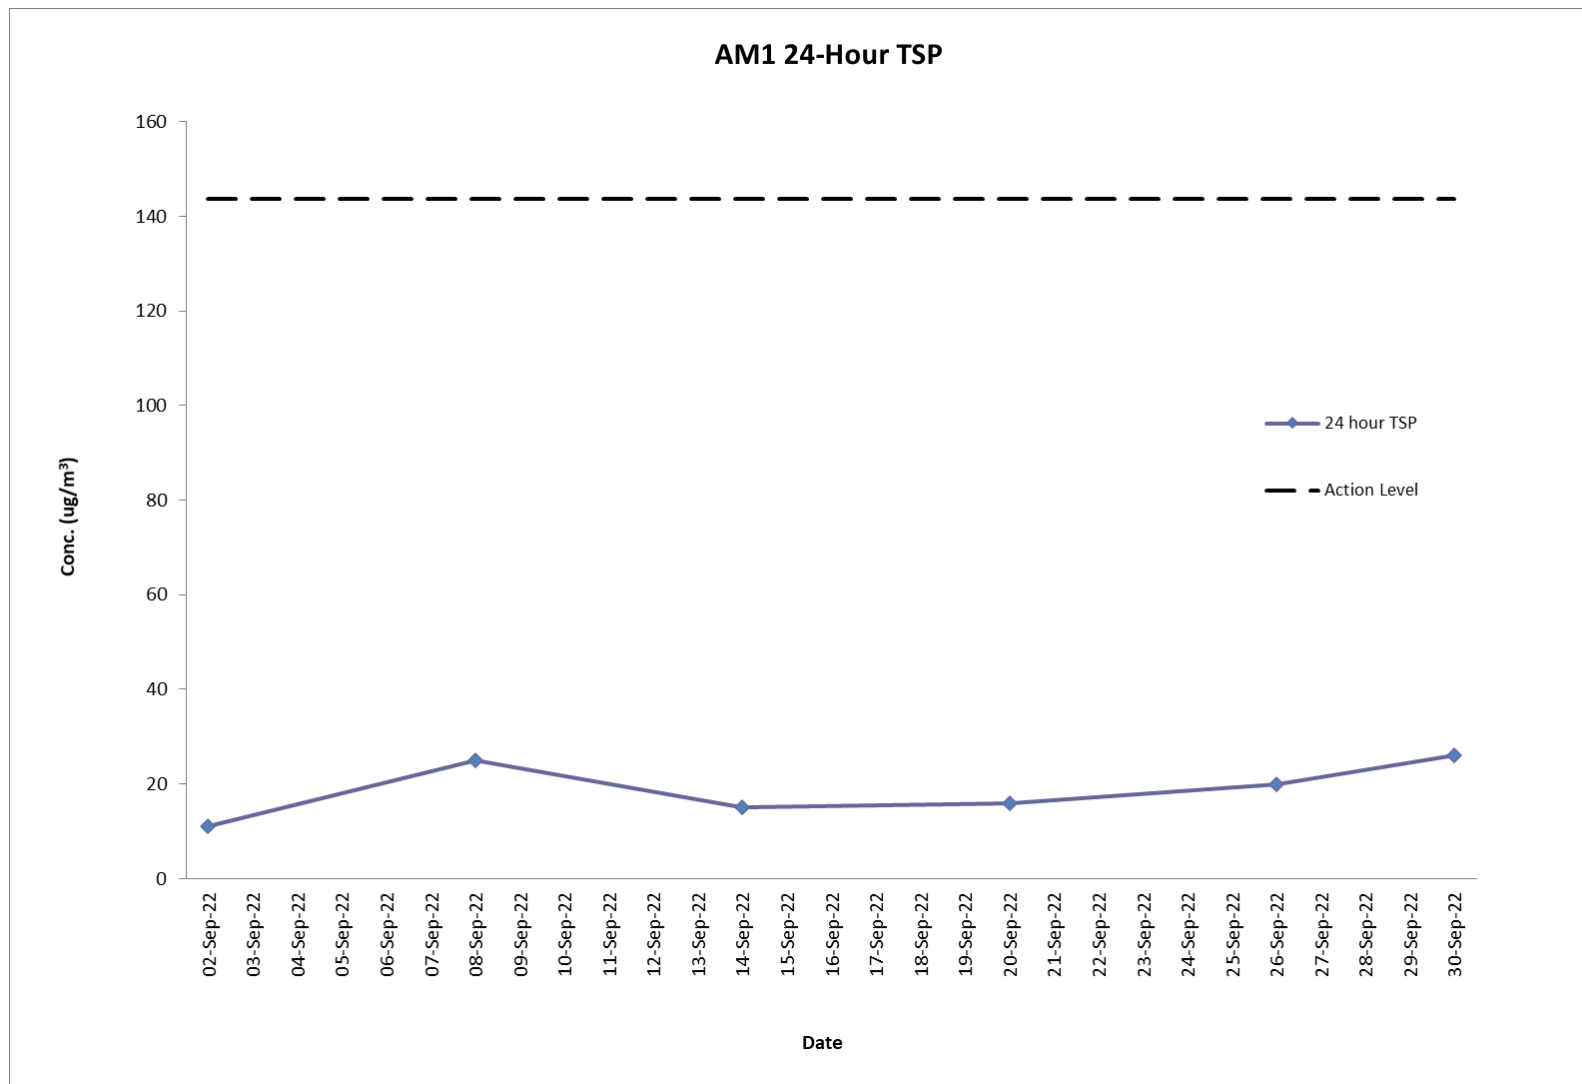
Graphical Presentation of Air Quality Monitoring Result at Station AM1 (24-hour TSP)

| Start | | Finish | | Filter Weight (g) | | Elapsed Time Reading | | Sampling Time (hrs) | Flow Rate (m ³ /min) | | | Conc. (µg/m ³) | Weather Condition | Action Level | Limit Level |
|---|---|---|---|---|---|---|---|---|---|---|---|---|---|---|---|
| 30-Sep-22 | 08:20 | 01-Oct-22 | 08:20 | 2.7194 | 2.7663 | 25544.38 | 25568.38 | 24 | 1.26 | 1.26 | 1.26 | 26 | Cloudy | 143.6 | 260 |

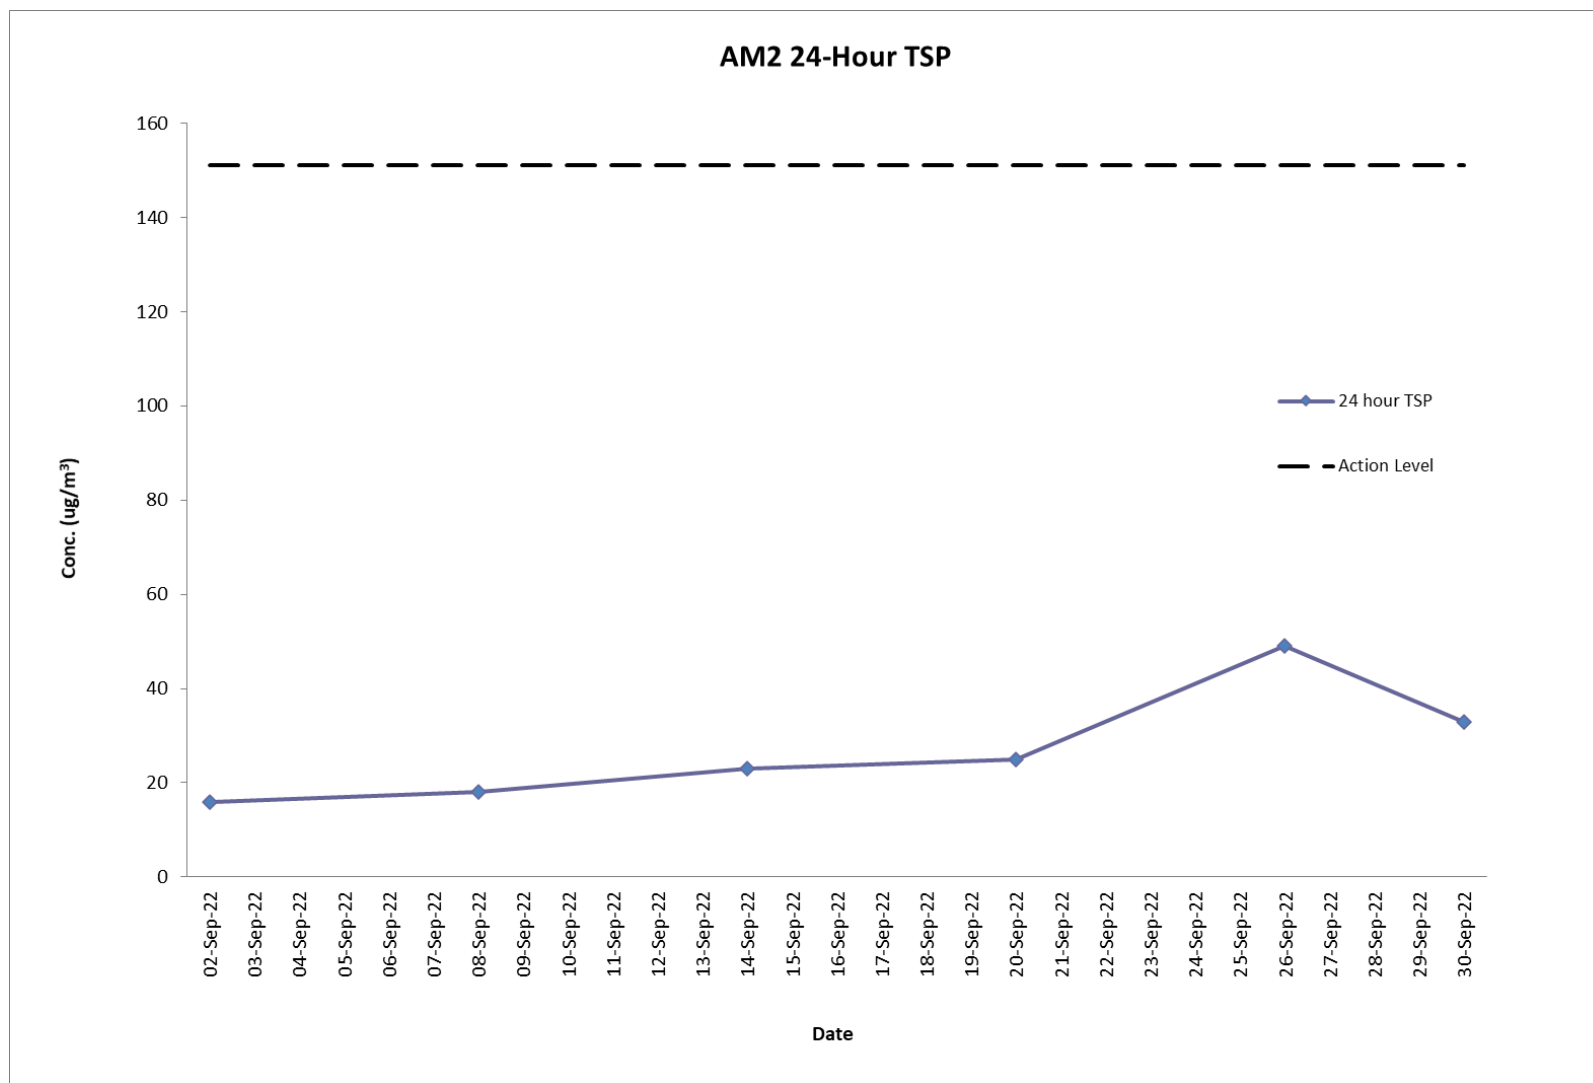
Graphical Presentation of Air Quality Monitoring Result at Station AM2 (24-hour TSP)

| Start | | Finish | | Sampling Time (hrs) | Conc. ($\mu\text{g}/\text{m}^3$) | Weather Condition | Action Level | Limit Level |
|---|---|---|---|---|---|---|---|---|
| 30-Sep-22 | 08:34 | 01-Oct-22 | 08:34 | 24 | 33 | Cloudy | 151.1 | 260 |

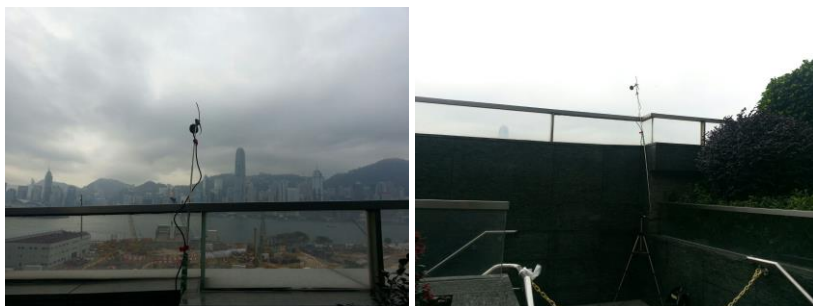
The station set-up of a free-field measurement at Station NM1A.

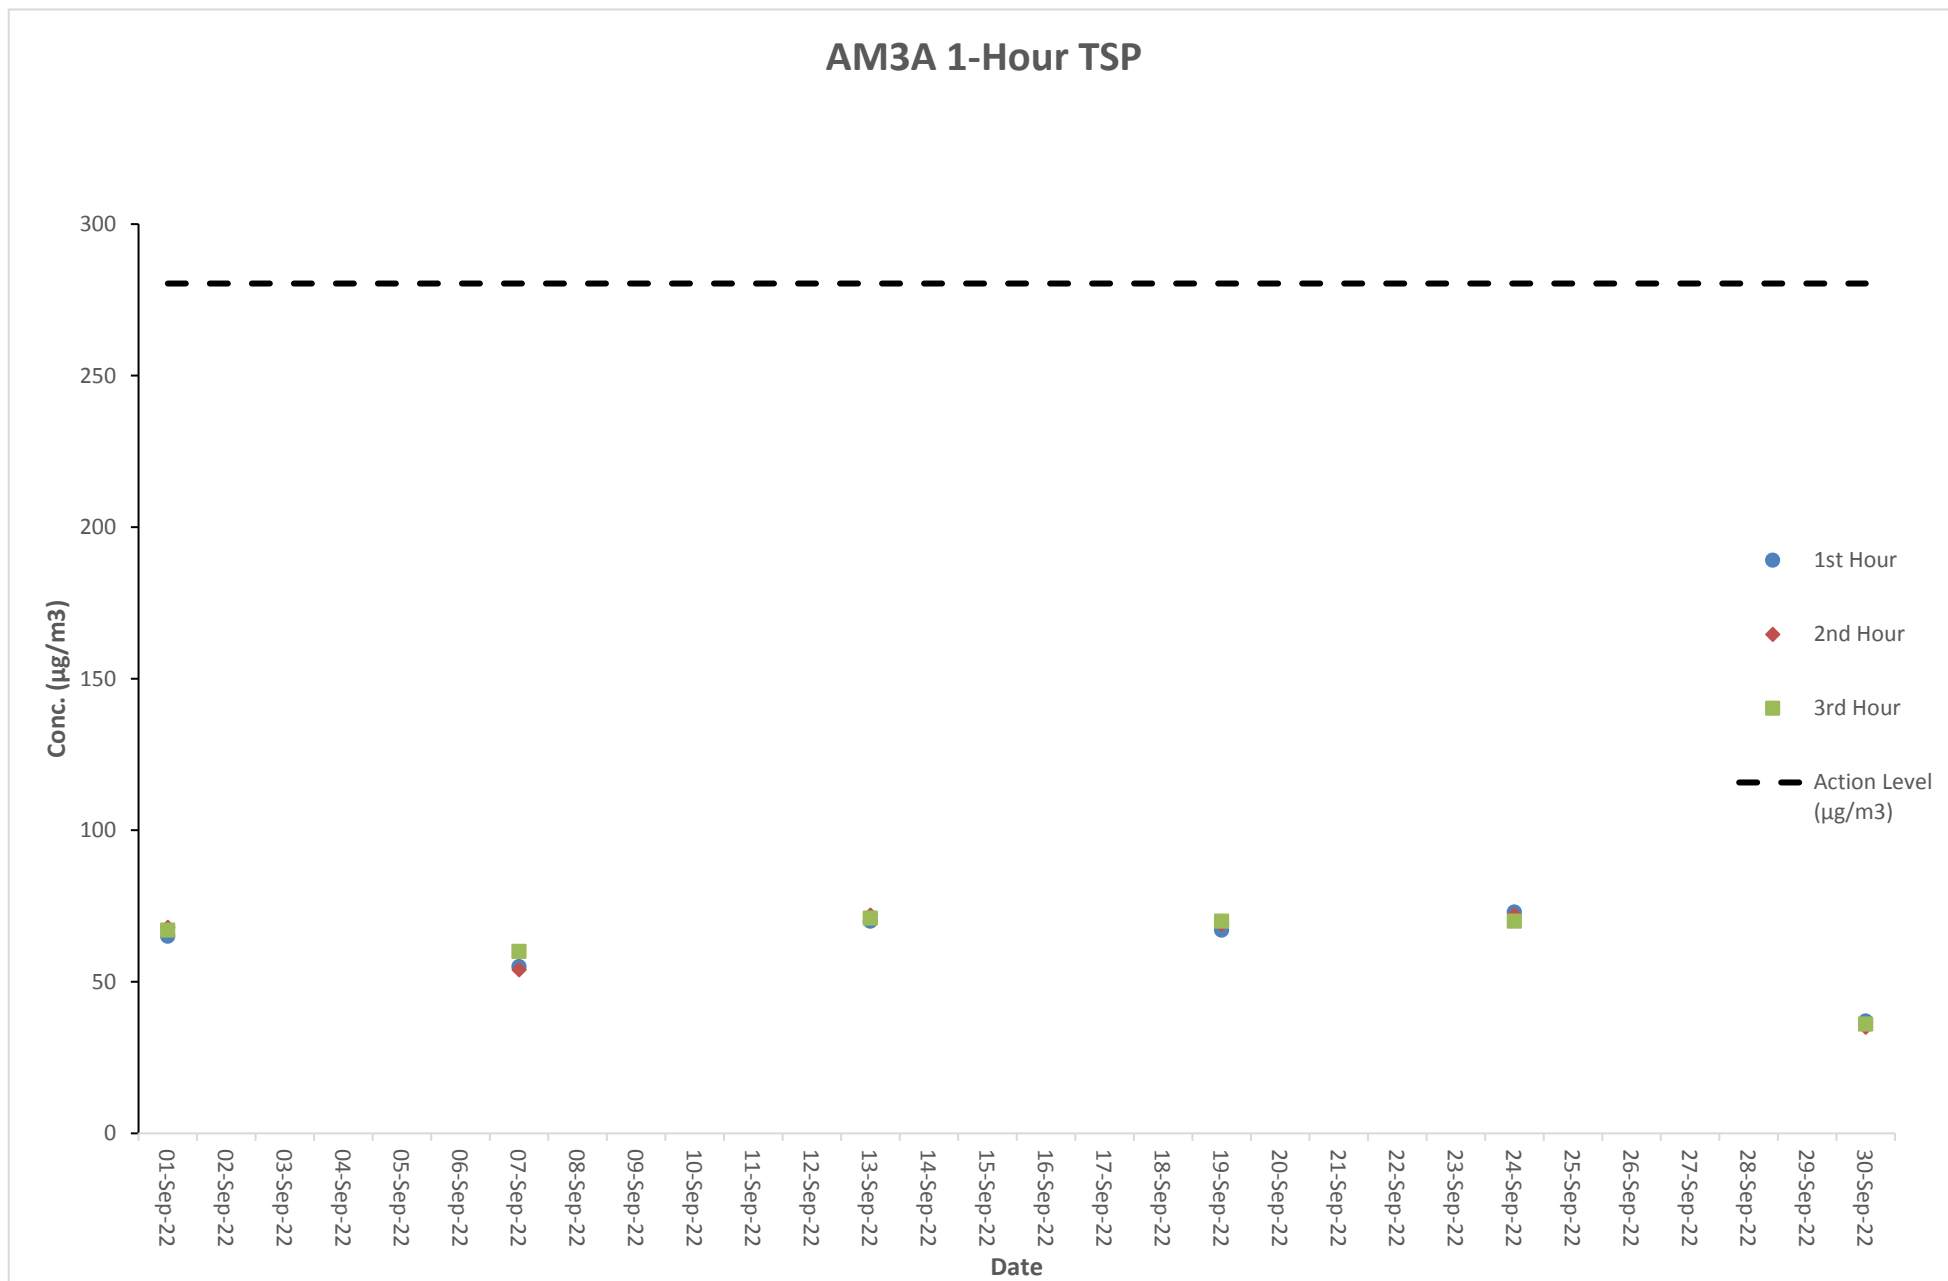
Graphical Presentation of Air Quality Monitoring Result at Station AM3A (1-hour TSP)

| Date | Weather Condition | Time | | Conc. ($\mu\text{g}/\text{m}^3$) | | | Action Level | Limit Level |
|---|---|---|---|---|---|---|---|---|
| 30-Sep-22 | Cloudy | 8:03 | 11:03 | 37 | 35 | 36 | 280.4 | 500 |

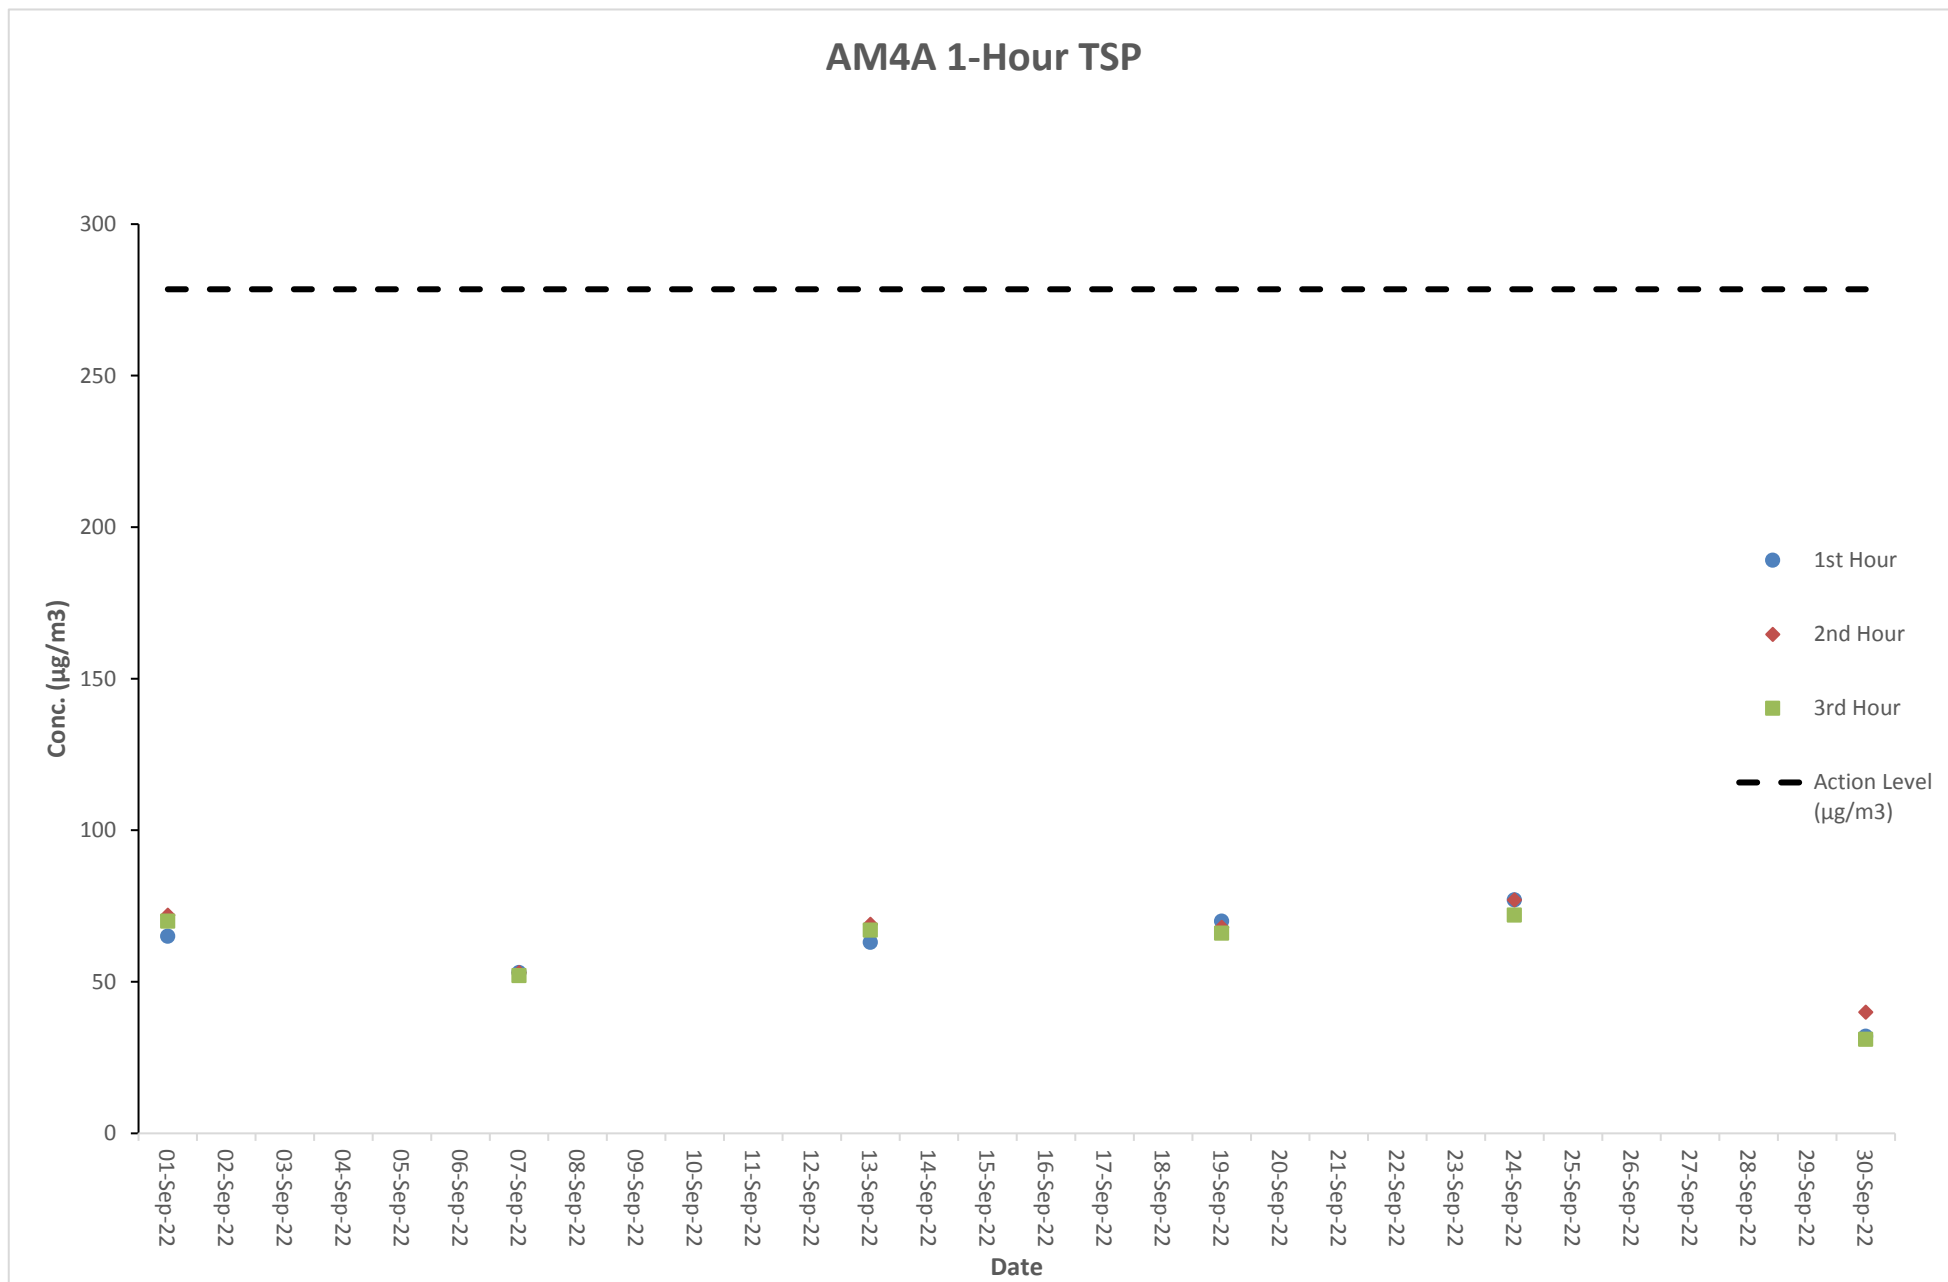
Graphical Presentation of Air Quality Monitoring Result at Station AM4A (1-hour TSP)

| Date | Weather Condition | Time | | Conc. ($\mu\text{g}/\text{m}^3$) | | | Action Level | Limit Level |
|---|---|---|---|---|---|---|---|---|
| 30-Sep-22 | Cloudy | 8:11 | 11:11 | 32 | 40 | 31 | 278.5 | 500 |

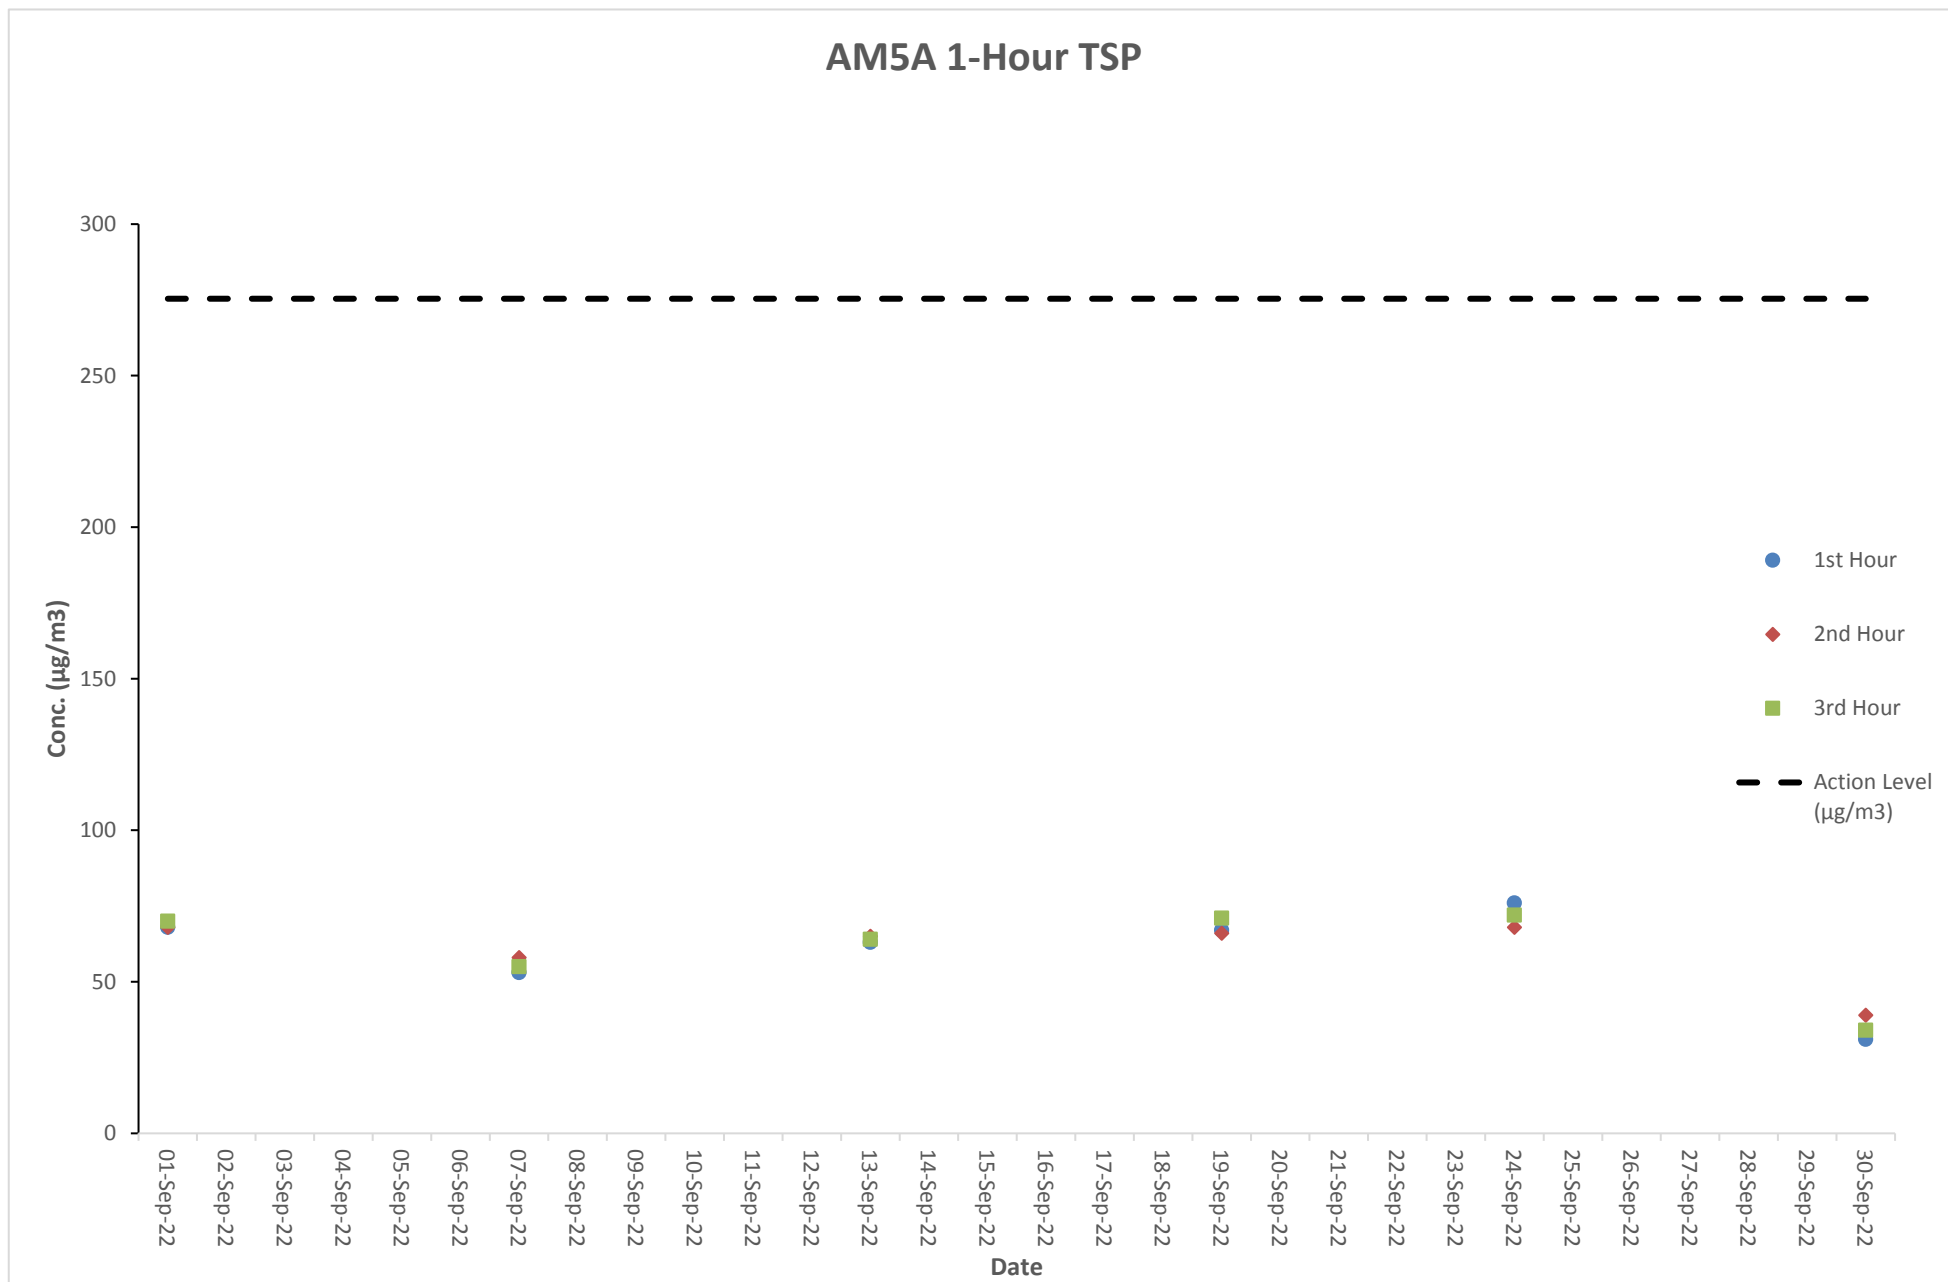
Graphical Presentation of Air Quality Monitoring Result at Station AM5A (1-hour TSP)

| Date | Weather Condition | Time | | Conc. ($\mu\text{g}/\text{m}^3$) | | | Action Level | Limit Level |
|---|---|---|---|---|---|---|---|---|
| 30-Sep-22 | Cloudy | 8:19 | 11:19 | 31 | 39 | 34 | 275.4 | 500 |

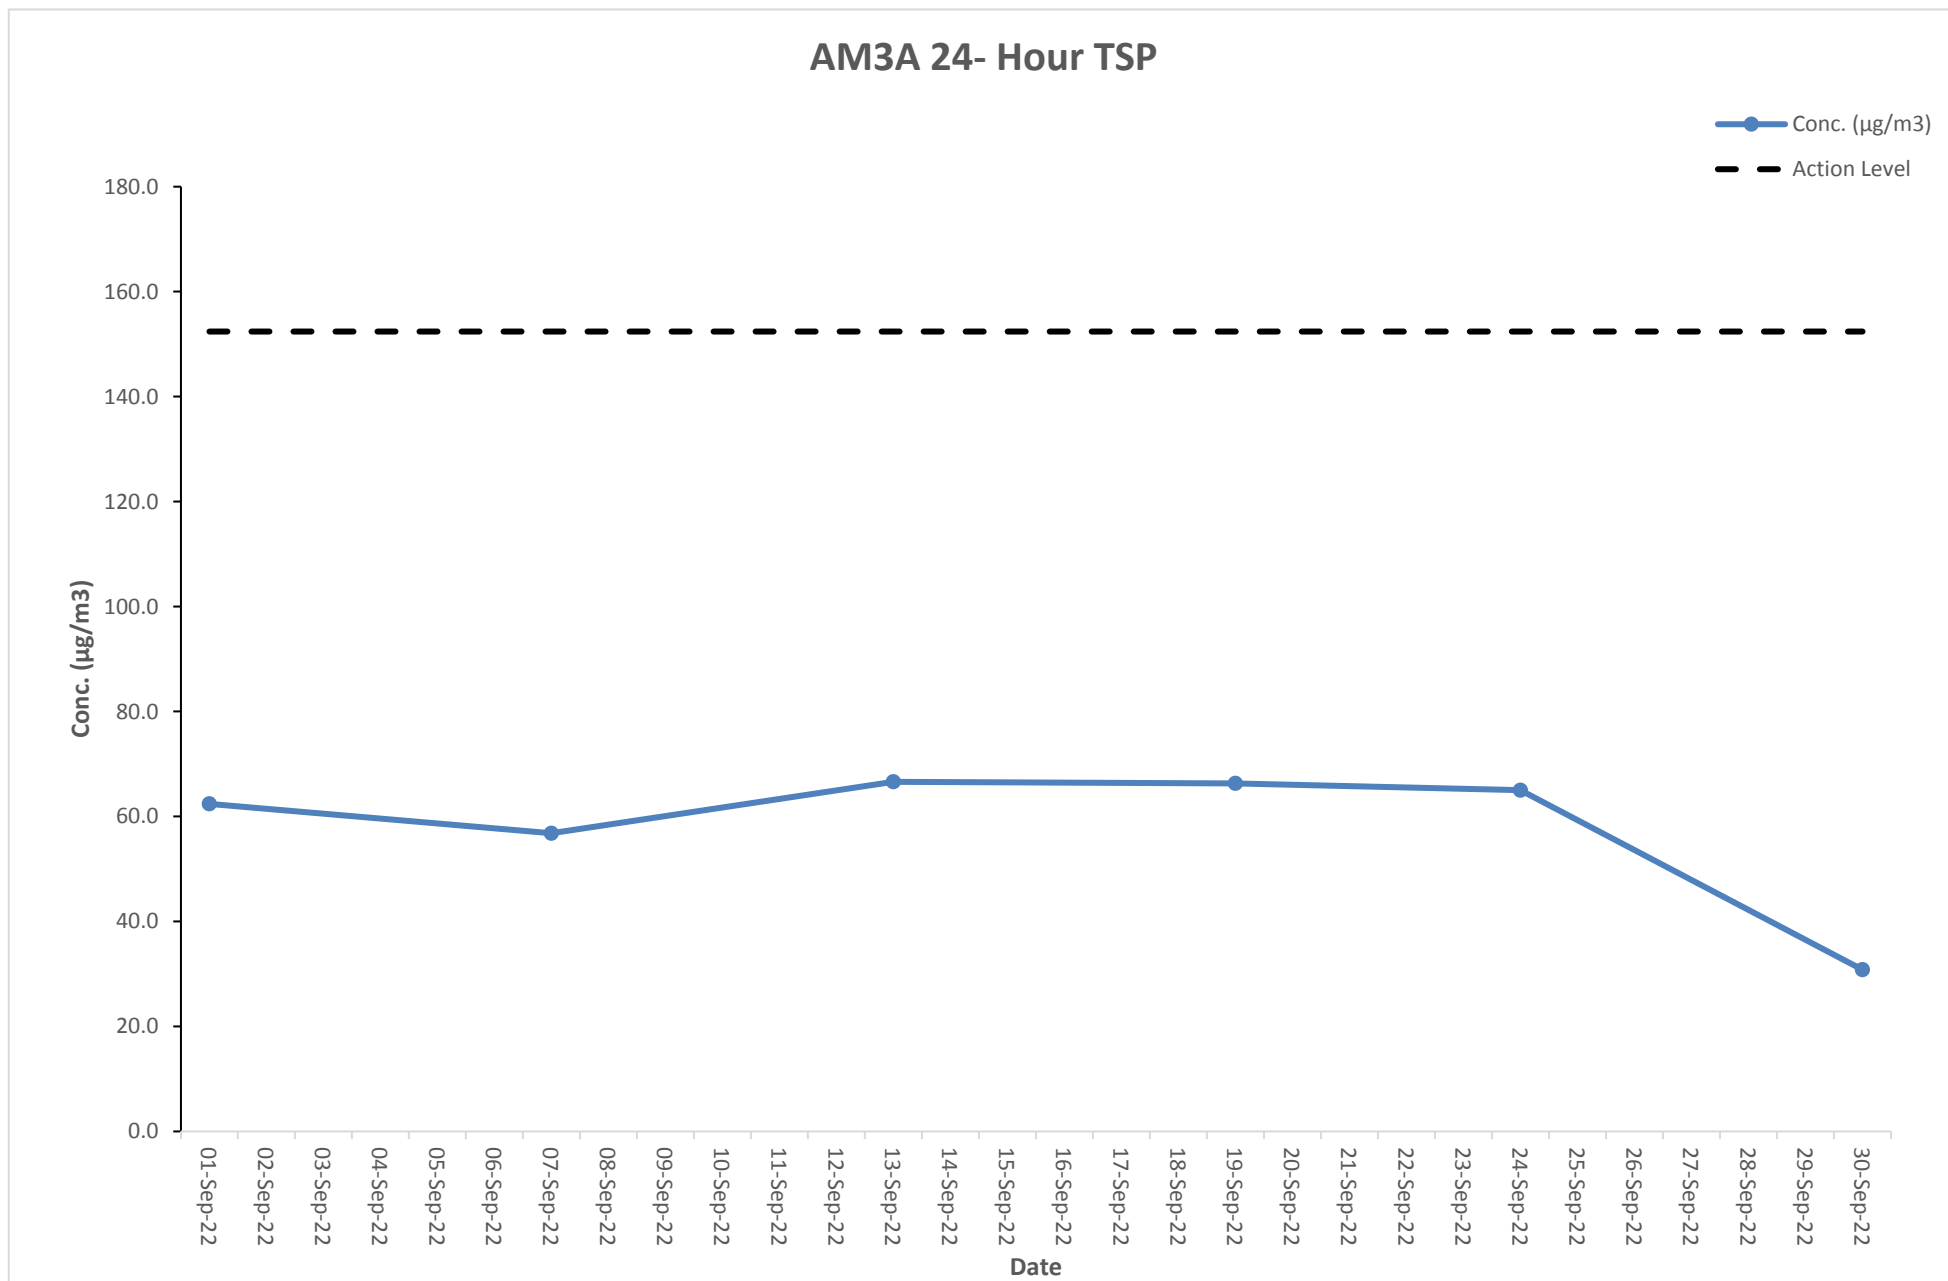
Graphical Presentation of Air Quality Monitoring Result at Station AM3A (24-hour TSP)

| Start | | Finish | | Filter Weight (g) | | Elapsed Time Reading | | Sampling Time (hrs) | Flow Rate (m ³ /min) | | | Conc. (µg/m ³) | Weather Condition | Action Level | Limit Level |
|---|---|---|---|---|---|---|---|---|---|---|---|---|---|---|---|
| 30-Sep-22 | 10:00AM | 01-Oct-22 | 10:00AM | 2.8062 | 2.8558 | 4180.8 | 4204.8 | 24 | 1.12 | 1.12 | 1.12 | 30.8 | Rainy | 152.4 | 260 |

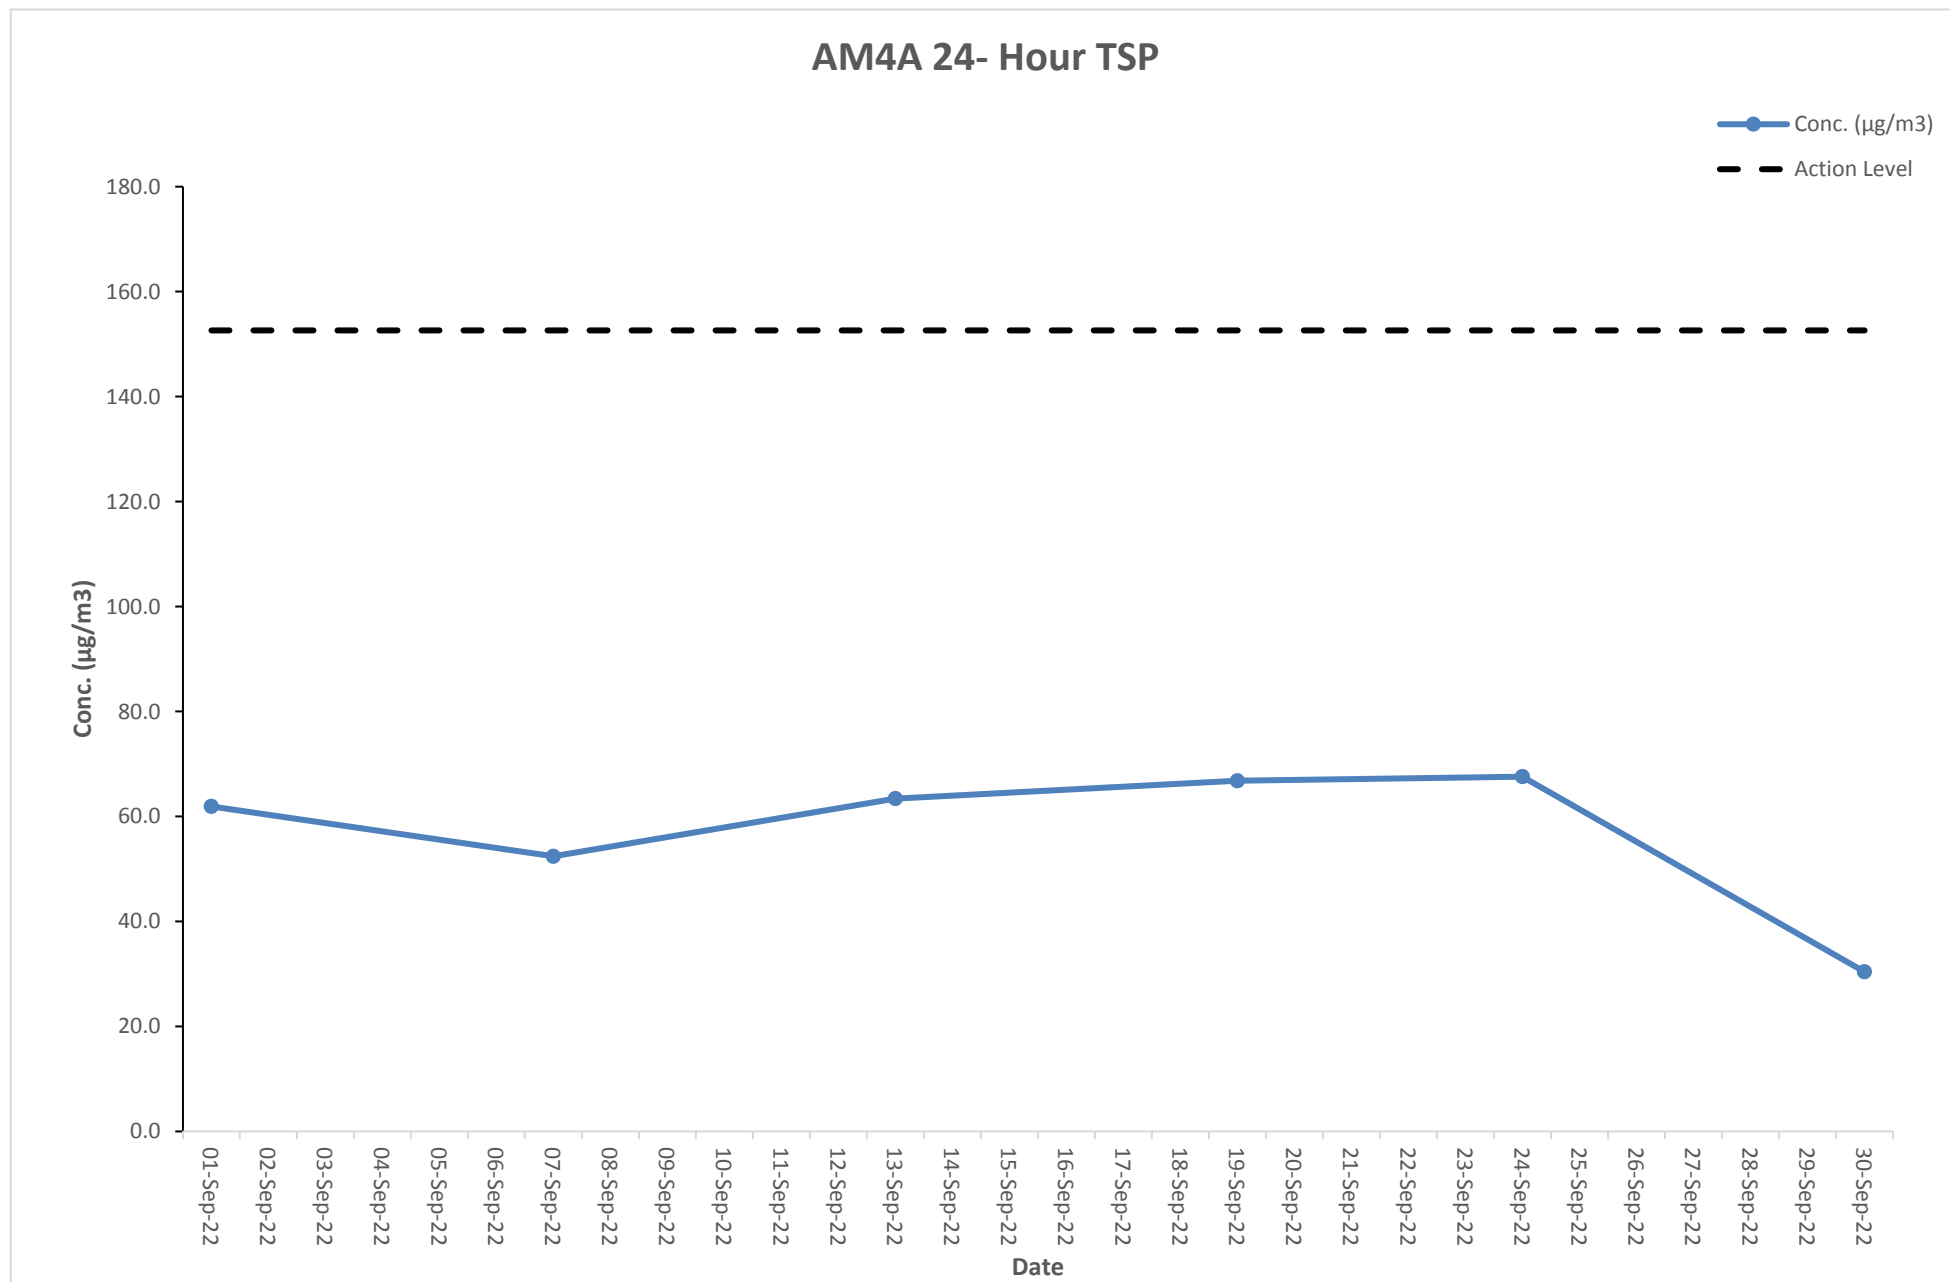
Graphical Presentation of Air Quality Monitoring Result at Station AM4A (24-hour TSP)

| Start | | Finish | | Filter Weight (g) | | Elapsed Time Reading | | Sampling Time (hrs) | Flow Rate (m ³ /min) | | | Conc. (µg/m ³) | Weather Condition | Action Level | Limit Level |
|---|---|---|---|---|---|---|---|---|---|---|---|---|---|---|---|
| 30-Sep-22 | 10:00AM | 01-Oct-22 | 10:00AM | 2.8081 | 2.8569 | 4600.4 | 4624.4 | 24 | 1.12 | 1.12 | 1.12 | 30.4 | Rainy | 152.6 | 260 |

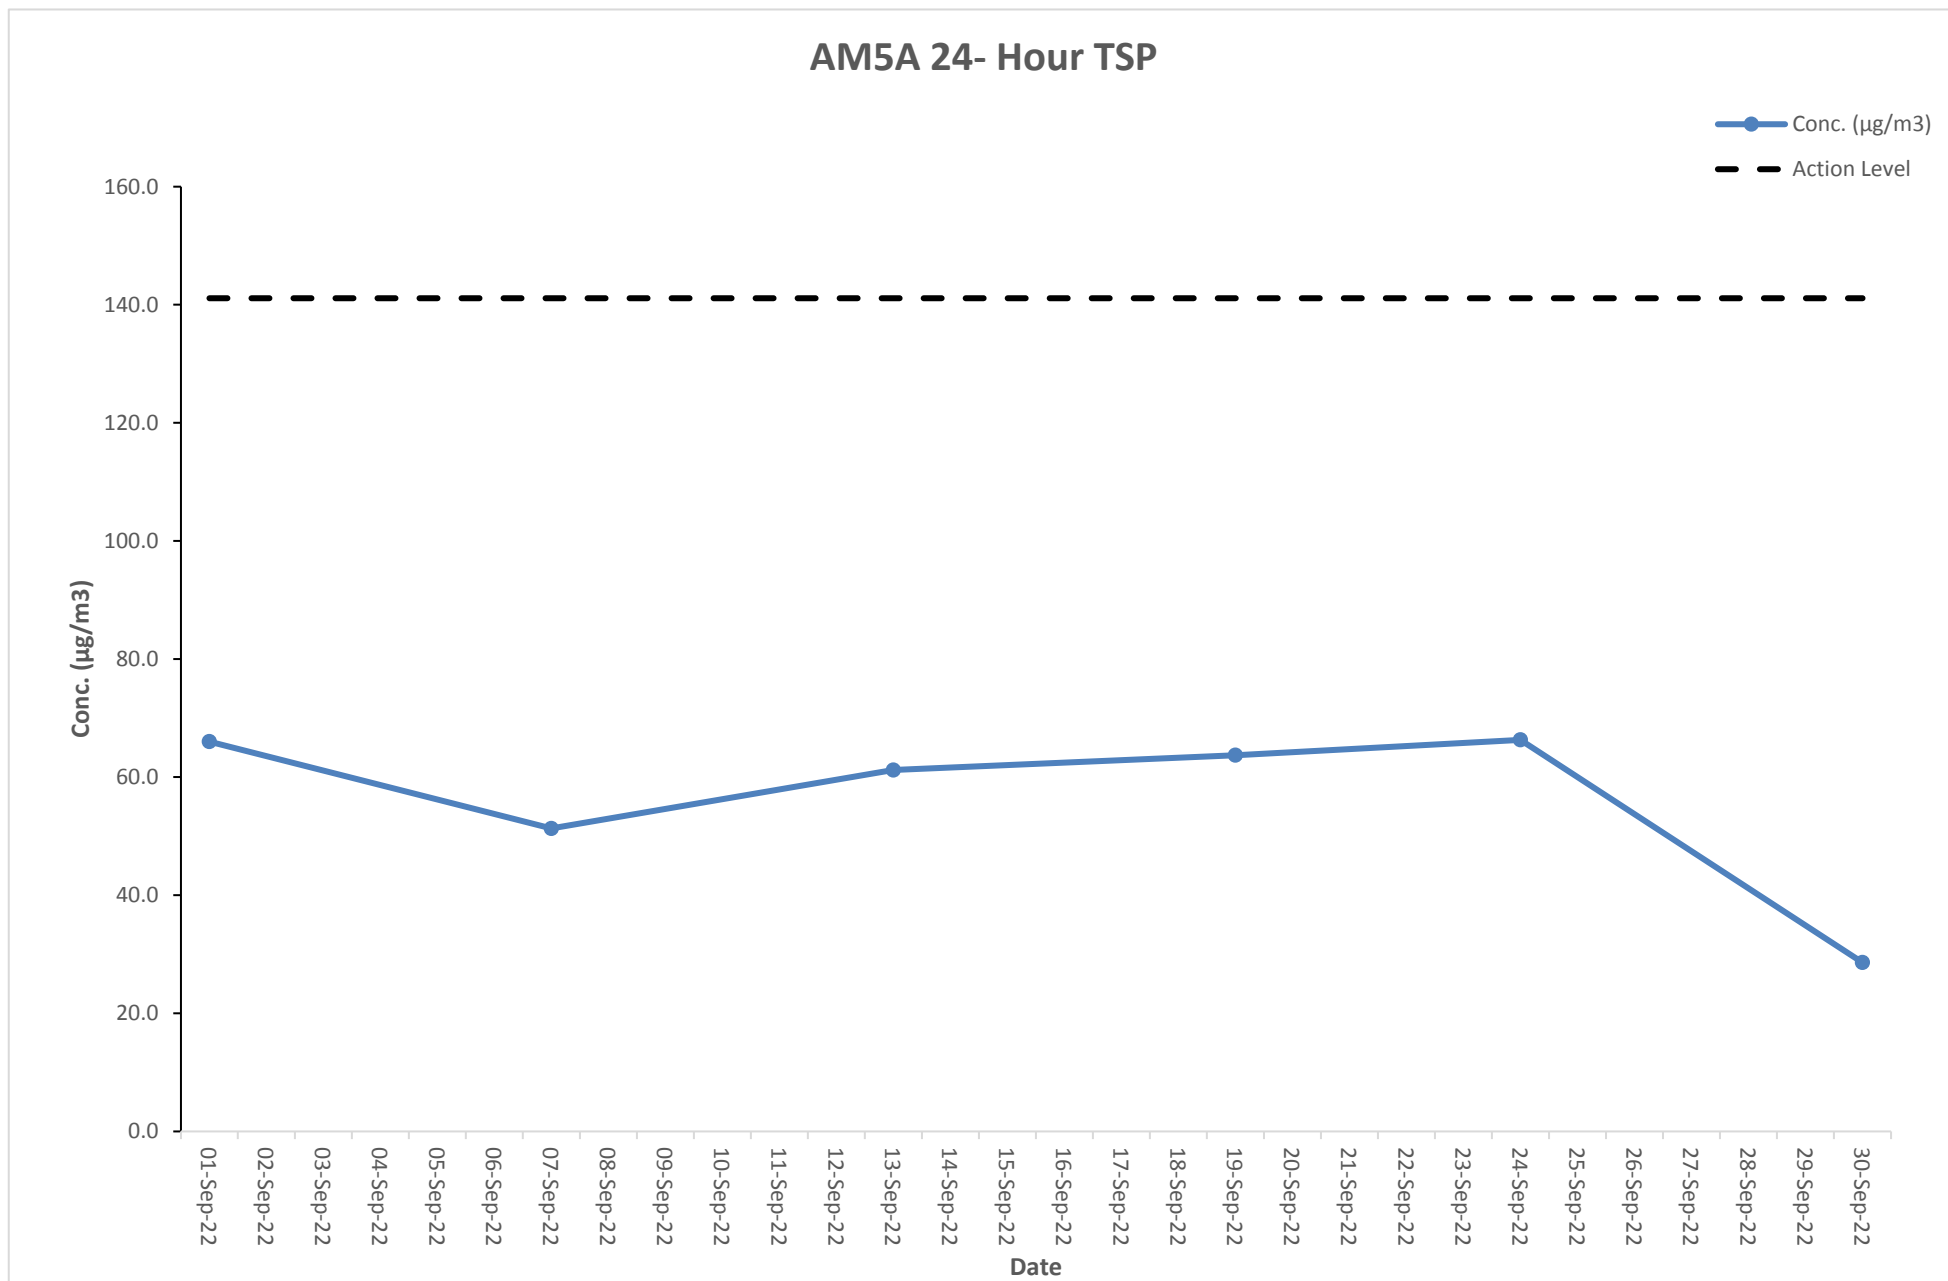
Graphical Presentation of Air Quality Monitoring Result at Station AM5A (24-hour TSP)

| Start | | Finish | | Filter Weight (g) | | Elapsed Time Reading | | Sampling Time (hrs) | Flow Rate (m ³ /min) | | | Conc. (µg/m ³) | Weather Condition | Action Level | Limit Level |
|---|---|---|---|---|---|---|---|---|---|---|---|---|---|---|---|
| 30-Sep-22 | 10:00AM | 01-Oct-22 | 10:00AM | 2.8019 | 2.8479 | 4740.6 | 4764.6 | 24 | 1.12 | 1.12 | 1.12 | 28.6 | Rainy | 141.1 | 260 |
