Development at West Kowloon Cultural District

**Monthly Environmental Monitoring and Audit (EM&A) Report
for September 2022**

**Part-2: EM&A for Foundation and ELS
Works in Zones 2A, 2B & 2C**

Part-1: EM&A at Lyric Theatre Complex

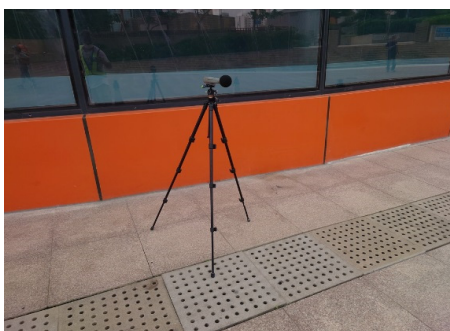
Graphical Presentation of Noise Monitoring Result at Station NM2A

The station set-up of a façade measurement at station NM2A.

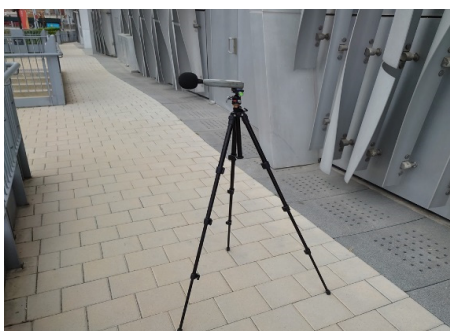
Graphical Presentation of Noise Monitoring Result at Station NM3A

The station set-up of a façade measurement at station NM3A.

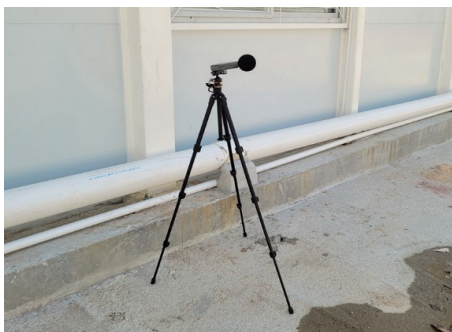
Graphical Presentation of Noise Monitoring Result at Station NM4A

The station set-up of a façade measurement at station NM4A.

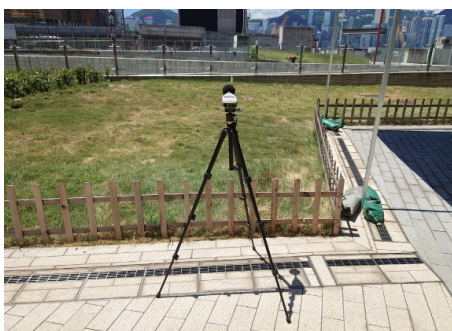
Graphical Presentation of Noise Monitoring Result at Station NM5A

+3dB(A) correction was applied to free-field measurement.

The station set-up of a free-field measurement at station NM5A.
