Development at West Kowloon Cultural District

Monthly Environmental Monitoring and Audit (EM&A) Report

for October 2022

Part-1: EM&A at Lyric Theatre Complex

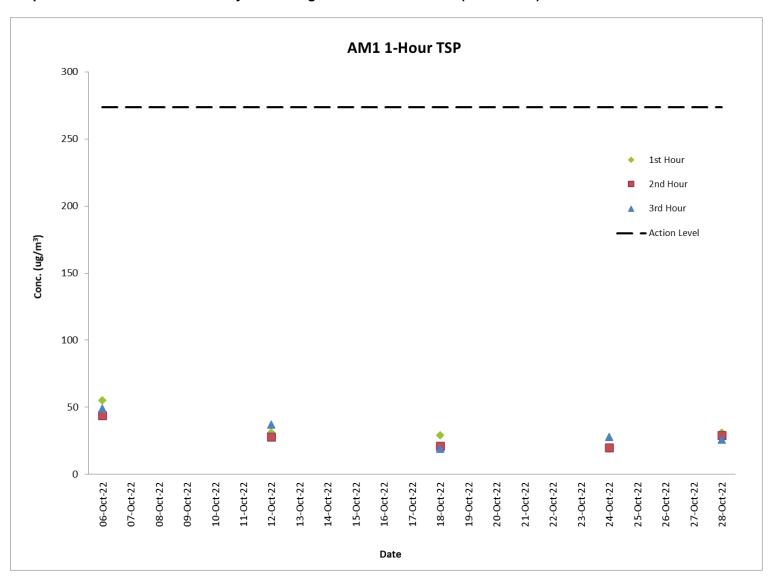
Weather			Conc. (μg/m³	Action Level	Limit Level	
Date	Condition	Time	1 st Hour	2 nd Hour	3 rd Hour	(μg/m³)	(µg/m³)
06-Oct-22	Fine	8:22 - 11:22	55	44	49	273.7	500
12-Oct-22	Sunny	8:22 - 11:22	31	28	37	273.7	500
18-Oct-22	Cloudy	8:33 - 11:33	29	21	19	273.7	500
24-Oct-22	Fine	8:30 - 11:30	19	20	28	273.7	500
28-Oct-22	Sunny	8:28 - 11:28	31	29	26	273.7	500

Graphical Presentation of Air Quality Monitoring Result at Station AM1 (1-hour TSP)

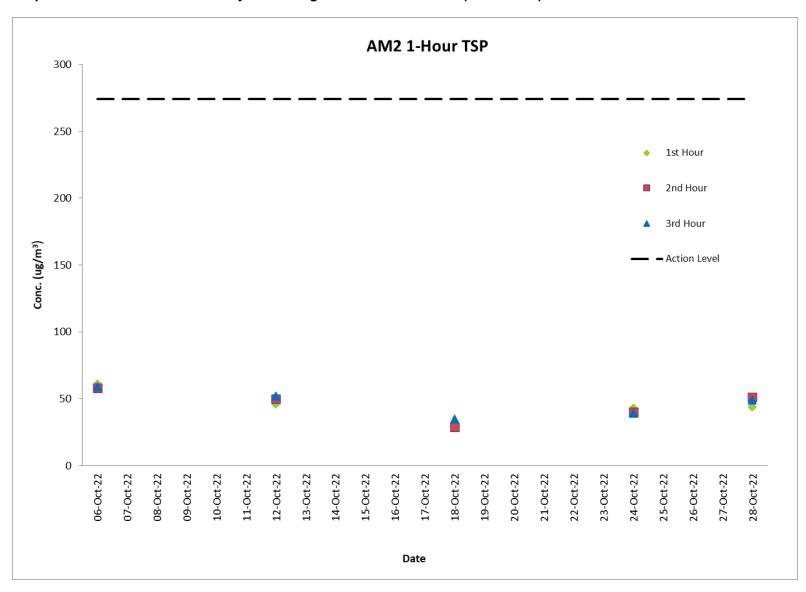
Weather			Conc. (µg/m³)	Action Level	Limit Level	
Date	Condition	Time	1 st Hour	2 nd Hour	3 rd Hour	(μg/m³)	(μg/m³)
06-Oct-22	Fine	8:34 - 11:34	61	58	59	274.2	500
12-Oct-22	Sunny	8:36 - 11:36	46	50	52	274.2	500
18-Oct-22	Cloudy	8:48 - 11:48	31	29	35	274.2	500
24-Oct-22	Fine	8:44 - 11:44	43	40	39	274.2	500
28-Oct-22	Sunny	8:43 - 11:43	44	51	49	274.2	500

Graphical Presentation of Air Quality Monitoring Result at Station AM2 (1-hour TSP)

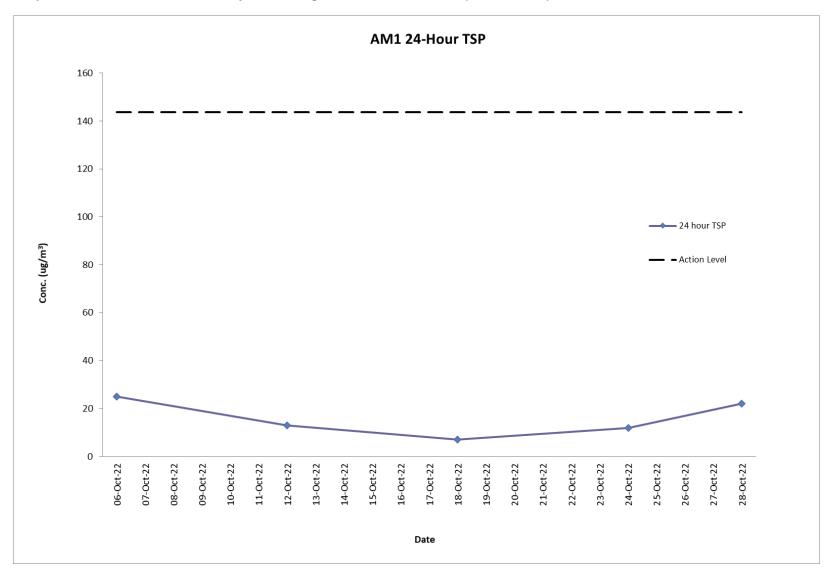
Sta	rt	Finis	sh	Filter W	eight (g)	Elapsed Time Reading		Sampling	Flow Rate (m ³ /min)		Conc.	Weather	Action	Limit	
Date	Time	Date	Time	Initial	Final	Initial	Final	Time (hrs)	Initial	Final	Average	(µg/m³)	Condition	Level	Level
06-Oct-22	08:20	07-Oct-22	08:20	2.7209	2.7655	25568.38	25592.38	24	1.26	1.26	1.26	25	Fine	143.6	260
12-Oct-22	08:20	13-Oct-22	08:20	2.7389	2.7633	25592.38	25616.38	24	1.26	1.26	1.26	13	Sunny	143.6	260
18-Oct-22	08:30	19-Oct-22	08:30	2.7656	2.7792	25616.38	25640.38	24	1.26	1.26	1.26	7	Cloudy	143.6	260
24-Oct-22	08:28	25-Oct-22	08:28	2.7590	2.7811	25640.38	25664.38	24	1.26	1.26	1.26	12	Fine	143.6	260
28-Oct-22	08:25	29-Oct-22	08:25	2.7838	2.8242	25664.38	25688.38	24	1.26	1.26	1.26	22	Sunny	143.6	260

Graphical Presentation of Air Quality Monitoring Result at Station AM1 (24-hour TSP)

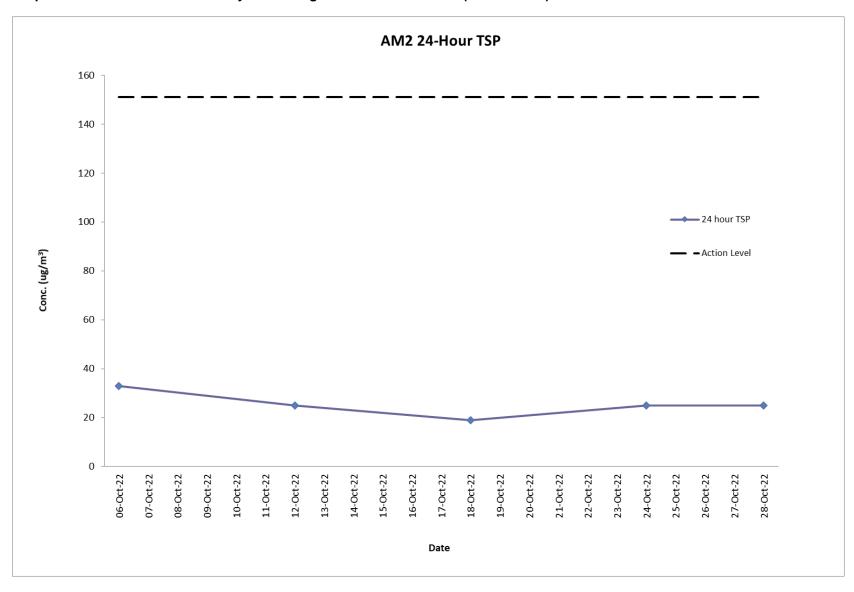
Sta	rt	Finis	sh	Sampling	Conc.	Weather	Action	
Date	Time	Date	Time	Time (hrs)	(µg/m³)	Condition	Level	Limit Level
06-Oct-22	08:32	07-Oct-22	08:32	24	33	Fine	151.1	260
12-Oct-22	08:34	13-Oct-22	08:34	24	25	Sunny	151.1	260
18-Oct-22	08:45	19-Oct-22	08:45	24	19	Cloudy	151.1	260
24-Oct-22	08:42	25-Oct-22	08:42	24	25	Fine	151.1	260
28-Oct-22	08:40	29-Oct-22	08:40	24	25	Sunny	151.1	260

Graphical Presentation of Air Quality Monitoring Result at Station AM2 (24-hour TSP)

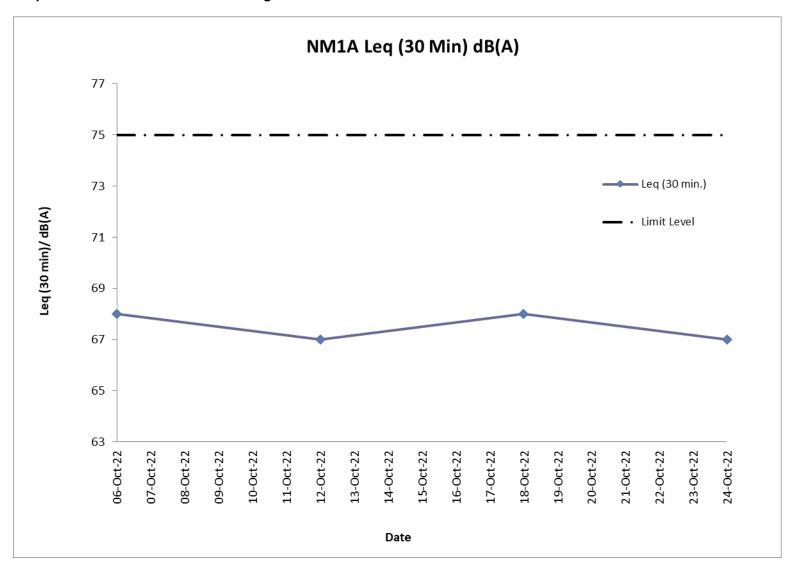
The station set-up of a free-field measurement at Station NM1A.

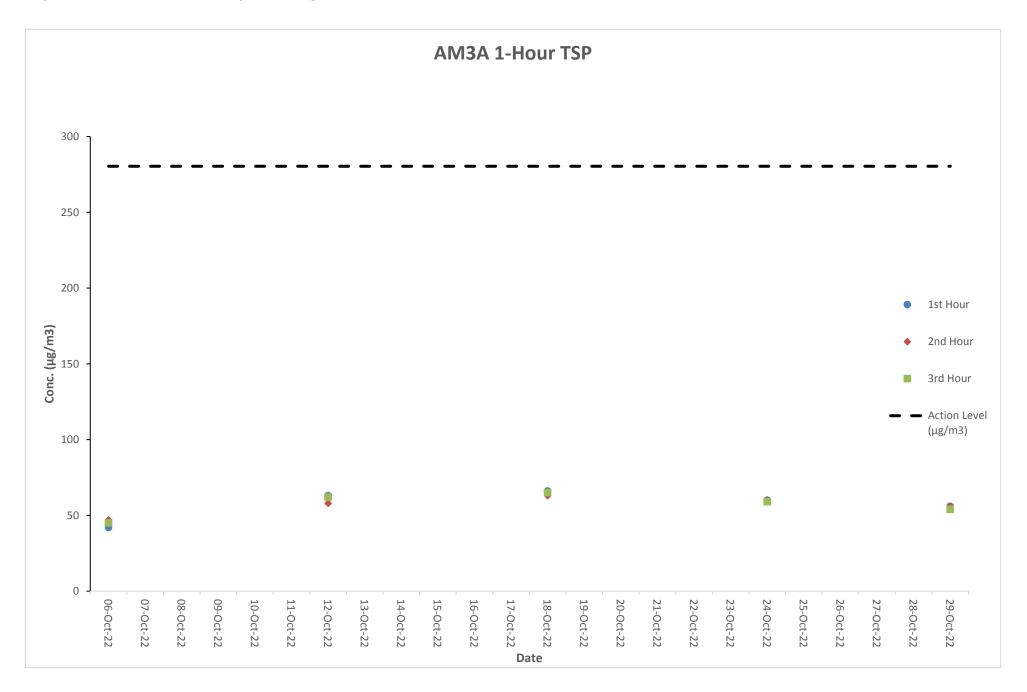
Air Quality Monitoring Result at Station AM3A (1-hour TSP)

Date	Weather	Time		C	onc. (µg/m3	3)	Action	Limit
Date	Condition	Start	Finish	1st Hour	2nd Hour	3rd Hour	Level	Level
06-Oct-22	Cloudy	8:01	11:01	42	47	45	280.4	500
12-Oct-22	Fine	14:05	17:05	63	58	62	280.4	500
18-Oct-22	Cloudy	8:03	11:03	66	63	65	280.4	500
24-Oct-22	Fine	14:06	17:06	60	60	59	280.4	500
29-Oct-22	Fine	8:07	11:07	56	56	54	280.4	500

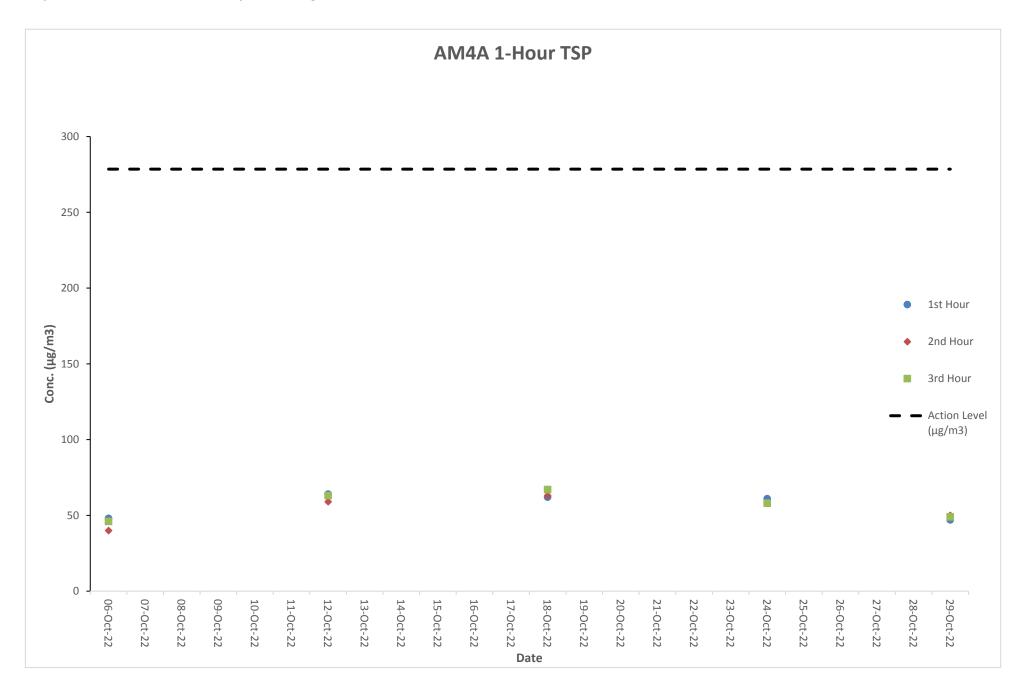
Air Quality Monitoring Result at Station AM4A (1-hour TSP)

Date	Weather	Tir	ne	C	onc. (µg/m3	Action	Limit	
Date	Condition	Start	Finish	1st Hour	2nd Hour	3rd Hour	Level	Level
06-Oct-22	Cloudy	8:09	11:09	48	40	46	278.5	500
12-Oct-22	Fine	14:13	17:13	64	59	63	278.5	500
18-Oct-22	Cloudy	8:11	11:11	62	63	67	278.5	500
24-Oct-22	Fine	14:14	17:14	61	58	58	278.5	500
29-Oct-22	Fine	8:15	11:15	47	50	49	278.5	500

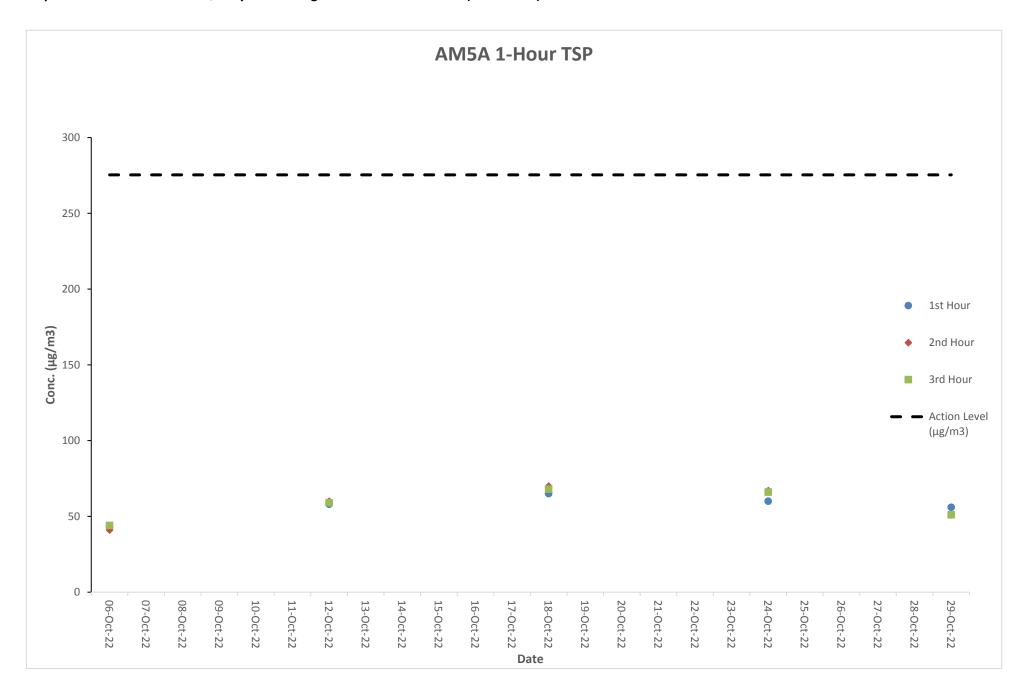
Air Quality Monitoring Result at Station AM5A (1-hour TSP)

Date Weather		Tir	ne	C	onc. (µg/m3	Action	Limit	
Date	Condition	Start	Finish	1st Hour	2nd Hour	3rd Hour	Level	Level
06-Oct-22	Cloudy	8:24	11:24	43	41	44	275.4	500
12-Oct-22	Fine	14:30	17:30	58	60	59	275.4	500
18-Oct-22	Cloudy	8:26	11:26	65	70	68	275.4	500
24-Oct-22	Fine	14:31	17:31	60	67	66	275.4	500
29-Oct-22	Fine	8:30	11:30	56	51	51	275.4	500

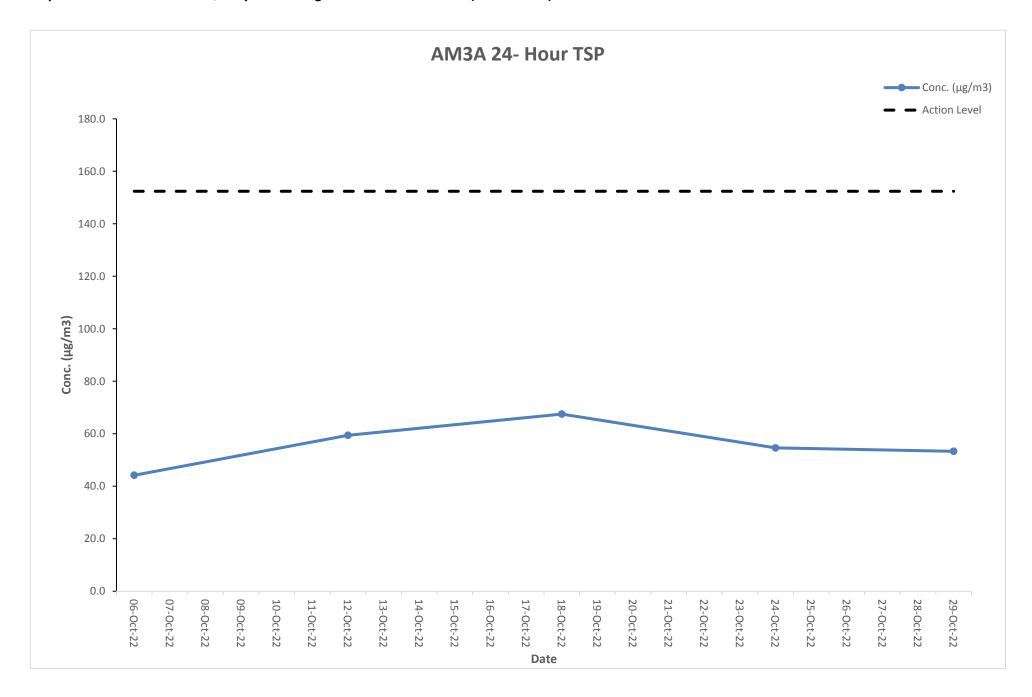
Air Quality Monitoring Result at Station AM3A (24-hour TSP)

Sta	rt	Fini	sh	Filter We	eight (g)	Elapsed Tir	ne Reading	Sampling	Flov	v Rate (m	n³/min)	Conc.	Weather	Action	Limit
Date	Time	Date	Time	Initial	Final	Initial	Final	Time (hrs)	Initial	Final	Average	(µg/m3)	Condition	Level	Level
06-Oct-22	10:00AM	07-Oct-22	10:00AM	2.8010	2.8722	4205.8	4229.8	24	1.12	1.12	1.12	44.2	Cloudy	152.4	260
12-Oct-22	10:00AM	13-Oct-22	10:00AM	2.8038	2.8994	4229.8	4253.8	24	1.12	1.12	1.12	59.4	Sunny	152.4	260
18-Oct-22	10:00AM	19-Oct-22	10:00AM	2.8018	2.9104	4253.8	4277.8	24	1.12	1.12	1.12	67.5	Rainy	152.4	260
24-Oct-22	10:00AM	25-Oct-22	10:00AM	2.8064	2.8943	4277.8	4301.8	24	1.12	1.12	1.12	54.6	Sunny	152.4	260
29-Oct-22	10:00AM	30-Oct-22	10:00AM	2.8039	2.8897	4301.8	4325.8	24	1.12	1.12	1.12	53.3	Sunny	152.4	260

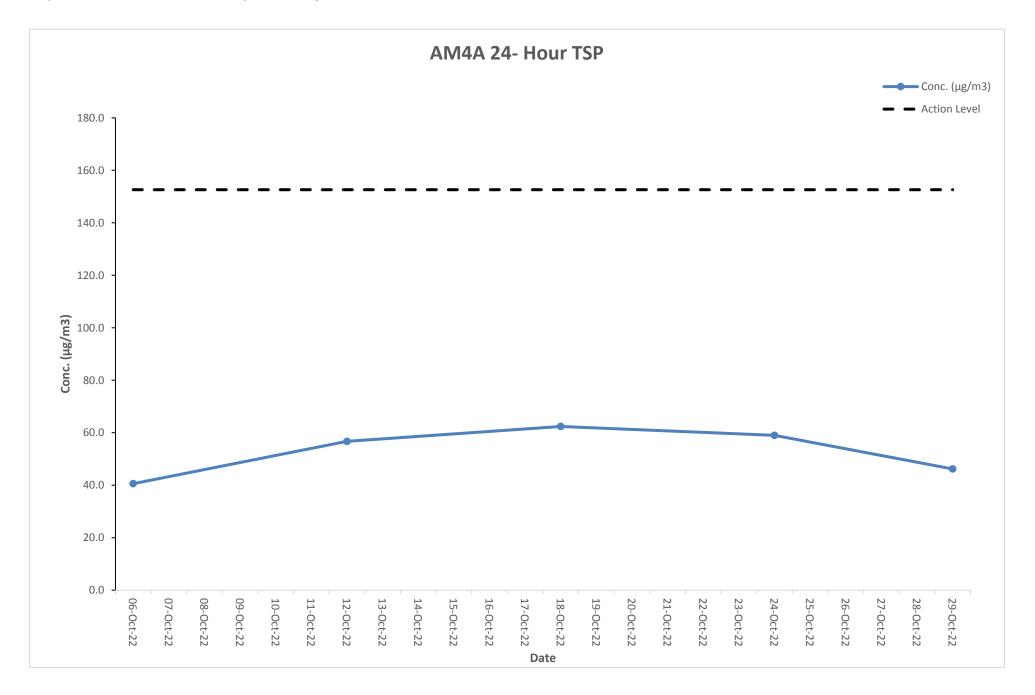
Air Quality Monitoring Result at Station AM4A (24-hour TSP)

Sta	ırt	Fini	sh	Filter W	eight (g)	Elapsed Tir	ne Reading	Sampling	Flov	v Rate (m	n³/min)	Conc.	Weather	Action	Limit
Date	Time	Date	Time	Initial	Final	Initial	Final	Time (hrs)	Initial	Final	Average	(µg/m3)	Condition	Level	Level
06-Oct-22	10:00AM	07-Oct-22	10:00AM	2.8045	2.8699	4625.4	4649.4	24	1.12	1.12	1.12	40.6	Cloudy	152.6	260
12-Oct-22	10:00AM	13-Oct-22	10:00AM	2.8016	2.8929	4649.4	4673.4	24	1.12	1.12	1.12	56.7	Sunny	152.6	260
18-Oct-22	10:00AM	19-Oct-22	10:00AM	2.8062	2.9066	4673.4	4697.4	24	1.12	1.12	1.12	62.4	Rainy	152.6	260
24-Oct-22	10:00AM	25-Oct-22	10:00AM	2.8081	2.9030	4697.4	4721.4	24	1.12	1.12	1.12	59.0	Sunny	152.6	260
29-Oct-22	10:00AM	30-Oct-22	10:00AM	2.8012	2.8755	4721.4	4745.4	24	1.12	1.12	1.12	46.2	Sunny	152.6	260

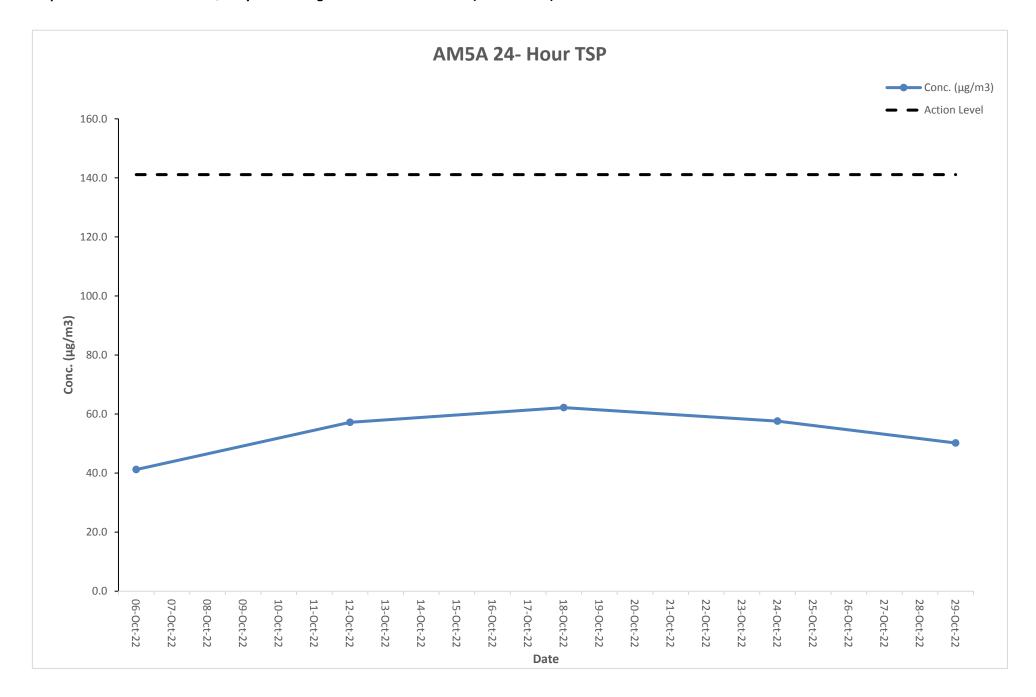
Air Quality Monitoring Result at Station AM5A (24-hour TSP)

Sta	rt	Fini	sh	Filter W	eight (g)	Elapsed Tir	ne Reading	Sampling	Flov	v Rate (m	n³/min)	Conc.	Weather	Action	Limit
Date	Time	Date	Time	Initial	Final	Initial	Final	Time (hrs)	Initial	Final	Average	(µg/m3)	Condition	Level	Level
06-Oct-22	10:00AM	07-Oct-22	10:00AM	2.8019	2.8683	4765.6	4789.6	24	1.12	1.12	1.12	41.2	Cloudy	141.1	260
12-Oct-22	10:00AM	13-Oct-22	10:00AM	2.8051	2.8971	4789.6	4813.6	24	1.12	1.12	1.12	57.2	Sunny	141.1	260
18-Oct-22	10:00AM	19-Oct-22	10:00AM	2.8021	2.9023	4813.6	4837.6	24	1.12	1.12	1.12	62.2	Rainy	141.1	260
24-Oct-22	10:00AM	25-Oct-22	10:00AM	2.8039	2.8966	4837.6	4861.6	24	1.12	1.12	1.12	57.6	Sunny	141.1	260
29-Oct-22	10:00AM	30-Oct-22	10:00AM	2.8046	2.8853	4861.6	4885.6	24	1.12	1.12	1.12	50.2	Sunny	141.1	260

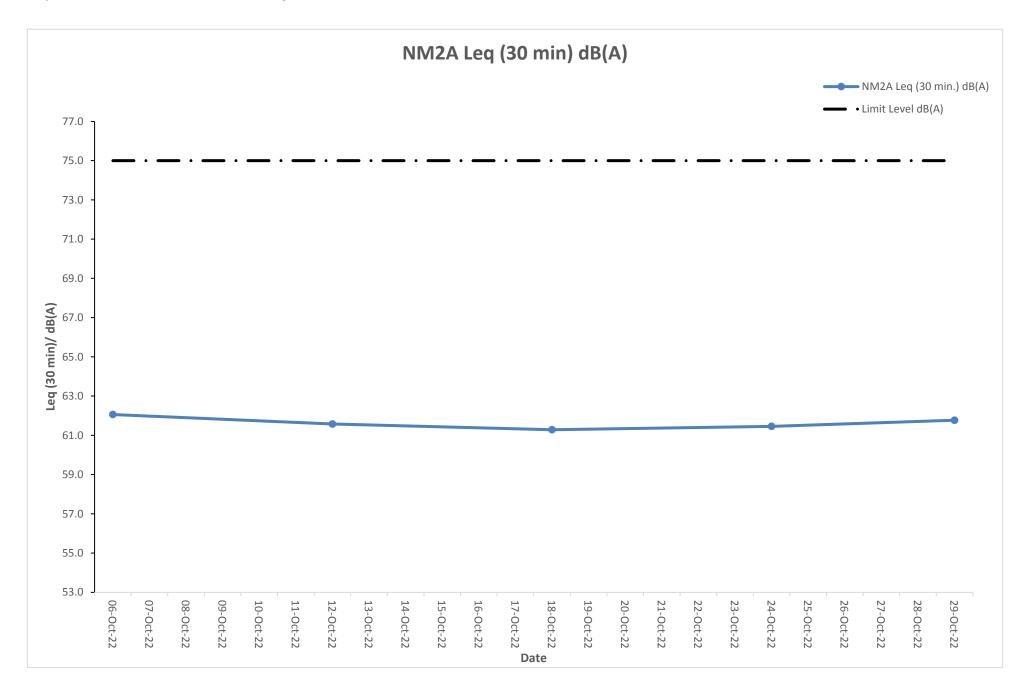
The station set-up of a façade measurement at station NM2A.

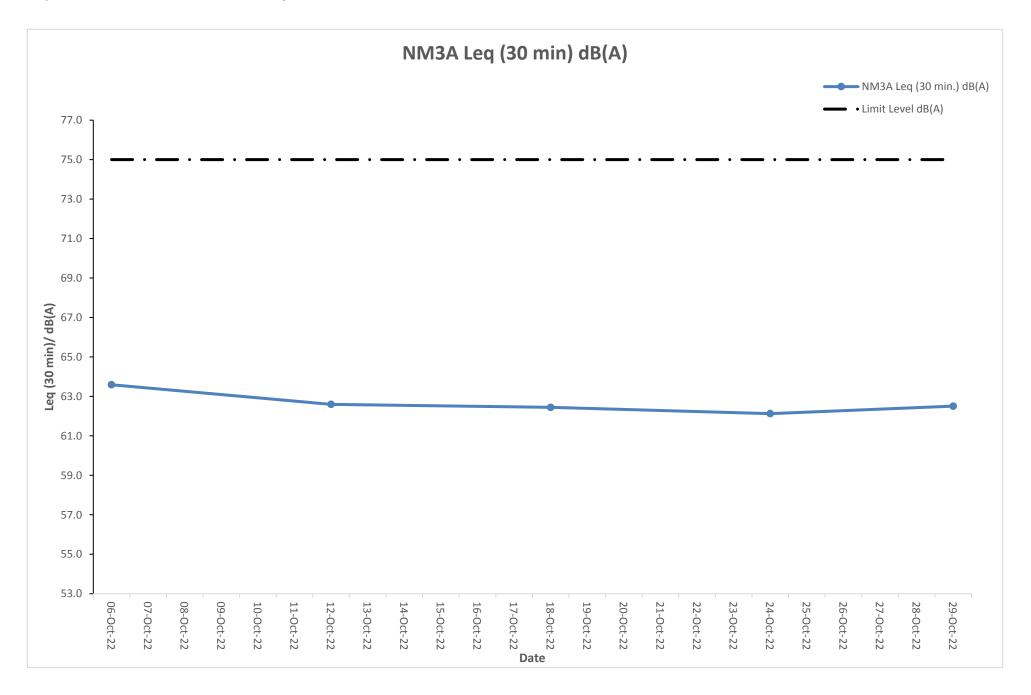
The station set-up of a façade measurement at station NM3A.

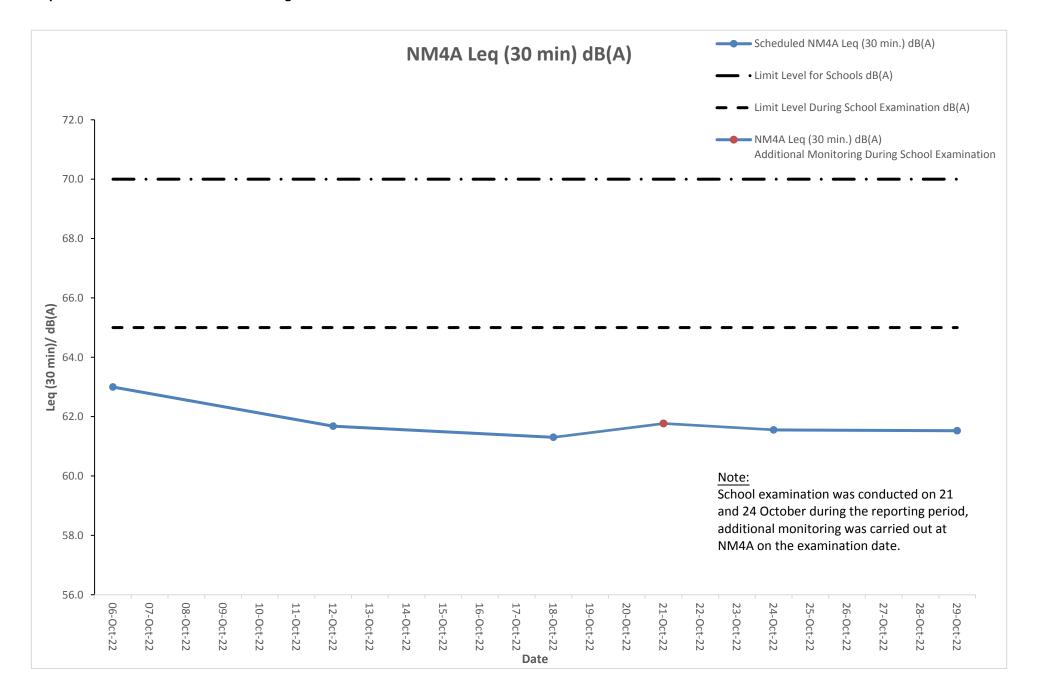
The station set-up of a façade measurement at station NM4A.

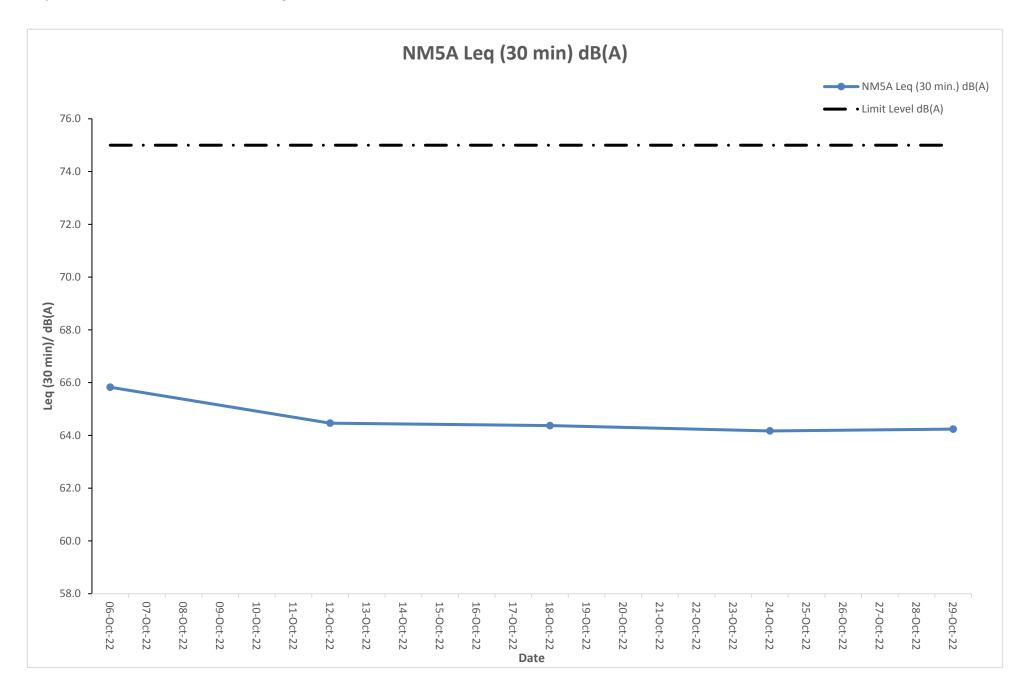
The station set-up of a free-field measurement at station NM5A.
