**JOB No.: TCS00881/18 & TCS00944/18**

**SITE FORMATION AND ASSOCIATED INFRASTRUCTURAL  
WORKS FOR DEVELOPMENT OF COLUMBARIUM,  
CREMATORIUM AND RELATED FACILITIES AT SANDY  
RIDGE CEMETERY**

**MONTHLY ENVIRONMENTAL MONITORING AND AUDIT  
REPORT (NO.55) – FEBRUARY 2023**

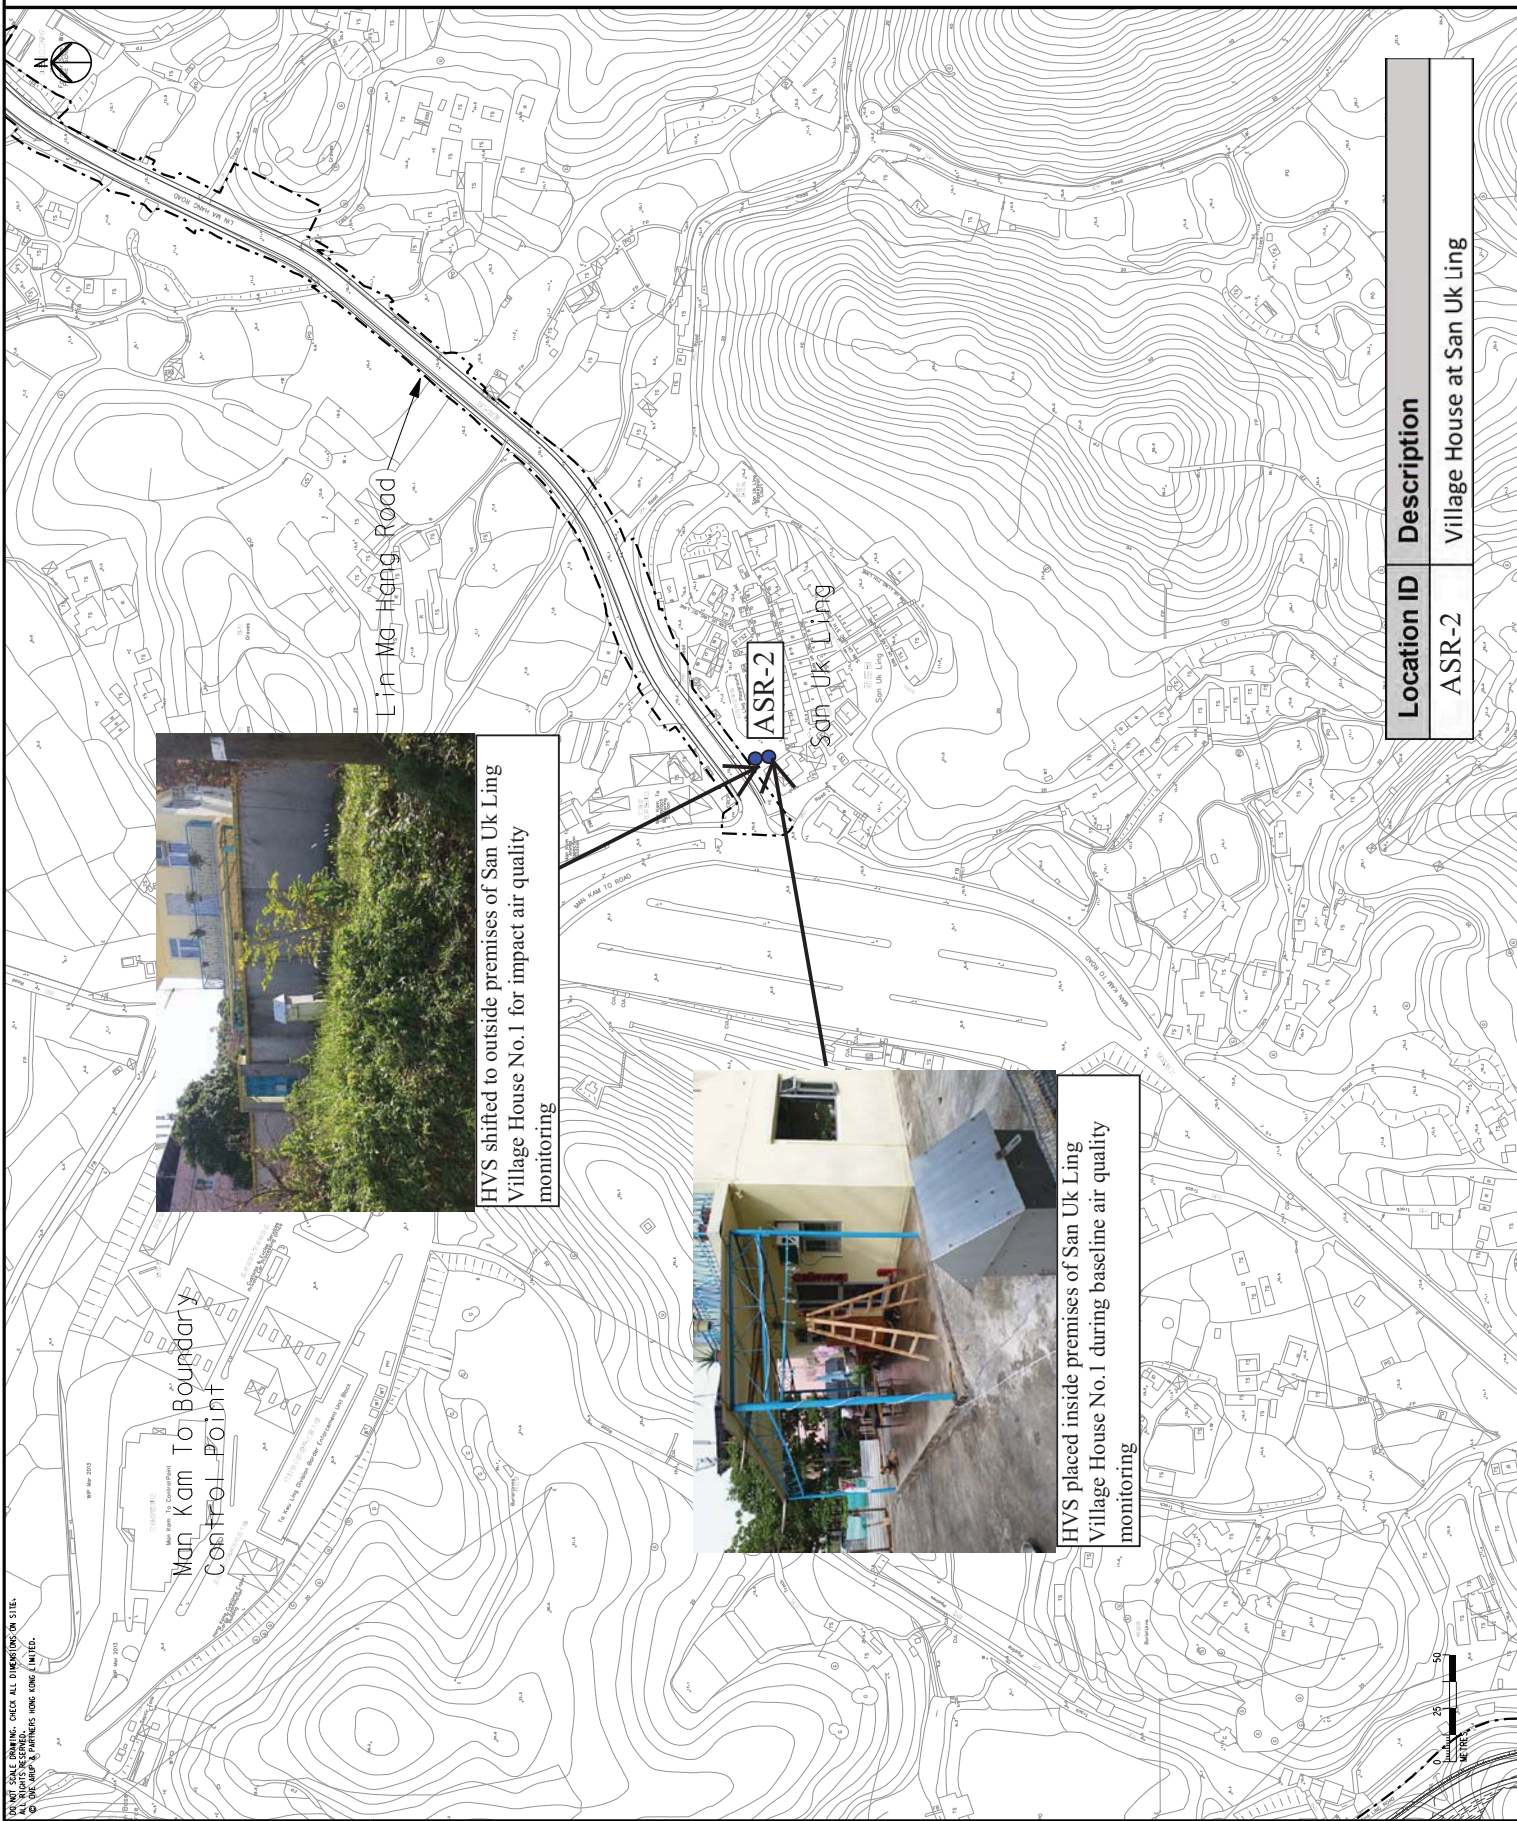
HVS shifted to outside premises of San Uk Ling Village House No.1 for impact air quality monitoring

HVS placed inside premises of San Uk Ling Village House No.1 during baseline air quality monitoring

3.3.3 There were three (3) designated air quality monitoring stations recommended in the Approved EM&A Manual Section 5.6.1.1. There was proposed relocation of air quality monitoring location ASR-3 in October 2018 since the landlord refused to set up the HVS at his premises and nearby Conservation Area due to noise nuisance and Muk Wu Nga Yiu House No. 2A was proposed as alternative location ASR-3a. The proposal dated on 9 November 2018 which verified by IEC was submitted to EPD for approval. Based on rationale in Section 3.3.2, the Contract-related air quality monitoring location for construction phase were summarized in *Table 3-2* and illustrated in *Appendix D*.

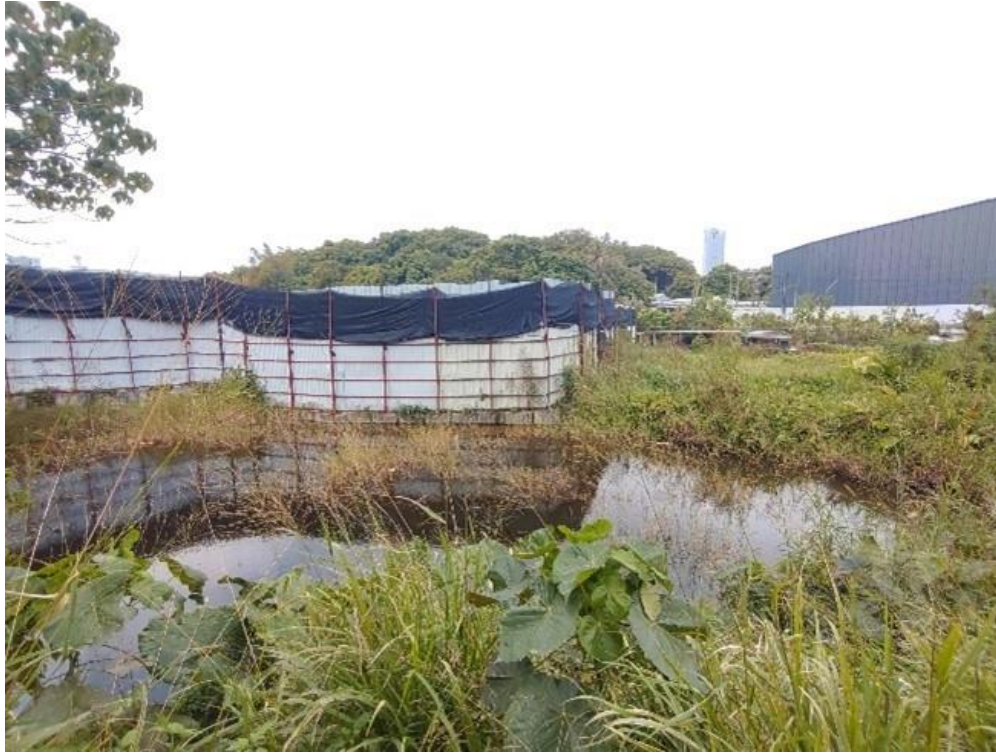
Watercourse in monitoring area.

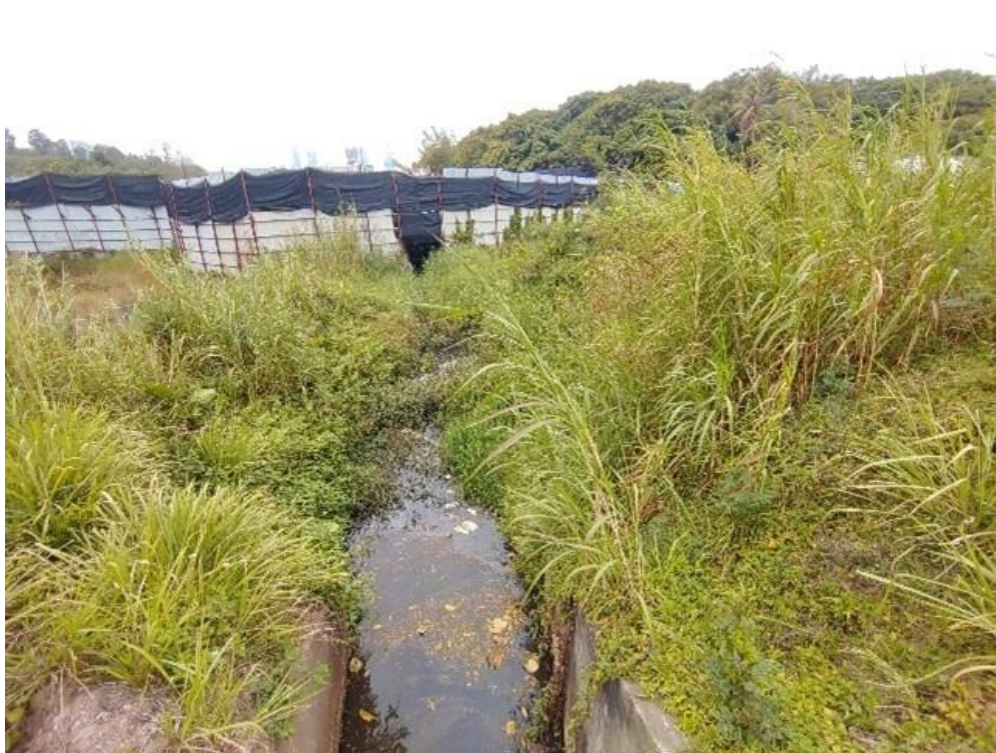
**Picture 2**

Watercourse in monitoring area.
