# **Development at West Kowloon Cultural District**

Monthly Environmental Monitoring and Audit (EM&A) Report for April 2023
11 May 2023

Part-1: EM&A at Lyric Theatre Complex

Part-2: EM&A for Foundation Works in Zone 2B & 2C

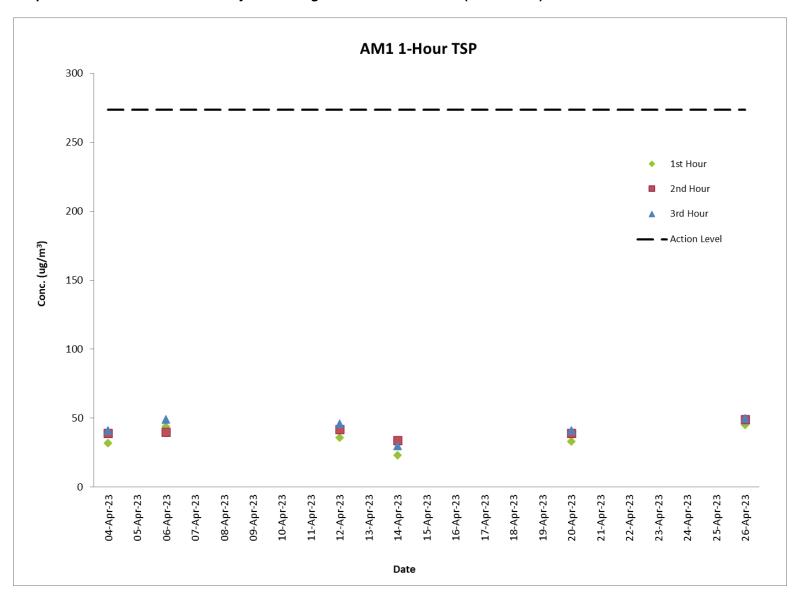
# **Graphical Presentation of Air Quality Monitoring Result at Station AM1 (1-hour TSP)**

Weather		Conc. (μg/m³)			Action Level	Limit Level
Date	Condition	Time	1 <sup>st</sup> Hour	2 <sup>nd</sup> Hour	3 <sup>rd</sup> Hour	(μg/m³)	(μg/m³)
04-Apr-23	Cloudy	8:24 - 11:24	32	39	41	273.7	500
06-Apr-23	Cloudy	8:23 - 11:23	44	40	49	273.7	500
12-Apr-23	Sunny	8:23 - 11:23	36	42	46	273.7	500
14-Apr-23	Cloudy	8:20 - 11:20	23	34	30	273.7	500
20-Apr-23	Cloudy	8:22 - 11:22	33	39	41	273.7	500
26-Apr-23	Fine	8:22 - 11:22	45	49	50	273.7	500

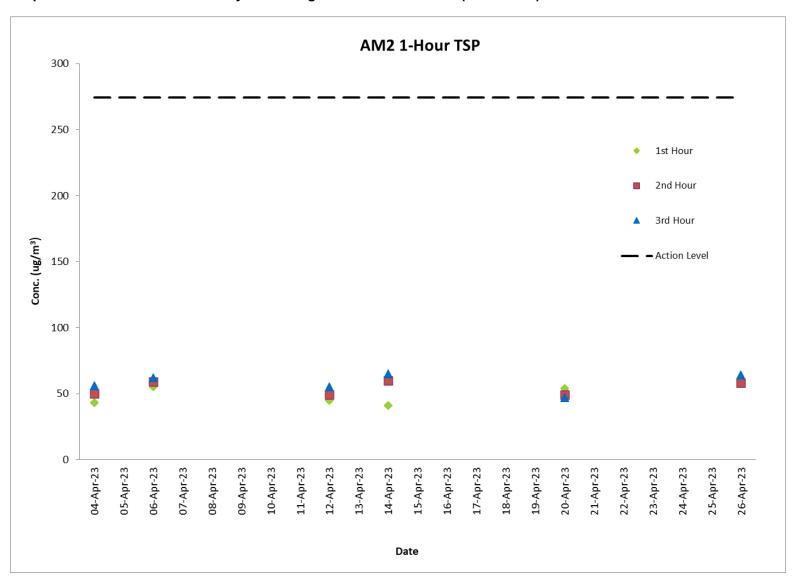
# **Graphical Presentation of Air Quality Monitoring Result at Station AM2 (1-hour TSP)**

Weather			Conc. (μg/m³	)	Action Level	Limit Level
Date	Condition	Time	1 <sup>st</sup> Hour	2 <sup>nd</sup> Hour	3 <sup>rd</sup> Hour	(μg/m³)	(μg/m³)
04-Apr-23	Cloudy	8:37 - 11:37	43	50	56	274.2	500
06-Apr-23	Cloudy	8:37 - 11:37	55	59	62	274.2	500
12-Apr-23	Sunny	8:38 - 11:38	45	49	55	274.2	500
14-Apr-23	Cloudy	8:33 - 11:33	41	60	65	274.2	500
20-Apr-23	Cloudy	8:36 - 11:36	54	49	47	274.2	500
26-Apr-23	Fine	8:37 - 11:37	61	58	64	274.2	500

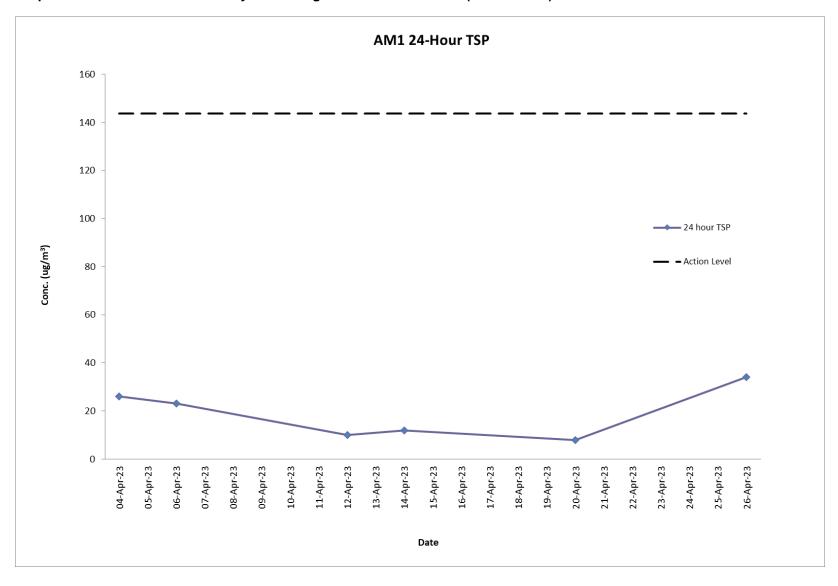
# **Graphical Presentation of Air Quality Monitoring Result at Station AM1 (24-hour TSP)**

Sta	rt	Finis	sh	Filter W	eight (g)	Elapsed Time ight (g) Reading Sampling Flow Rate (m³/min)		Conc.	Weather	Action	Limit				
Date	Time	Date	Time	Initial	Final	Initial	Final	Time (hrs)	Initial	Final	Average	(µg/m <sup>3</sup> )	Condition	Level	Level
04-Apr-23	08:20	05-Apr-23	08:20	2.7717	2.8166	26332.38	26356.38	24	1.2	1.2	1.2	26	Cloudy	143.6	260
06-Apr-23	08:21	07-Apr-23	08:21	2.7827	2.8220	26356.38	26380.38	24	1.2	1.2	1.2	23	Cloudy	143.6	260
12-Apr-23	08:21	13-Apr-23	08:21	2.7636	2.7813	26380.38	26404.38	24	1.2	1.2	1.2	10	Sunny	143.6	260
14-Apr-23	08:18	15-Apr-23	08:18	2.7633	2.7848	26404.38	26428.38	24	1.2	1.2	1.2	12	Cloudy	143.6	260
20-Apr-23	08:20	21-Apr-23	08:20	2.7821	2.7957	26428.38	26452.38	24	1.2	1.2	1.2	8	Cloudy	143.6	260
26-Apr-23	08:20	27-Apr-23	08:20	2.7864	2.8452	26452.38	26476.38	24	1.2	1.2	1.2	34	Fine	143.6	260

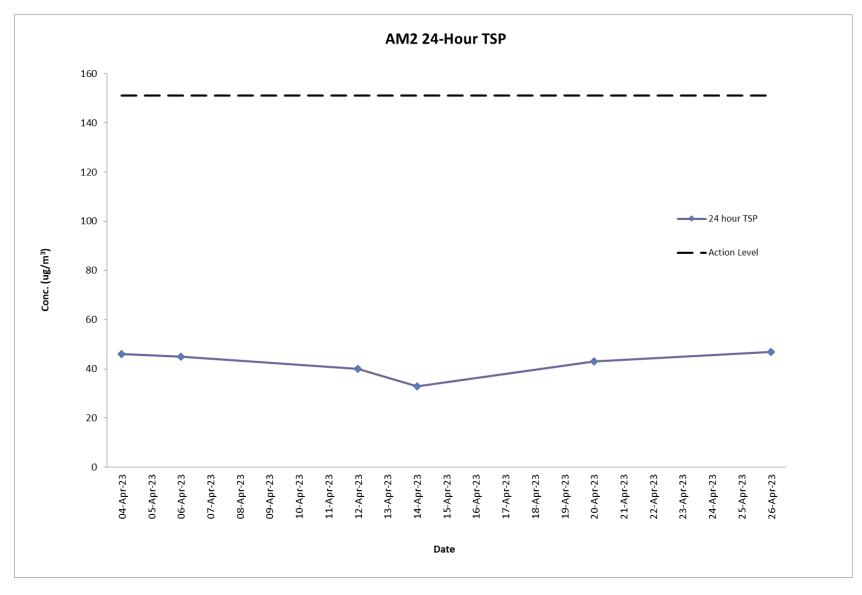
# **Graphical Presentation of Air Quality Monitoring Result at Station AM2 (24-hour TSP)**

Sta	rt	Finis	sh	Sampling	Conc.	Weather	Action	
Date	Time	Date	Time	Time (hrs)	(µg/m³)	Condition	Level	Limit Level
04-Apr-23	08:34	05-Apr-23	08:34	24	46	Cloudy	151.1	260
06-Apr-23	08:34	07-Apr-23	08:34	24	45	Cloudy	151.1	260
12-Apr-23	08:35	13-Apr-23	08:35	24	40	Sunny	151.1	260
14-Apr-23	08:31	15-Apr-23	08:31	24	33	Cloudy	151.1	260
20-Apr-23	08:33	21-Apr-23	08:33	24	43	Cloudy	151.1	260
26-Apr-23	08:34	27-Apr-23	08:34	24	47	Fine	151.1	260

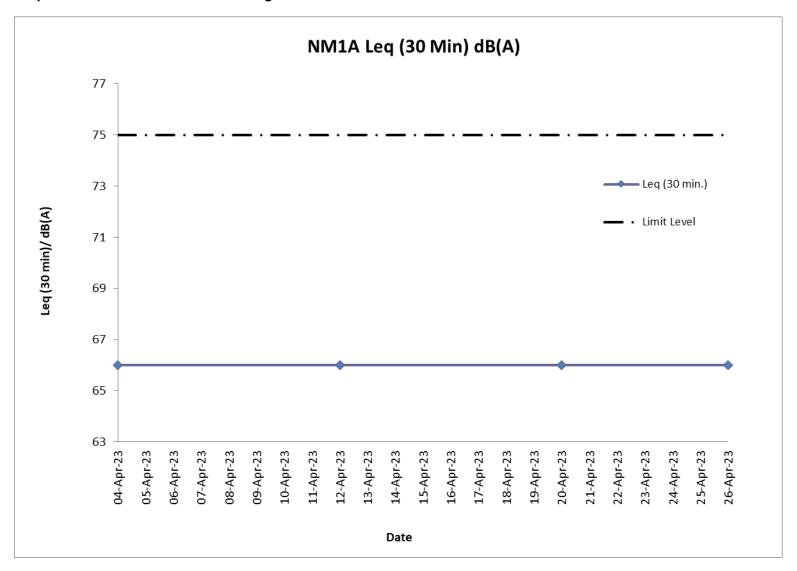
The station set-up of a free-field measurement at Station NM1A.

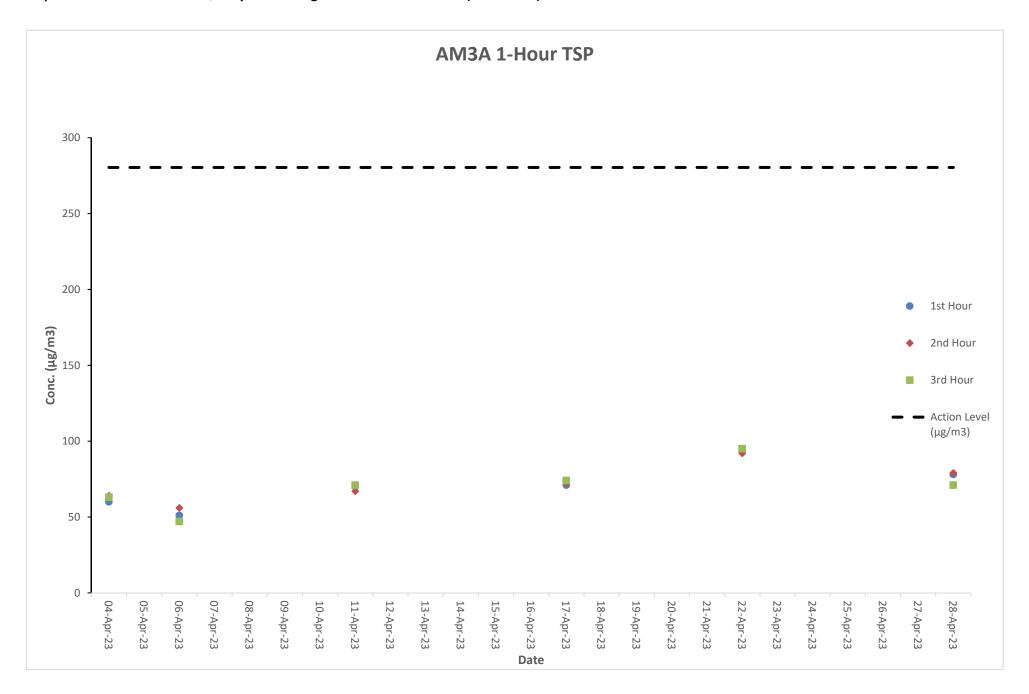
# Air Quality Monitoring Result at Station AM3A (1-hour TSP)

Date	Weather	Tir	ne	C	onc. (µg/m3	3)	Action	Limit
Date	Condition	Start	Finish	1st Hour	2nd Hour	3rd Hour	Level	Level
04-Apr-23	Cloudy	14:00	17:00	60	64	63	280.4	500
06-Apr-23	Cloudy	8:03	11:03	51	56	47	280.4	500
11-Apr-23	Fine	14:09	17:09	70	67	71	280.4	500
17-Apr-23	Fine	8:07	11:07	71	72	74	280.4	500
22-Apr-23	Cloudy	14:05	17:05	93	92	95	280.4	500
28-Apr-23	Cloudy	8:02	11:02	78	79	71	280.4	500

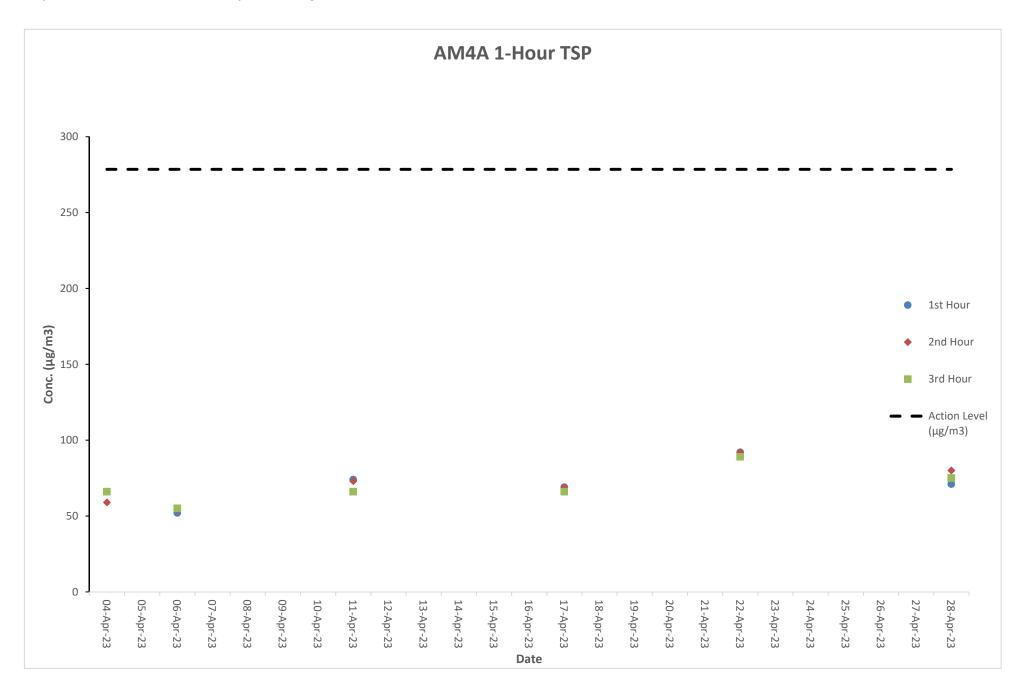
# Air Quality Monitoring Result at Station AM4A (1-hour TSP)

Date	Weather	Time		C	onc. (µg/m3	Action	Limit	
Date	Condition	Start	Finish	1st Hour	2nd Hour	3rd Hour	Level	Level
04-Apr-23	Cloudy	14:08	17:08	66	59	66	278.5	500
06-Apr-23	Cloudy	8:11	11:11	52	54	55	278.5	500
11-Apr-23	Fine	14:17	17:17	74	73	66	278.5	500
17-Apr-23	Fine	8:15	11:15	69	69	66	278.5	500
22-Apr-23	Cloudy	14:13	17:13	92	92	89	278.5	500
28-Apr-23	Cloudy	8:10	11:10	71	80	75	278.5	500

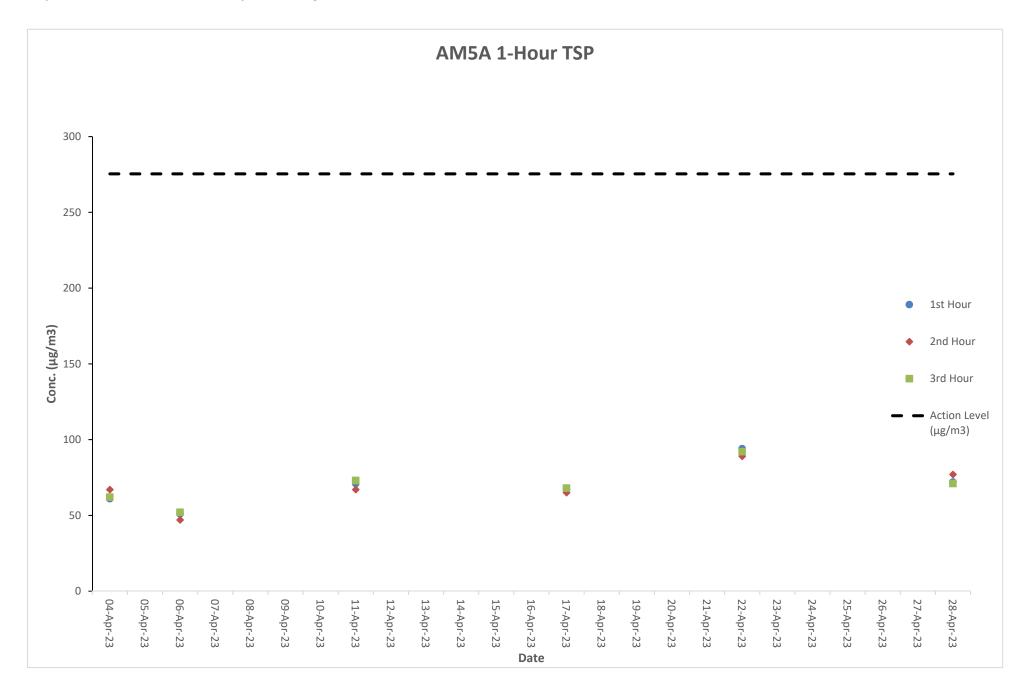
# Air Quality Monitoring Result at Station AM5A (1-hour TSP)

Date	Weather	Tir	ne	С	onc. (µg/m3	3)	Action	Limit
Date	Condition	Start	Finish	1st Hour	2nd Hour	3rd Hour	Level	Level
04-Apr-23	Cloudy	14:23	17:23	61	67	62	275.4	500
06-Apr-23	Cloudy	8:28	11:28	51	47	52	275.4	500
11-Apr-23	Fine	14:32	17:32	71	67	73	275.4	500
17-Apr-23	Fine	8:32	11:32	67	65	68	275.4	500
22-Apr-23	Cloudy	14:28	17:28	94	89	92	275.4	500
28-Apr-23	Cloudy	8:27	11:27	72	77	71	275.4	500

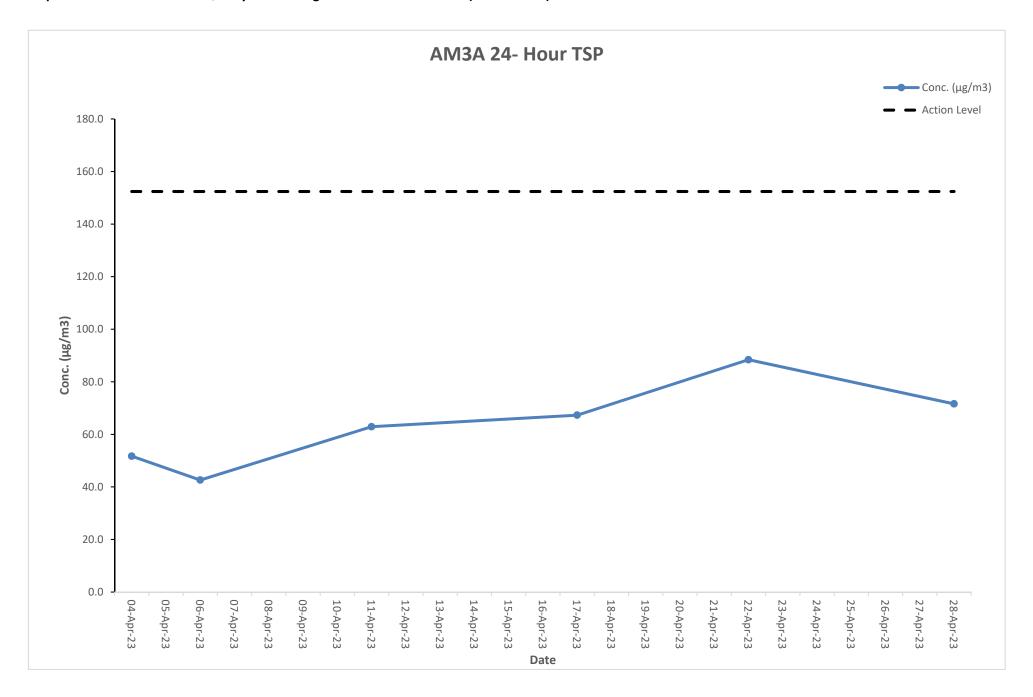
## Air Quality Monitoring Result at Station AM3A (24-hour TSP)

Start		Finish		Filter Weight (g)		Elapsed Time Reading		Sampling	Flow Rate (m³/min)		Conc.	Weather	Action	Limit	
Date	Time	Date	Time	Initial	Final	Initial	Final	Time (hrs)	Initial	Final	Average	(µg/m3)	Condition	Level	Level
04-Apr-23	10:00AM	05-Apr-23	10:00AM	2.8067	2.8899	4999.8	5023.8	24	1.12	1.12	1.12	51.7	Rainy	152.4	260
06-Apr-23	10:00AM	07-Apr-23	10:00AM	2.8036	2.8721	5023.8	5047.8	24	1.12	1.12	1.12	42.6	Rainy	152.4	260
11-Apr-23	10:00AM	12-Apr-23	10:00AM	2.8037	2.9049	5047.8	5071.8	24	1.12	1.12	1.12	62.9	Sunny	152.4	260
17-Apr-23	10:00AM	18-Apr-23	10:00AM	2.8026	2.9109	5071.8	5095.8	24	1.12	1.12	1.12	67.3	Sunny	152.4	260
22-Apr-23	10:00AM	23-Apr-23	10:00AM	2.8034	2.9457	5095.8	5119.8	24	1.12	1.12	1.12	88.4	Cloudy	152.4	260
28-Apr-23	10:00AM	29-Apr-23	10:00AM	2.8068	2.9220	5119.8	5143.8	24	1.12	1.12	1.12	71.6	Cloudy	152.4	260

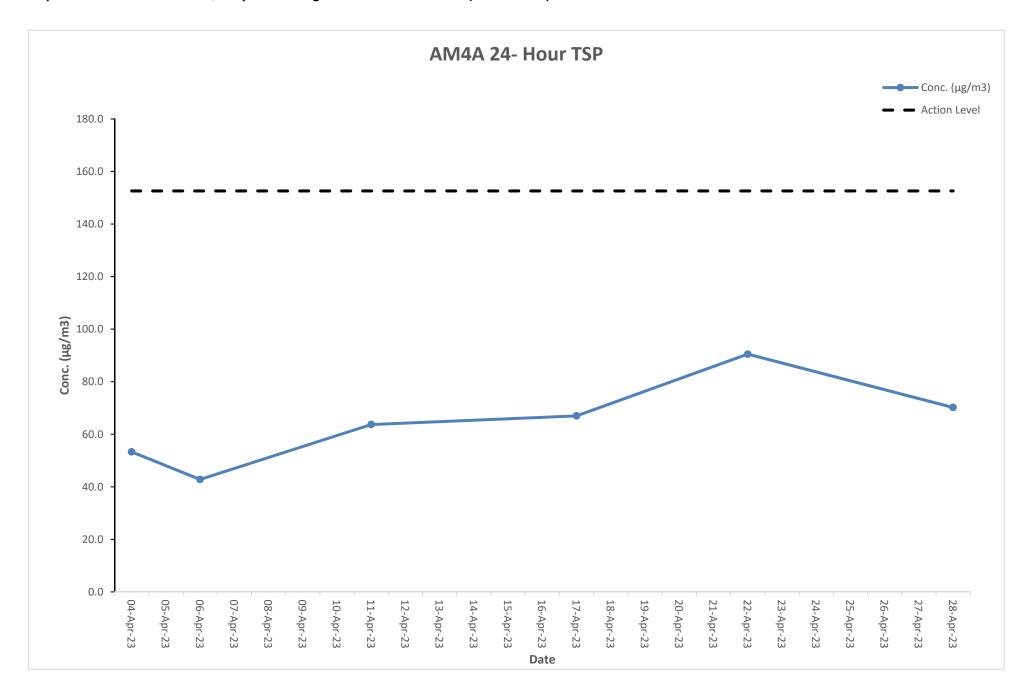
# Air Quality Monitoring Result at Station AM4A (24-hour TSP)

Sta	rt	Fini	sh	Filter W	eight (g)	Elapsed Tir	ne Reading	Sampling	Flov	w Rate (m	n³/min)	Conc.	Weather	Action	Limit
Date	Time	Date	Time	Initial	Final	Initial	Final	Time (hrs)	Initial	Final	Average	(µg/m3)	Condition	Level	Level
04-Apr-23	10:00AM	05-Apr-23	10:00AM	2.8048	2.8907	5419.4	5443.4	24	1.12	1.12	1.12	53.3	Rainy	152.6	260
06-Apr-23	10:00AM	07-Apr-23	10:00AM	2.8012	2.8702	5443.4	5467.4	24	1.12	1.12	1.12	42.8	Rainy	152.6	260
11-Apr-23	10:00AM	12-Apr-23	10:00AM	2.8017	2.9042	5467.4	5491.4	24	1.12	1.12	1.12	63.7	Sunny	152.6	260
17-Apr-23	10:00AM	18-Apr-23	10:00AM	2.8025	2.9104	5491.4	5515.4	24	1.12	1.12	1.12	67.0	Sunny	152.6	260
22-Apr-23	10:00AM	23-Apr-23	10:00AM	2.8016	2.9472	5515.4	5539.4	24	1.12	1.12	1.12	90.5	Cloudy	152.6	260
28-Apr-23	10:00AM	29-Apr-23	10:00AM	2.8036	2.9166	5539.4	5563.4	24	1.12	1.12	1.12	70.2	Cloudy	152.6	260

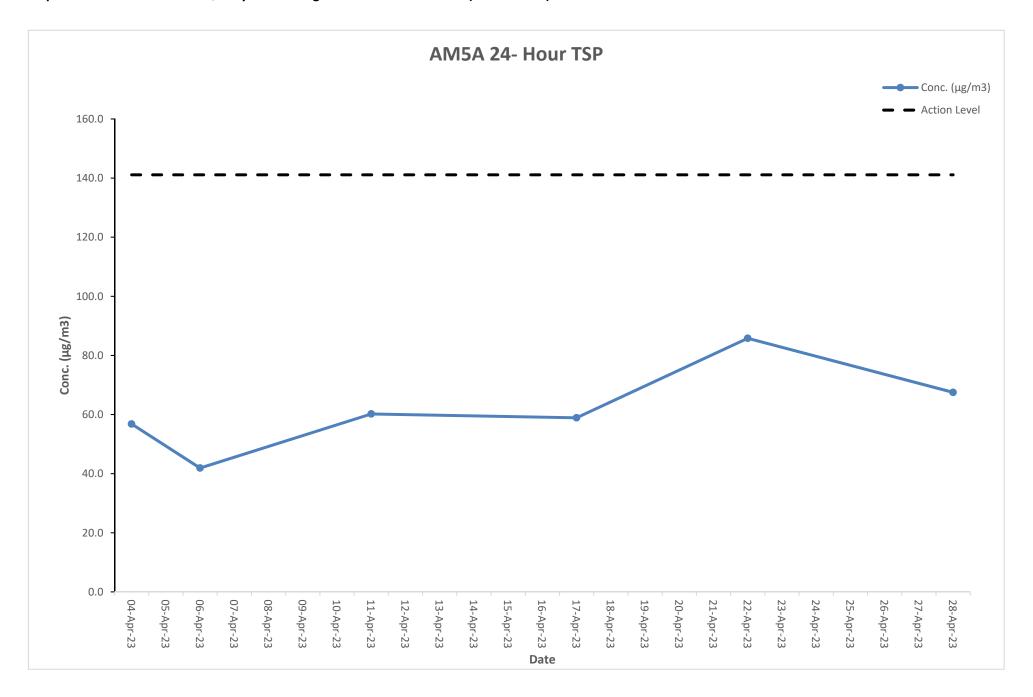
# Air Quality Monitoring Result at Station AM5A (24-hour TSP)

Sta	rt	Fini	sh	Filter W	eight (g)	Elapsed Tir	me Reading	Sampling	Flov	v Rate (m	n³/min)	Conc.	Weather	Action	Limit
Date	Time	Date	Time	Initial	Final	Initial	Final	Time (hrs)	Initial	Final	Average	(µg/m3)	Condition	Level	Level
04-Apr-23	10:00AM	05-Apr-23	10:00AM	2.8083	2.8996	5559.6	5583.6	24	1.12	1.12	1.12	56.8	Rainy	141.1	260
06-Apr-23	10:00AM	07-Apr-23	10:00AM	2.8020	2.8695	5583.6	5607.6	24	1.12	1.12	1.12	41.9	Rainy	141.1	260
11-Apr-23	10:00AM	12-Apr-23	10:00AM	2.8053	2.9022	5607.6	5631.6	24	1.12	1.12	1.12	60.2	Sunny	141.1	260
17-Apr-23	10:00AM	18-Apr-23	10:00AM	2.8085	2.9032	5631.6	5655.6	24	1.12	1.12	1.12	58.9	Sunny	141.1	260
22-Apr-23	10:00AM	23-Apr-23	10:00AM	2.8057	2.9438	5655.6	5679.6	24	1.12	1.12	1.12	85.8	Cloudy	141.1	260
28-Apr-23	10:00AM	29-Apr-23	10:00AM	2.8089	2.9175	5679.6	5703.6	24	1.12	1.12	1.12	67.5	Cloudy	141.1	260

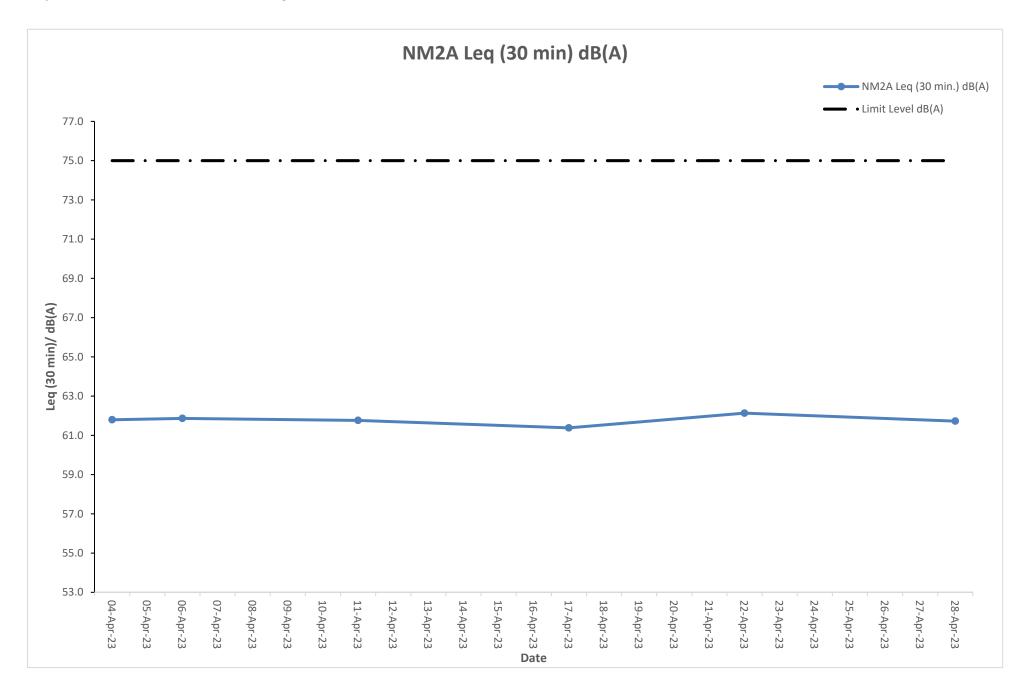
The station set-up of a façade measurement at station NM2A.

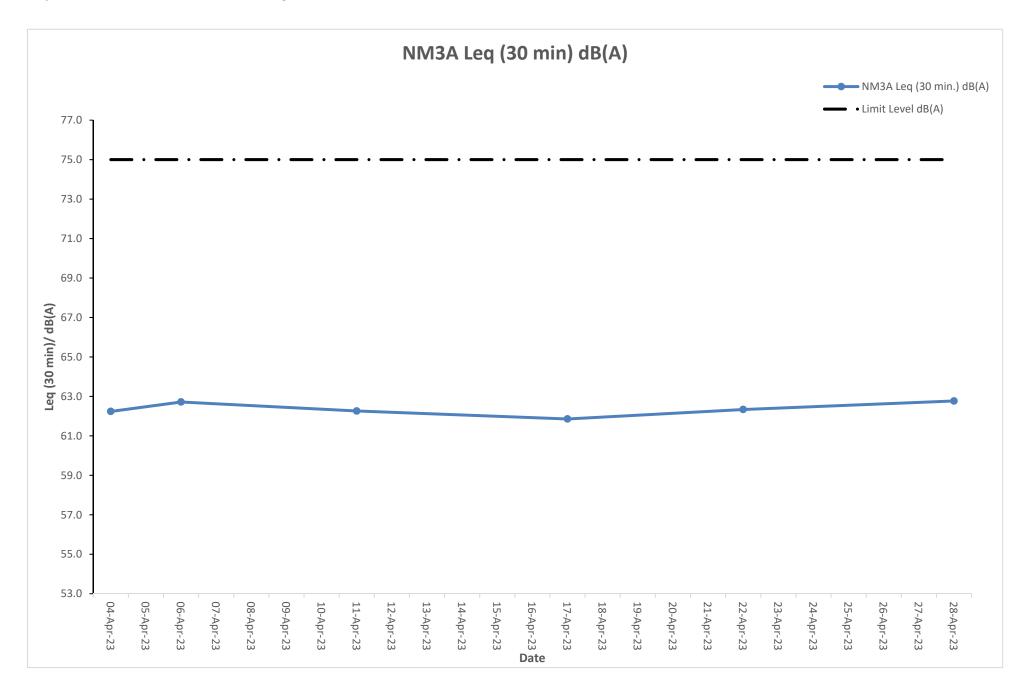
The station set-up of a façade measurement at station NM3A.

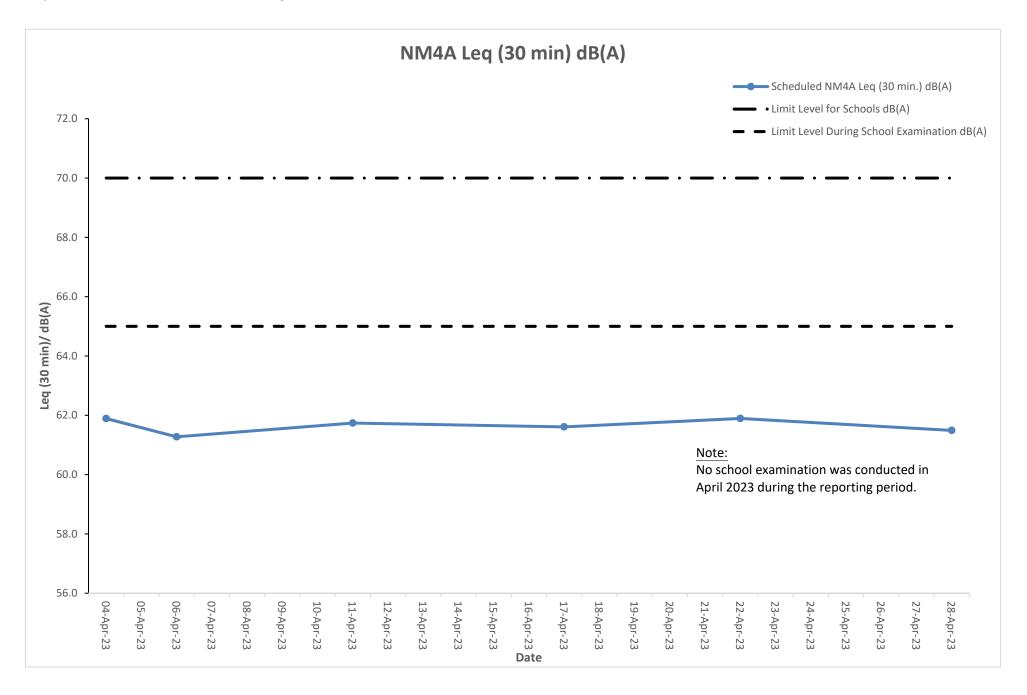
The station set-up of a façade measurement at station NM4A.

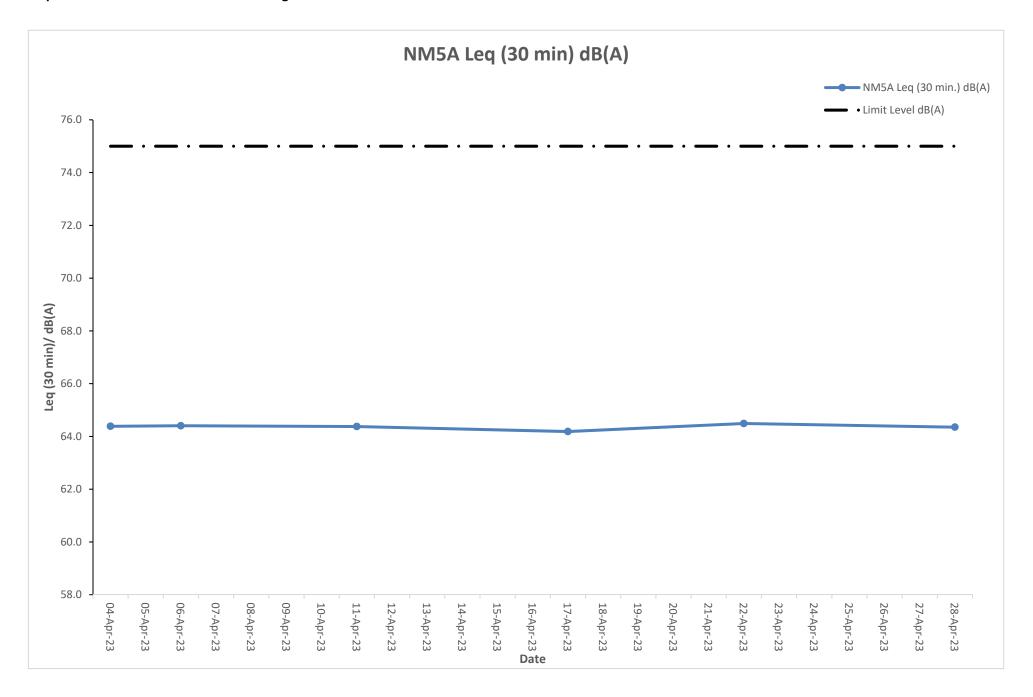
The station set-up of a free-field measurement at station NM5A.
