Vol. 3 of 5 FEP-03/457/2013/D Central Kowloon Route Yau Ma Tei East Contract No. HY/2014/08 April 2023

Central Kowloon Route Contract HY/2014/08 Section of Yau Ma Tei East

Monthly EM&A Report No. 61

(Period from 1 to 30 April 2023)

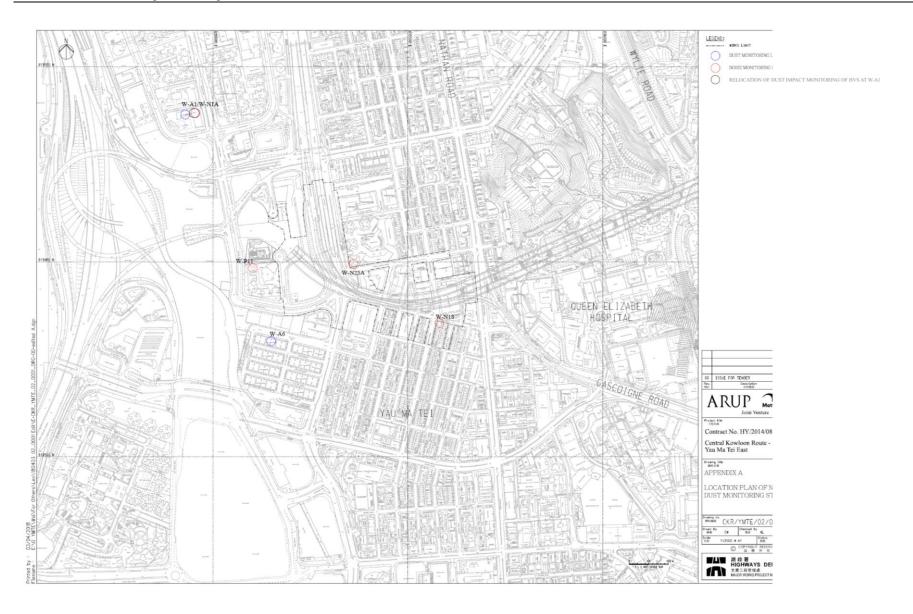
Appendix K
Location Plan of Noise and Air Quality
Monitoring Station

3.4.1. During the site visit, both of the original proposed dust monitoring locations were rejected due to the condition at The Coronation was not favourable for monitoring and the access was declined by the management office of Hong Kong Community College (HKCC) of PolyU. Two alternative air monitoring stations Yau Ma Tei Catholic Primary School (Hoi Wang Road) and Man Cheong Building had been proposed by ET and approved by IEC. 2 designated air monitoring locations were identified and agreed with IEC and EPD. Details of air monitoring stations are described in Table 3.3. The location plan of air quality monitoring stations is shown in Appendix K.

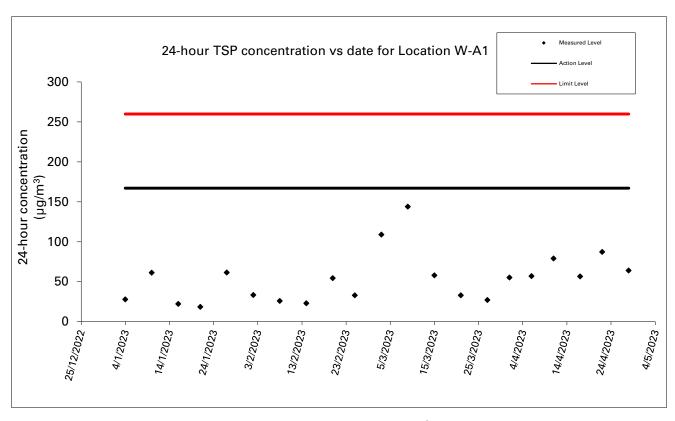
Figure 3: Graphical Illustration of Measured 24-hour TSP (μg/m³) Levels at W-A1

-										Maximum:	130	μg/m ³	Minimum:	25	μg/m ³

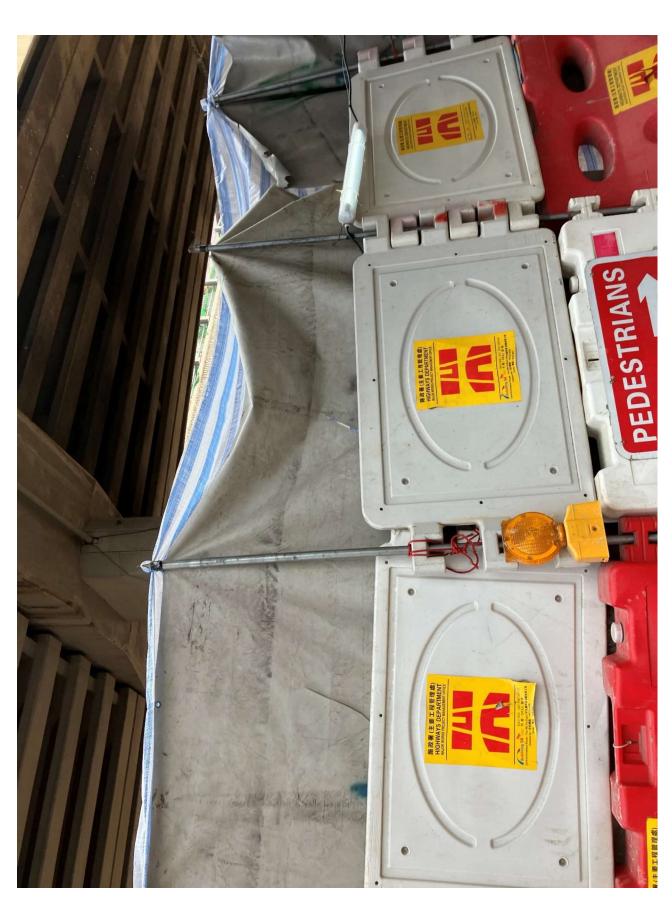
Remark 3: Noise barrier at the concerned area

Limit level dB(A)	SL
L ₉₀ dB(A)	7.99
L ₁₀ dB(A)	73.2
Leq dB(A)	70.1
End Time	11:20 - 11:50
Veather Start Time - End Time $L_{eq} dB(A) = L_{10} dB(A) = L_{90} dB(A)$	- 11:20
Weather	Sunny
Date	17/04/2023
