**Central Kowloon Route**

**Yau Ma Tei East**

**Contract No. HY/2014/08**

Document/~~Plan~~ to be ~~Certified~~/ Verified: Monthly EM&A Report No.62 (May 2023)  
Date of Report: 9 June 2023  
Date received by IEC: 9 June 2023

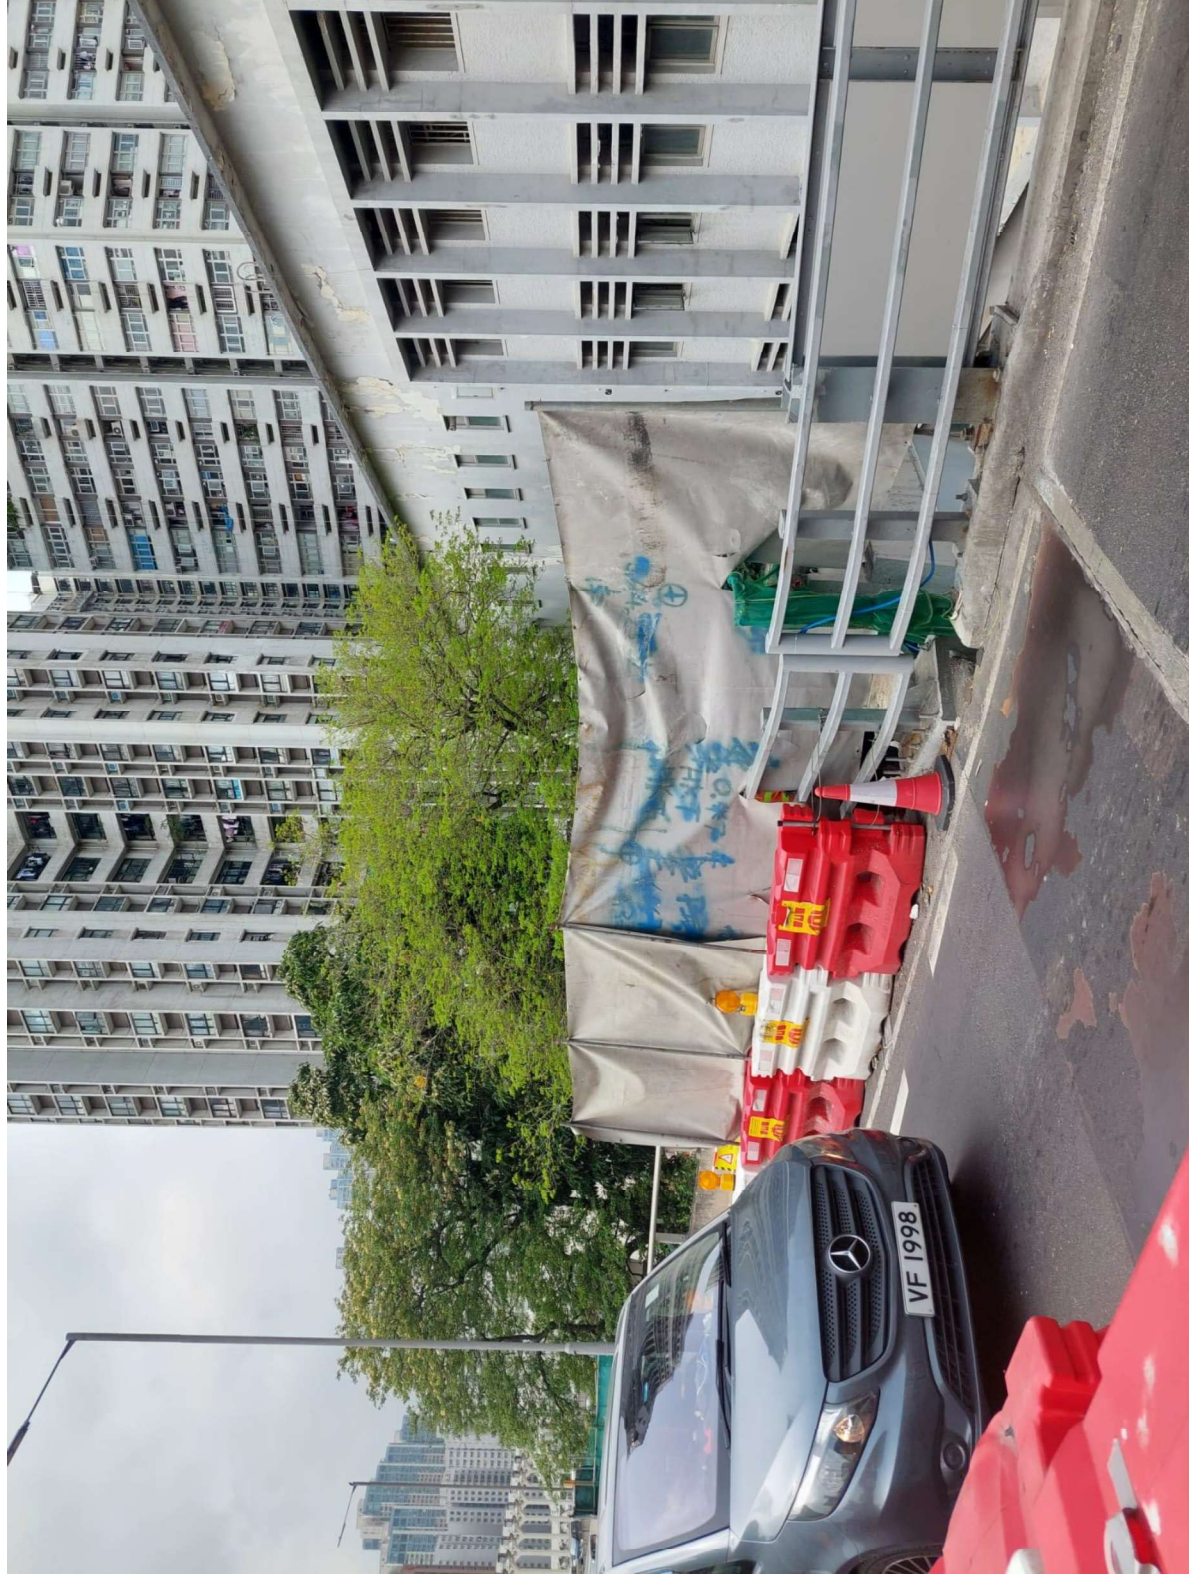
**Remark 3: Noise monitoring results of the concerned period**

Location: Prosperous Garden Block 1 (W-N25A)  
Monitoring date: 28 April 2023  
Parameter :  $L_{eq}$ ,  $L_{10}$ ,  $L_{90}$   
Other Factors Nearby traffic

Actions taken / to be taken	<p>In view of compliance and public concerns, the following preventative measures were taken / to be taken:</p> <ul style="list-style-type: none"> <li>• In case of unscheduled emergency works required to address safety concern, make use of EPD reporting system for emergency works and report the works immediately;</li> <li>• In case of emergency repairing required, make use of any noise mitigation measures and control of the tools use to avoid excessive noise emissions;</li> <li>• Plan the day-to-day construction work properly and allow buffer time in case of emergency; and</li> <li>• Provide training to frontline staff to ensure their understanding and awareness of EPD’s reporting system for emergency works.</li> </ul>
Remarks (Shown in next page)	<ol style="list-style-type: none"> <li>1. Works location of the concerned area</li> <li>2. Emergency excavation permit</li> <li>3. Notification of Emergency Works</li> <li>4. Record of Emergency Work</li> </ol>

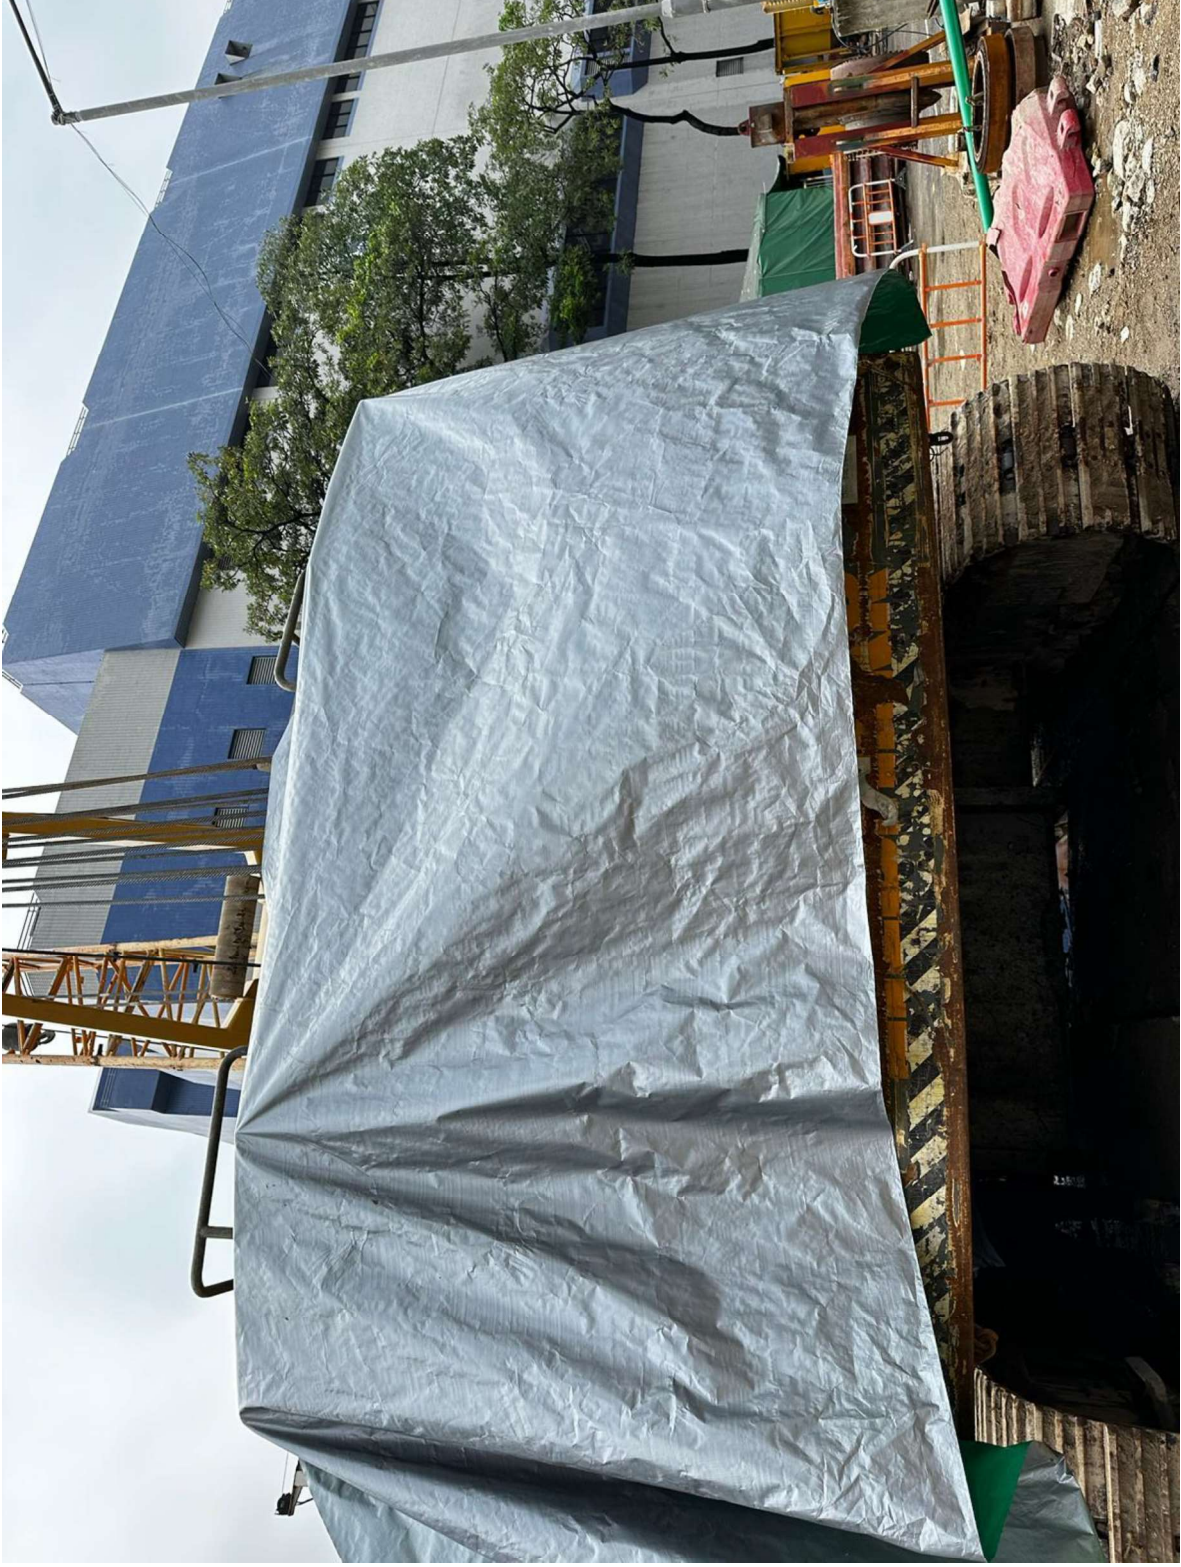
Date	Weather	Start Time - End Time	$L_{eq}$ dB(A)	$L_{10}$ dB(A)	$L_{90}$ dB(A)	Limit level dB(A)
20/05/2023	Sunny	13:47 - 14:17	69.5	72.3	66.5	75

**Remark 3: Additional noise canvas at the engineering part of the mobile crane**

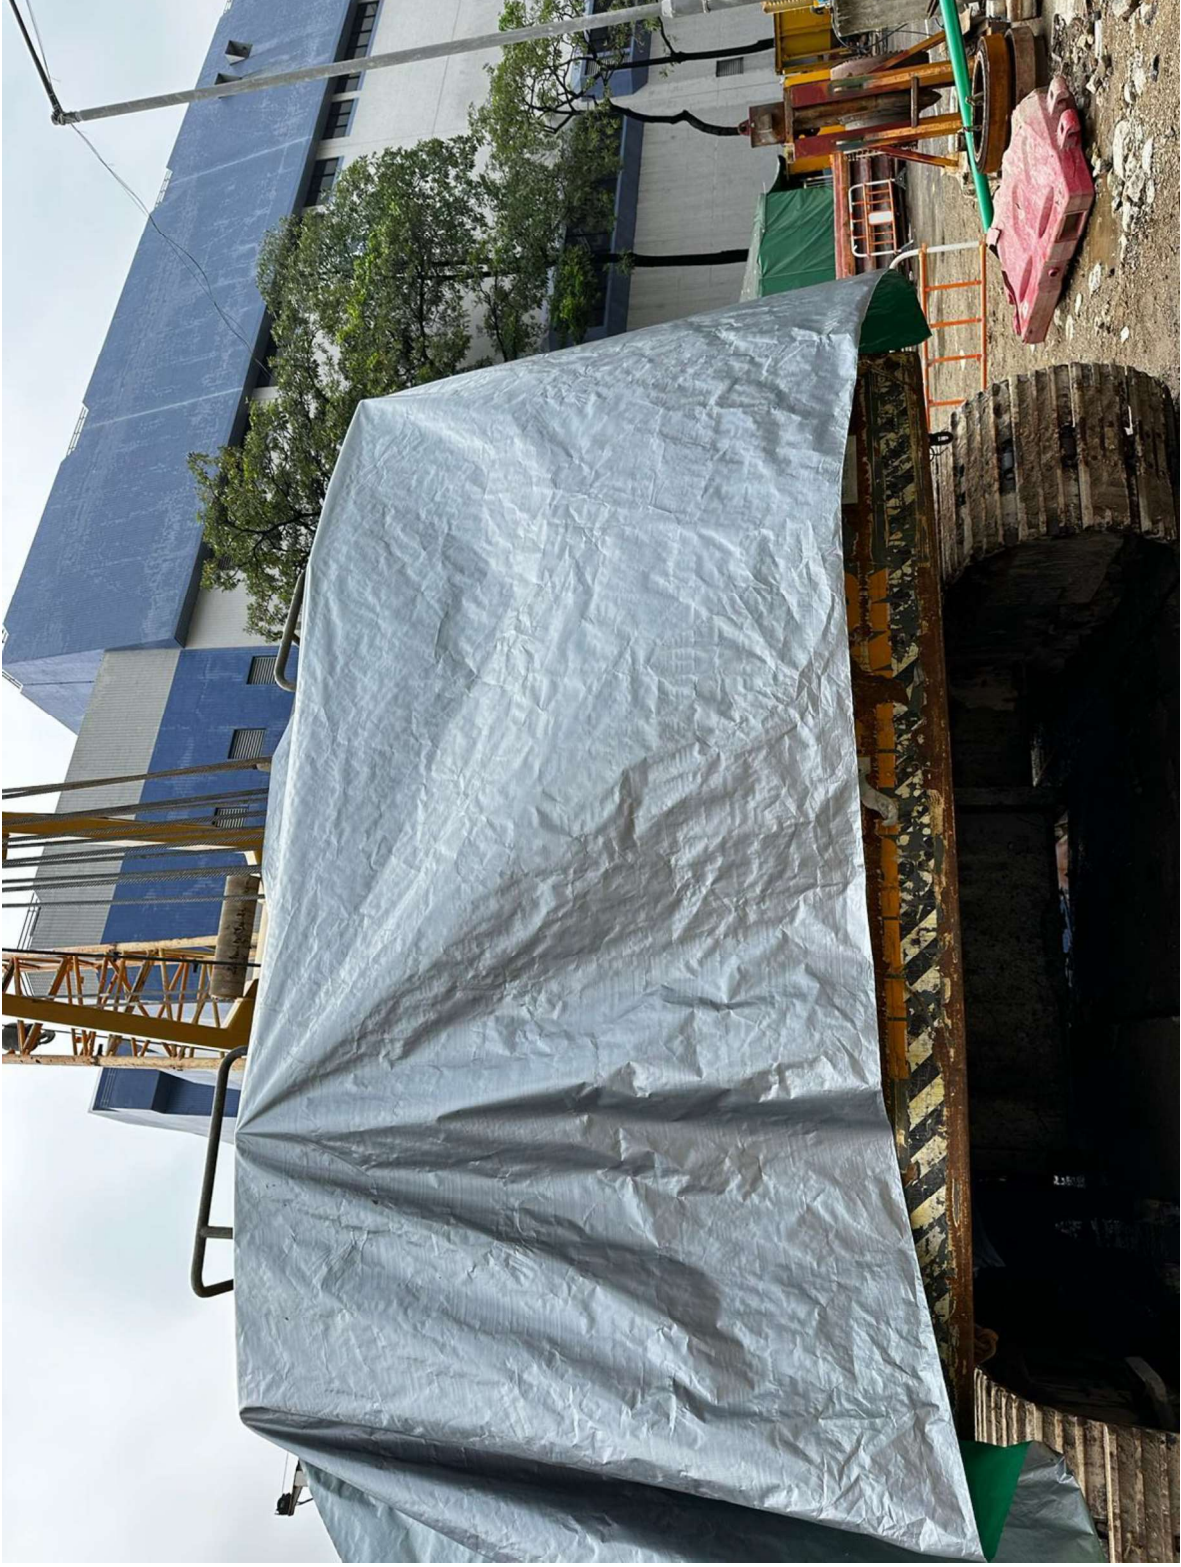
Date	Weather	Start Time - End Time	$L_{eq}$ dB(A)	$L_{10}$ dB(A)	$L_{90}$ dB(A)	Limit level dB(A)
20/05/2023	Sunny	13:47 - 14:17	69.5	72.3	66.5	75

**Remark 3: Additional noise canvas at the engineering part of the mobile crane**
