**Central Kowloon Route**

**Yau Ma Tei East**

**Contract No. HY/2014/08**

Document/ <del>Plan</del> to be <del>Certified</del> / Verified:	Monthly EM&A Report No.63 (June 2023)
Date of Report:	6 July 2023
Date received by IEC:	6 July 2023

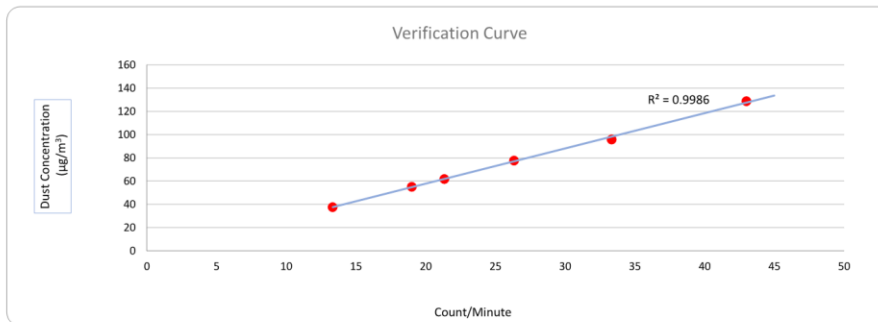
**Linear Regression of y on x**

Slope, K factor:	<b>3.0313</b>	Intercept:	<b>-2.8495</b>	*Correlation Coefficient, R:	<b>0.9993</b>
Verification Test Result: <b>Strong Correlation, Results were accepted.</b>			* If the Correlation Coefficient, R is <0.5. Checking and Re-verification are required.

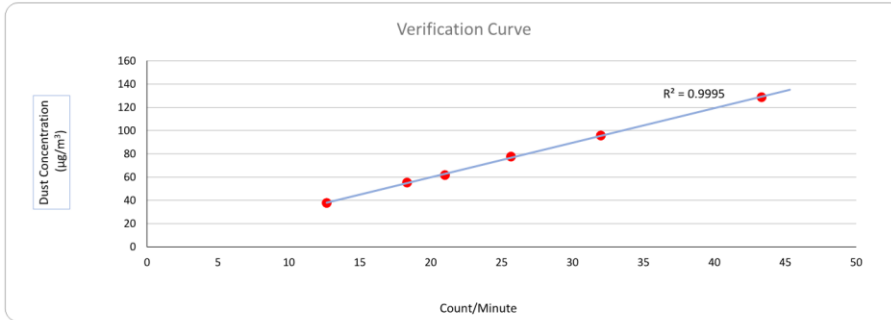
**Linear Regression of y on x**

Slope, K factor:	<b>2.9749</b>	Intercept:	<b>0.2715</b>	*Correlation Coefficient, R:	<b>0.9998</b>
Verification Test Result: <b>Strong Correlation, Results were accepted.</b>			* If the Correlation Coefficient, R is <0.5. Checking and Re-verification are required.

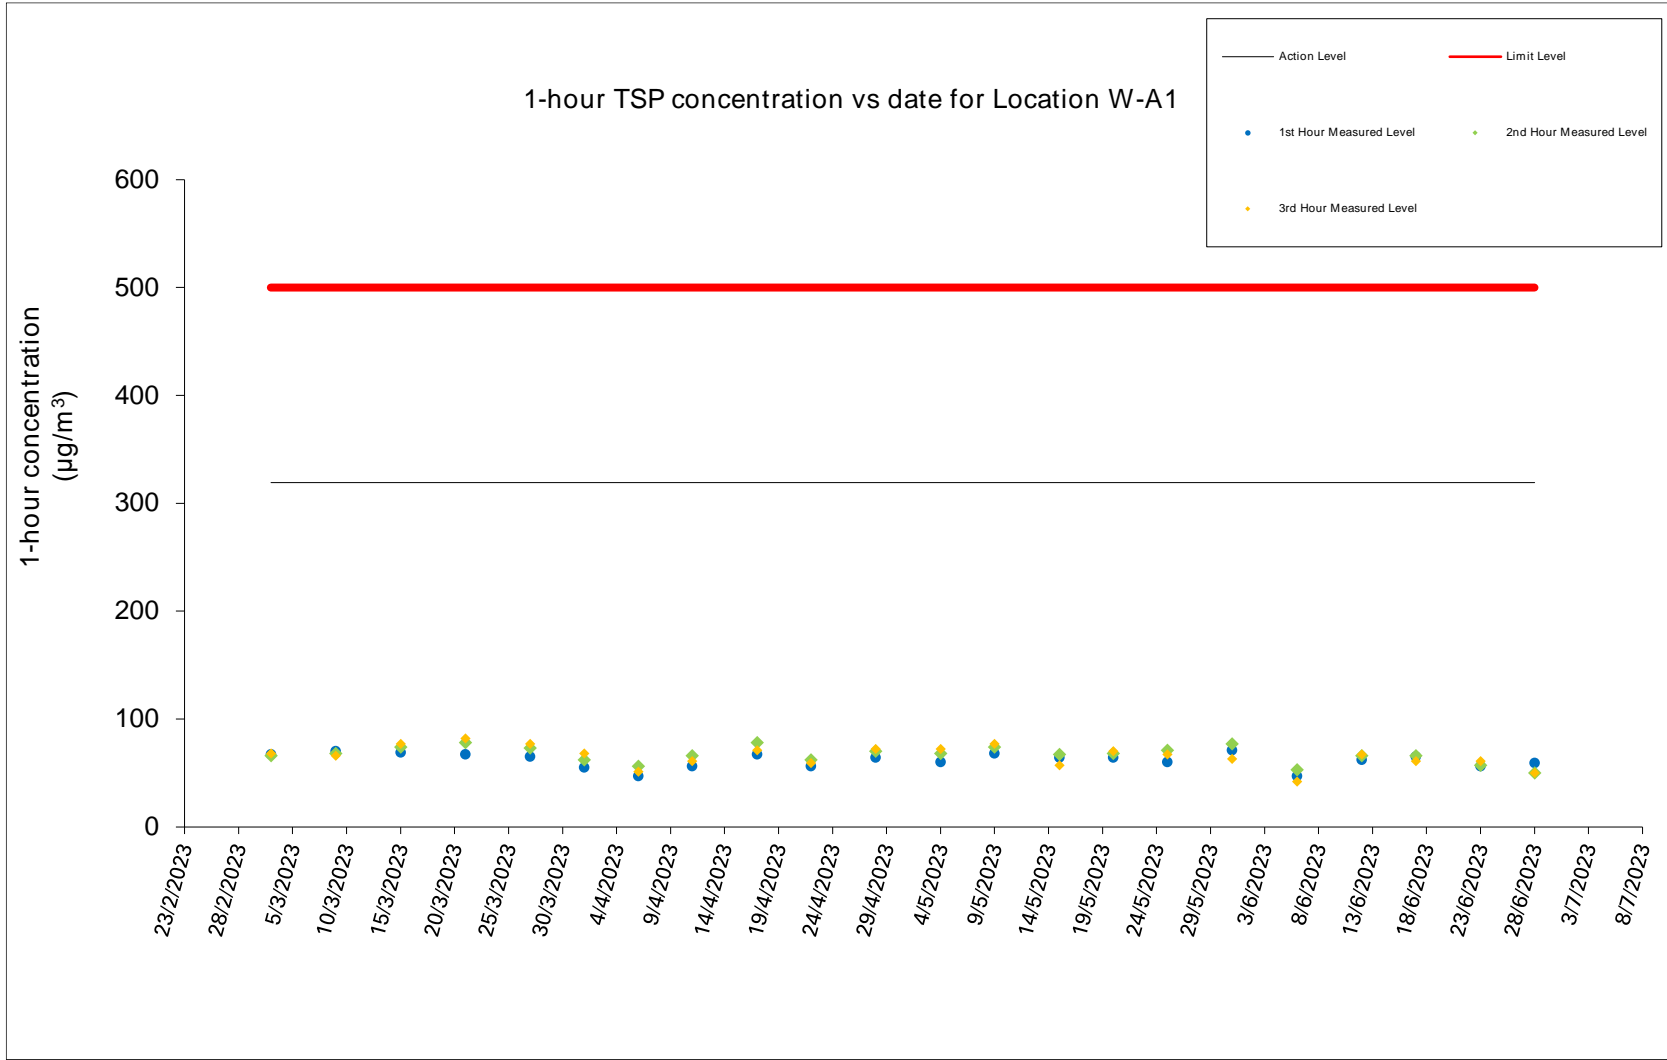
Figure 1: Graphical Illustration of Measured 1-hour TSP ( $\mu\text{g}/\text{m}^3$ ) Levels at W-A1

Date	1-hour TSP ( $\mu\text{g}/\text{m}^3$ )				
	Weather	Start Time	1 <sup>st</sup> Hour ( $\mu\text{g}/\text{m}^3$ )	2 <sup>nd</sup> Hour ( $\mu\text{g}/\text{m}^3$ )	3 <sup>rd</sup> Hour ( $\mu\text{g}/\text{m}^3$ )
06/06/2023	Cloudy	09:36	64	55	58
12/06/2023	Cloudy	09:42	70	65	72
17/06/2023	Cloudy	09:39	69	71	65
23/06/2023	Cloudy	14:30	66	63	68
28/06/2023	Cloudy	11:21	64	58	69
Minimum: 55 $\mu\text{g}/\text{m}^3$			Maximum: 72 $\mu\text{g}/\text{m}^3$

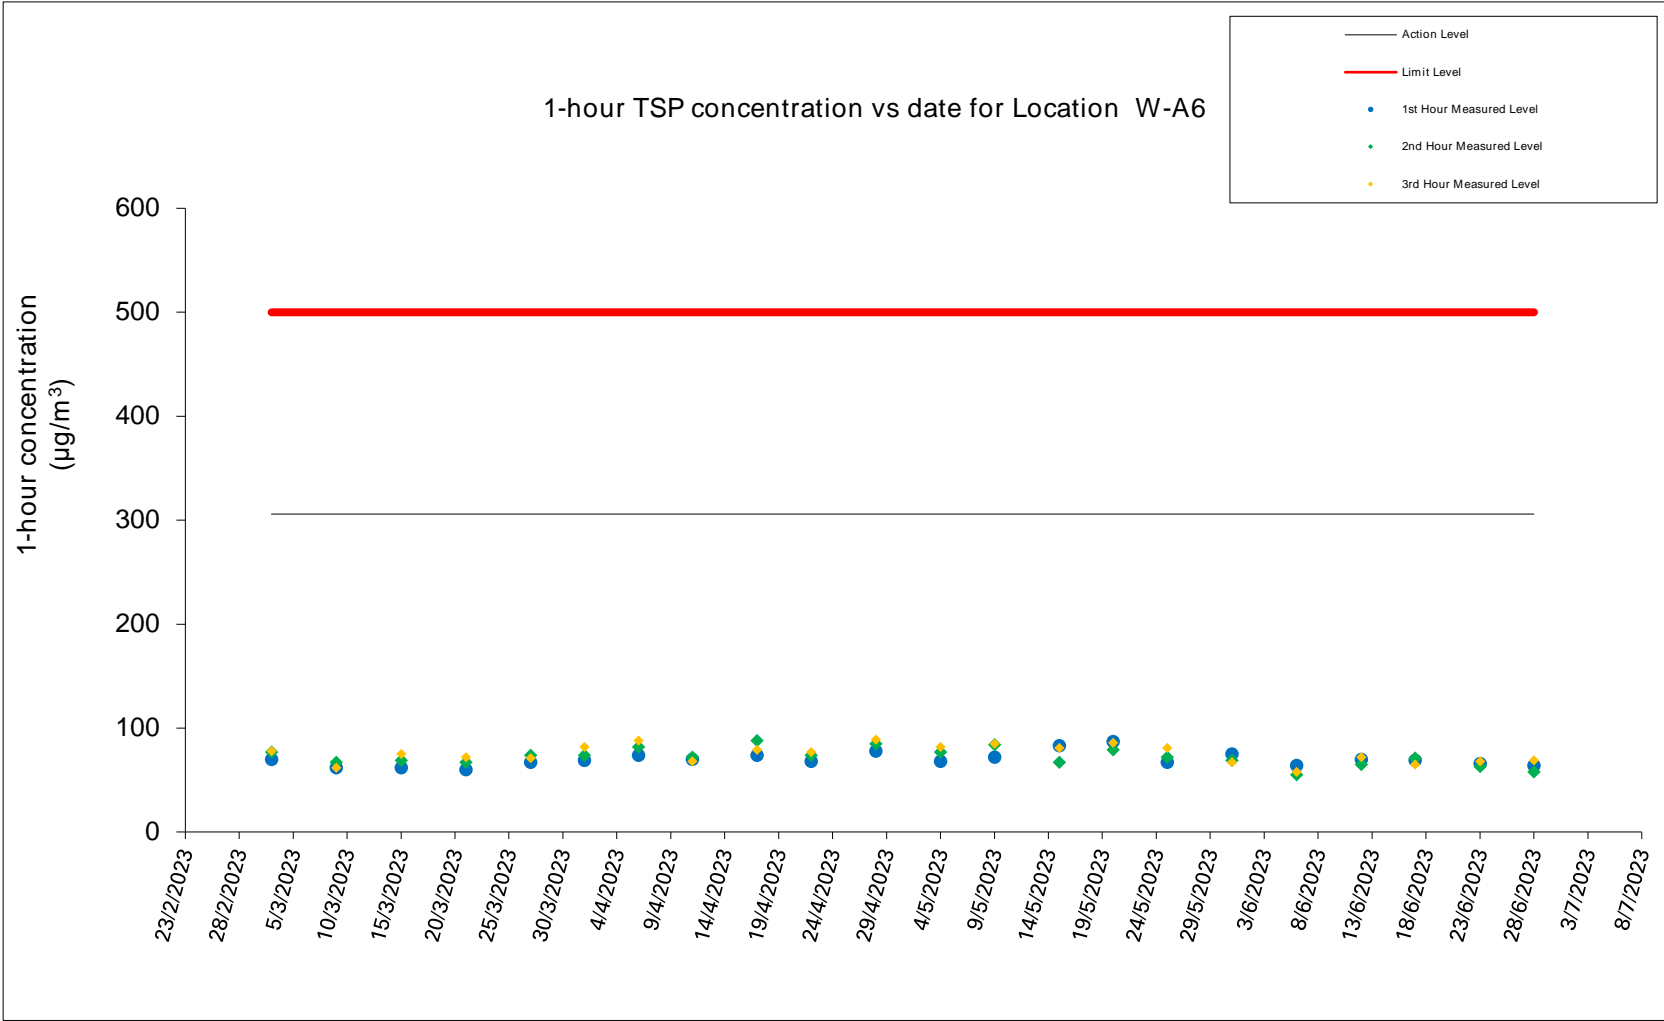
Figure 2: Graphical Illustration of Measured 1-hour TSP ( $\mu\text{g}/\text{m}^3$ ) Levels at W-A6

Location: Man Cheong Building (W-A6)  
Monitoring date: 6, 12, 17, 23 and 28 June 2023  
Parameter : TSP 1-hour  
Other Factors Nearby traffic

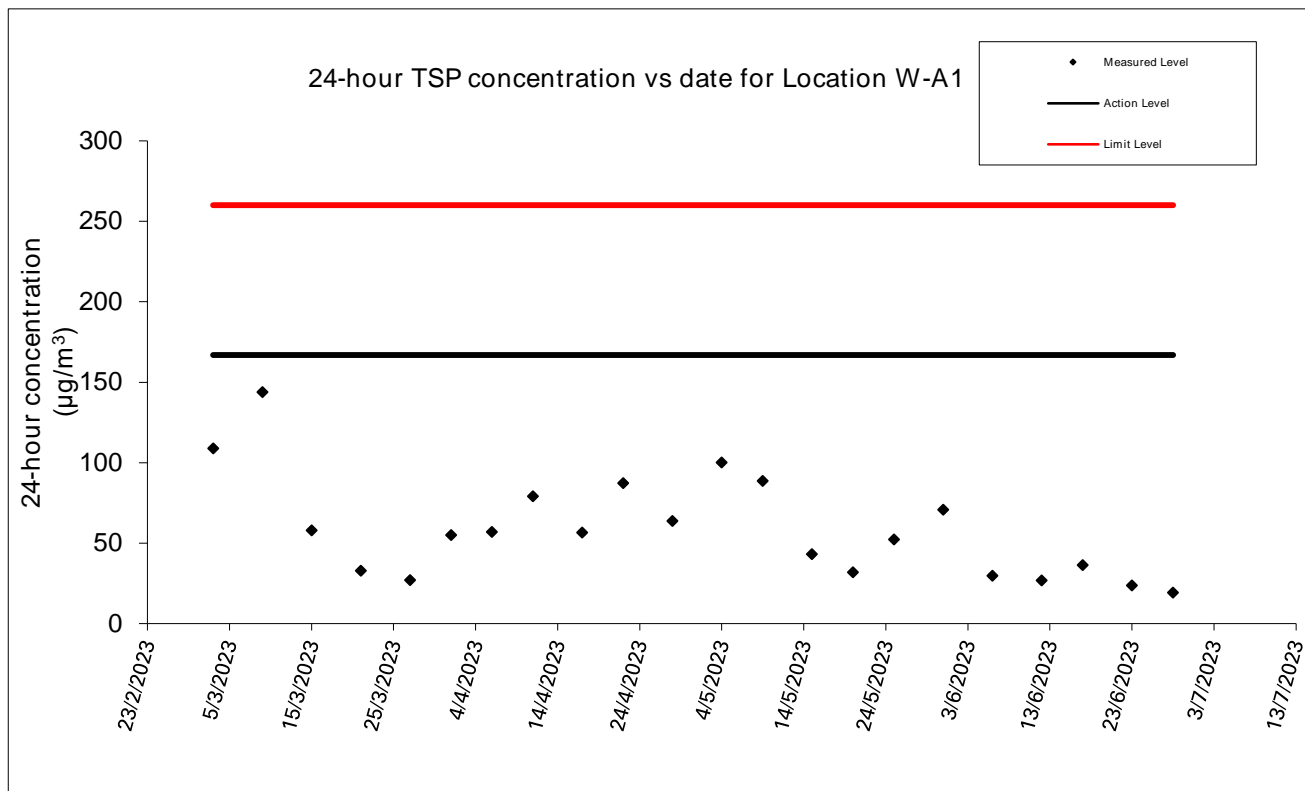
Figure 3: Graphical Illustration of Measured 24-hour TSP ( $\mu\text{g}/\text{m}^3$ ) Levels at W-A1

Location: Yau Ma Tei Catholic Primary School (Hoi Wang Road) (W-A1)  
 Monitoring date: 6, 12, 17, 23 and 28 June 2023  
 Parameter : TSP 24-hour  
 Other Factors Nearby traffic

Start Date	Weather Condition	Elapse Time			Chart Reading			Avg Air Temp (°C)	Avg Atmospheric Pressure (hPa)	Flow Rate (m <sup>3</sup> /min)	Standard Air Volume (m <sup>3</sup> )	Filter Weight (g)		Particulate weight (g)	Conc. (µg/m <sup>3</sup> )		
		Initial	Final	Actual (min)	Min	Max	Avg					Initial	Final				
6/6/2023	Cloudy	9478.2	9502.2	1440.00	36	36	36.0	28.5	1008.3	1.12	1618	2.6874	2.7390	0.0516	32		
12/6/2023	Cloudy	9502.2	9526.2	1440.00	39	39	39.0	30.0	1002.3	1.22	1760	2.6773	2.7169	0.0396	22		
17/6/2023	Cloudy	9526.6	9550.6	1440.00	39	39	39.0	27.1	1009.1	1.24	1785	2.7675	2.8291	0.0616	35		
23/6/2023	Cloudy	9550.6	9574.6	1440.00	39	39	39.0	29.6	1006.8	1.22	1758	2.6637	2.7144	0.0507	29		
28/6/2023	Cloudy	9574.6	9598.6	1440.00	40	41	40.5	29.2	1008.4	1.28	1843	2.6790	2.7266	0.0476	26		
Maximum:												35 µg/m <sup>3</sup>		Minimum:		22 µg/m <sup>3</sup>

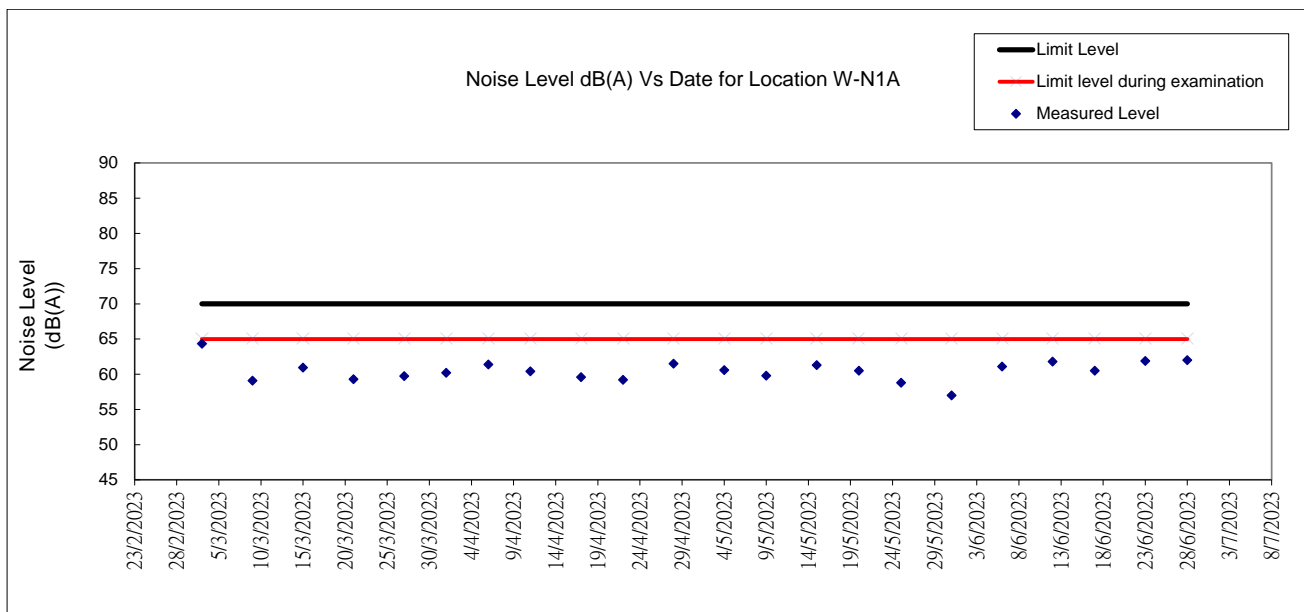
Figure 1: Graphical Illustration of Measured Noise Levels at W-N1A

Date	Weather	Start Time - End Time	$L_{eq}$	$L_{10}$	$L_{90}$	Wind speed (m/s)
06/06/2023	Cloudy	11:48 - 12:18	66.4	67.5	64.8	3.6
12/06/2023	Cloudy	11:55 - 12:25	68.3	70.4	65.5	3.1
17/06/2023	Cloudy	11:52 - 12:22	65.0	69.6	59.7	3.6
23/06/2023	Cloudy	10:38 - 11:08	68.9	71.0	65.3	3.9
28/06/2023	Cloudy	10:37 - 11:07	68.3	71.1	65.6	2.5

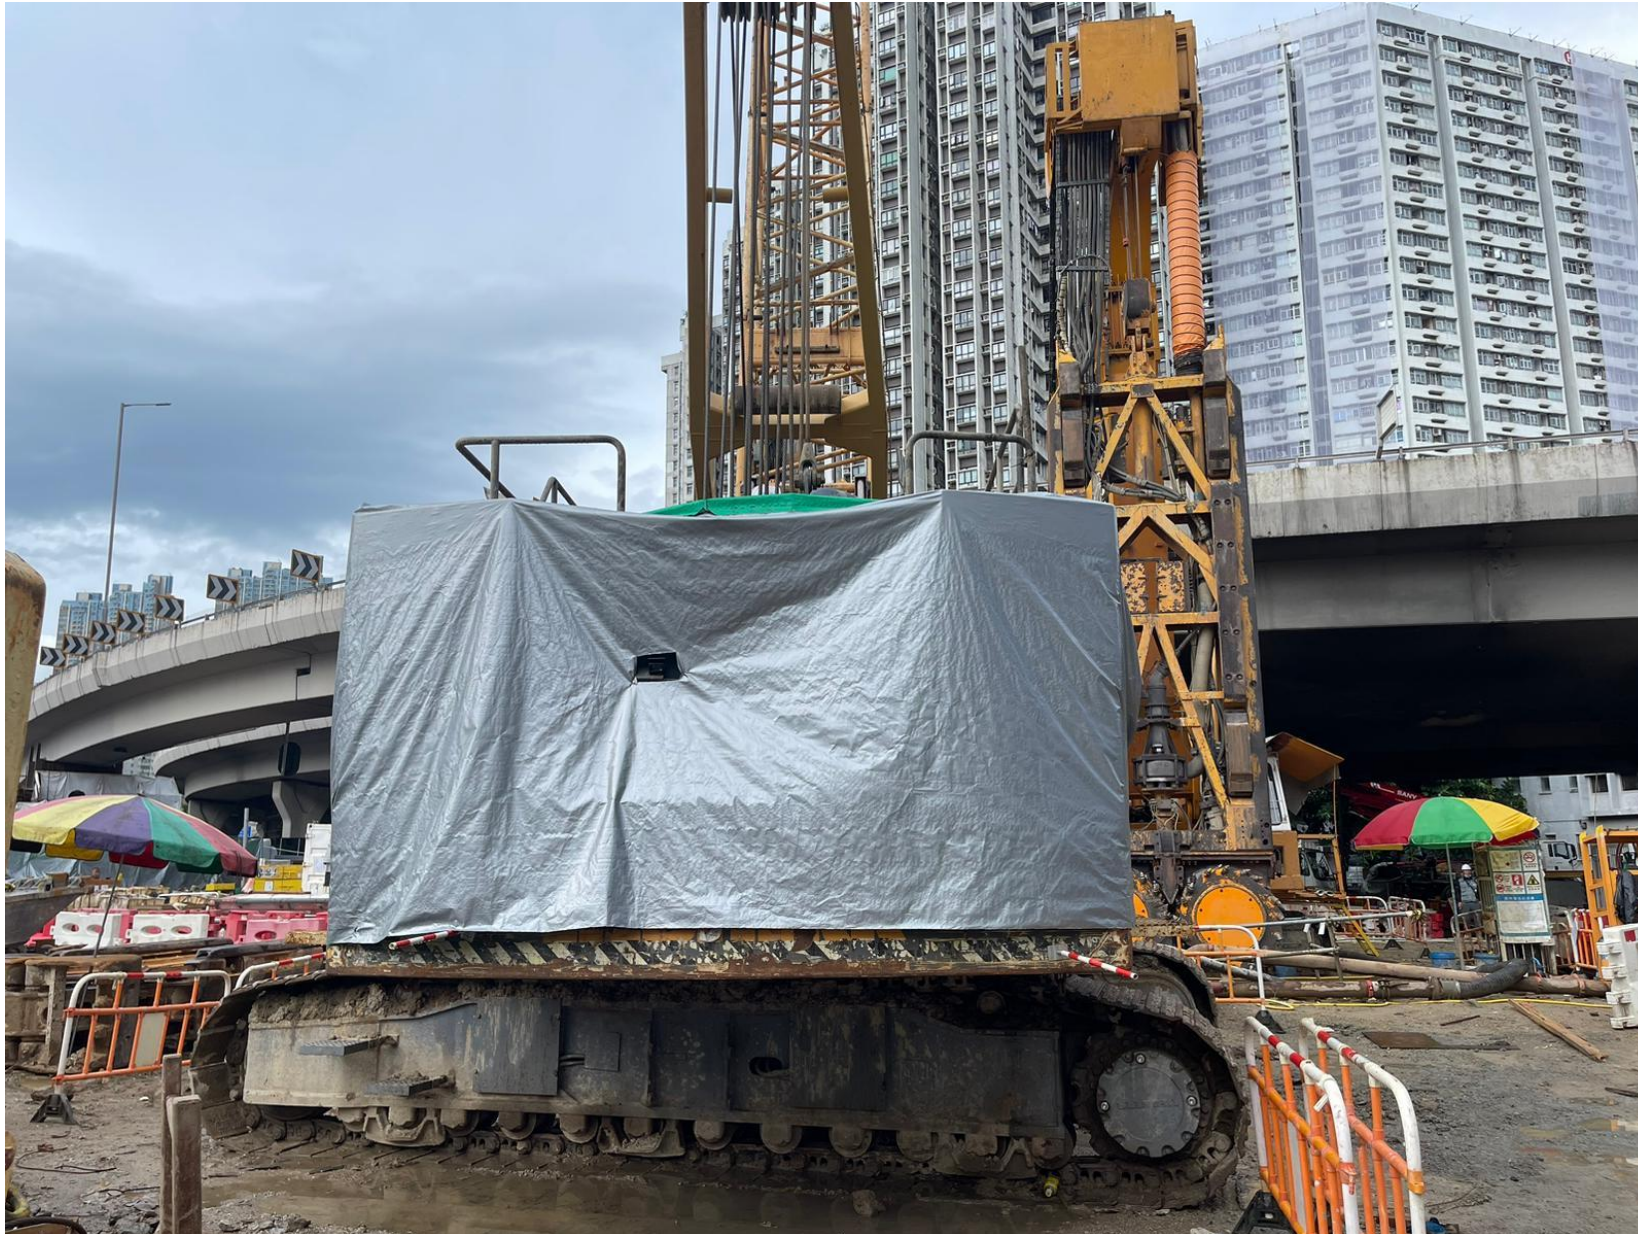
**Remark 3: Additional noise canvas at the engineering part of the mobile crane**
