Central Kowloon Route

Yau Ma Tei East (HY/2014/08)

Monthly EM&A Report No. 66

(Period from 1 to 30 September 2023)

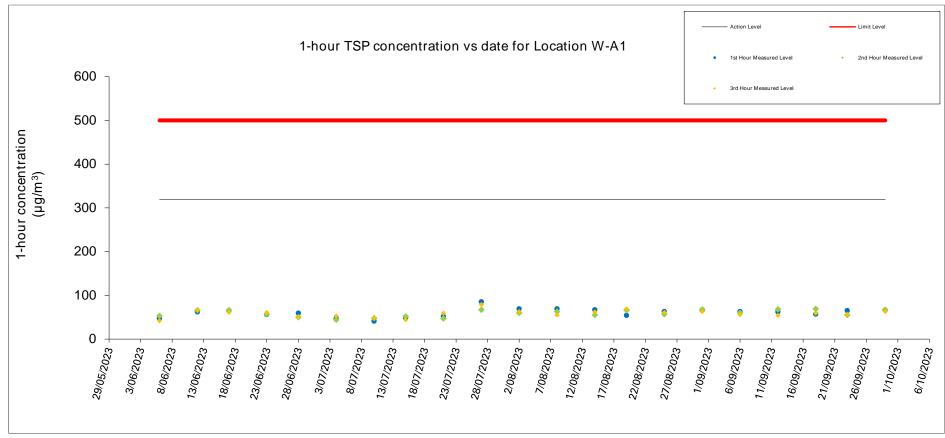
Figure 1: Graphical Illustration of Measured 1-hour TSP (μg/m³) Levels at W-A1

1-hour TSP (μg/m³)										
Date	Weather	Start Time	1 st Hour (μg/m³)	2 nd Hour (μg/m³)	3 rd Hour (μg/m³)						
06/09/2023	/2023 Fine 9:20 66 62										
12/09/2023	Fine	9:26	54	68	54						
18/09/2023	Fine	9:23	67	57	62						
23/09/2023	Fine	9:21	57	57	70						
29/09/2023	Fine	9:20	55	59	65						
Ì	Minimum: 54	μg/m ³		Maximum: 70 μg	g/m^3

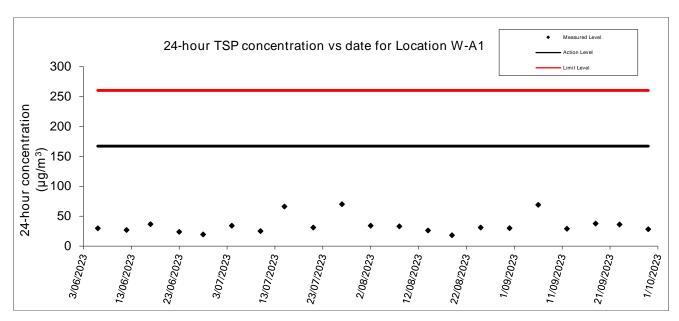
Figure 3: Graphical Illustration of Measured 24-hour TSP (μg/m³) Levels at W-A1

Start Date	Weather Condition	Elapse Time			C	hart Reading		Avg Air Temp	Avg Atmospheric Pressure	Flow Rate	Standard Air Volume	Filter W	eight (g)	Particulate weight	Conc.
	Condition	Initial	Final	Actual (min)	Min	Max	Avg	(°C)	(hPa)	(m³/min)	(m ³)	Initial	Final	(g)	(μg/m ³)
6/09/2023	Fine	9886.6	9910.6	1440.00	42	42	42.0	28.6	1005.9	1.14	1642	2.7342	2.8408	0.1066	65
12/09/2023	Fine	9910.6	9934.6	1440.00	41	41	41.0	27.5	1006.6	1.12	1614	2.7336	2.7928	0.0592	37
18/09/2023	Fine	9934.6	9958.6	1440.00	41	41	41.0	29.4	1011.7	1.12	1616	2.7418	2.7851	0.0433	27
23/09/2023	Fine	9958.6	9982.6	1440.00	41	41	41.0	30.0	1010.2	1.32	1896	2.6750	2.7411	0.0661	35
29/09/2023	Fine	9982.6	10006.6	1440.00	42	42	42.0	29.9	1011.2	1.36	1954	2.7411	2.8196	0.0785	40
			-			-			-	Maximum:	65	μg/m ³	Minimum:	27	μg/m ³

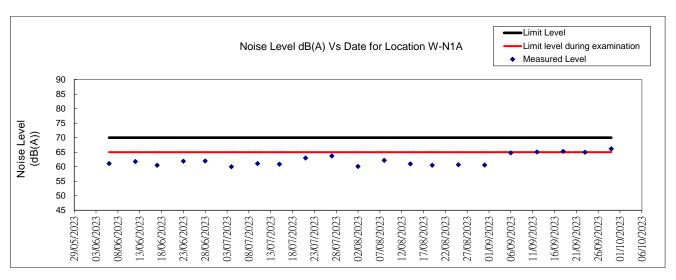
Figure 1: Graphical Illustration of Measured Noise Levels at W-N1A

Date	Weather	Start Time	-	End Time	L _{eq}	L_{10}	L ₉₀	Wind speed (m/s)
06/09/2023	Fine	11:33	-	12:03	63.9	69.8	55.4	3.1
12/09/2023	Fine	11:37	-	12:07	68.3	70.4	65.5	4.7
18/09/2023	Fine	11:35	-	12:05	64.9	69.4	55.2	2.2
23/09/2023	Fine	11:40	-	12:10	68.9	71.0	65.3	4.4
29/09/2023	Fine	11:41	-	12:11	63.8	70.0	56.0	3.6

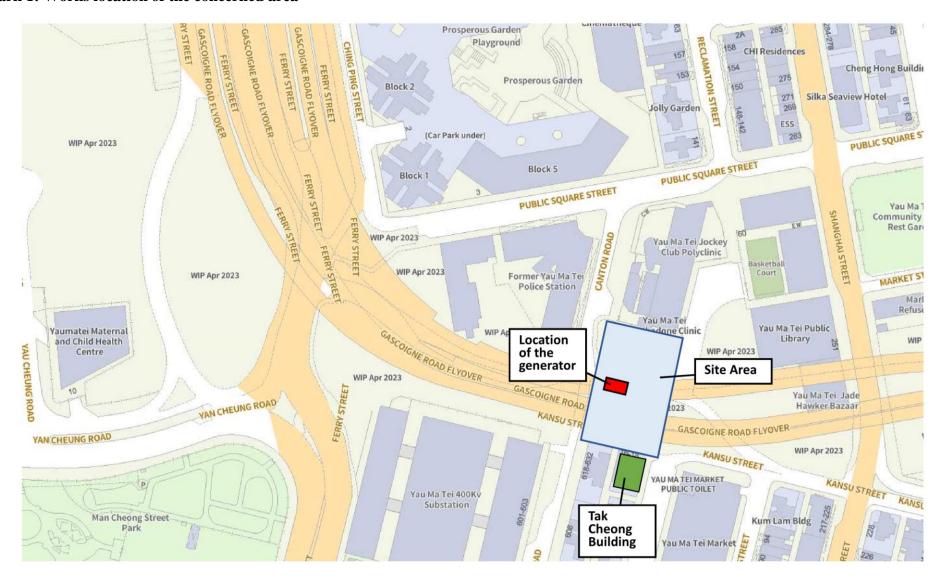
Remark 1: Works location of the concerned area

The complaint was received on 14 Sep 2023, about the air nuisance of unpleasant smell near the site area at Zone G.		Central Kowloon Route, Yau Ma Tei East Section			
Parameter	*				
Parameter Air quality The complainant is middle-level resident of Tak Cheong Building. The complaint was concerned about the air nuisance of unpleasant smell near the site area Zone G¹. The investigation period would be from 8 Sep 2023 to 14 Sep 2023. For construction works undertaken during permitted or restricted hours, all equipment operated on site was under regular maintenance. No malfunction of equipment, no open burning nor black smoke emission was observed and recorded as confirmed by the Contractor. The odor was suspected to be the exhaust of a generator which was operated at nighttime from 1900 to 0700, from 8 Sep 2023 to 14 Sep 2023, under the valid Construction Noise Permits (CNP) (Permit No: GW-RE0590-23). According to the Contractor information, the generator uses ultra-low Sulphur diesel and is checked monthly. Filter of the generator will be replaced if necessary. Considering the fulfillment of stipulated requirements by the Contractor for EM&A manual and CNP, it is concluded that there was no non-compliance of the Project regarding air quality impact from the construction site. Actions taken / to be taken	Complaint description

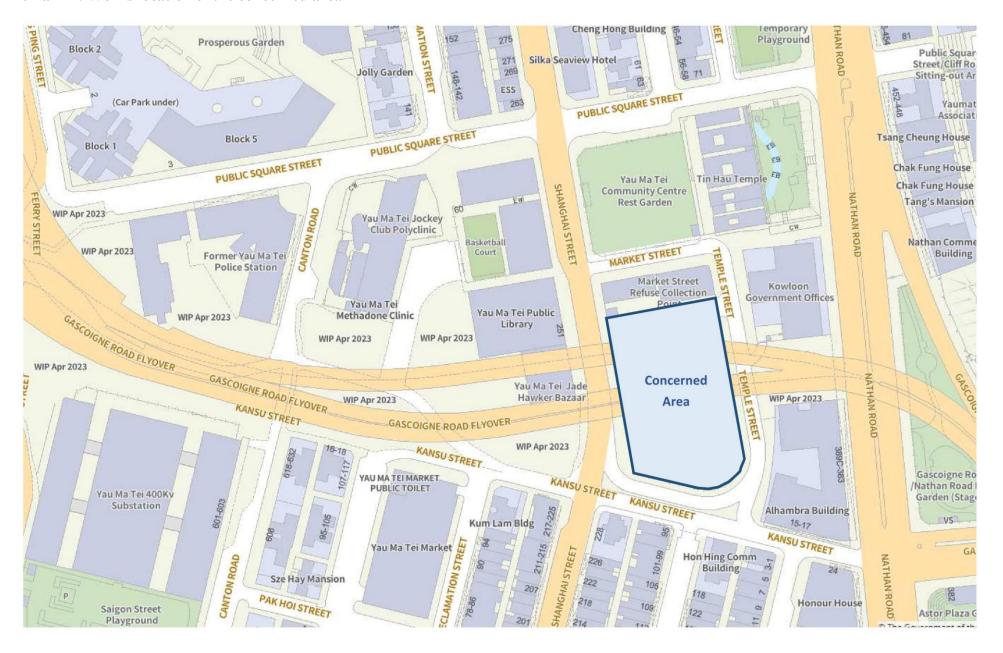
Remark 1: Works location of the concerned area

Project	Central Kowloon Route, Yau Ma Tei East Section			
Complaint Code	EC097-CKRYMTE20230920_001			
Complaint description	The complainant made the complaint on 15 Sep 2023, about the heavy vehicle leaving			
		site without washin	g the wheels.	
Parameter	Water Quality			
Investigation finding	The complaint was concerned about the heavy vehicle leaving the construction site ¹ without washing the wheels.			
	According to the Contractor's information, notice has been displayed to remind workers to wash the vehicles before leaving the site ² . Wheel washing has been performed regularly for vehicle before leaving the site ³ .			
	The Contractor was advised to perform checking and remind workers to ensure all			
Actions taken / to be taken	vehicles leaving the site are properly washed.			
Actions taken / to be taken	The Contractor had followed EM&A Manual strictly to implement mitigation measures in order to minimize nuisance to the public. The Contractor was advised to perform checking to ensure all vehicles leaving the site are

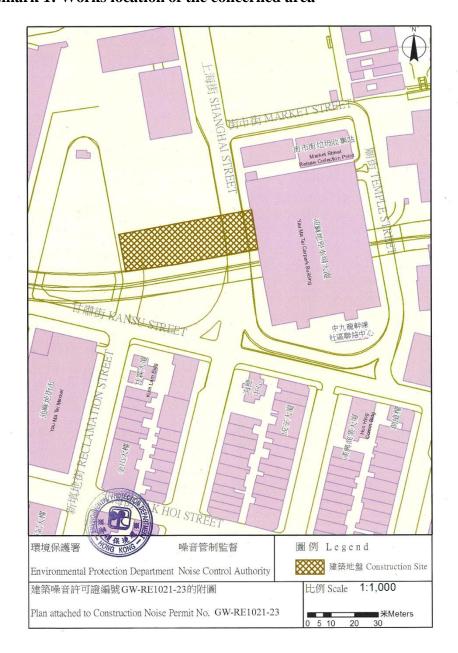
Remark 1: Works location of the concerned area

Project	Central Kowloon I	Route, Yan Ma Tei	East Section	
Complaint Code	Central Kowloon Route, Yau Ma Tei East Section EC098-CKRYMTE20230920_002			
Complaint description	The complainant made the complaint on 11 Sep 2023, about the construction noise			
	from the site area during nighttime.			
Parameter	Construction Noise			
Investigation finding	The complaint was concerned about the construction noise from the site area during nighttime. The investigation period would be from 05 Sep 2023 to 11 Sep 2023.			
	For construction works undertaken within restricted hours, the Contractor applied for valid Construction Noise Permits (CNP) (Permit No: GW-RE1021-23) which was granted from EPD, effective from 19 Aug 2023 to 18 Nov 2023 with coverage of the construction site at the concerned area ¹ . As noted by the contractor, launching of formtraveller at Shanghai Street was carried out from 1900 5 Sep 2023 to 0700 6 Sep 2023. PME used during launching of formtraveller included 2 hydraulic jack and 1 hydraulic pump. The aforementioned PME were classified in PME Group B of CNP and were allowed to be operated in Working Zone during 0000-0700 and 1900-2400 on any day not being a general holiday. As confirmed by the Contractor, CNP conditions had been strictly followed when operated PME during restricted hours. No violation and non-compliance of CNP was observed or recorded. The Contractor had followed the requirements as stipulated in CNP.

Considering the fulfillment of stipulated requirements by the Contractor for CNP, it is concluded that there was no non-compliance of the Project regarding noise quality impact from construction site.			
Actions taken / to be taken	The Contractor had followed granted CNP strictly to implement mitigation measures in order to minimize nuisance to the public.			
	 In view of public concerns, the following additional remedial measures are taken: Provide training to workers to minimize noise; Reschedule the operation time of the noisy equipment to less sensitive hours; Provide site supervision to ensure the noise mitigation measures required in the CNP are maintained properly to alleviate noise impacts; and Review the working hours and method to reduce noise nuisance to Noise Sensitive Receivers (NSRs) during event and night-time. 			
Remarks (Shown in next page)	1. Works loc	ation of the concern	ned area

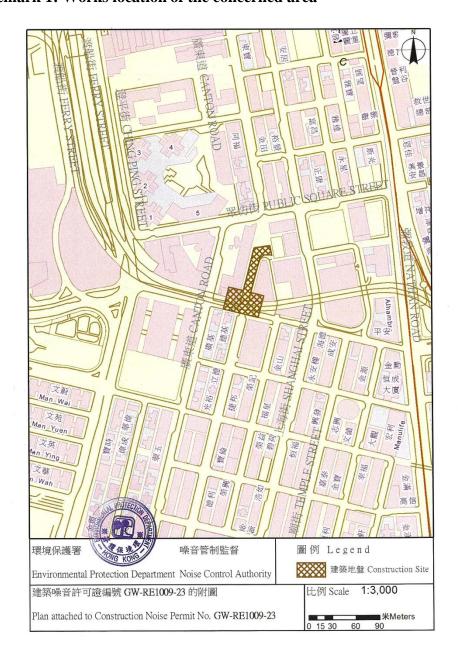
Remark 1: Works location of the concerned area

Project	Central Kowloon I	Route, Yau Ma Tei	Fast Section	
Complaint Code	EC099-CKRYMT		Last Section	
Complaint description	The complainant made the complaint on 28 Sep 2023, about the construction noise			
r a same r	from the site area at around 0000 and 0504 on 28 Sep 2023.			
Parameter	Construction Noise			
Investigation finding	The complaint was concerned about the construction noise from the site area at around 0000 and 0504 on 28 Sep 2023.			
	valid Construction from EPD, effective site at the concern carried out from 0 Sep 2023. PME use with crane (5.5 too label showing sour in PME Group Gr	Noise Permits (CN) we from 23 Aug 202 ed area ¹ . As noted 100 to 0600 and noted for installation of the composition of the co		
	Considering the fulfillment of stipulated requirements by the Contractor for CN concluded that there was no non-compliance of the Project regarding noise quality from construction site.

Actions taken / to be taken				
	 In view of public concerns, the following additional remedial measures are taken: Provide training to workers to minimize noise; Reschedule the operation time of the noisy equipment to less sensitive hours; Provide site supervision to ensure the noise mitigation measures required in the CNP are maintained properly to alleviate noise impacts; and Review the working hours and method to reduce noise nuisance to Noise Sensitive Receivers (NSRs) during event and night-time. 			
Remarks (Shown in next page)	1. Works loc	ation of the concern	ned area	
Prepared by ET (Acuity Sustainability Consulting Limited)	Kako Ho	Ho		
Reviewed by ETL (Acuity Sustainability Consulting Limited)	Kevin Li	K		
Verified by IEC (ERM-Hong Kong, Limited)	Mandy To	Mandy2.		
Date	04 Octobe	r 2023
