Central Kowloon Route

Yau Ma Tei East (HY/2014/08)

Monthly EM&A Report No. 68

(Period from 1 to 30 November 2023)

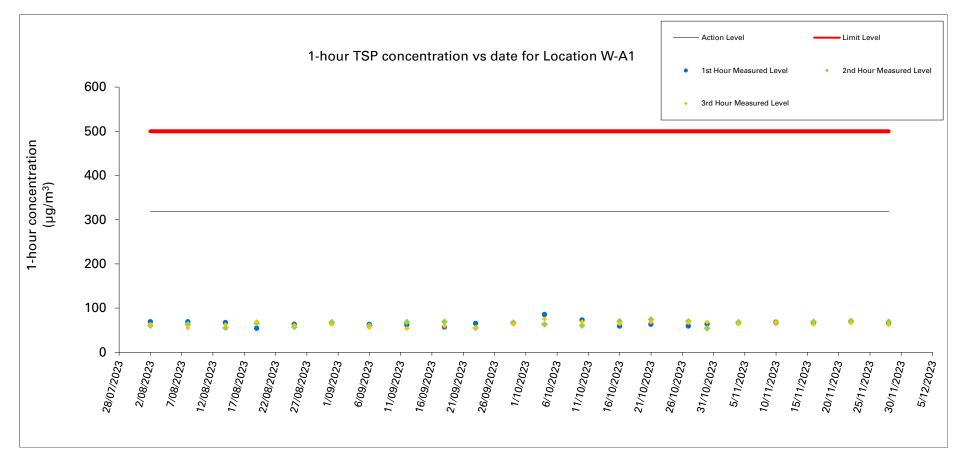
Figure 1: Graphical Illustration of Measured 1-hour TSP (μg/m³) Levels at W-A1

1-hour TSP (μg/m³)											
Date	Weather	Start Time	1 st Hour (μg/m³)	2 nd Hour (μg/m³)	3 rd Hour (μg/m³)							
04/11/2023	Fine	9:15	69	67	65							
10/11/2023	Fine	9:17	65	70	69							
16/11/2023	Fine	9:13	73	70	65							
22/11/2023	Fine	9:15	66	68	69							
28/11/2023	Fine	9:16	65	71	72							
	Minimum: 65	μg/m ³		Maximum: 73 μg	$/\mathrm{m}^3$

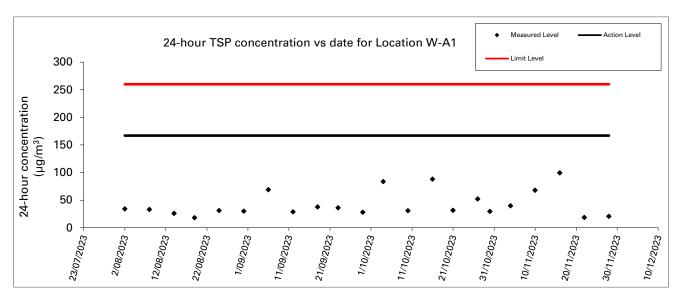
Figure 3: Graphical Illustration of Measured 24-hour TSP (μg/m³) Levels at W-A1

Start Date	Weather Condition	Elapse Time			Chart Reading			Avg Air Temp	Avg Atmospheric Pressure	Flow Rate Standard Air Volume	Filter Weight (g)		Particulate weight	Conc.	
		Initial	Final	Actual (min)	Min	Max	Avg	(°C)	(hPa)	(m³/min)	(m ³)	Initial	Final	(g)	(μg/m ³)
4/11/2023	Fine	10291.9	10315.9	1440.00	41	41	41.0	26.5	1014.2	1.14	1645	2.6937	2.7652	0.0715	43
10/11/2023	Fine	10315.9	10339.9	1440.00	41	41	41.0	26.1	1016.9	1.15	1649	2.7165	2.8238	0.1073	65
16/11/2023	Fine	10339.9	10363.9	1440.00	40	40	40.0	20.2	1023.8	1.14	1638	2.6308	2.7823	0.1515	92
22/11/2023	Fine	10363.9	10387.9	1440.00	40	40	40.0	22.8	1016.4	1.38	1984	2.6635	2.7750	0.1115	56
28/11/2023	Fine	10387.9	10411.9	1440.00	41	41	41.0	22.8	1018.7	1.42	2043	2.6226	2.7496	0.1270	62
						-				Maximum:	92	μg/m ³	Minimum:	43	μg/m ³

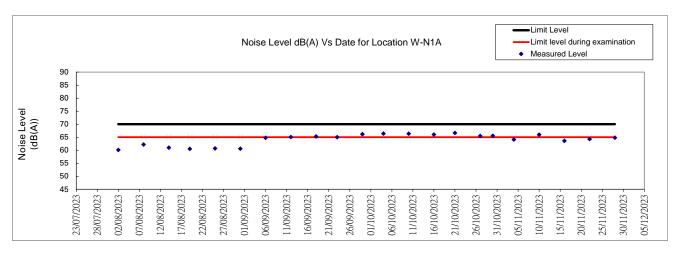
Figure 1: Graphical Illustration of Measured Noise Levels at W-N1A

Date	Weather	Start Time - End Time	L _{eq}	L_{10}	L ₉₀	Wind speed (m/s)	Limit level
04/11/2023	Fine	11:22 - 11:52	64.8	69.5	60.3	1.4	75.0
10/11/2023	Fine	11:23 - 11:15	68.3	70.4	65.5	2.5	75.0
16/11/2023	Fine	11:24 - 11:54	65.0	73.4	59.1	3.5	75.0
22/11/2023	Fine	11:26 - 13:30	68.9	71.0	65.3	2.8	75.0
28/11/2023	Fine	11:32 - 12:02	64.6	71.2	59.3	3.6	75.0

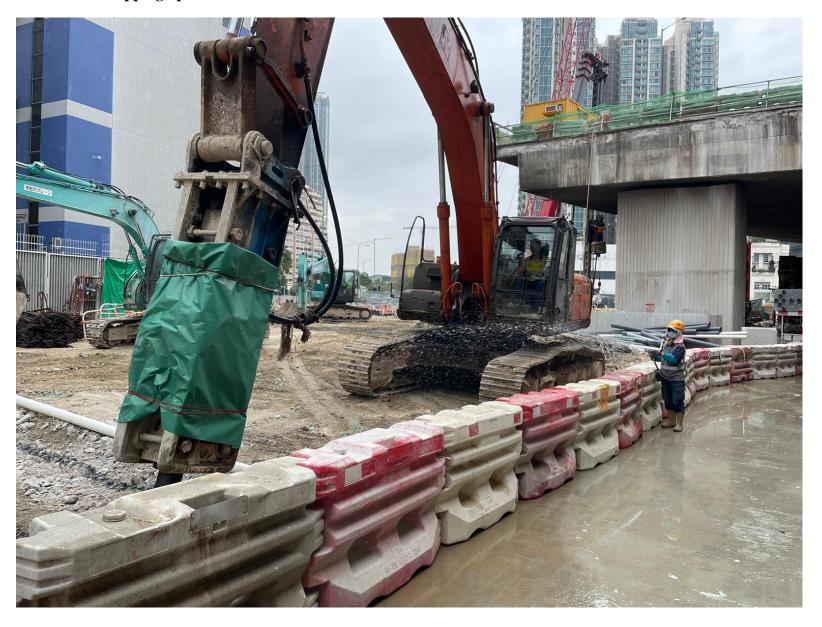
Remark 3: Wrapping up breaker head

For construction works undertaken within restricted hours, the Contractor applied for valid Construction Noise Permits (CNP) (Permit No: GW-RE1166-23) which was granted from EPD, effective from 26 Sep 2023 to 25 Dec 2023 with coverage of the construction site at the concerned area ⁵ . As noted by the contractor, excavation at Zone C underground was performed during 1900-2300 from 30 Oct 2023 to 6 Nov 2023. PME used for excavation included 1 excavator, excavator mounted breaker (hydraulic) and 1 ventilation fan. The aforementioned PME were classified in PME Group A of CNP and were allowed to be operated in Working Zone during 1900-2300 on any day not being a general holiday and during 0700-2300 on general holidays including Sundays. All PME were operated inside the underground working zone so that no part of such equipment is visible from any nearby NSR. CNP conditions had been strictly followed when operated PME during restricted hours. No violation and non-compliance of CNP was observed or recorded. The Contractor had followed the requirements as stipulated in CNP.

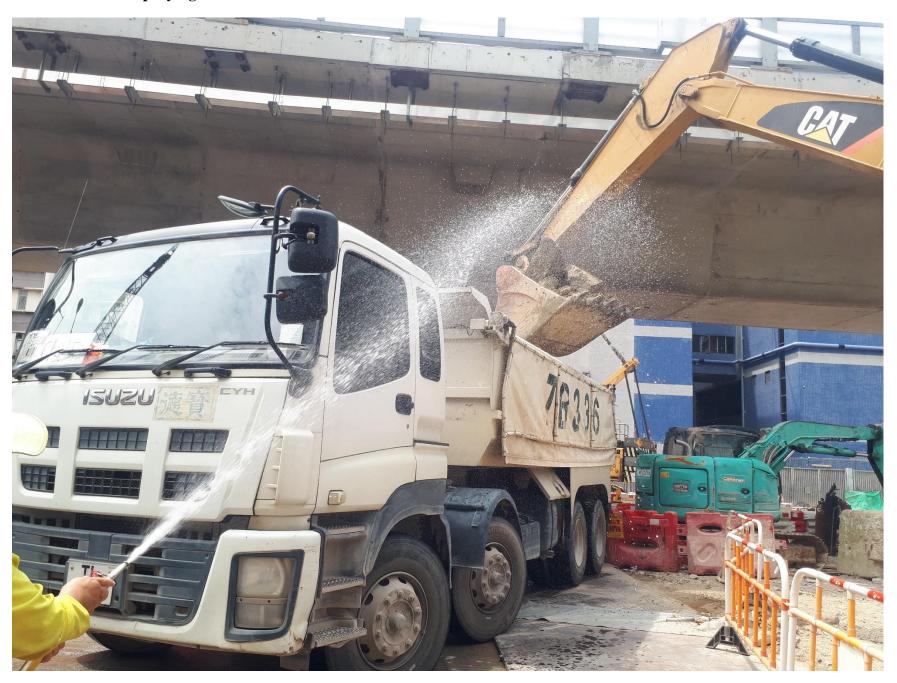
Remark 4: Water spraying

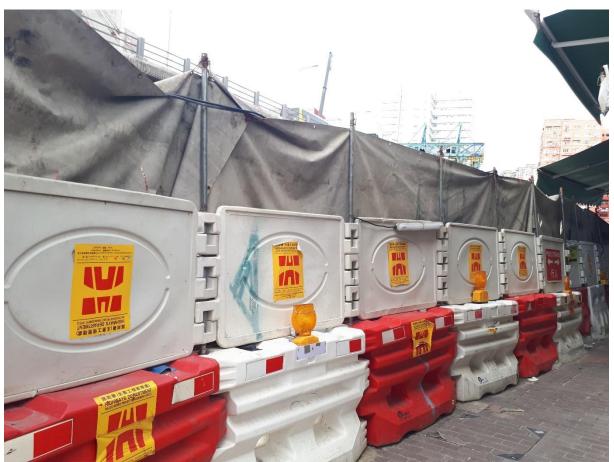
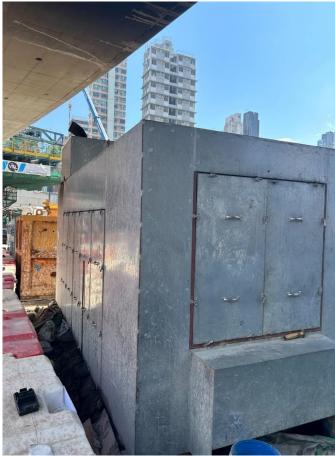
Remark 3: Noise mitigation measures

led that there was no non-compliance of the Project				
		ality impact from c					
Actions taken / to be taken	The Contractor ha	ad followed EM&A	A Manual and the CNMMP strictly to implement nize nuisance to the public.				
	 In view of public concerns, the following additional remedial measures are taken: Carry out site inspection to ensure all PMEs are well-maintained and in proper function to avoid excessive noise; Provide training to workers of using PME carefully to minimize noise; Reschedule the operation time of the noisy equipment to less sensitive hours if possible; and Use the materials with better acoustic performance to wrap up breaker head. 						
Remarks		ation of the concern					
(Shown in next page)	2. Noise mor	nitoring results of th	e concerned period

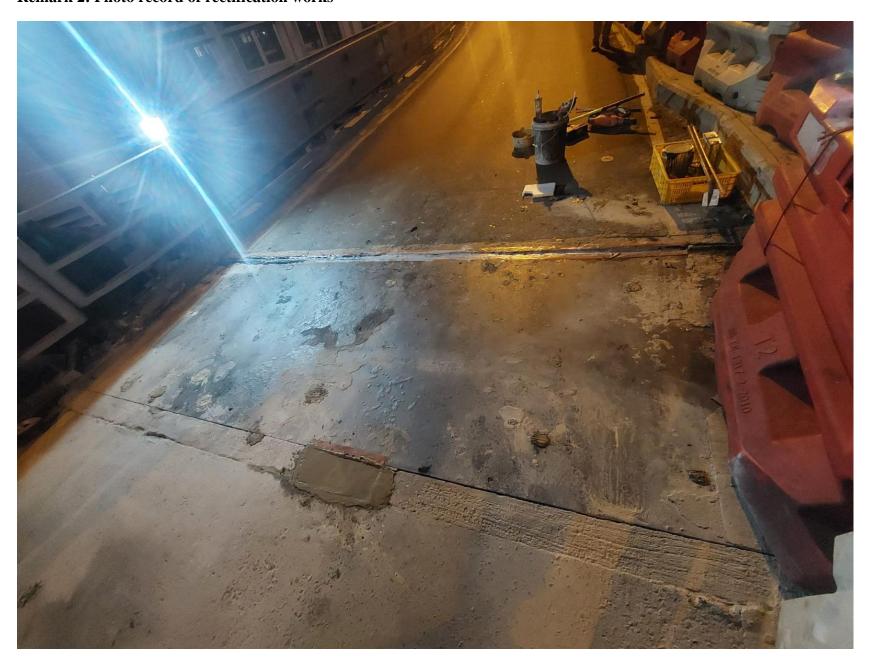
Remark 2: Photo record of rectification works

Project	Central Kowloon Route, Yau Ma Tei East Section				
Complaint Code	EC106-CKRYMTE20231121_001				
Complaint description	The complaint was received on 21 Nov 2023, about the noise generated when vehicles				
			r near Temple Street.		
Parameter	Construction Nois				
Investigation finding			ov 2023, about the noise generated when vehicles		
			near Temple Street ¹ . All construction works at the		
			npleted. The Gascoigne Road Flyover was currently		
	in operation phase	and therefore no co	onstruction works were performed.		
	According to the (Contractor's inform	ation, once the complaint was received on 21 Nov		
			el plate at the movement joint of Gascoigne Road		
			Nov 2023 to avoid noise generation when vehicles		
	passing on it. After	r the rectification w	orks had been completed, the noise was eliminated.		
Actions taken / to be taken		minded to keep on 1	reviewing the efficiency of the rectification work at

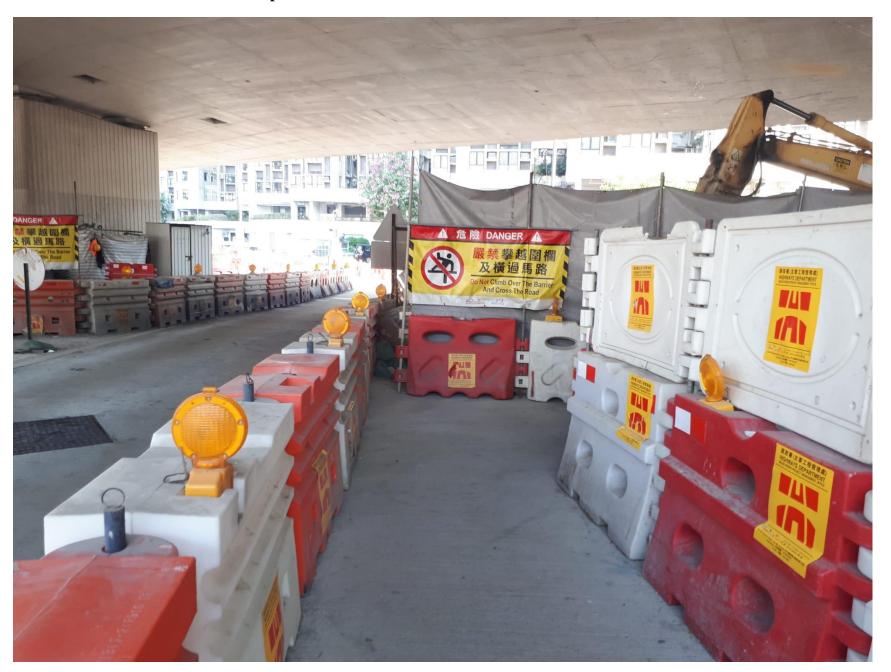
Remark 2: Photo record of on-site inspection

Actions taken / to be taken	The Contractor had followed EM&A Manual strictly to implement mitigation measures in order to minimize water pollution to the public.				
	 Add impertue the bridge Provide busite; and 	rvious sheeting at t;	wing additional remedial measures will be taken: he base of the bridge to block water dripping from e to prevent surface runoff outside the construction		
Remarks		ation of the concern			
(Shown in next page)		ord of on-site inspec			
Prepared by ET (Acuity Sustainability Consulting Limited)	Kako Ho	Ho			
Reviewed by ETL (Acuity Sustainability Consulting Limited)	Kevin Li	K			
Verified by IEC (ERM-Hong Kong, Limited)	Mandy To	Mandy2.			
Date	27 Nov 20)23
