Central Kowloon Route

Yau Ma Tei East

Contract No. HY/2014/08

Monthly EM&A Report No. 72

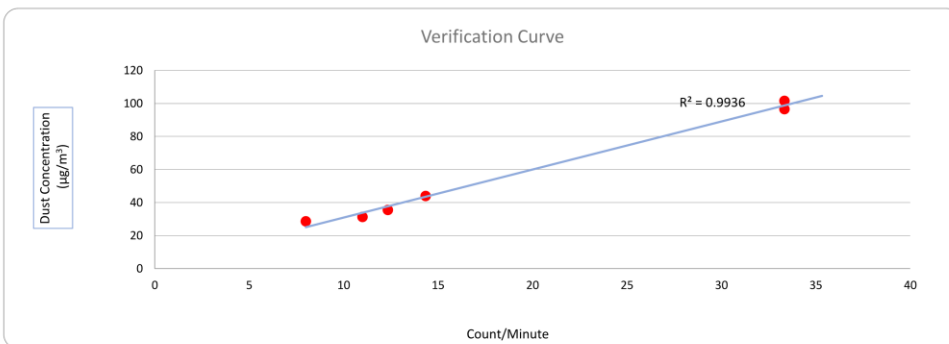
Linear Regression of y on x

Slope, K factor:	<u>2.9083</u>	Intercept:	<u>1.8061</u>	*Correlation Coefficient, R:	<u>0.9968</u>
Verification Test Result: <u>Strong Correlation, Results were accepted.</u>				* If the Correlation Coefficient, R is <0.5. Checking and Re-verification are required.

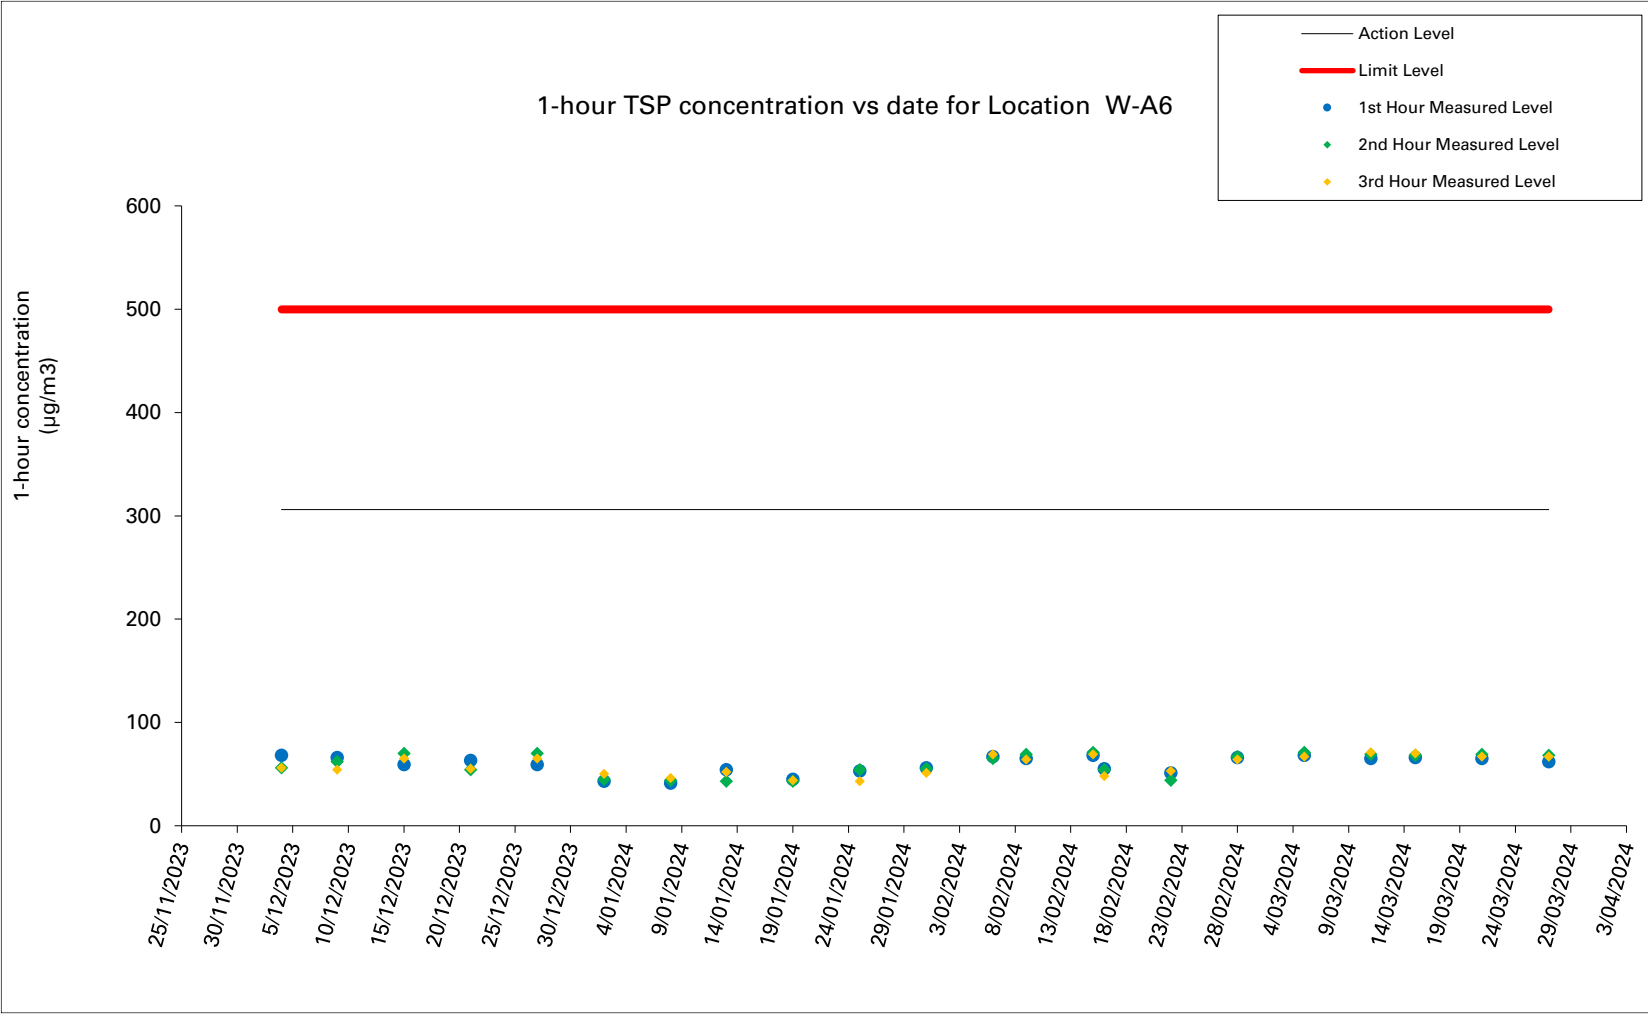
Figure 2: Graphical Illustration of Measured 1-hour TSP ($\mu\text{g}/\text{m}^3$) Levels at W-A6

Location: Man Cheong Building (W-A6)
Monitoring date: 5, 11, 15, 21 and 27 March 2024
Parameter : TSP 1-hour
Other Factors Nearby traffic

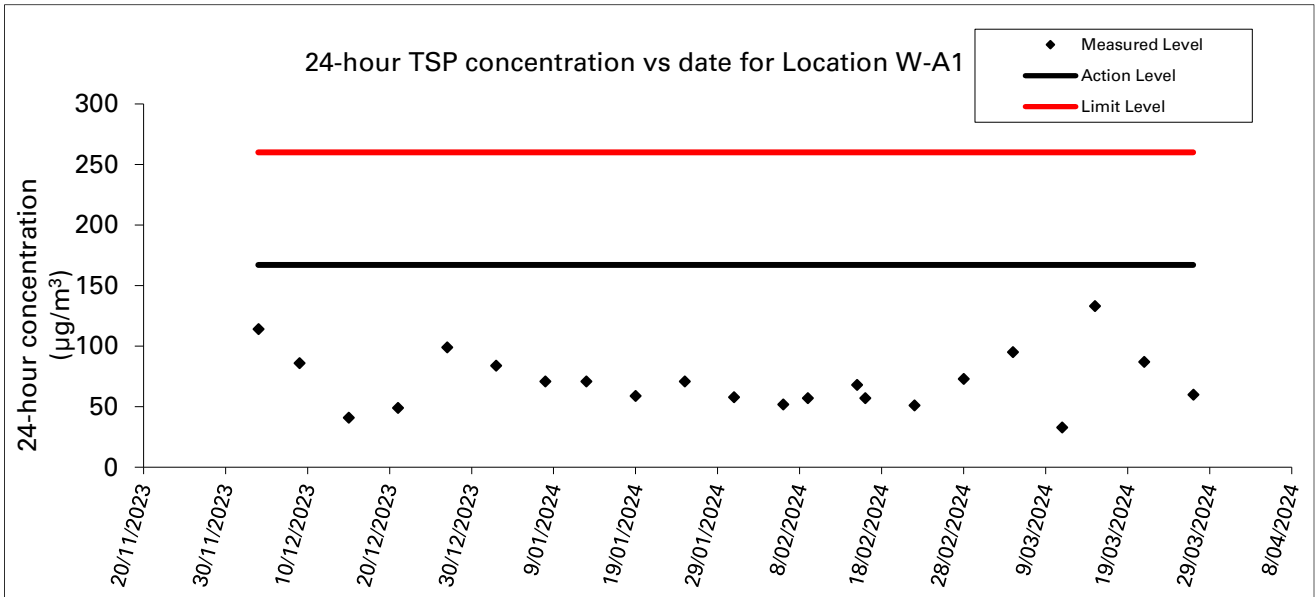
Figure 3: Graphical Illustration of Measured 24-hour TSP ($\mu\text{g}/\text{m}^3$) Levels at W-A1

Location: Yau Ma Tei Catholic Primary School (Hoi Wang Road) (W-A1)
 Monitoring date: 5, 11, 15, 21 and 27 March 2024
 Parameter : TSP 24-hour
 Other Factors Nearby traffic

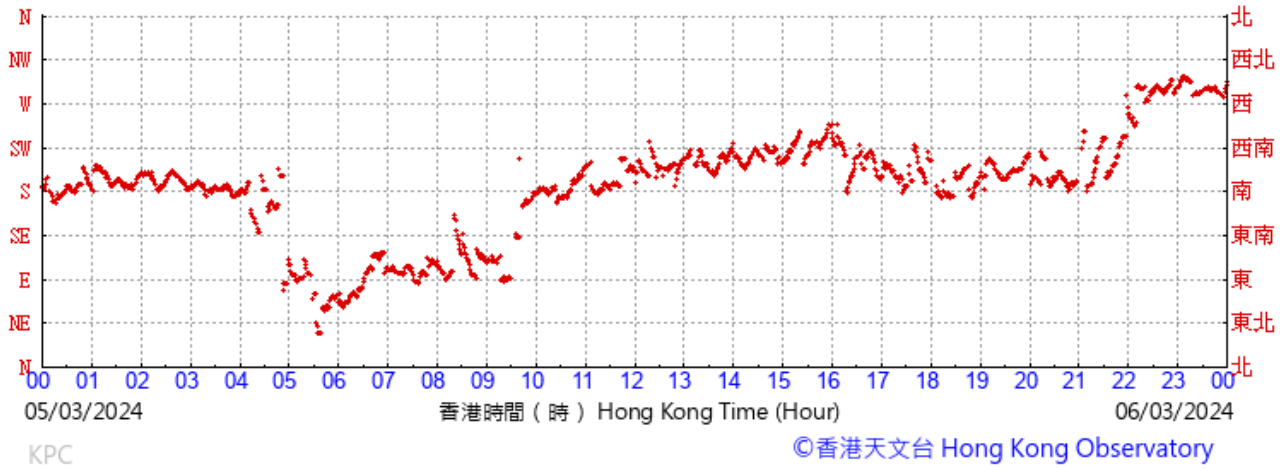
(於香港時間06/03/2024 00 時 00 分更新) (Updated at 00:00H on 06/03/2024)

Wind direction data for 5, 6, 11, 12, 15, 16, 21, 22, 27 and 28 March 2024

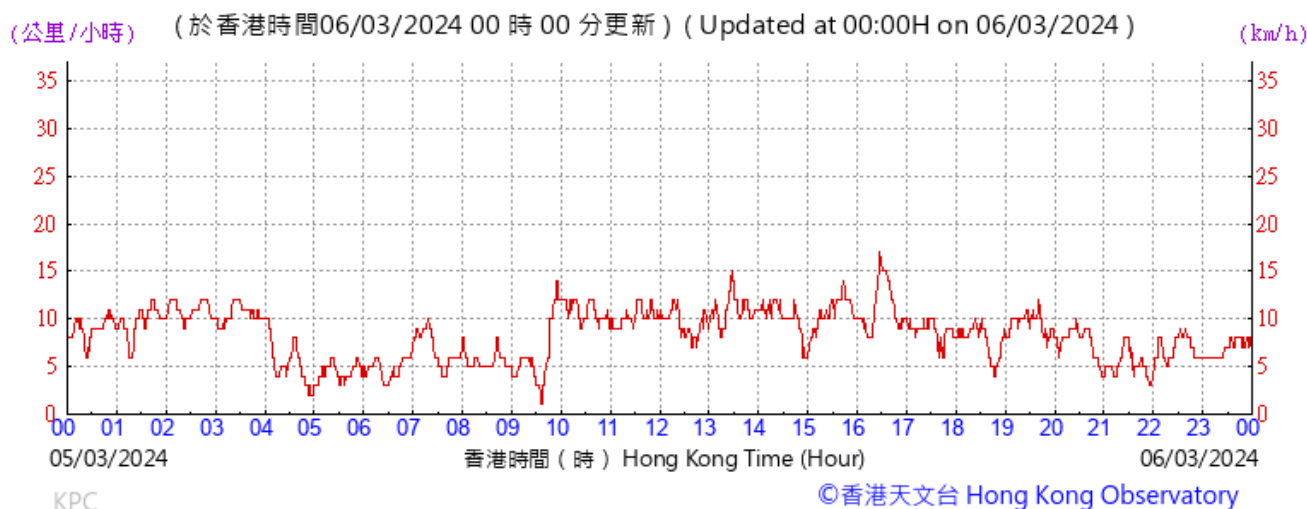
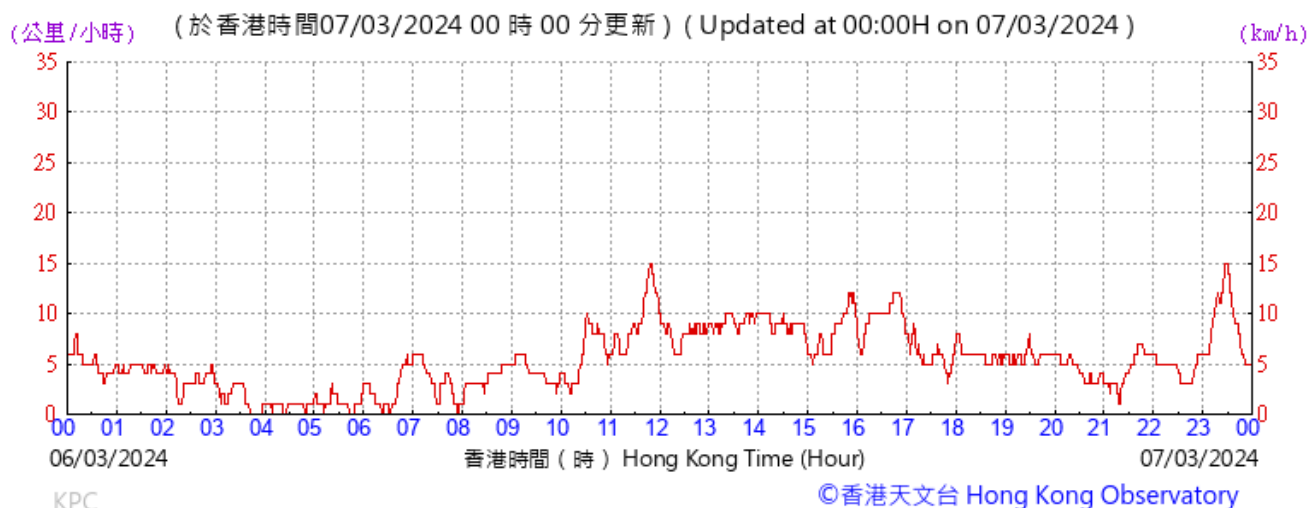
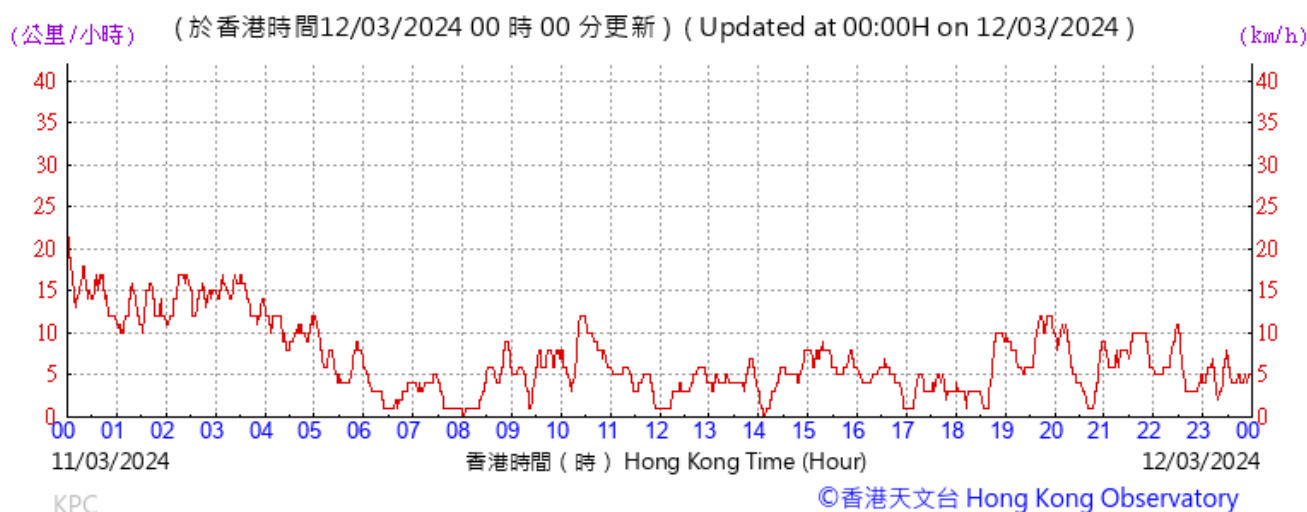
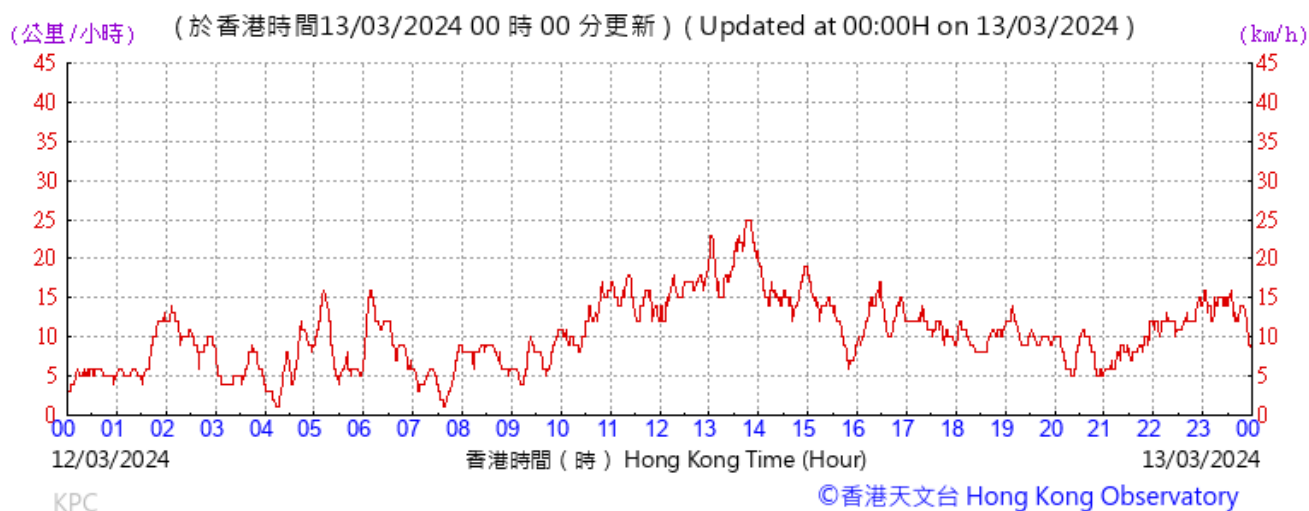
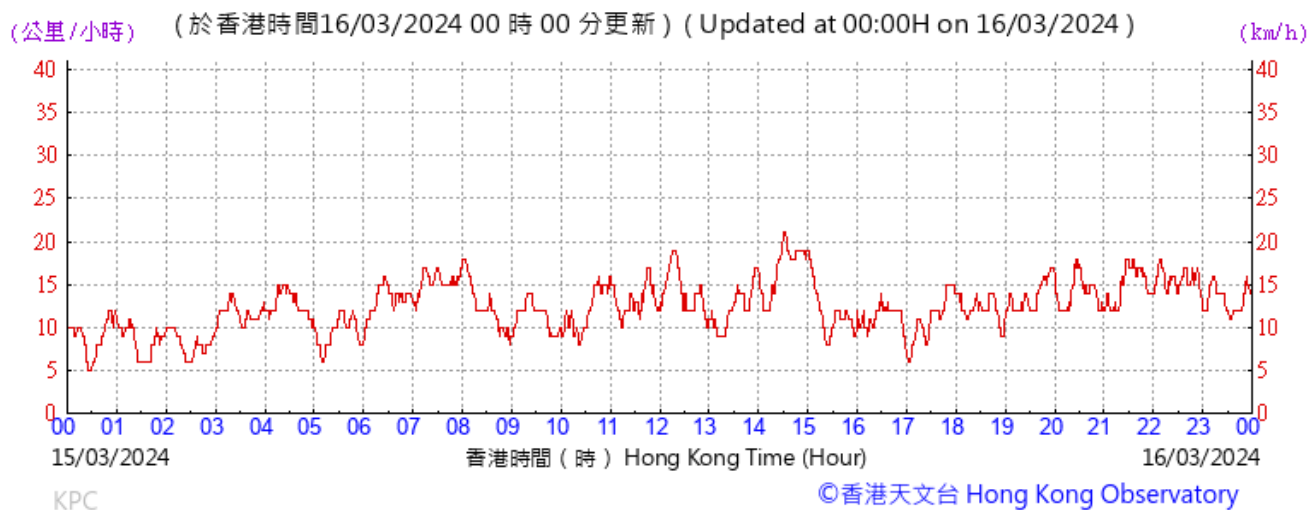
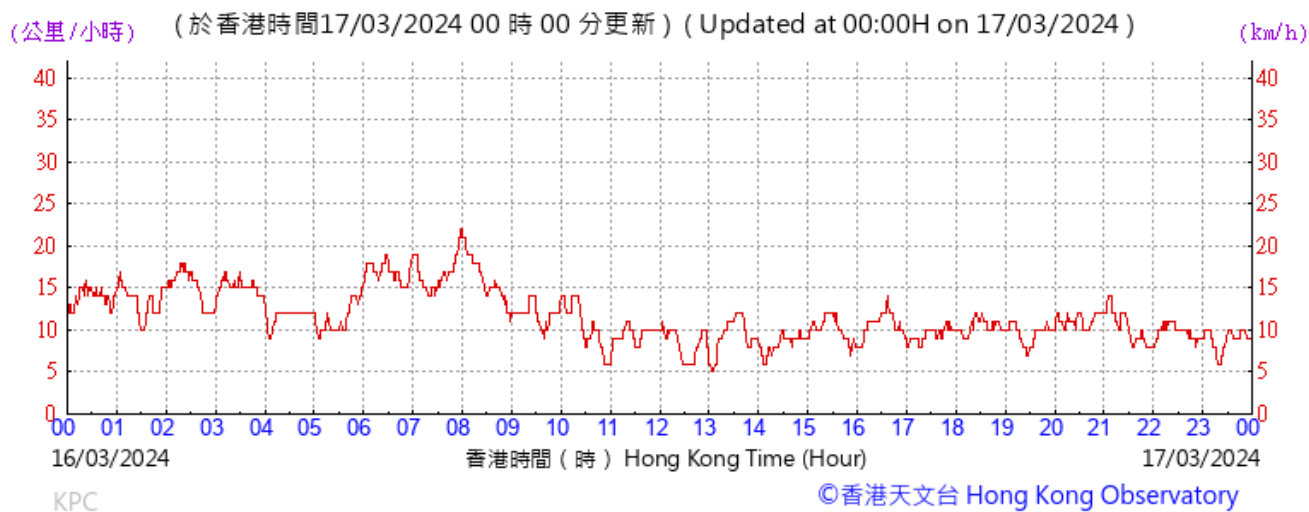
Wind speed data for 5, 6, 11, 12, 15, 16, 21, 22, 27 and 28 March 2024

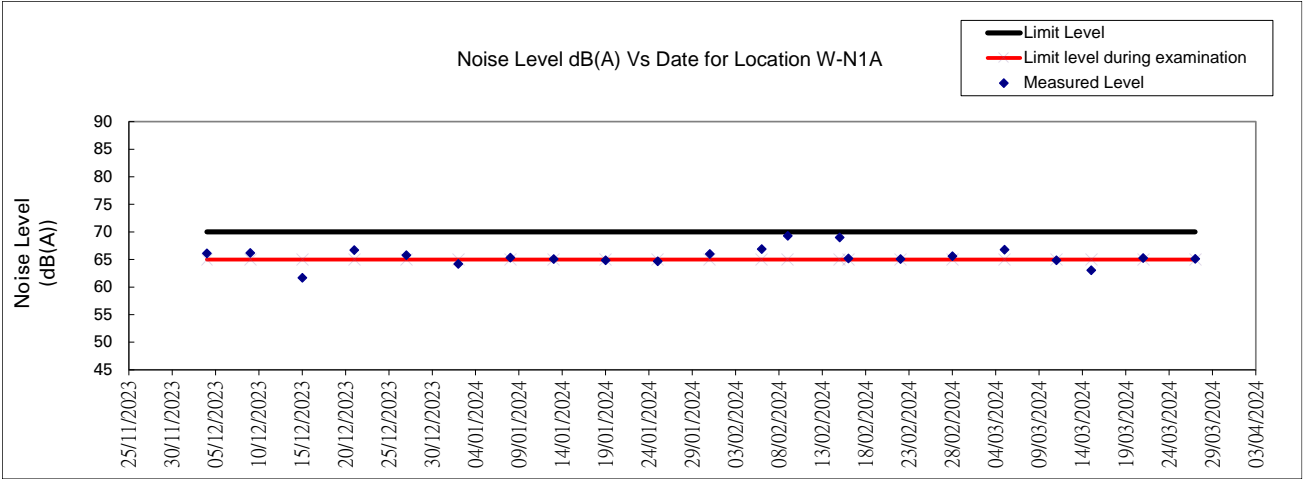
Figure 1: Graphical Illustration of Measured Noise Levels at W-N1A

Date	Weather	Start Time - End Time	L_{eq}	L_{10}	L_{90}	Wind speed (m/s)
05/03/2024	Fine	9:40 - 10:10	66.5	72.2	59.8	2.5
11/03/2024	Fine	9:43 - 11:15	64.8	72.7	59.2	1.9
15/03/2024	Fine	9:44 - 10:14	63.5	72.3	59.8	3.1
21/03/2024	Fine	9:42 - 13:30	64.6	68.7	62.5	3.6
27/03/2024	Fine	9:45 - 10:15	65.4	68.7	62.1	3.5
