JOB No.: TCS00694/13

**AGREEMENT NO. CE 45/2008 (CE)
LIANTANG/HEUNG YUEN WAI
BOUNDARY CONTROL POINT AND ASSOCIATED WORKS**

**MONTHLY ENVIRONMENTAL MONITORING AND AUDIT
REPORT (NO.50) – SEPTEMBER 2017**

**PREPARED FOR
CIVIL ENGINEERING AND DEVELOPMENT DEPARTMENT
(CEDD)**

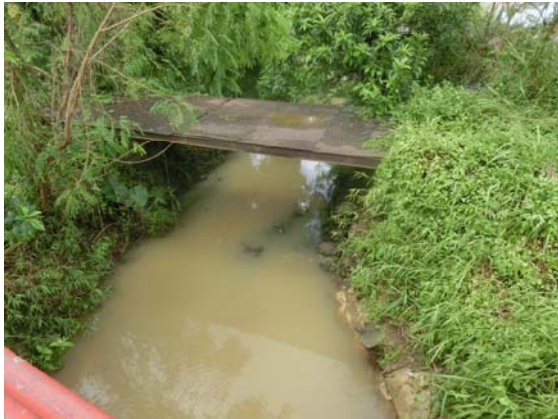
Photo 1

On 24 August 2017, muddy water was observed at WM2A(a).

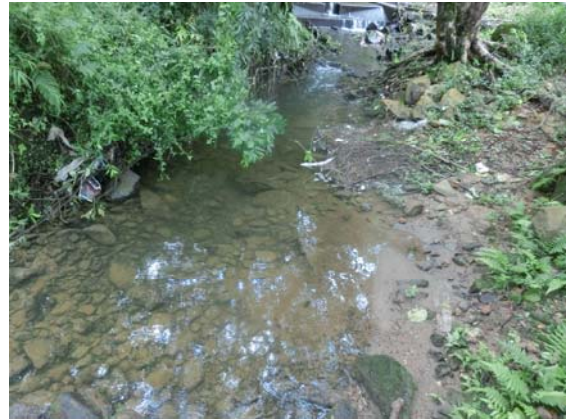
Photo 2

On 24 August 2017, the water quality observed at WM2A-C was clear.

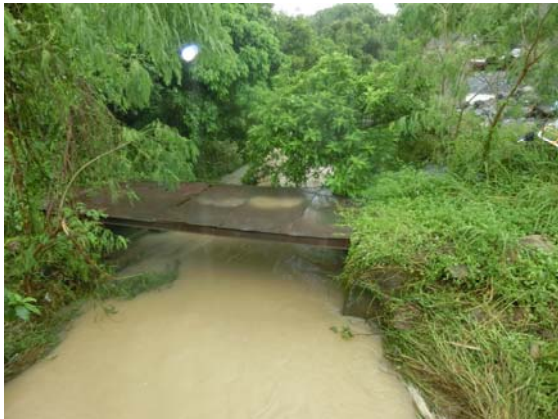
Photo 3

On 28 August 2017, muddy water was observed at WM2A(a) and the water sampling was conducted during rain.

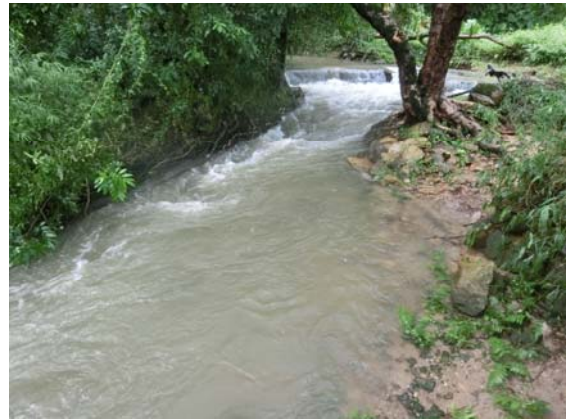
Photo 4

On 28 August 2017, rapid flow of turbid water was observed at WM2A-C and the water sampling was conducted during rain.

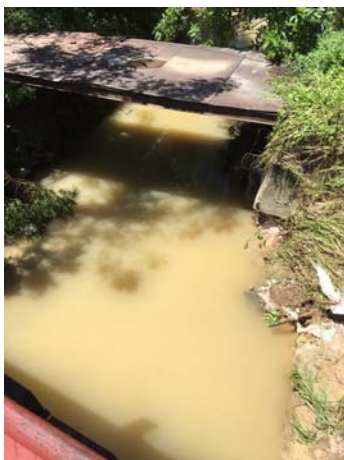
Photo 5

On 29 August 2017, muddy water was observed at WM2A(a).

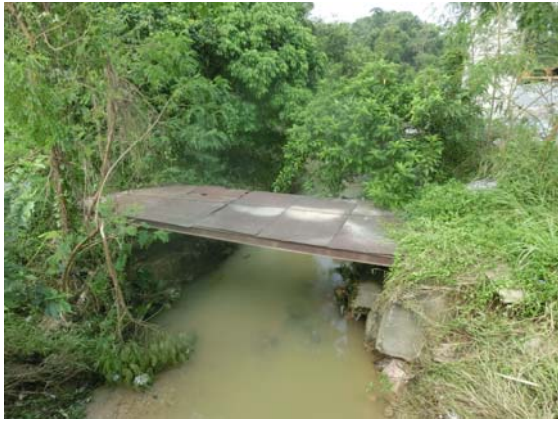
Photo 7

On 30 August 2017, muddy water was observed at WM2A(a).

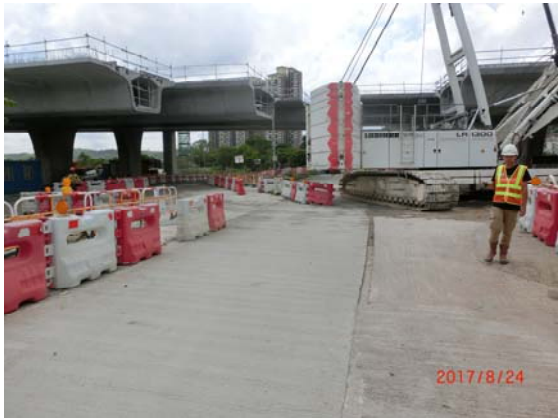
Photo 9

During site inspection on 24 August 2017, construction works carried out at Bridge D was mainly segment installation and there was no discharge due to nature of works.

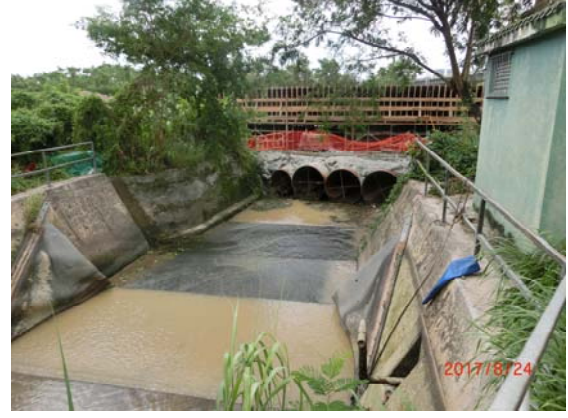
Photo 10

On 24 August 2017, it was observed that the nylon dam was deflated and muddy water was flowing to downstream before the water sampling.

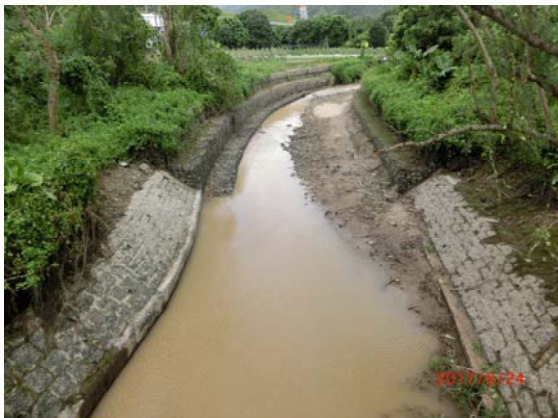
Photo 11

During site inspection on 24 August 2017, it was observed that the existing river water was turbid even without the impact from the construction work.

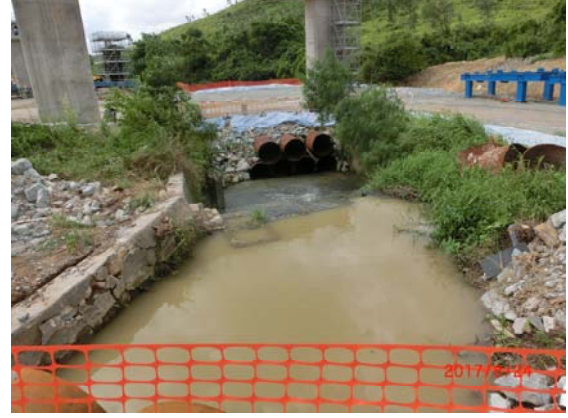
Photo 12

During site inspection on 24 August 2017, it was observed that the existing river water was turbid even without the impact from the construction work.

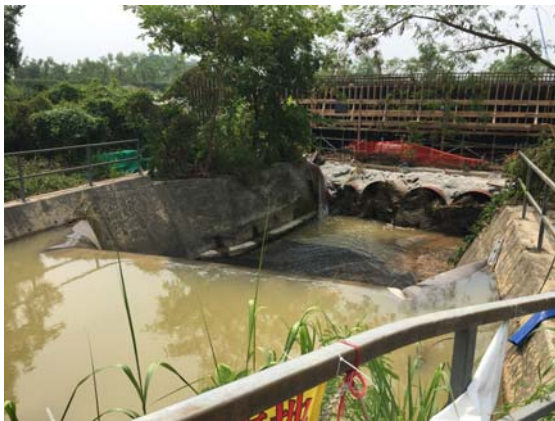
Photo 15

During site inspection on 30 August 2017, it was observed that the existing river water near the Nylon Dam was slightly turbid even without the impact from the construction work.

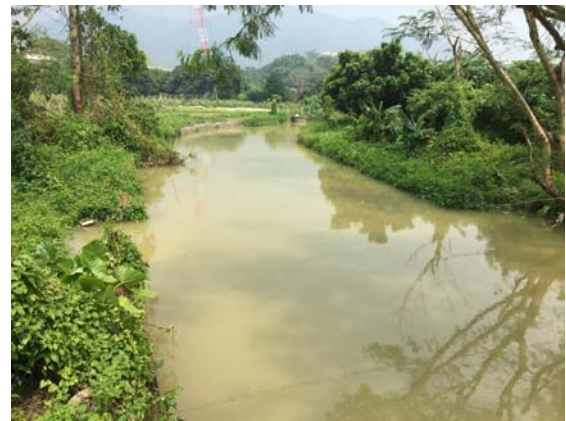
Photo 16

During site inspection on 30 August 2017, it was observed that the existing river water near the Nylon Dam was slightly turbid even without the impact from the construction work.

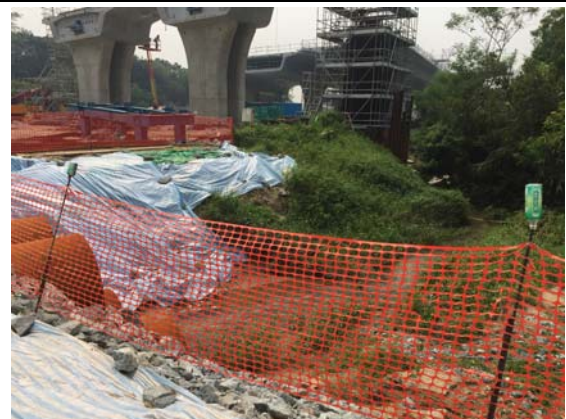
Photo 18

As water quality mitigation measures, temporary bund was constructed align the river course and the slope adjacent to river course was entirely covered with tarpaulin sheet.

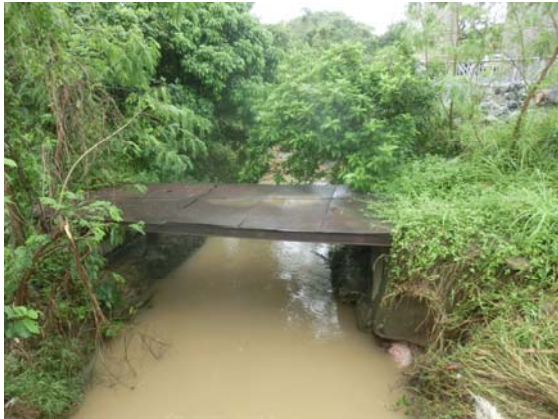
Photo 1

On 4 September 2017, muddy water was observed at WM2A(a).

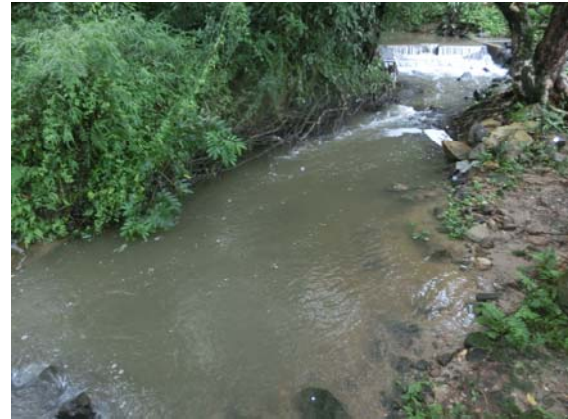
Photo 2

On 4 September 2017, the water quality observed at WM2A-C was slightly turbid.

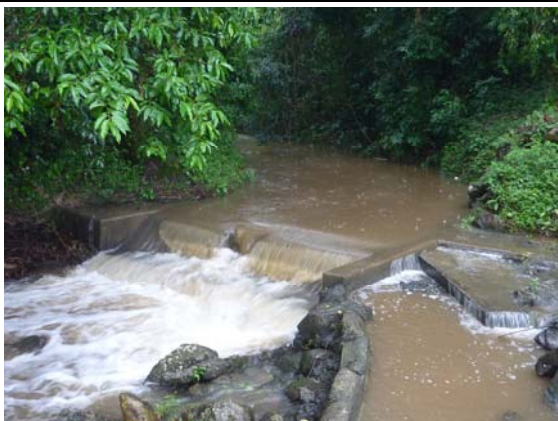
Photo 5

Muddy water was also observed at the upstream area in early morning of 4 September 2017 due to the Tropical Cyclone and rainstorm on 4 September 2017.

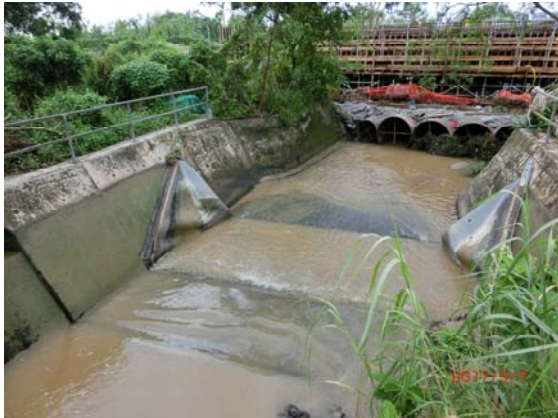
Photo 7

On 7 September 2017, it was observed that the nylon dam was deflated and muddy water was flowing to downstream before the water sampling.

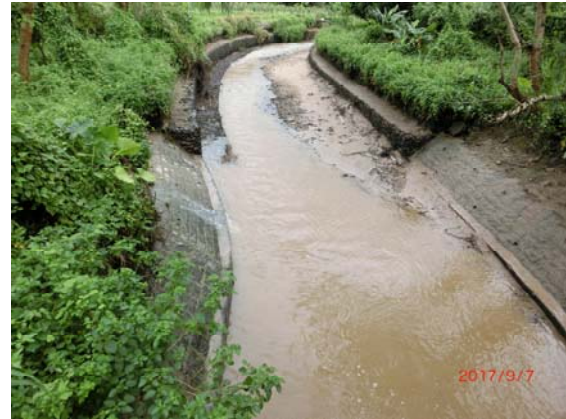
Photo 8

On 7 September 2017, it was observed that the nylon dam was deflated and muddy water was flowing to downstream before the water sampling.

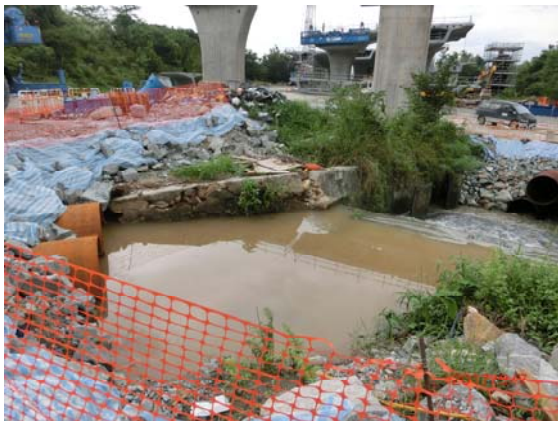
Photo 9

During site inspection on 7 September 2017, it was observed that the existing river water was turbid even without the impact from the construction work.

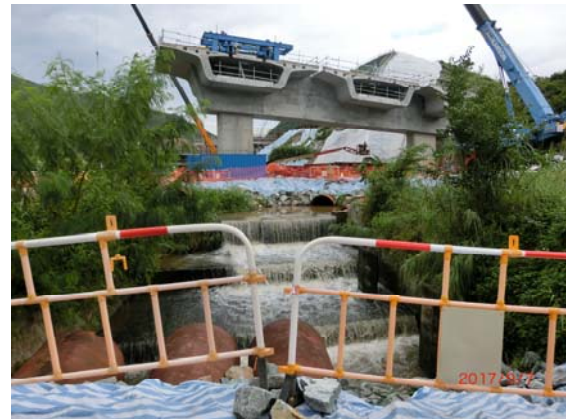
Photo 10

During site inspection on 7 September 2017, it was observed that the existing river water was turbid even without the impact from the construction work.

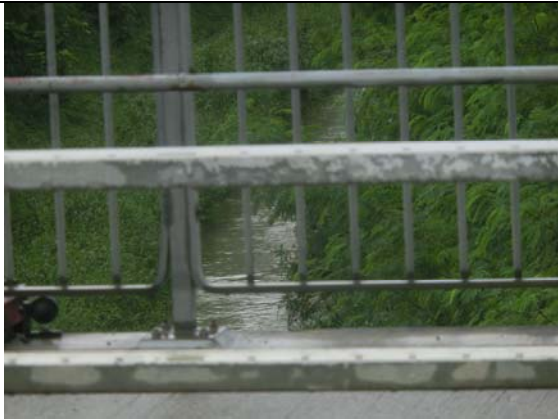
Photo 1

During water quality monitoring on 22 September 2017, it was observed that the water quality at WM4 was slightly turbid.

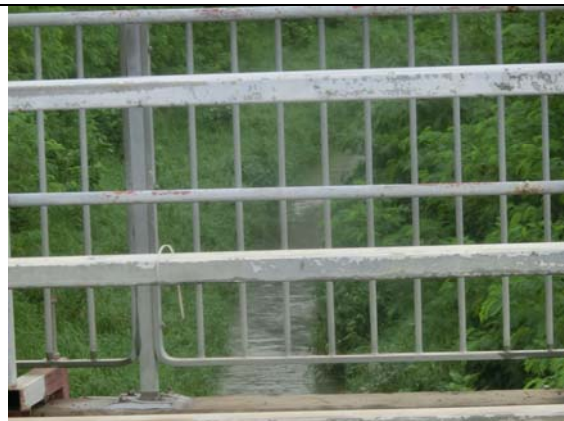
Photo 4

During water quality monitoring on 23 September 2017, it was observed that the water quality at WM4 was slightly turbid.

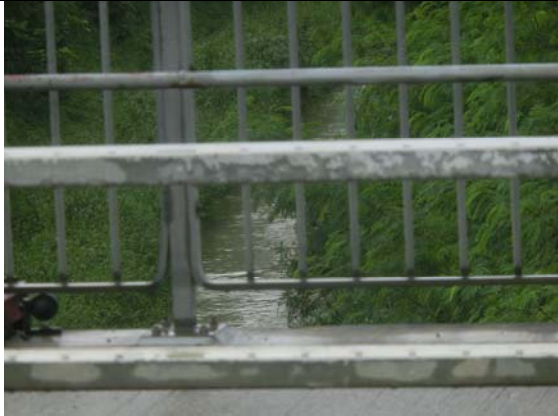
Photo 1

During water quality monitoring on 22 September 2017, it was observed that the water quality at WM4 was slightly turbid.

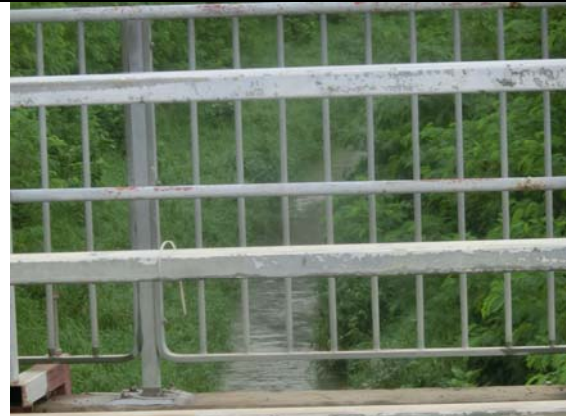
Photo 4

During water quality monitoring on 23 September 2017, it was observed that the water quality at WM4 was slightly turbid.

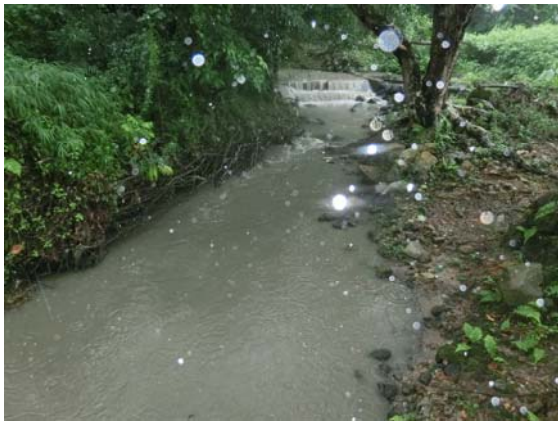
Photo 1

On 30 September 2017, muddy water was observed at WM2A(a).

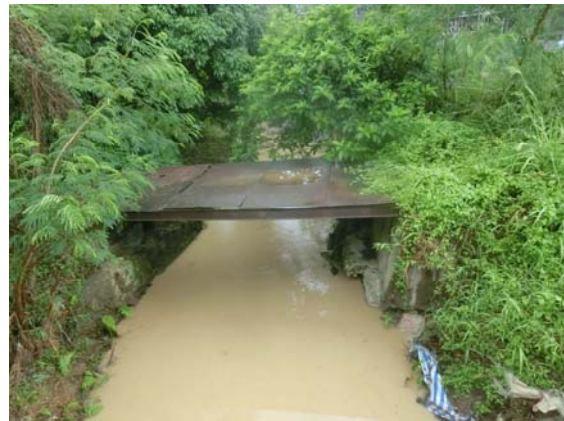
Photo 2

On 30 September 2017, the water quality observed at WM2A-C was slightly turbid.

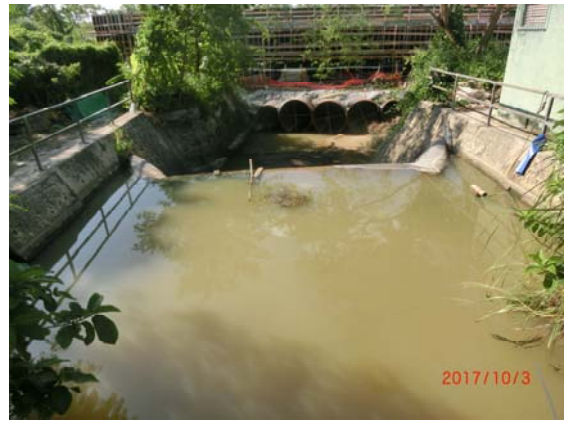
Photo 4

During site inspection on 3 October 2017, it was observed that the existing river water was appeared slightly turbid even without the impact from the construction work.

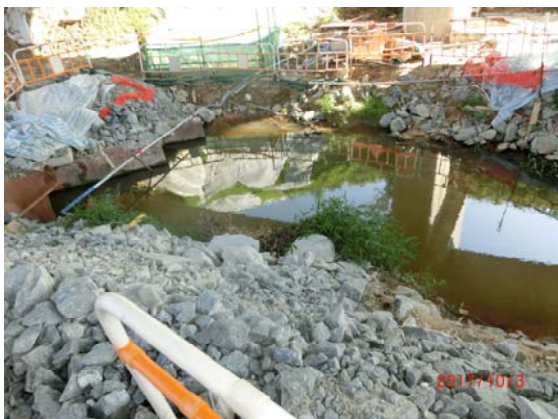
Photo 5

During site inspection on 3 October 2017, it was observed that the existing river water was turbid even without the impact from the construction work.
