**AGREEMENT NO. CE 45/2008 (CE)
LIANTANG/HEUNG YUEN WAI
BOUNDARY CONTROL POINT AND ASSOCIATED WORKS**

**MONTHLY ENVIRONMENTAL MONITORING AND AUDIT
REPORT (NO.53) – DECEMBER 2017**

**PREPARED FOR
CIVIL ENGINEERING AND DEVELOPMENT DEPARTMENT
(CEDD)**

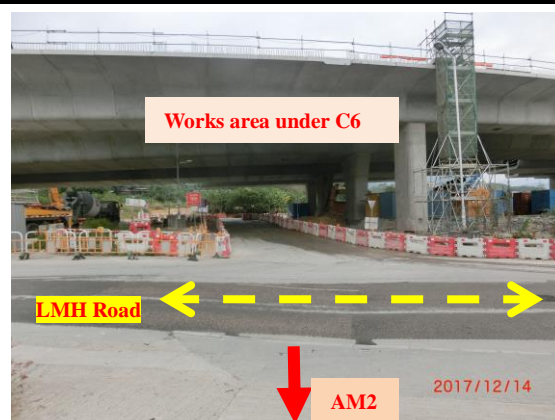
Photo 2

The works area of Bridge D – Lin Ma Hang and AM2 was separated by Lin Ma Hang Road. As observed during site inspection, the main dust source was dominated by traffic dust in LMH Road.

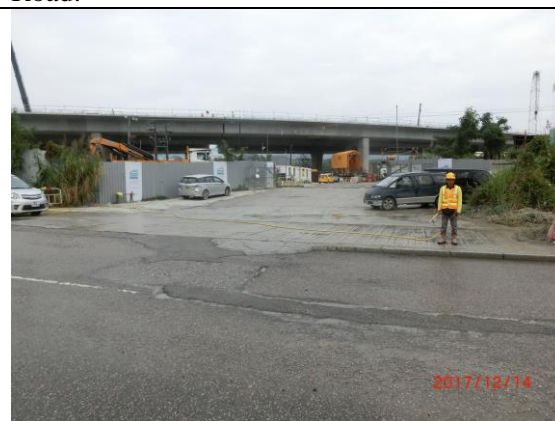
Photo 4 (Bridge D Site Exit under LT/C6)

The condition of Bridge D Site Exit under LT/C6 and adjoined LMH road was satisfactory without mud and debris.

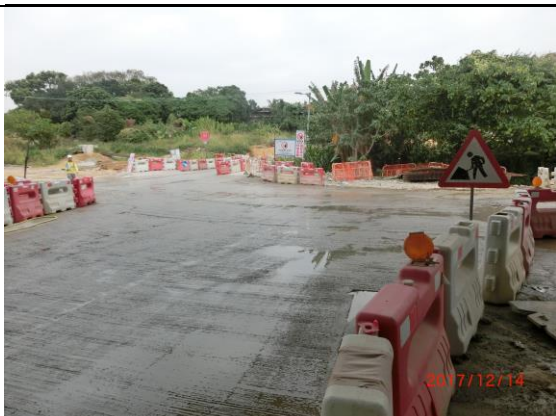
Photo 5 (Chuk Yuen Rd Site exit under LT/C6)
Wheel washing facilities were provided and properly maintained by CCKJV.

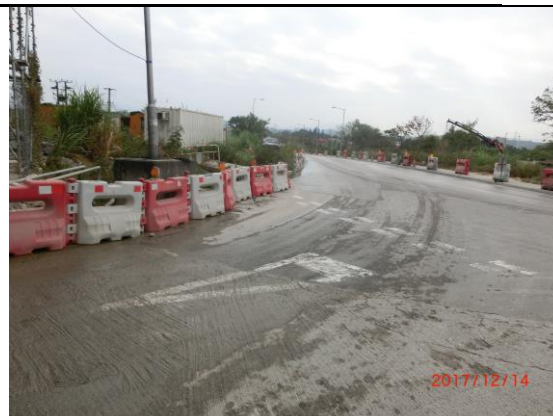
Photo 6 (Chuk Yuen Rd Site exit under LT/C6)
The condition of Chuk Yuen Rd Site Exit under LT/C6 and adjoined LMH road was satisfactory without mud and debris.

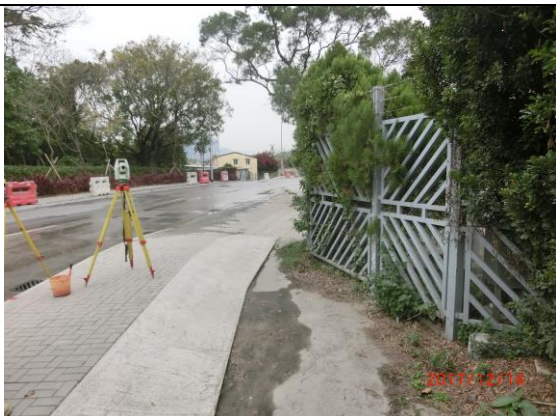
Photo 7
Works area of LT/C6 was far away from the air quality monitoring station AM3 and no adverse dust impact due to the project work was observed at AM3.

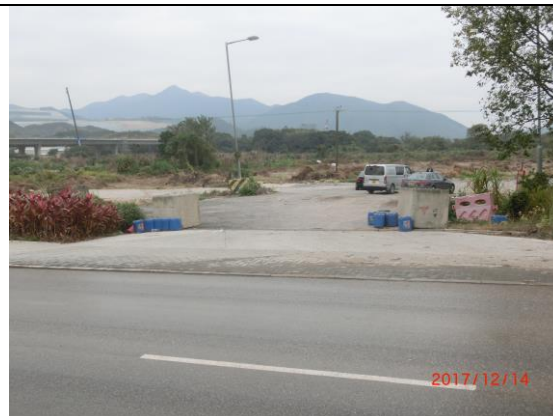
Photo 8 (Unknown Exit 1)
The condition of unknown site exit 1 and adjoined LMH road was fair and fugitive dust dusty was observed when vehicles passing by the road. The maintenance party/ ownership of the site exit is unknown.

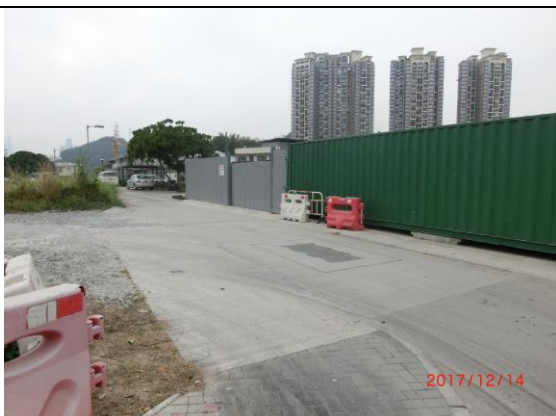
Photo 9 (Unknown Exit 2)
The condition of unknown site exit 2 and adjoined LMH road was fair and fugitive dust dusty was observed when vehicles passing by the road. The maintenance party/ ownership of the site exit is unknown.

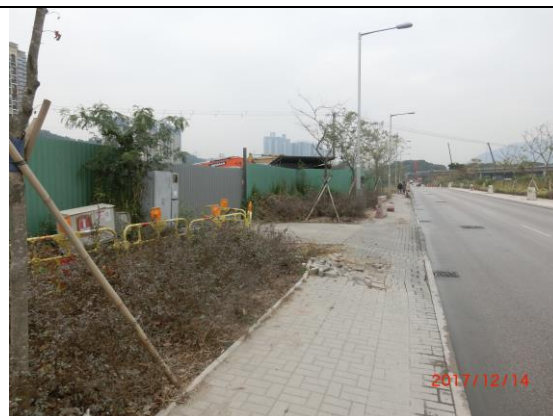
Photo 10 (Unknown Exit 3)
The condition of unknown site exit 3 and adjoined LMH road was fair and fugitive dust dusty was observed when vehicles passing by the road. The maintenance party/ ownership of the site exit is unknown.

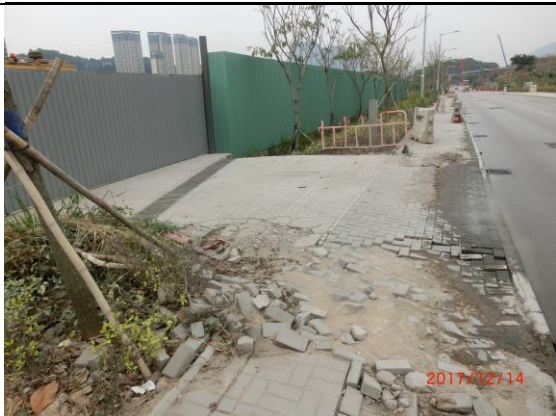
Photo 11 (Unknown Exit 4)

The condition of unknown site exit 4 and adjoined LMH road was fair and fugitive dust dusty was observed when vehicles passing by the road. The maintenance party/ ownership of the site exit is unknown.

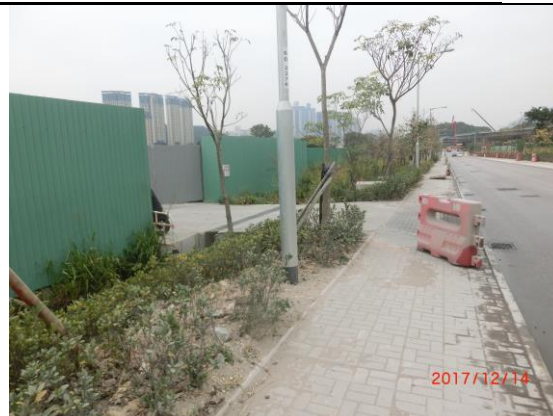
Photo 12 (Unknown Exit 5)

The condition of unknown site exit 5 and adjoined LMH road was fair and fugitive dust dusty was observed when vehicles passing by the road. The maintenance party/ ownership of the site exit is unknown.

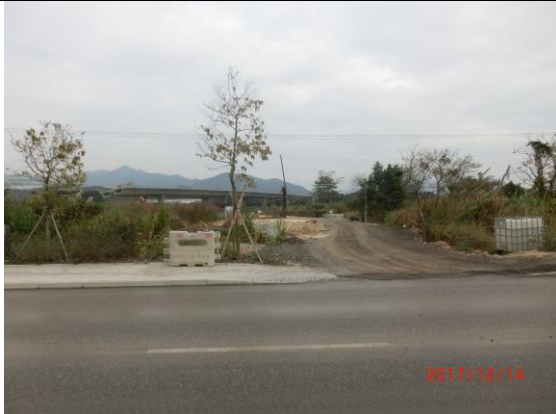
Photo 13 (Unknown Exit 6)

The condition of unknown site exit 6 and adjoined LMH road was fair and fugitive dust dusty was observed when vehicles passing by the road. The maintenance party/ ownership of the site exit is unknown.

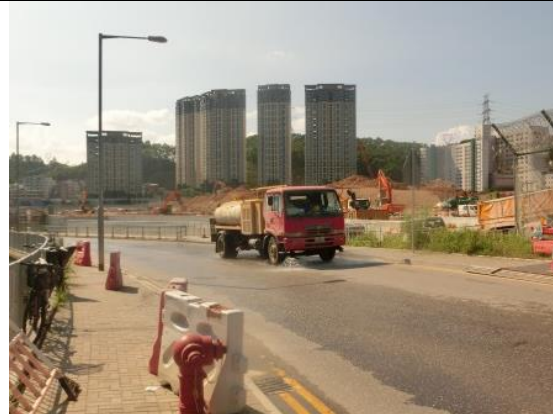
Photo 14

During the regular site inspection, it was observed that the road surface of LMH Road was wetted by water bowsers to suppress fugitive dust.

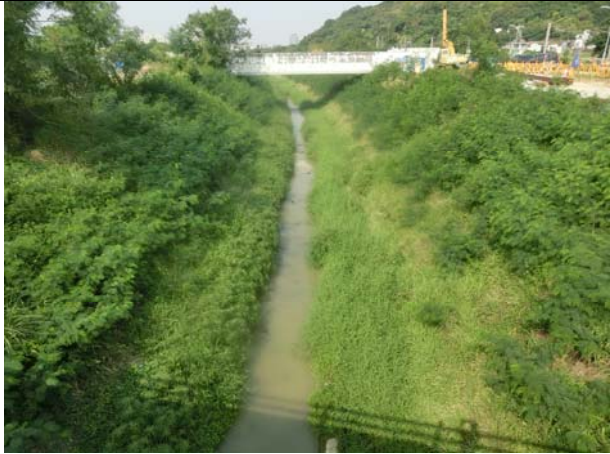
Photo 1

During water quality monitoring on 6 December 2017, turbid water was observed at WM4.

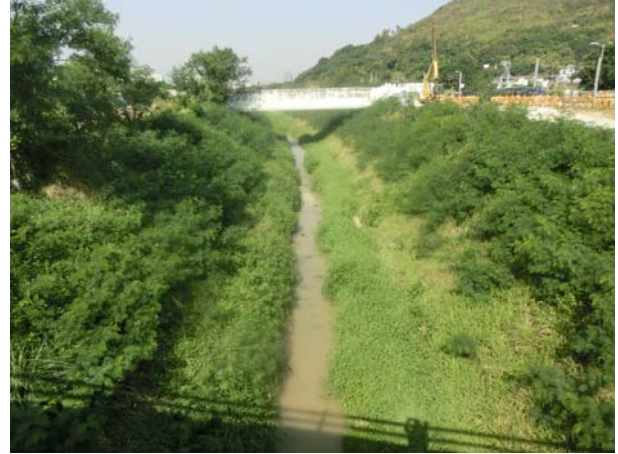
Photo 4

During water quality monitoring on 11 December 2017, turbid water was observed at WM4.

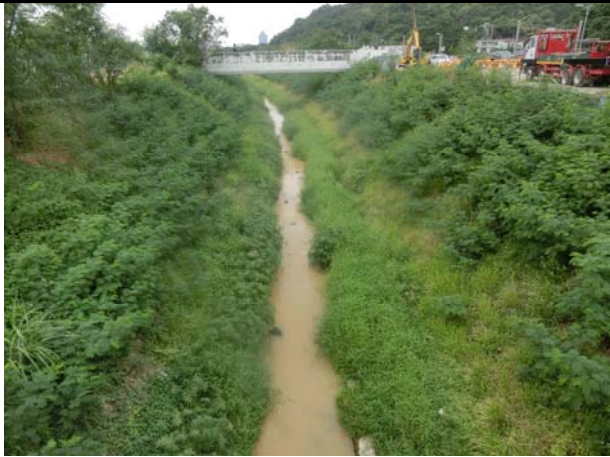
Photo 7

During water quality monitoring on 15 December 2017, turbid water was observed at WM4.

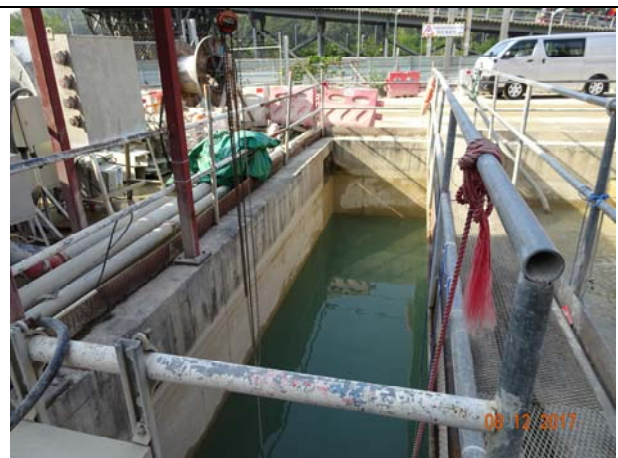
Photo 10

Weekly joint site inspection by the RE, DHK, IEC and ET was conducted on 8 December 2017. It was observed that wastewater treatment facilities implemented in South Portal Site under Contract 2 was functioned properly.

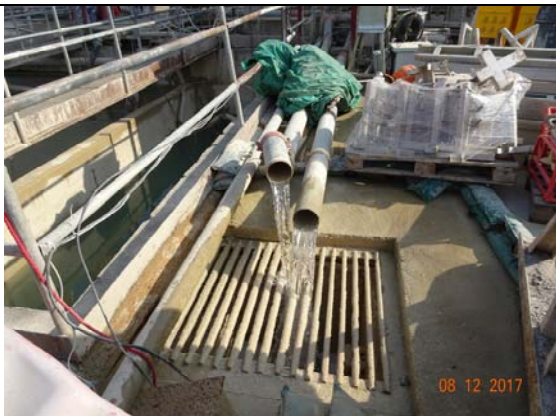
Photo 11

Weekly joint site inspection by the RE, DHK, IEC and ET was conducted on 8 and 15 December 2017. It was observed that wastewater treatment facilities implemented in South Portal Site under Contract 2 was functioned properly and the discharge was clear.

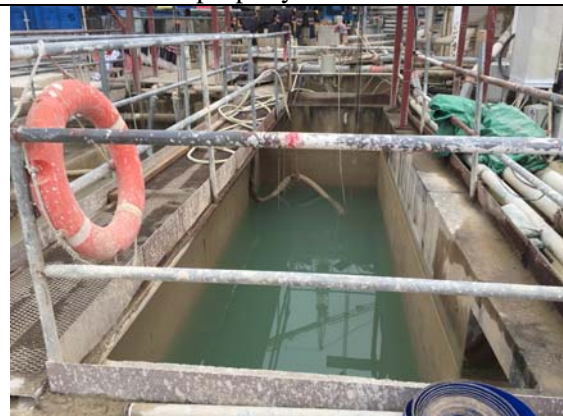
Photo 12

Weekly joint site inspection by the RE, DHK, IEC and ET was conducted on 15 December 2017. It was observed that wastewater treatment facilities implemented in South Portal Site under Contract 2 was functioned properly.

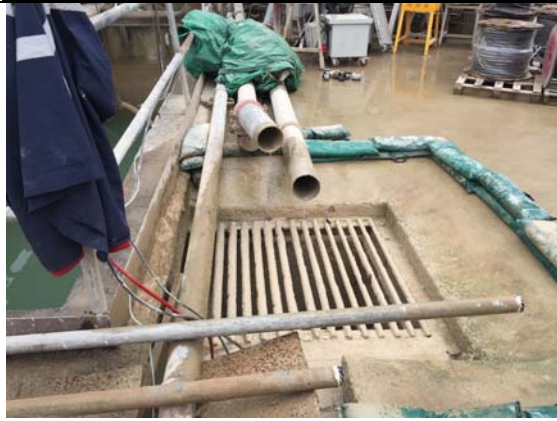
Photo 13

Weekly joint site inspection by the RE, DHK, IEC and ET was conducted on 15 December 2017. It was observed that wastewater treatment facilities implemented in South Portal Site under Contract 2 was functioned properly and the discharge was clear.

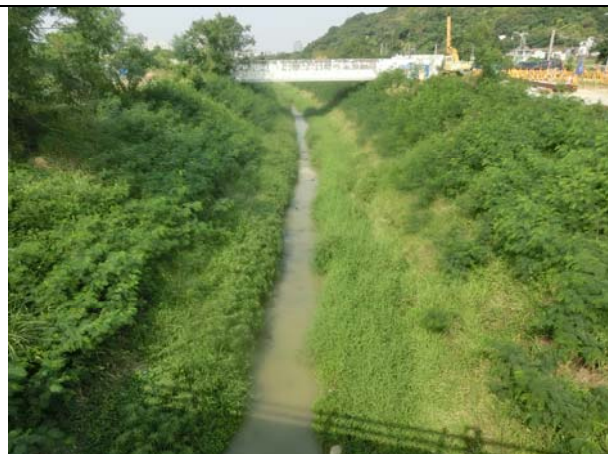
Photo 1

During water quality monitoring on 6 December 2017, turbid water was observed at WM4.

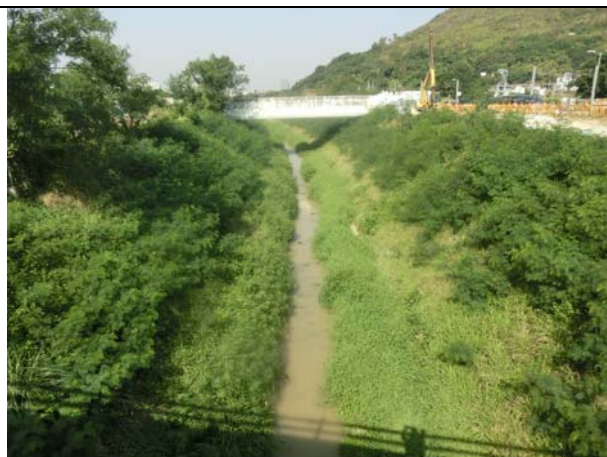
Photo 4

During water quality monitoring on 11 December 2017, turbid water was observed at WM4.

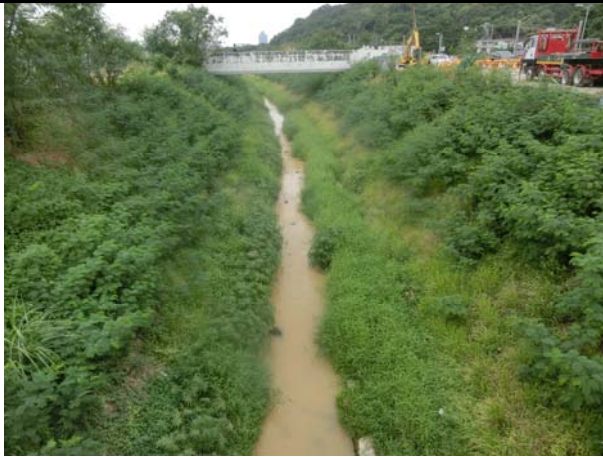
Photo 7
During water quality monitoring on 15 December 2017, turbid water was observed at WM4.

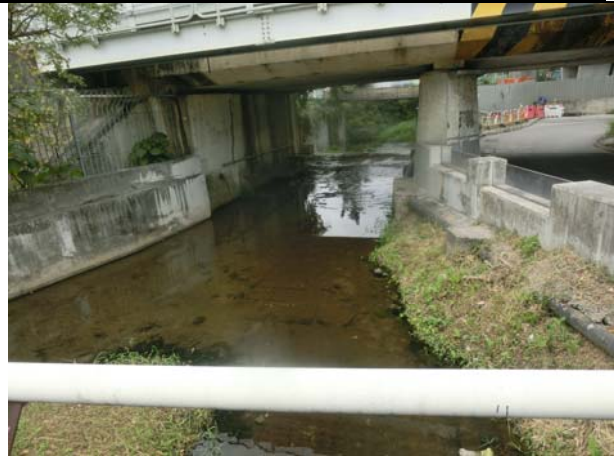
Photo 8
During water quality monitoring on 15 December 2017, the water quality at WM4-CA was clear.

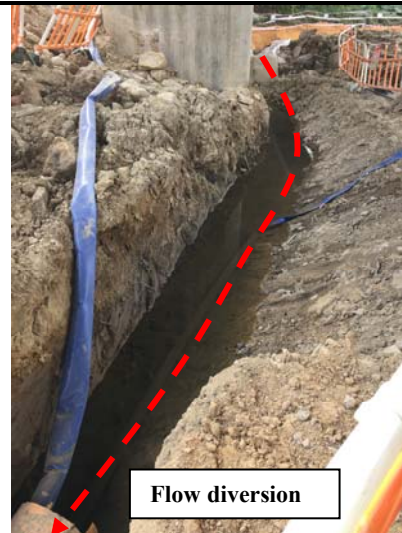
Photo 14

The condition of water in the flow division was in clear but Chun Wo was advised to provide protective measure on the exposed area to minimize muddy runoff in to the water flow.

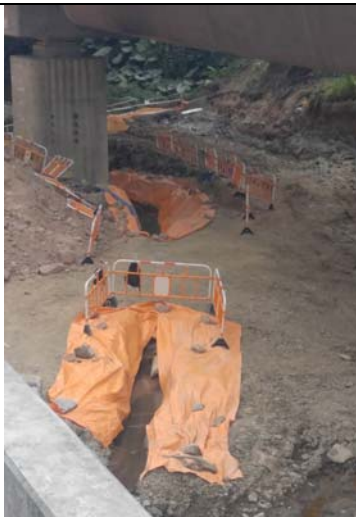
Photo 15

The expose surface of the flow division was covered with tarpaulin sheet to minimize muddy runoff.

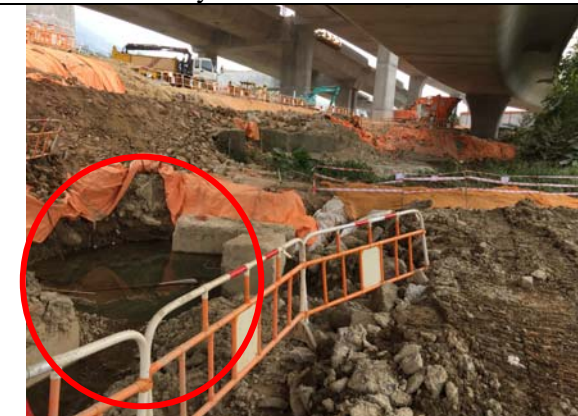
Photo 16

The condition of water in the catch pit was clear but Chun Wo was advised to further cover the exposed slope around to catch pit properly.

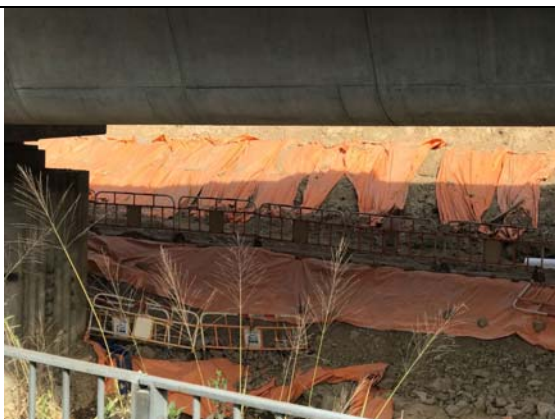
Photo 17

The expose slope around to the catch pit was covered with tarpaulin sheet to minimize muddy runoff.

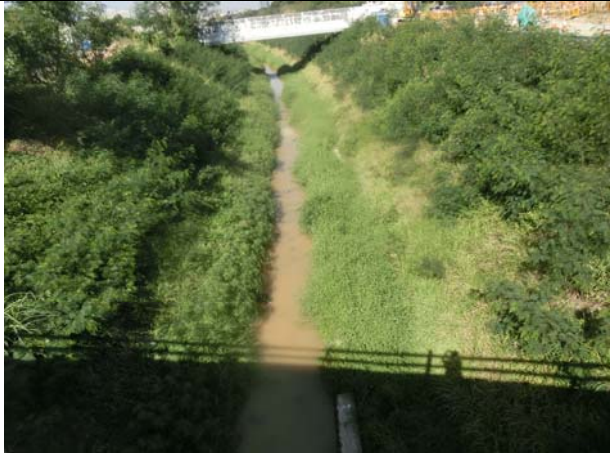
Photo 1

During water quality monitoring on 21 December 2017, turbid water was observed at WM4.

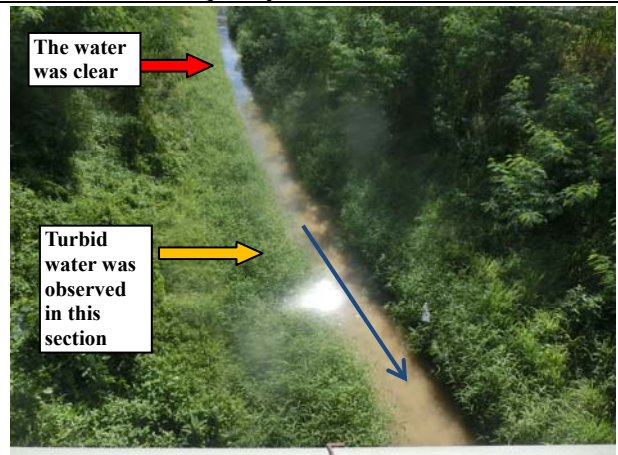
Photo 4

During water quality monitoring on 21 December 2017, inflow of turbid water to Ma Wat River was observed and the source of unknown turbid water was out of the site boundary.

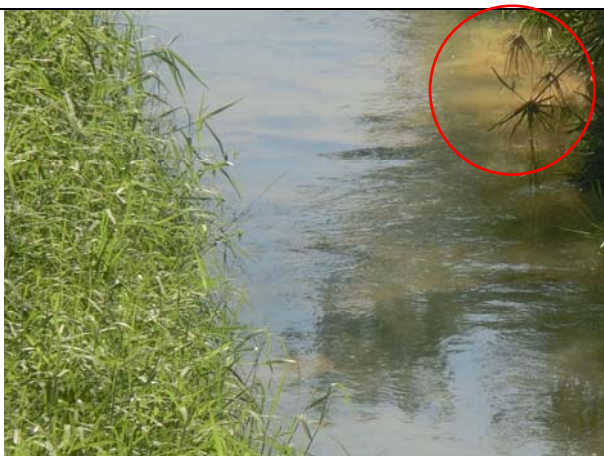
Photo 5

Inflow of turbid water to Ma Wat River was observed from the river edge and the source of unknown turbid water was out of the site boundary.

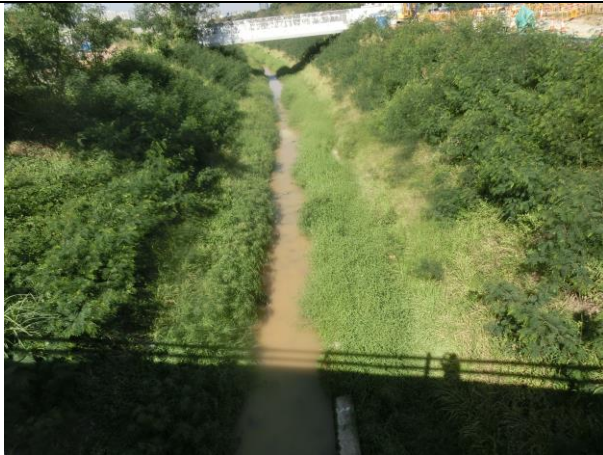
Photo 1

During water quality monitoring on 21 December 2017, turbid water was observed at WM4.

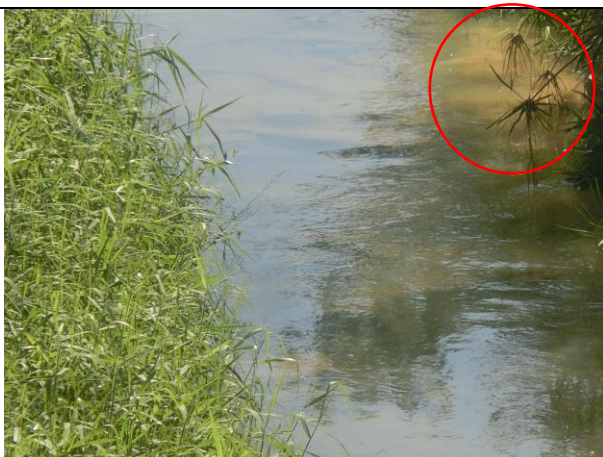
Photo 5

Inflow of turbid water to Ma Wat River was observed from the river edge and the source of unknown turbid water was out of the site boundary.

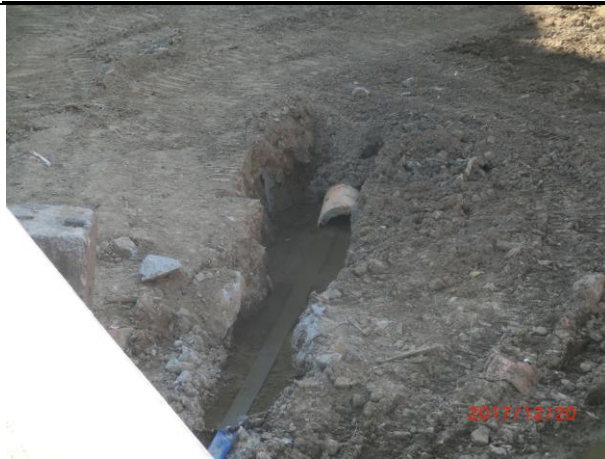
Photo 7

The diversion flow was observed in good condition without contaminated by the construction activities. However, Chun Wo was reminded to maintain the water diversion system and ensure the stream water shall be not contaminated by the works.

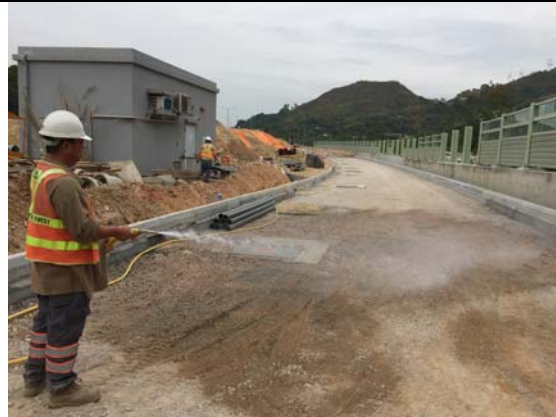
Photo 6

Water spraying on the site haul road was observed as dust suppression measures.
