**Agreement No. CE 59/2015 (EP)
Environmental Team for
Tseung Kwan O – Lam Tin Tunnel
Design and Construction**

**Quarterly Environmental
Monitoring and Audit Report –
May to July 2017**

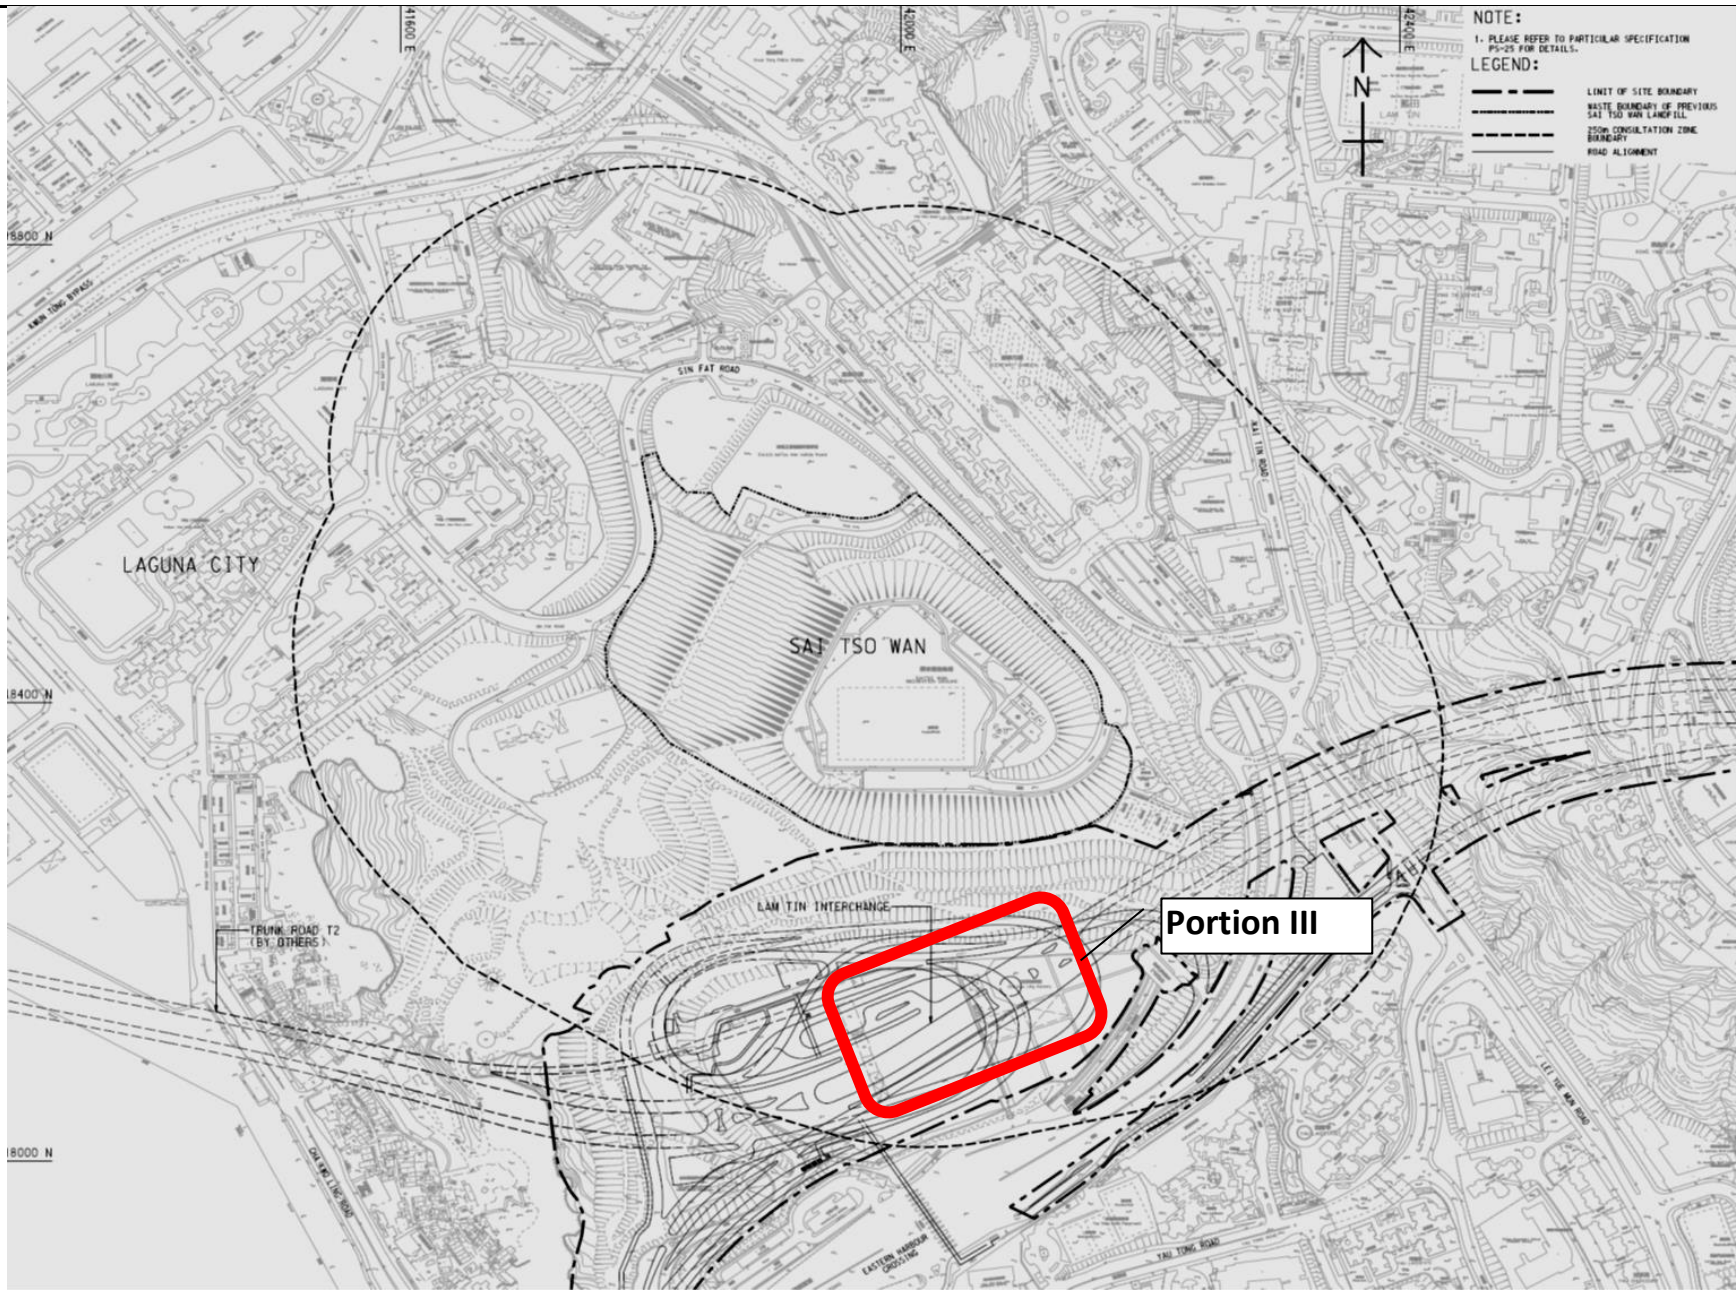
Title Agreement No. CE/59/2015 (EP)
 Environmental Team for Tseung Kwan O - Lam Tin Tunnel - Design and Construction
 Locations of Landfill Gas Monitoring

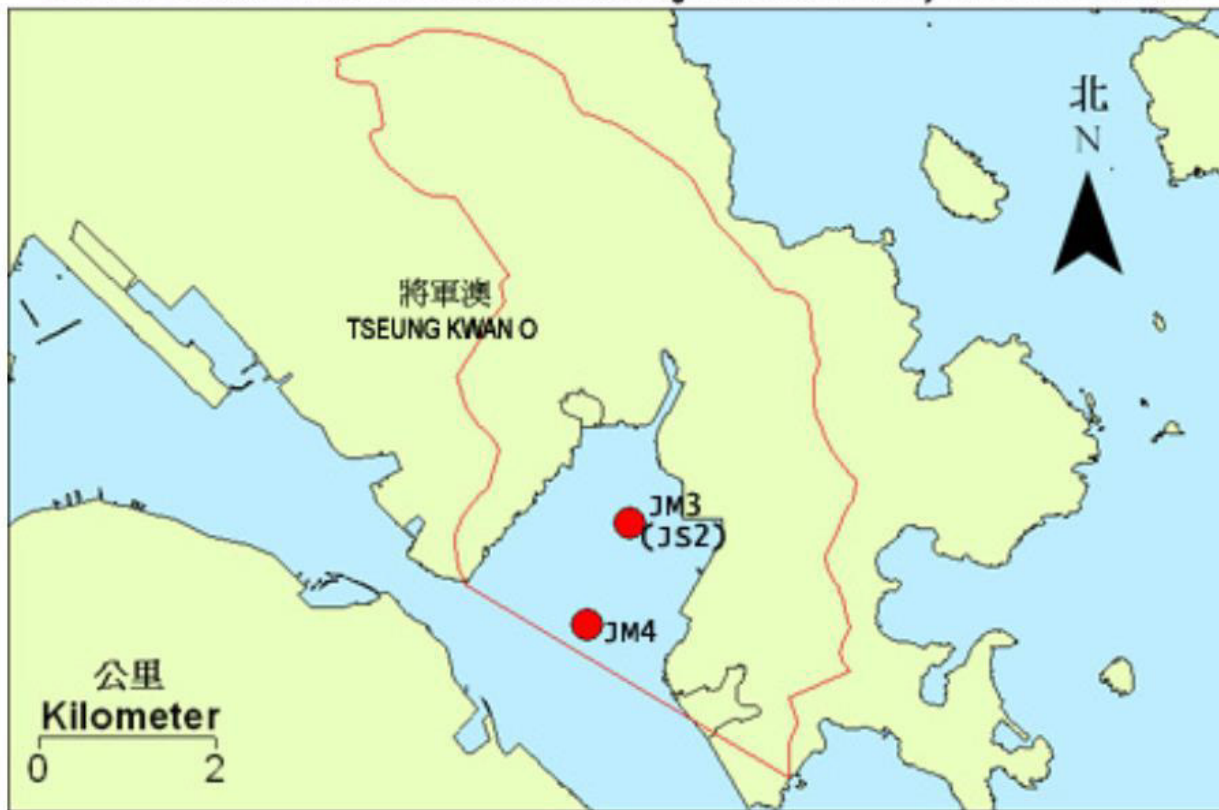
**Ranges of Dissolved Oxygen (mg/L) Monitoring Results under Marine Water Quality Monitoring Programme of EPD
(every July of 2011 – 2015)**

將軍澳水質管制區海水水質及沉積物監測站位置圖
Locations of marine water and sediment monitoring stations in Junk Bay Water Control Zone

Station	Surface and Middle	Middle	Bottom
JM3 (JS2)	4.7 – 8.5	4.1 – 8.3	2.7 – 6.4
JM4	5.4 – 7.5	2.9 – 6.7	2.7 – 5.1

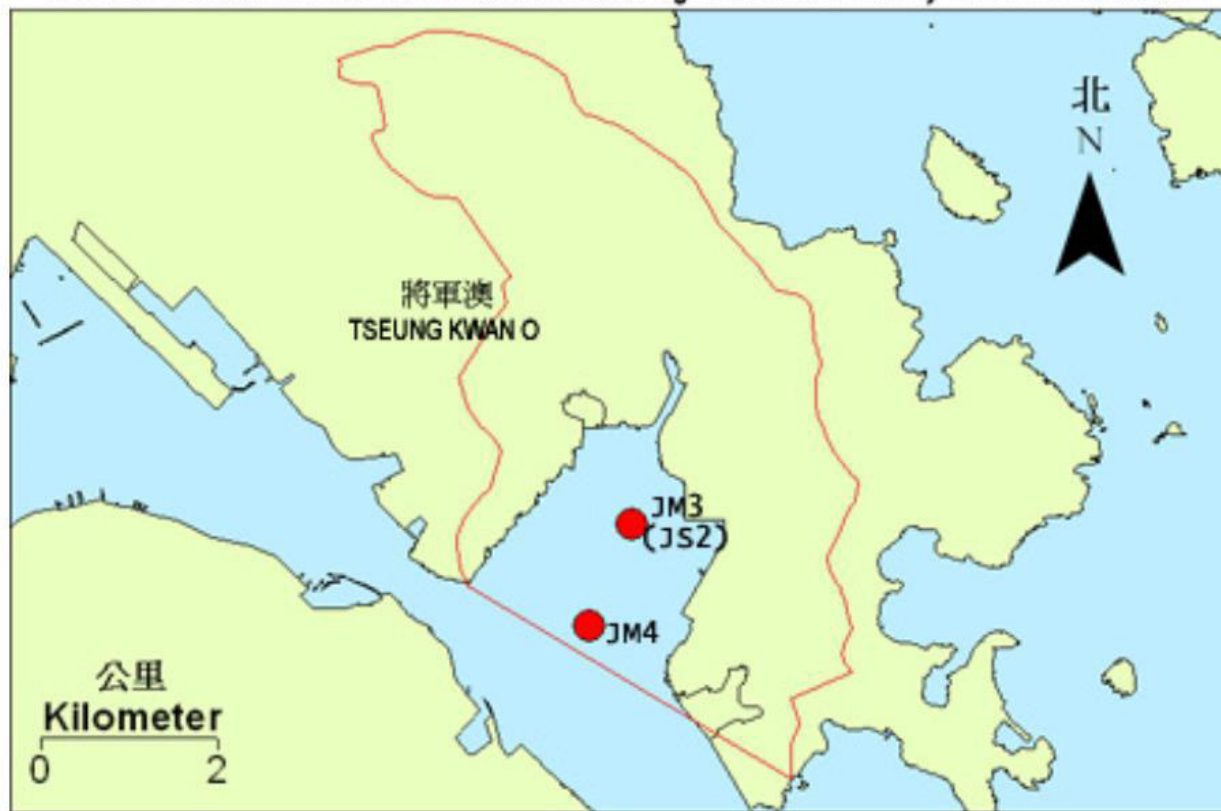
**Ranges of Dissolved Oxygen (mg/L) Monitoring Results under Marine Water Quality Monitoring Programme of EPD
(every July of 2011 – 2015)**

將軍澳水質管制區海水水質及沉積物監測站位置圖
Locations of marine water and sediment monitoring stations in Junk Bay Water Control Zone

Station	Surface and Middle	Middle	Bottom
JM3 (JS2)	4.7 – 8.5	4.1 – 8.3	2.7 – 6.4
JM4	5.4 – 7.5	2.9 – 6.7	2.7 – 5.1
