Civil Engineering and Development Department

**Agreement No. CE 59/2015 (EP)
Environmental Team for
Tseung Kwan O – Lam Tin Tunnel
Design and Construction**

**Monthly Environmental Monitoring and
Audit Report for October 2017**

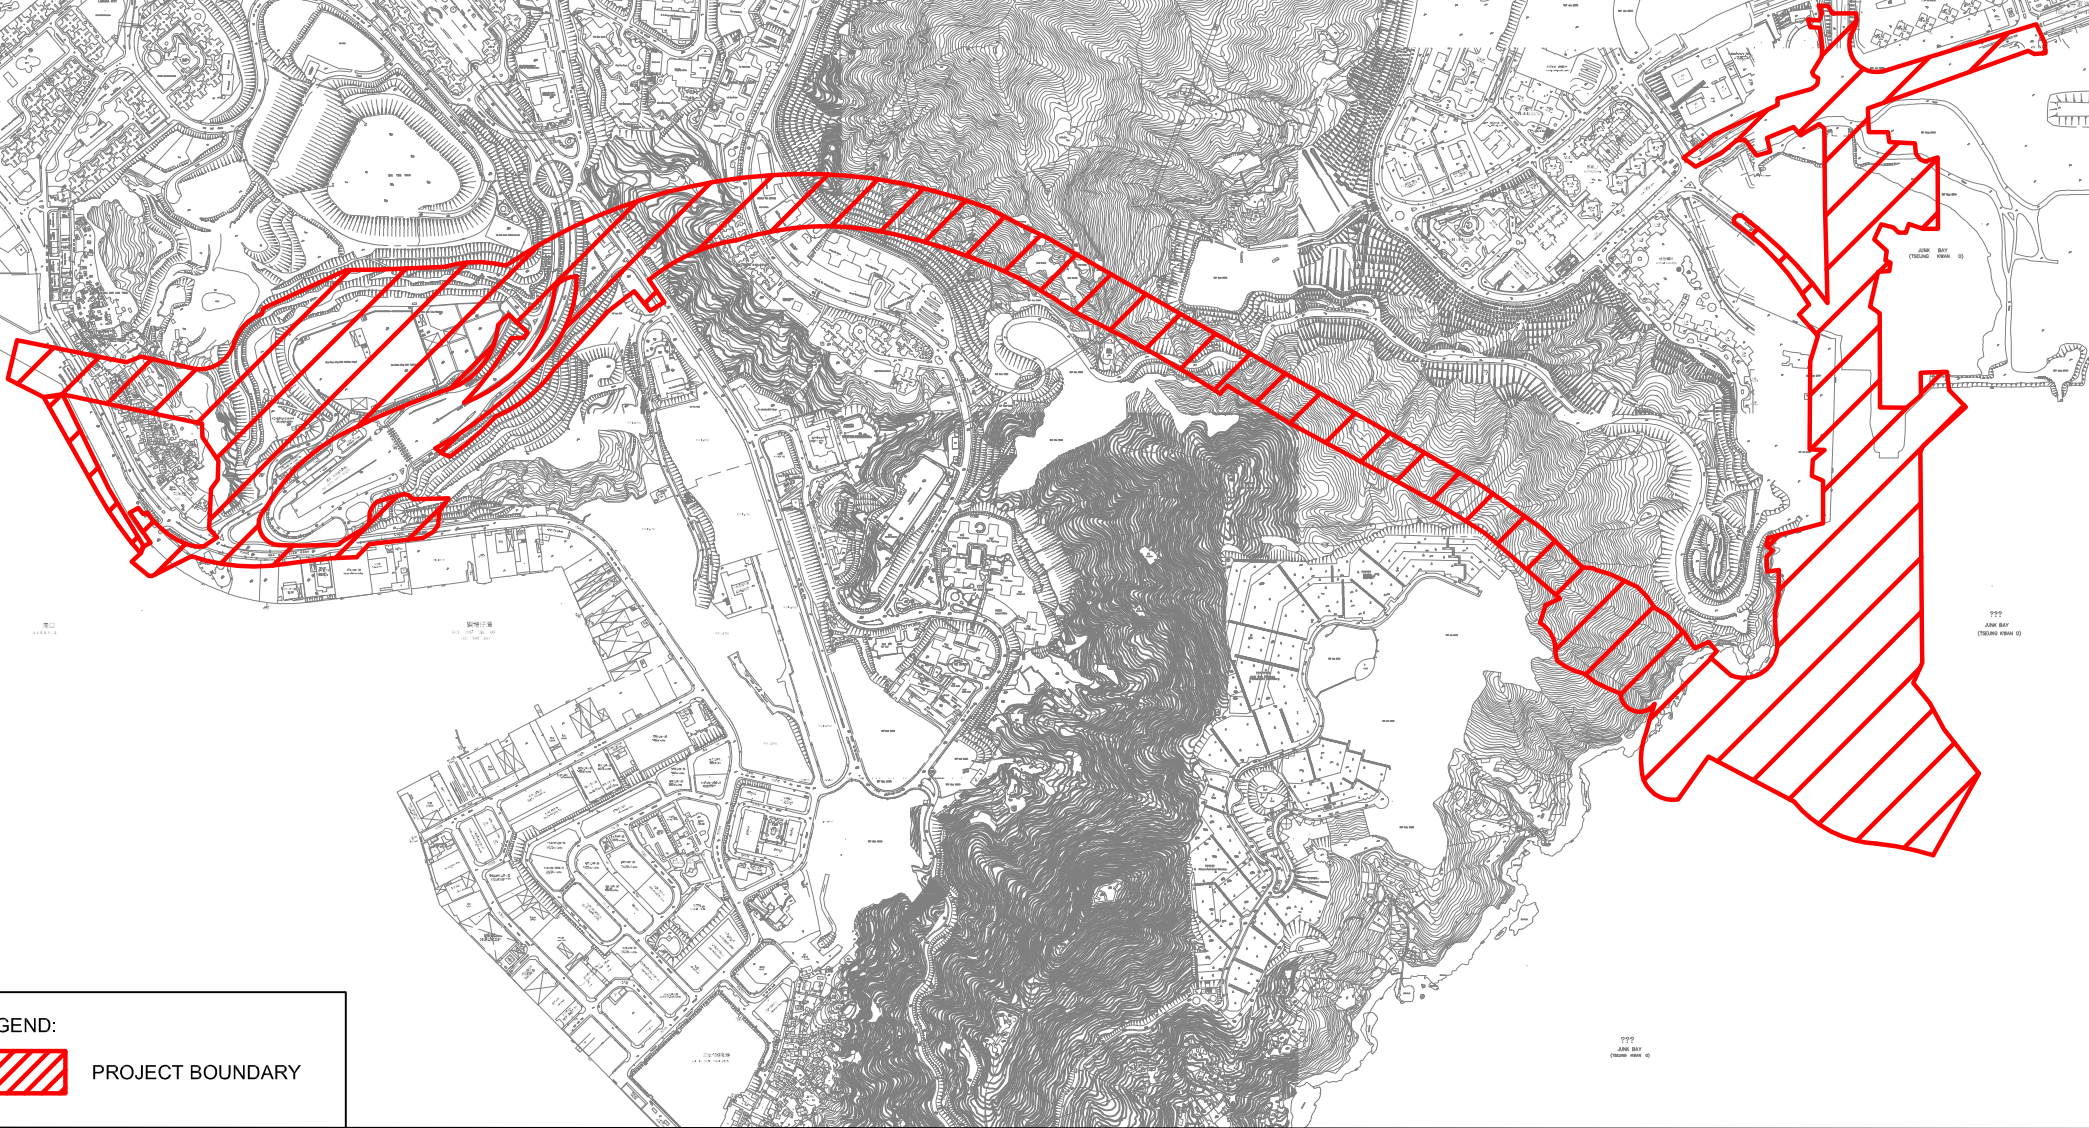
| JOB No. | MA16034 | FIGURE NO. | 1 | REV |

- 2.2 At present, the Tseung Kwan O Tunnel is the main connection between Tseung Kwan O (TKO) and other areas in the territory. To cope with the anticipated transport need, the TKO Study recommended the provision of Tseung Kwan O – Lam Tin Tunnel (TKO-LTT) (hereinafter referred to as “the Project”) and Cross Bay Link (CBL) to meet the long-term traffic demand between TKO and the external areas. The site layout plan for the Project is shown in **Figure 1**.

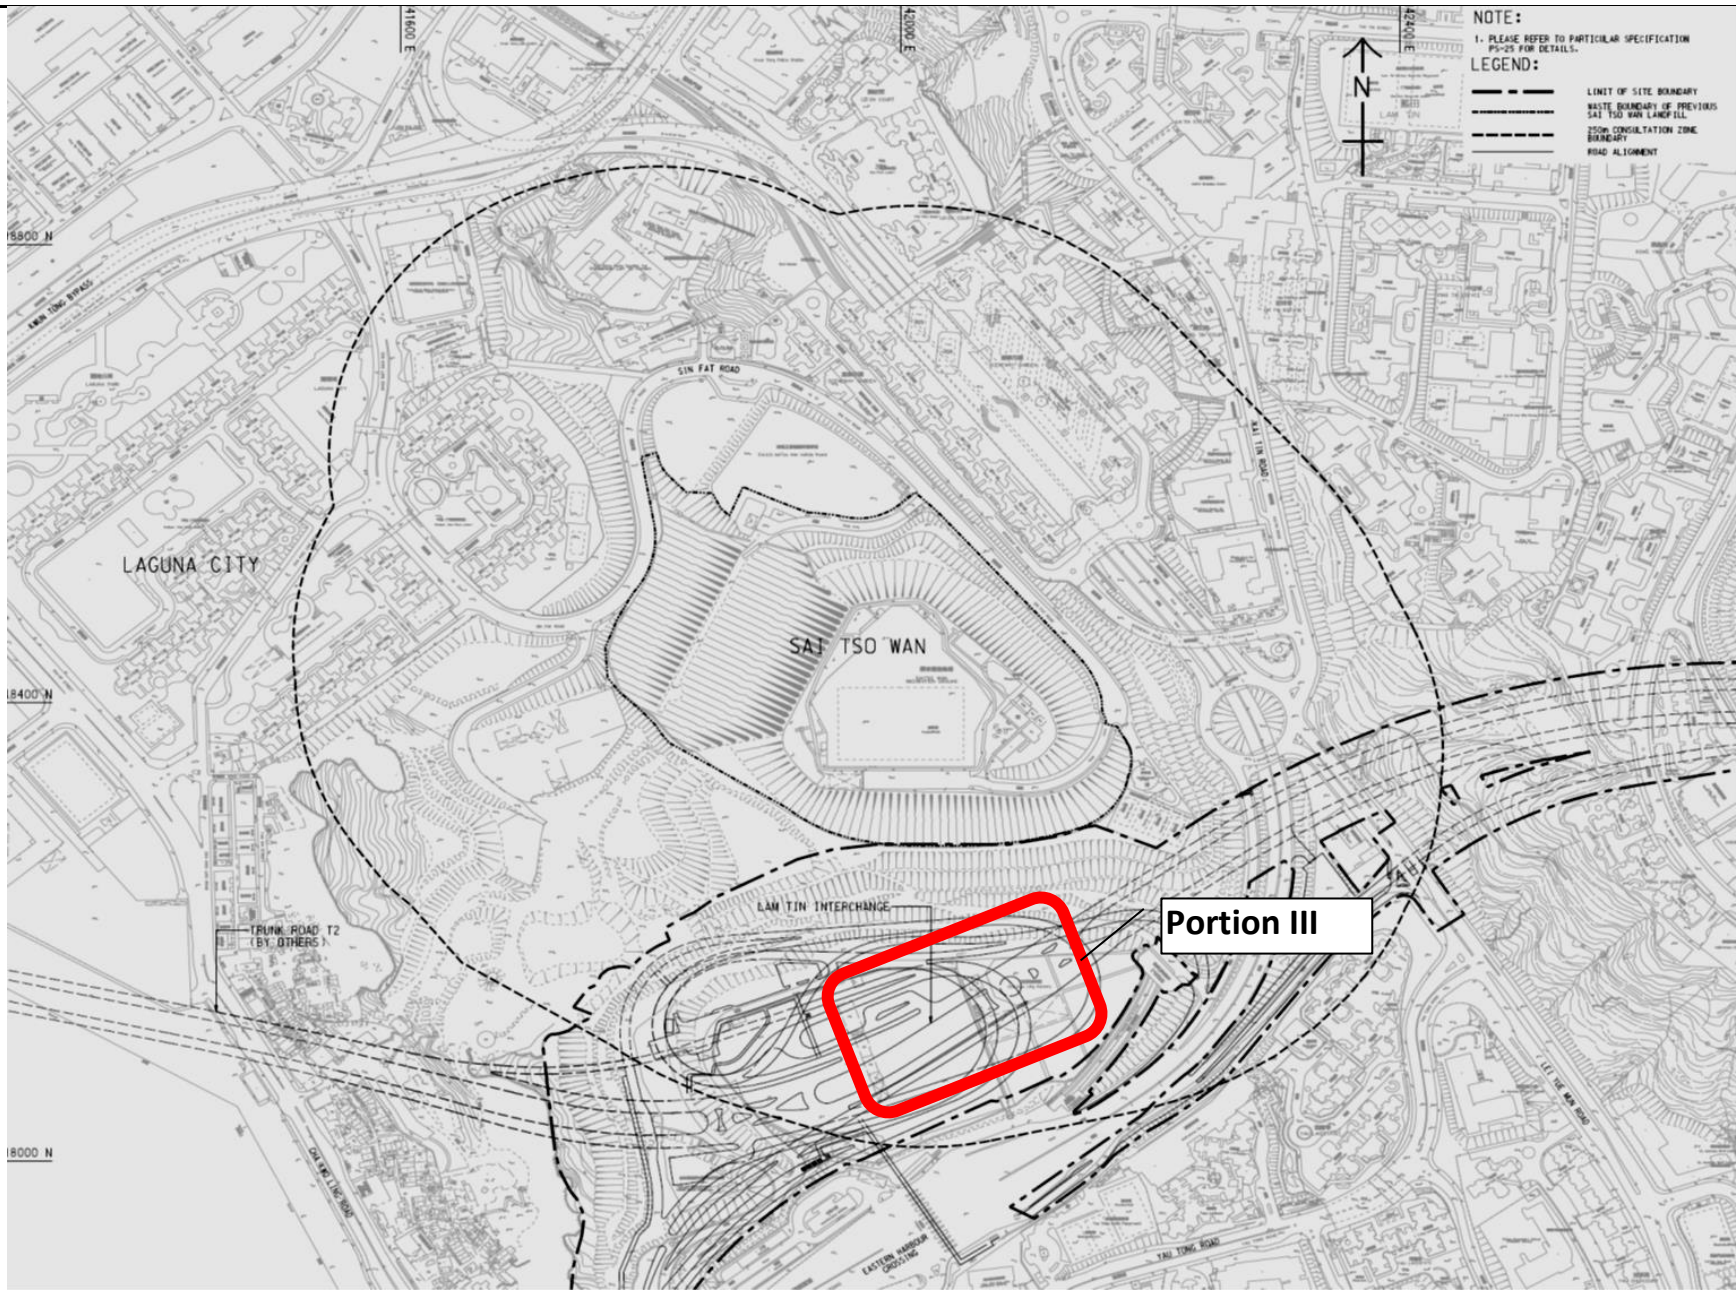
Project No. MA16034
 Figure 6

- 9.5 Monitoring of oxygen, methane and carbon dioxide was performed for excavations at 1m depth or more within the Consultation Zone. In this reporting month, the area required to be monitored for landfill gas are shown below and **Figure 6** shows the landfill gas monitoring locations.

Title Agreement No. CE/59/2015 (EP)
 Environmental Team for Tseung Kwan O - Lam Tin Tunnel - Design and Construction
 Locations of Landfill Gas Monitoring
