**Civil Engineering and Development Department**

**Agreement No. CE 59/2015 (EP)  
Environmental Team for  
Tseung Kwan O – Lam Tin Tunnel  
Design and Construction**

**Quarterly Environmental  
Monitoring and Audit Report –  
November 2017 – January 2018**

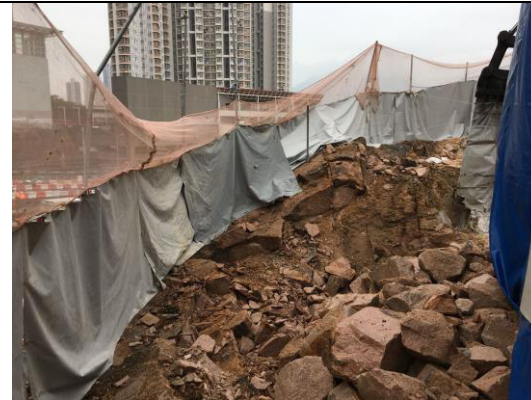
Photo 3  
Repaired noise barrier near Slope H

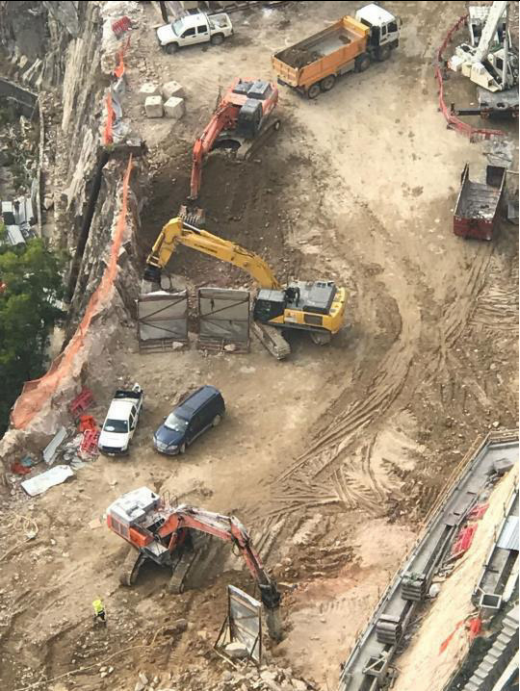
It was observed rock breaking and noisy works at Portion IVc was suspended during the noise monitoring. The major noise source from construction activities of this Project was rock breaking works at "Slope H" at site Portion IVb (Photo 1). Based on checking of site record of 23 Jan 2018 by the Contractor, TWO excavator-mounted breakers were in operation alternately for rock breaking at "Slope H" at site Portion IVb.

<p>A close-up aerial view of a steep rock face. Several excavators with breakers are working on the rock. There are orange safety barriers and some vehicles parked nearby. The ground is a mix of dirt and rock.</p>
<p>Photo 1 Overview of Portion IVc and Slope H (22 Jan 2018)</p>	<p>Photo 2 Rock breaking works at "Slope H" (23 Jan 2018)</p>

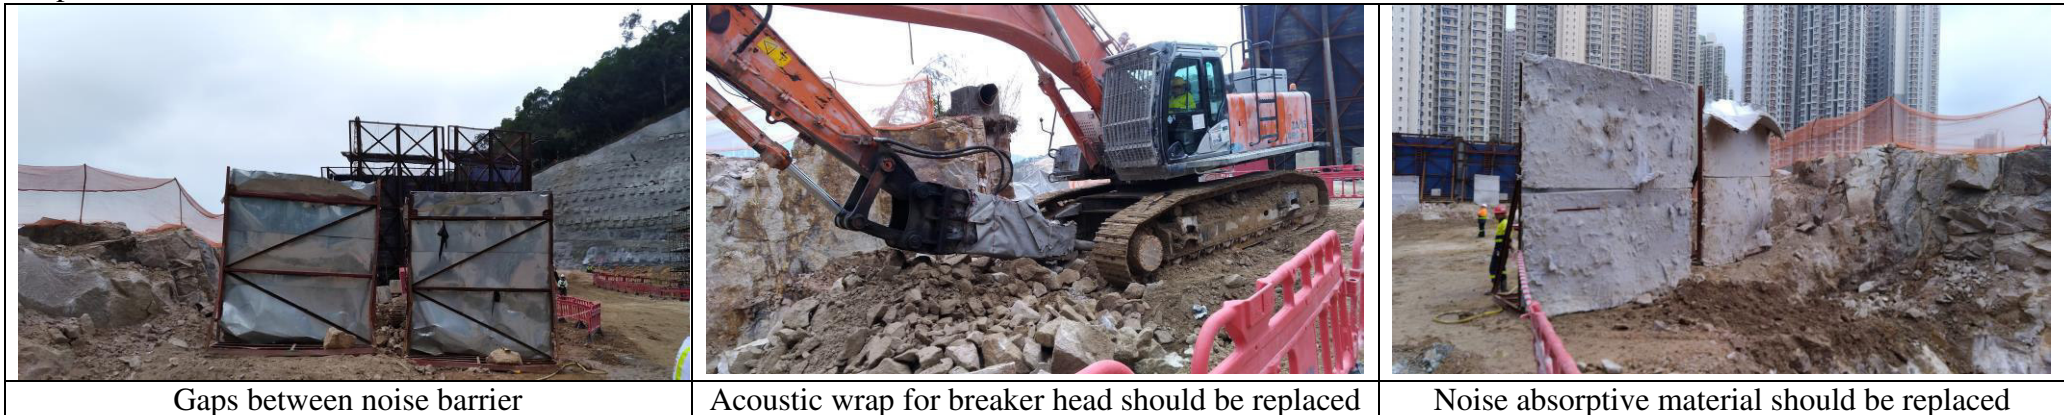
Upon being noticed of the noise exceedance, the Contractor has suspended rock breaking works. The followings observations are recorded during ET site inspection on 24 Jan 2018:

Refer to the above observations (Photo 1-4), the Contractor had implemented the following:

- Movable noise barrier was erected at Slope H and placed as close as to the excavator-mounted breaker;
- Gaps between noise barrier panels at Slope H are sealed and placed with extra noise absorptive material in between;
- Acoustic wrap for breaker at Slope H is repaired;
- At Portion IVc, cantilever portion of noise barriers are with replaced with acoustic mat.
