Civil Engineering and Development Department

**Agreement No. CE 59/2015 (EP)
Environmental Team for
Tseung Kwan O – Lam Tin Tunnel
Design and Construction**

**Monthly Environmental Monitoring and
Audit Report for January 2018**

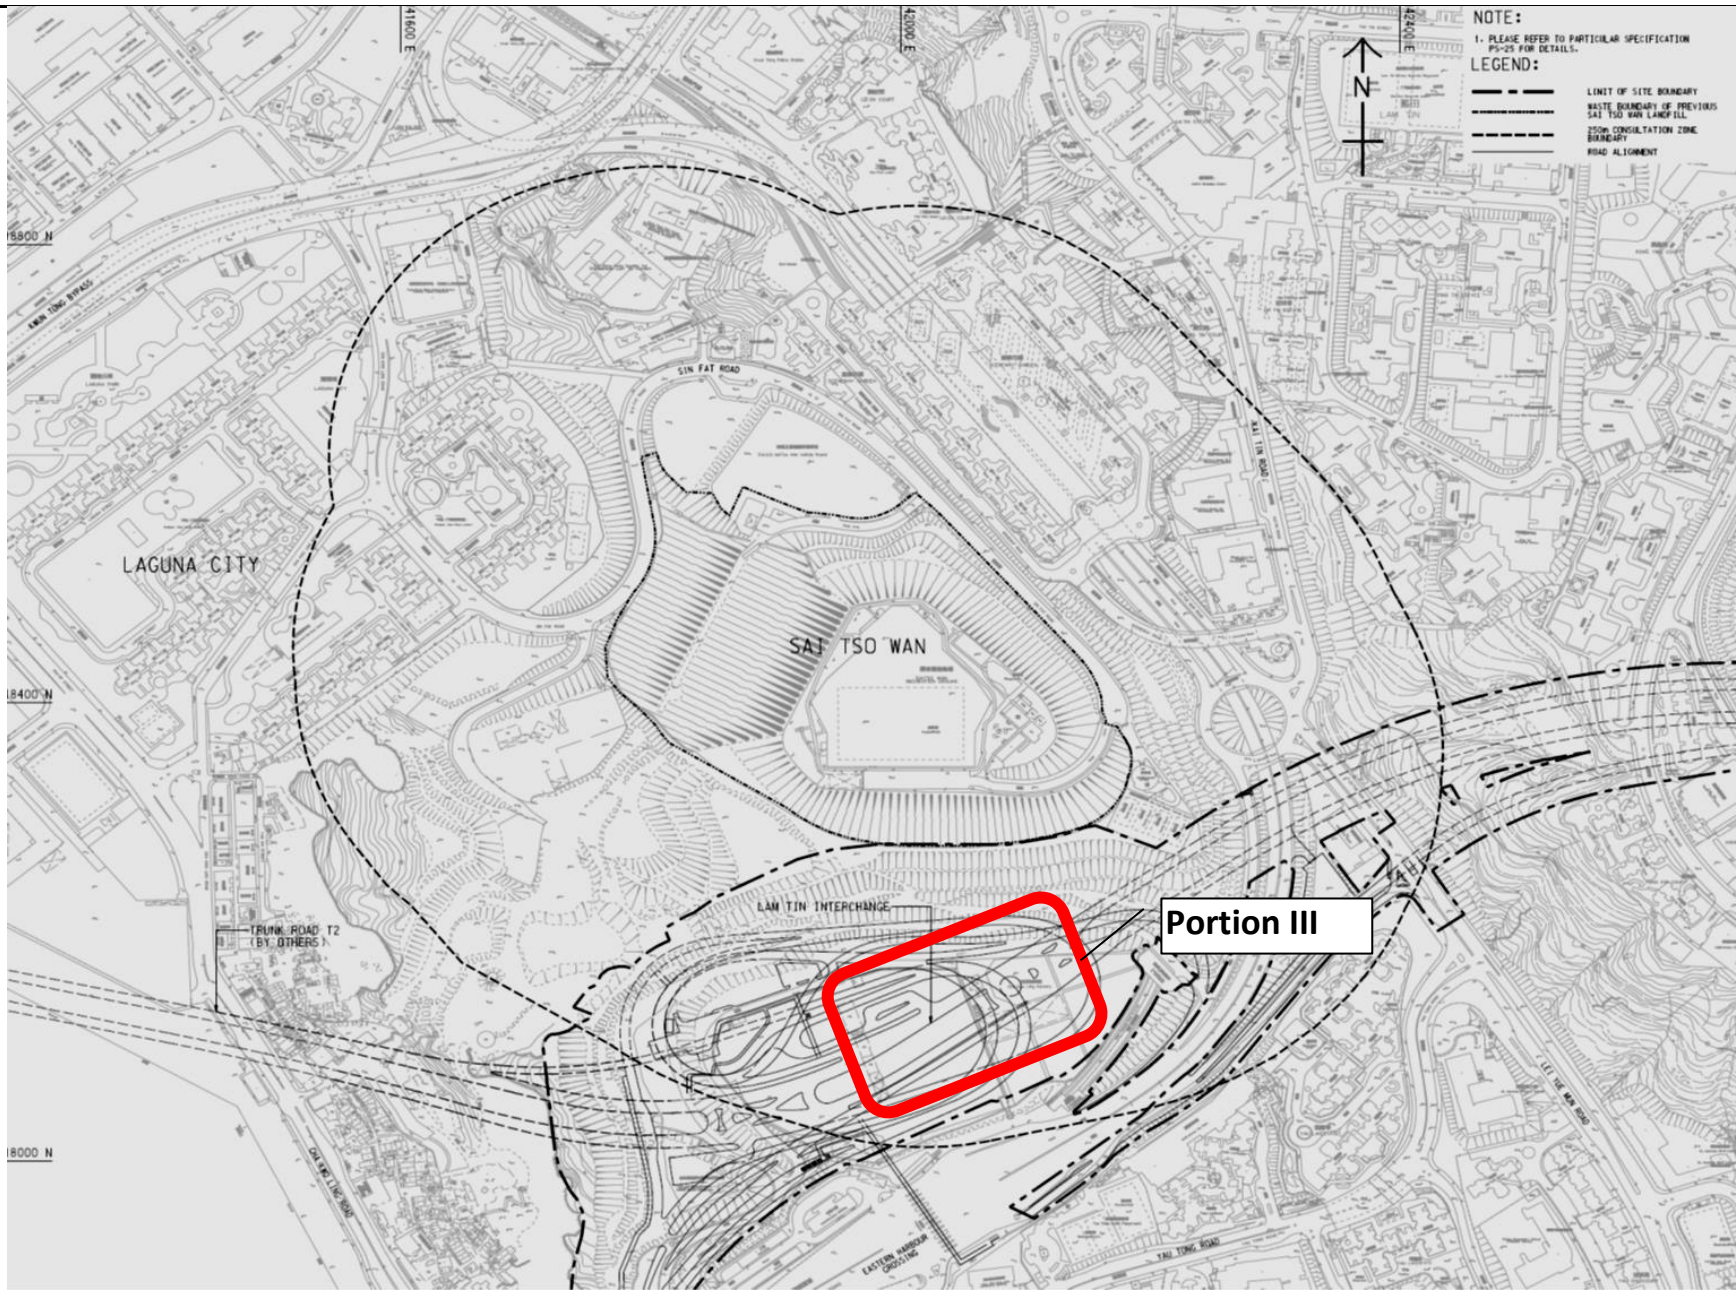
SCALE	N.T.S	DATE	AUG 2016	
CHECK	JF	DRAWN	JW	
PROJECT NO.	MA16034	FIGURE NO.	5	REV —

Locations of Water Quality Monitoring Stations

- 5.8 A total of twelve monitoring stations are designated for the water quality monitoring program according to EM&A Manual. One additional monitoring station (W1) is designated for monitoring of oxygen depletion in the embayed waters during the period when the fully enclosed barrier is installed. The locations are also summarized in **Table 5.2** and shown on **Figure 5** and **Figure 9**.

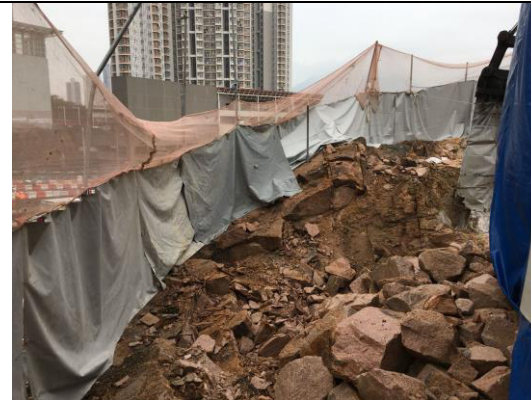
Photo 3
Repaired noise barrier near Slope H

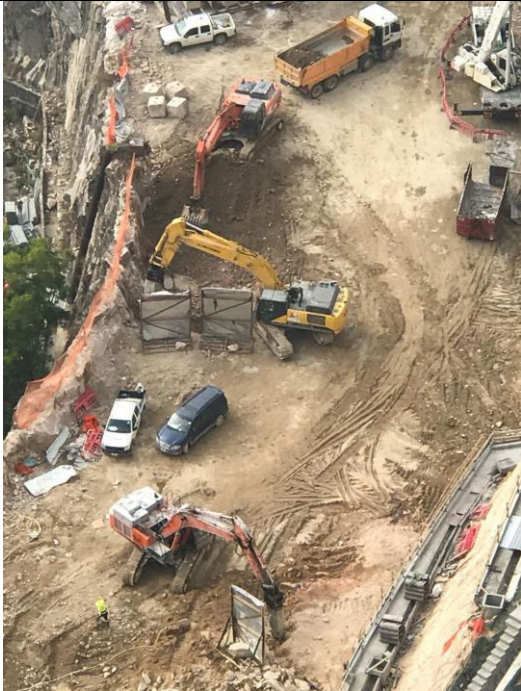
It was observed rock breaking and noisy works at Portion IVc was suspended during the noise monitoring. The major noise source from construction activities of this Project was rock breaking works at "Slope H" at site Portion IVb (Photo 1). Based on checking of site record of 23 Jan 2018 by the Contractor, TWO excavator-mounted breakers were in operation alternately for rock breaking at "Slope H" at site Portion IVb.

<p>A close-up aerial view of the construction site. Several excavators with breakers are working on a steep, rocky slope. There are several trucks and cars parked nearby. The ground is dirt and rock. The work area is marked with orange safety tape.</p>
<p>Photo 1 Overview of Portion IVc and Slope H (22 Jan 2018)</p>	<p>Photo 2 Rock breaking works at "Slope H" (23 Jan 2018)</p>

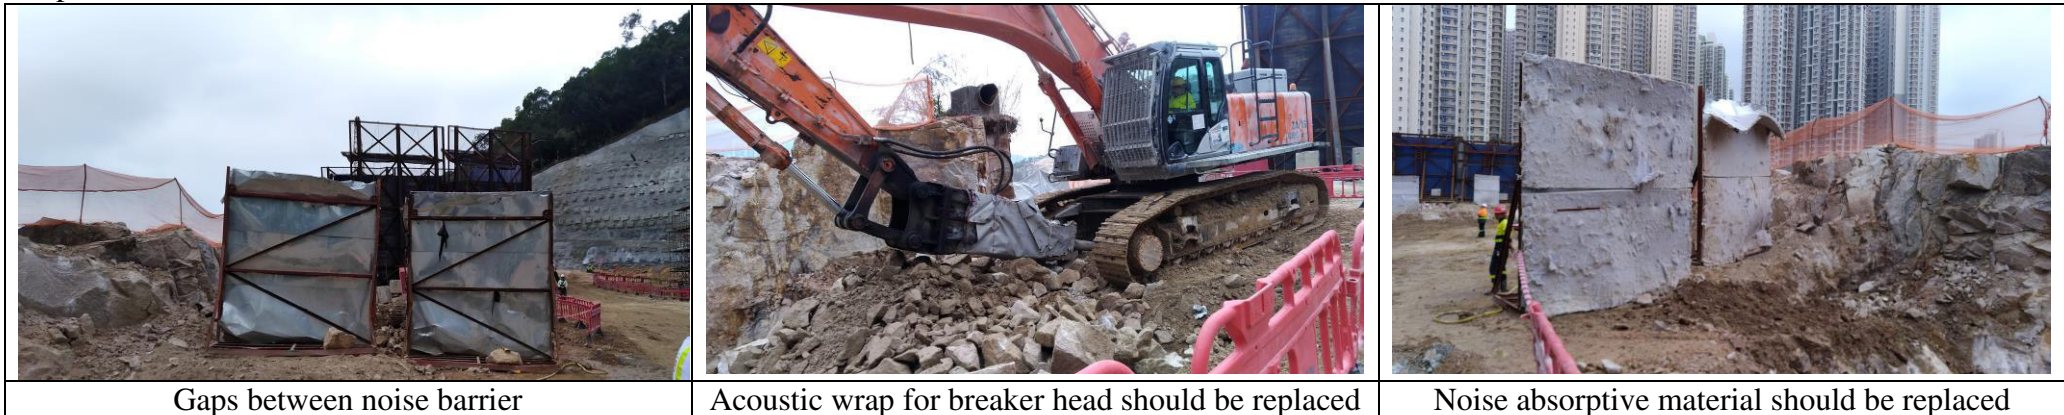
Upon being noticed of the noise exceedance, the Contractor has suspended rock breaking works. The followings observations are recorded during ET site inspection on 24 Jan 2018:

Refer to the above observations (Photo 1-4), the Contractor had implemented the following:

- Movable noise barrier was erected at Slope H and placed as close as to the excavator-mounted breaker;
- Gaps between noise barrier panels at Slope H are sealed and placed with extra noise absorptive material in between;
- Acoustic wrap for breaker at Slope H is repaired;
- At Portion IVc, cantilever portion of noise barriers are with replaced with acoustic mat.
