**Agreement No. CE 59/2015 (EP)  
Environmental Team for  
Tseung Kwan O – Lam Tin Tunnel  
Design and Construction**

**Monthly Environmental Monitoring and  
Audit Report for February 2018  
(version 2.0)**

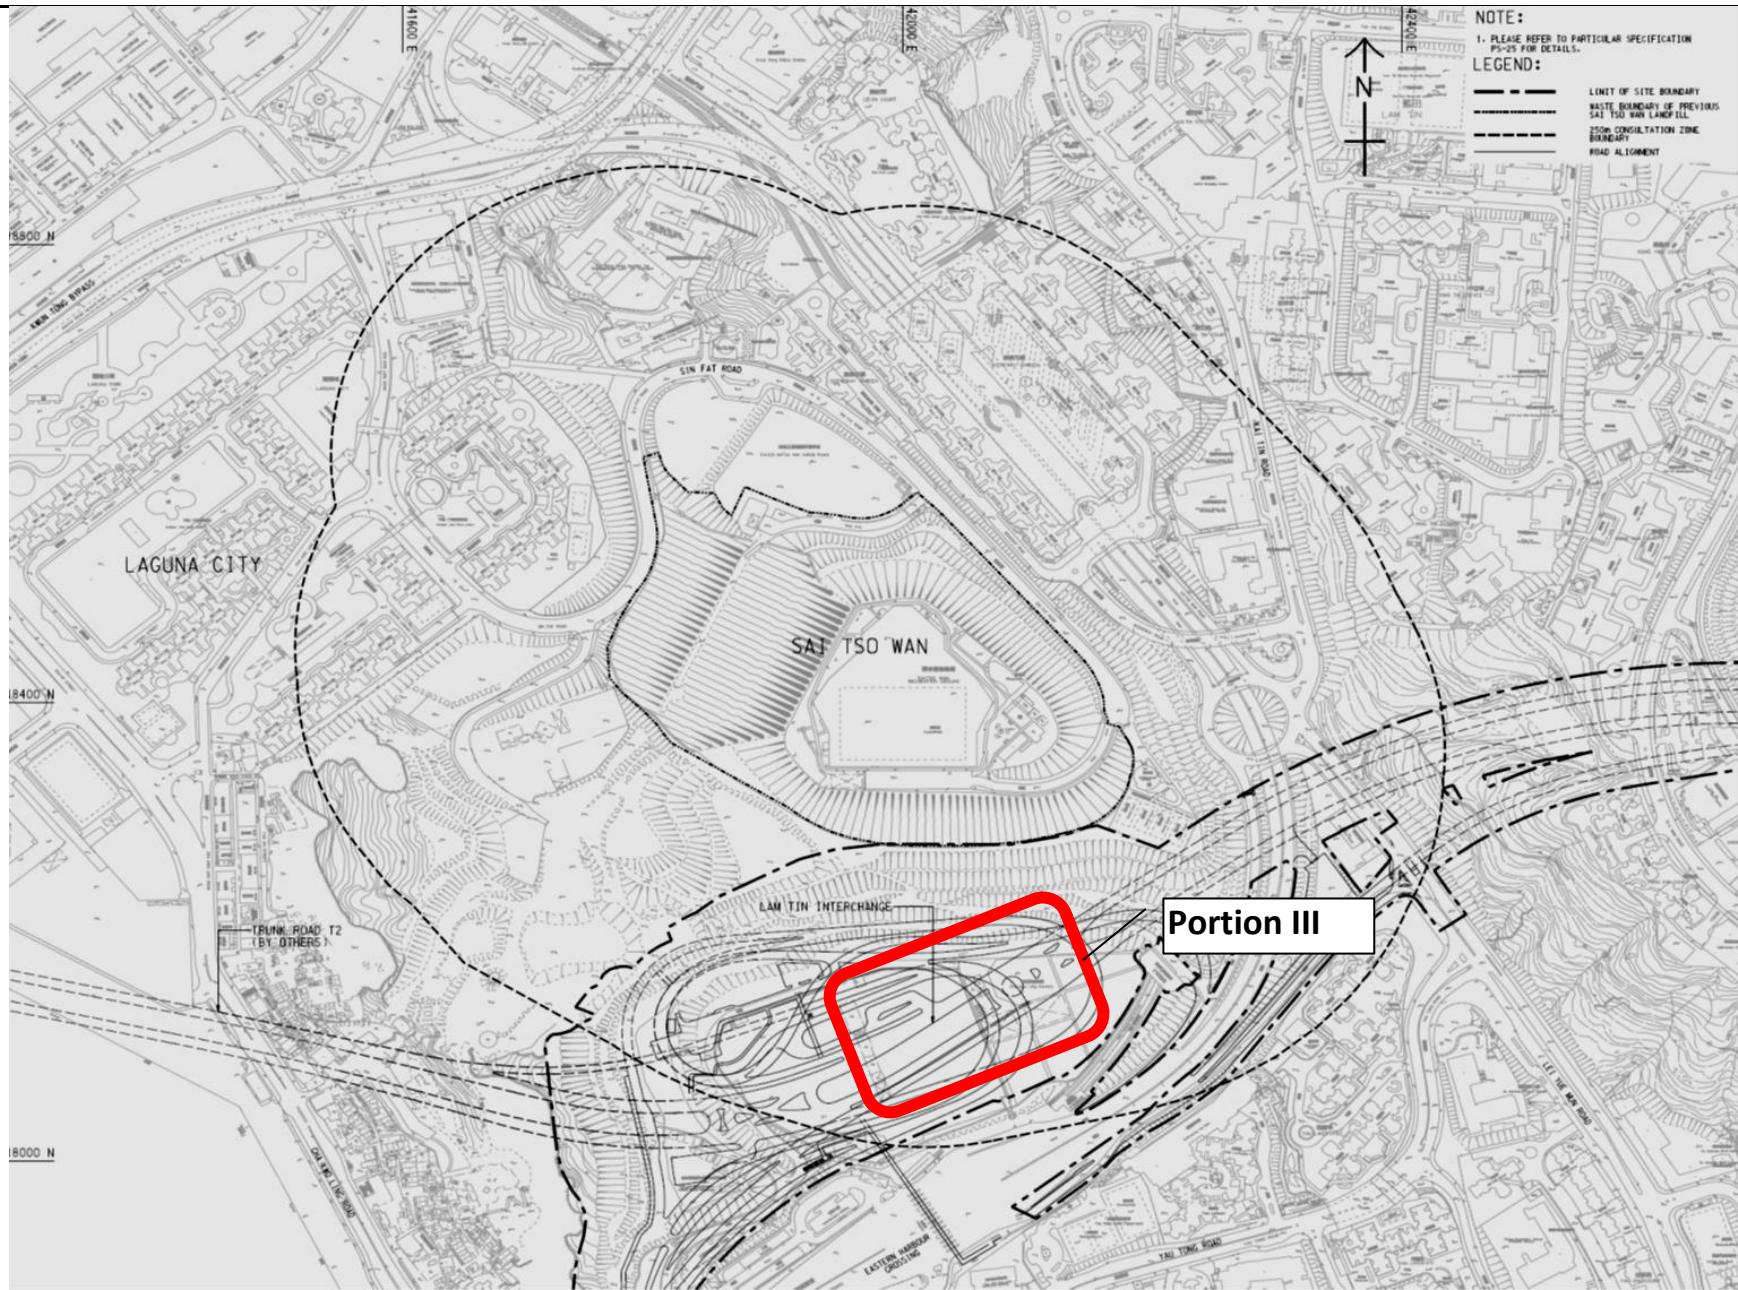
SCALE	N.T.S	DATE	AUG 2016	
CHECK	JF	DRAWN	JW	
PROJECT NO.	MA16034	FIGURE NO.	5	REV —

Title Agreement No. CE/59/2015 (EP)  
 Environmental Team for Tseung Kwan O - Lam Tin Tunnel - Design and Construction  
 Locations of Landfill Gas Monitoring
