# Civil Engineering and Development Department

**Agreement No. CE 59/2015 (EP)  
Environmental Team for  
Tseung Kwan O – Lam Tin Tunnel  
Design and Construction**

**Quarterly Environmental  
Monitoring and Audit Report –  
May 2018 – July 2018**

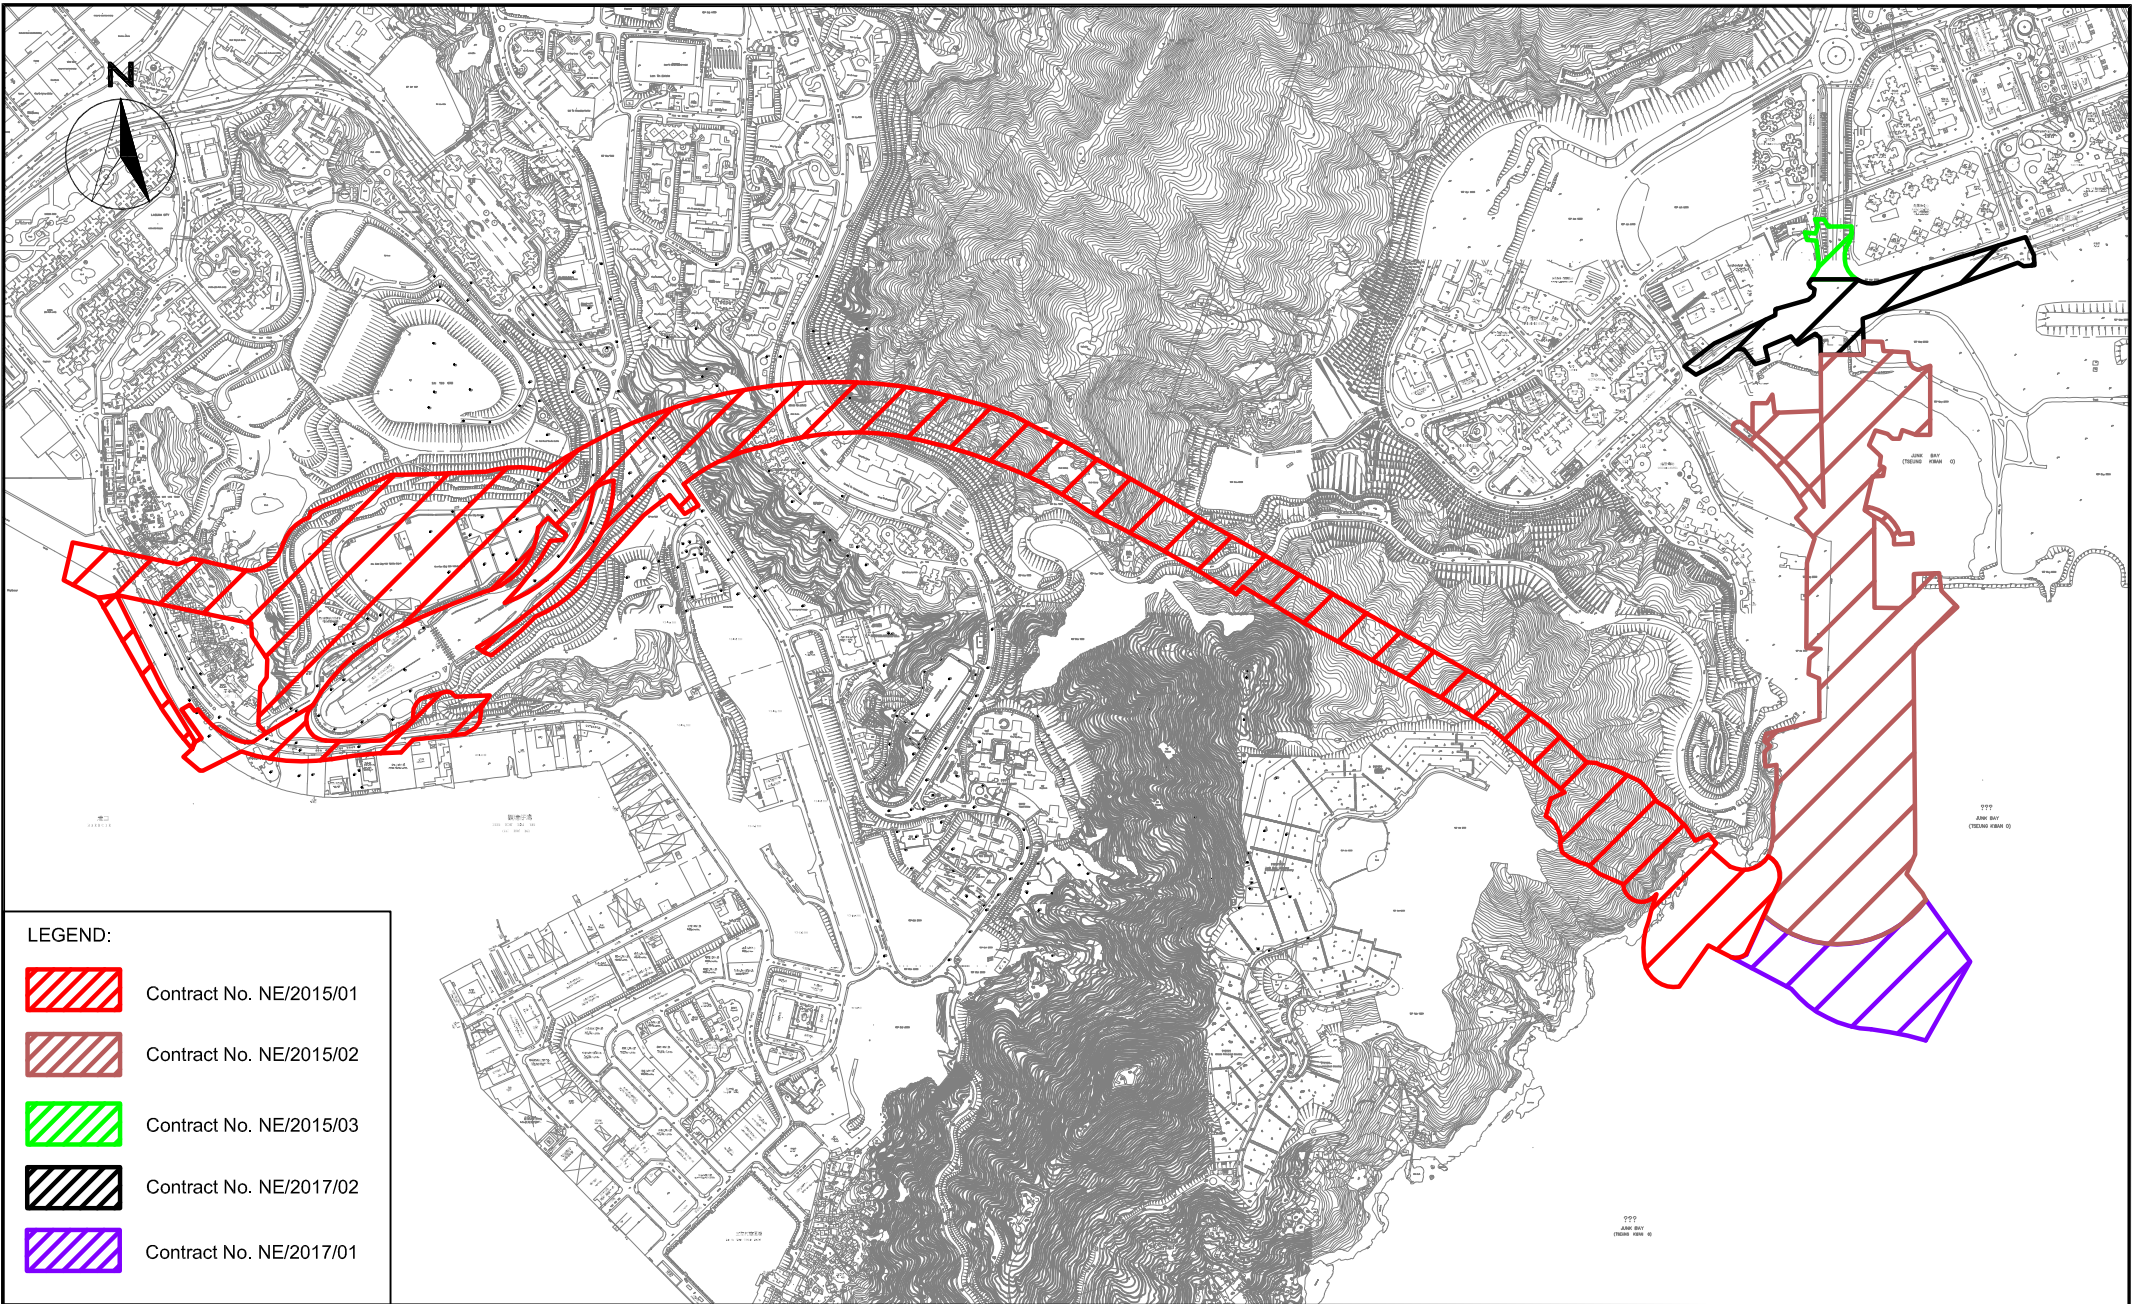
SCALE	1:15000 @ A4	DATE	APR 2018	
CHECK	JF	DRAWN	AC	
JOB No.	MA16034	FIGURE NO.	1	REV -

- 1.2 At present, the Tseung Kwan O Tunnel is the main connection between Tseung Kwan O (TKO) and other areas in the territory. To cope with the anticipated transport need, the TKO Study recommended the provision of Tseung Kwan O – Lam Tin Tunnel (TKO-LTT) (hereinafter referred to as “the Project”) and Cross Bay Link (CBL) to meet the long-term traffic demand between TKO and the external areas. The site layout plan for the Project is shown in **Figure 1**.

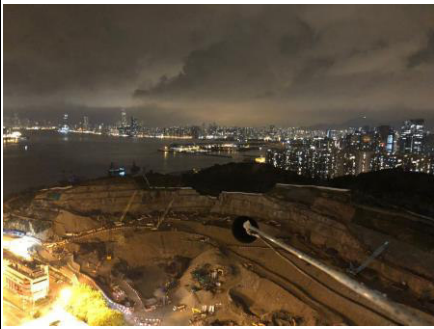
<p>(a) Statement of exceedance(s) Construction noise measured at CM1, CM2 &amp; CM3 exceeded the construction noise (night time) limit level.</p>

<p>(b) Cause of exceedance(s) The exceedance was not considered related to the Project works:</p> <ul style="list-style-type: none"> <li>• According to our field observation, road traffic noise were identified as the dominant noise source. No noticeable noise from blasting / associated works was identified.</li> <li>• No major construction activity was observed in Lam Tin Interchange during monitoring (see photo).</li> <li>• As confirmed by RE, only construction works inside the tunnel were being conducted with the blast door closed.</li> </ul>

**Part C – Recommendation:** No further action is required.

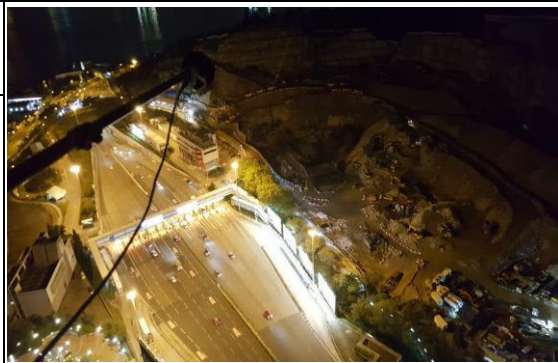
<p>(a) Statement of exceedance(s) Construction noise measured at CM1, CM2 &amp; CM3 exceeded the construction noise (night time) limit level.</p>

<p>(b) Cause of exceedance(s) The exceedance was not considered related to the Project works:</p> <ul style="list-style-type: none"> <li>• According to our field observation, road traffic noise were identified as the dominant noise source. No noticeable noise from blasting / associated works was identified.</li> <li>• No major construction activity was observed in Lam Tin Interchange during monitoring (see photo).</li> <li>• As confirmed by RE, only construction works inside the tunnel were being conducted with the blast door closed.</li> </ul>

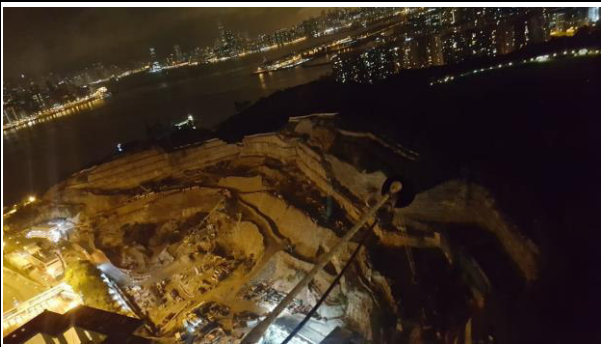
<p>(a) Statement of exceedance(s) Construction noise measured at CM1, CM2 &amp; CM3 exceeded the construction noise (night time) limit level.</p>

<p>(b) Cause of exceedance(s) The exceedance was not considered related to the Project works:</p> <ul style="list-style-type: none"> <li>• According to our field observation, road traffic noise were identified as the dominant noise source. No noticeable noise from blasting / associated works was identified.</li> <li>• No major construction activity was observed in Lam Tin Interchange during monitoring (see photo).</li> <li>• As confirmed by RE, only construction works inside the tunnel were being conducted with the blast door closed.</li> </ul>

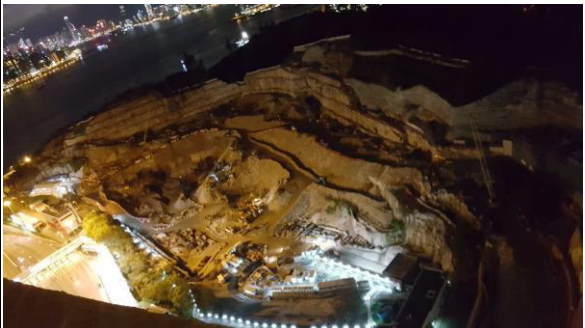
<p>(a) Statement of exceedance(s) Construction noise measured at CM1, CM2 &amp; CM3 exceeded the construction noise (night time) limit level.</p>

<p>(b) Cause of exceedance(s) The exceedance was not considered related to the Project works:</p> <ul style="list-style-type: none"> <li>• According to our field observation, road traffic noise were identified as the dominant noise source. No noticeable noise from blasting / associated works was identified.</li> <li>• No major construction activity was observed in Lam Tin Interchange during monitoring (see photo).</li> <li>• As confirmed by RE, only construction works inside the tunnel were being conducted with the blast door closed.</li> </ul>

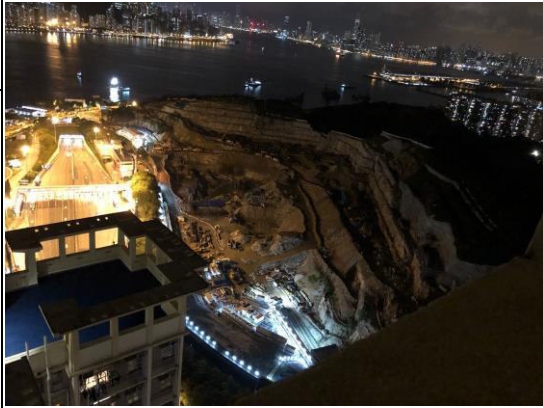
<p>(a) Statement of exceedance(s) Construction noise measured at CM1, CM2 &amp; CM3 exceeded the construction noise (night time) limit level.</p>

<p>(b) Cause of exceedance(s) The exceedance was not considered related to the Project works:</p> <ul style="list-style-type: none"> <li>• According to our field observation, road traffic noise were identified as the dominant noise source. No noticeable noise from blasting / associated works was identified.</li> <li>• No major construction activity was observed in Lam Tin Interchange during monitoring (see photo).</li> <li>• As confirmed by RE, only construction works inside the tunnel were being conducted with the blast door closed.</li> </ul>

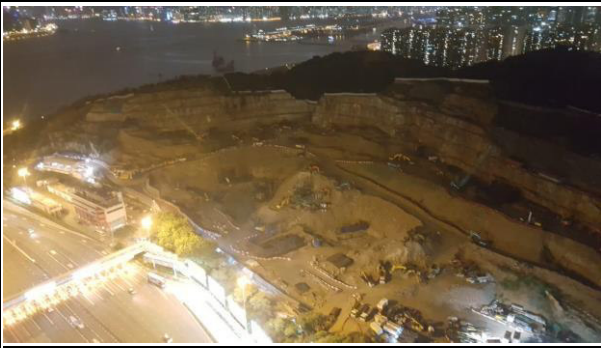
<p>(a) Statement of exceedance(s) Construction noise measured at CM1, CM2 &amp; CM3 exceeded the construction noise (night time) limit level.</p>

<p>(b) Cause of exceedance(s) The exceedance was not considered related to the Project works:</p> <ul style="list-style-type: none"> <li>• According to our field observation, road traffic noise were identified as the dominant noise source. No noticeable noise from blasting / associated works was identified.</li> <li>• No major construction activity was observed in Lam Tin Interchange during monitoring (see photo).</li> </ul>

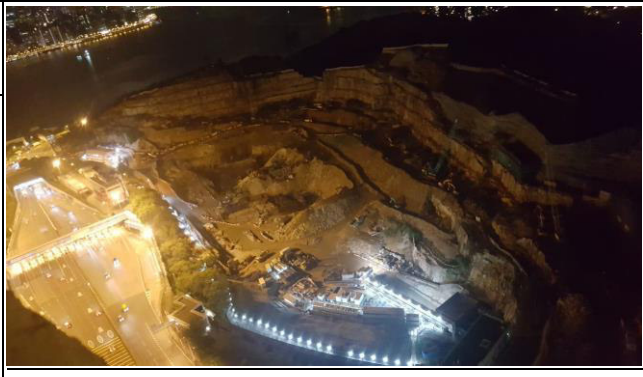
<p>(a) Statement of exceedance(s) Construction noise measured at CM1, CM2 &amp; CM3 exceeded the construction noise (night time) limit level.</p>

<p>(b) Cause of exceedance(s) The exceedance was not considered related to the Project works:</p> <ul style="list-style-type: none"> <li>• According to our field observation, road traffic noise were identified as the dominant noise source. No noticeable noise from blasting / associated works was identified.</li> <li>• No major construction activity was observed in Lam Tin Interchange during monitoring (see photo).</li> </ul>
