**Agreement No. CE 59/2015 (EP)
Environmental Team for
Tseung Kwan O – Lam Tin Tunnel
Design and Construction**

**Quarterly Environmental
Monitoring and Audit Report –
August 2018 – October 2018**

(version 1.0)

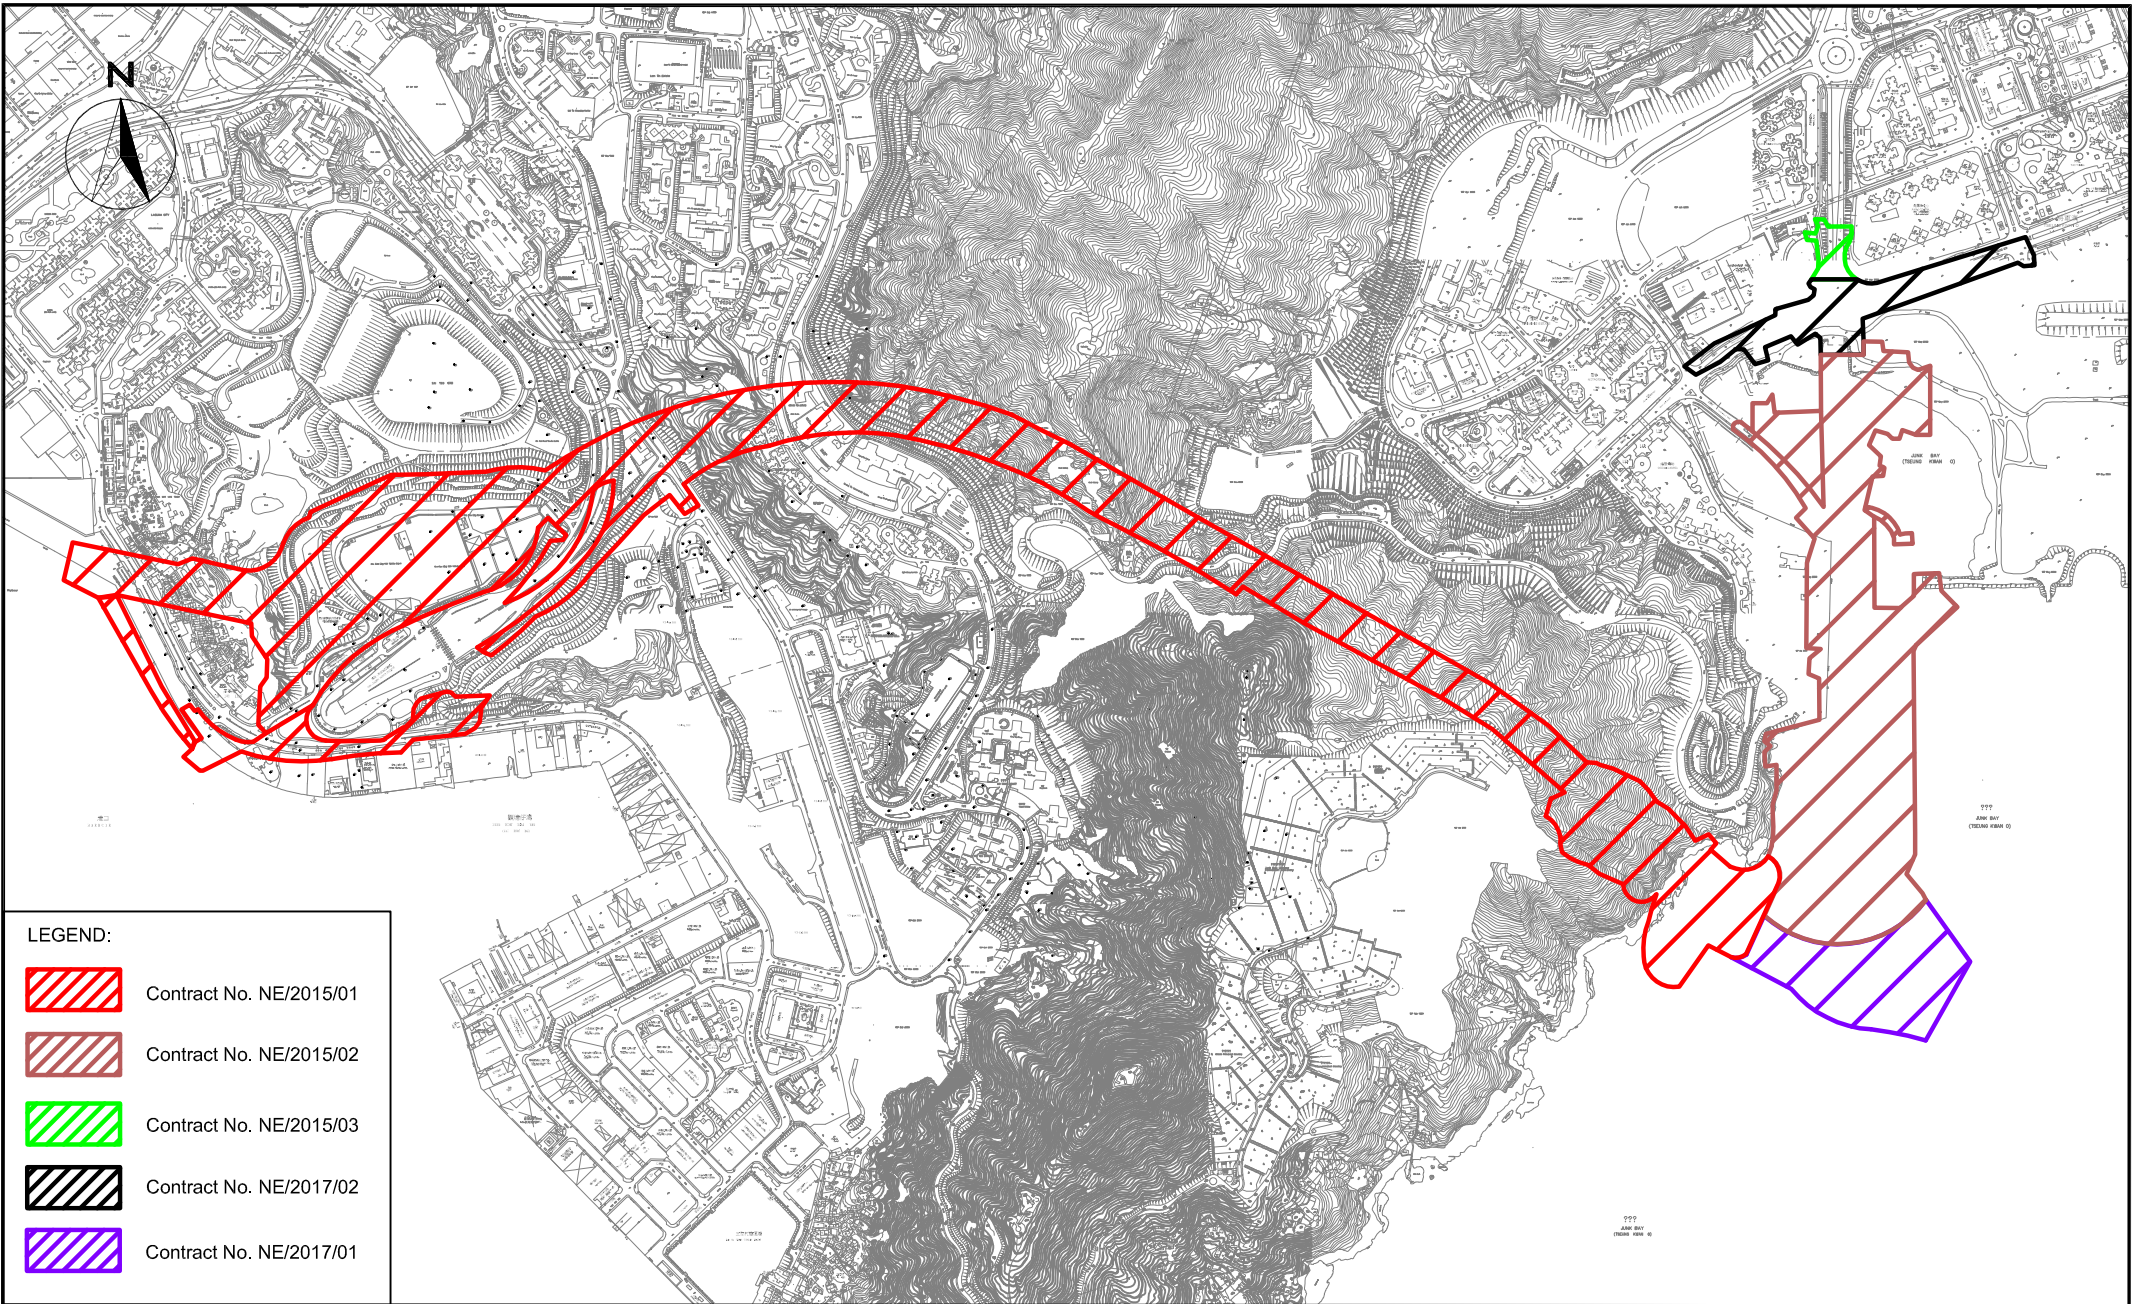
SCALE	1:15000 @ A4	DATE	APR 2018
CHECK	JF	DRAWN	AC
JOB No.	MA16034	FIGURE NO.	1
		REV	-

- 1.2 At present, the Tseung Kwan O Tunnel is the main connection between Tseung Kwan O (TKO) and other areas in the territory. To cope with the anticipated transport need, the TKO Study recommended the provision of Tseung Kwan O – Lam Tin Tunnel (TKO-LTT) (hereinafter referred to as “the Project”) and Cross Bay Link (CBL) to meet the long-term traffic demand between TKO and the external areas. The site layout plan for the Project is shown in **Figure 1**.

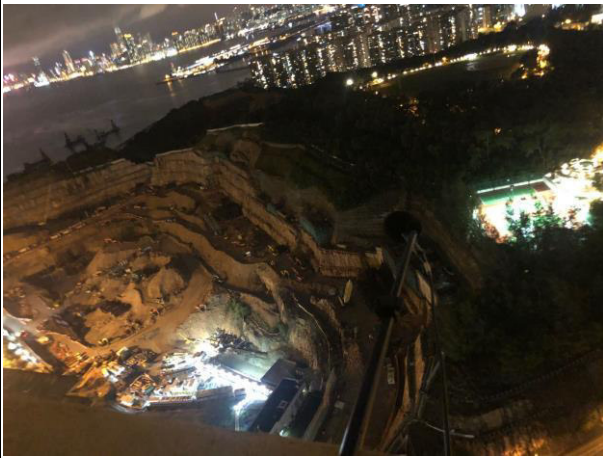
<p>(a) Statement of exceedance(s) Construction noise measured at CM1, CM2& CM3 exceeded the construction noise (night time) limit level.</p>

<p>(b) Cause of exceedance(s) The exceedance was not considered related to the Project works:</p> <ul style="list-style-type: none"> • According to our field observation, road traffic noise were identified as the dominant noise source. No noticeable noise from blasting / associated works was identified. • No major construction activity was observed in Lam Tin Interchange during monitoring (see photo).

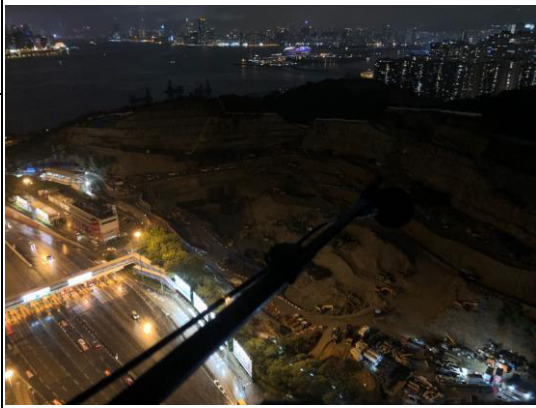
<p>(a) Statement of exceedance(s) Construction noise measured at CM1 & CM2 exceeded the construction noise (night time) limit level.</p>

<p>(b) Cause of exceedance(s) The exceedance was not considered related to the Project works:</p> <ul style="list-style-type: none"> • According to our field observation, road traffic noise were identified as the dominant noise source. No noticeable noise from blasting / associated works was identified. • No major construction activity was observed in Lam Tin Interchange during monitoring (see photo).
