# Civil Engineering and Development Department

**Agreement No. CE 59/2015 (EP)  
Environmental Team for  
Tseung Kwan O – Lam Tin Tunnel  
Design and Construction**

**Quarterly Environmental  
Monitoring and Audit Report –  
February 2019 – April 2019  
(version 1.0)**

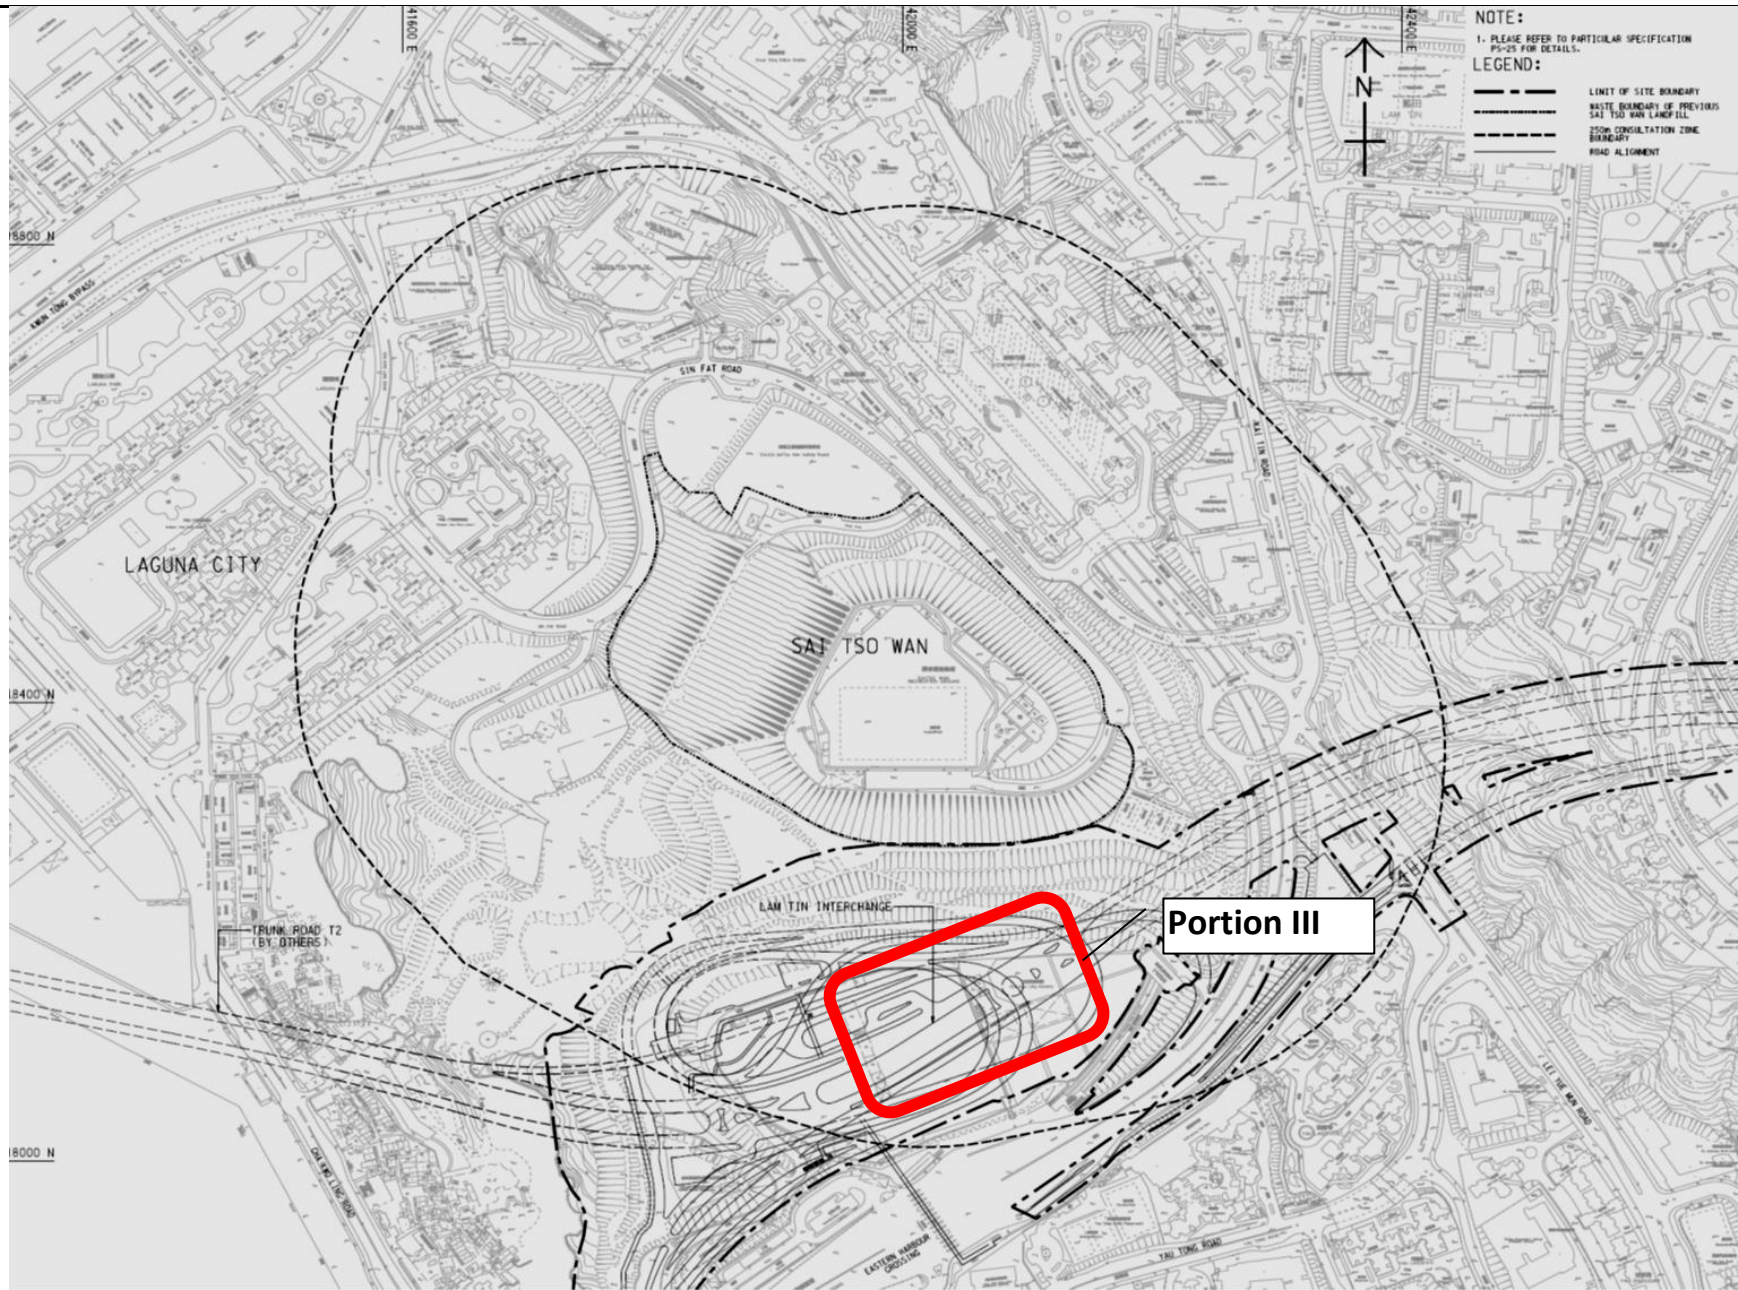
Project No. MA16034  
 Figure 6

Title Agreement No. CE/59/2015 (EP)  
 Environmental Team for Tseung Kwan O - Lam Tin Tunnel - Design and Construction  
 Locations of Landfill Gas Monitoring

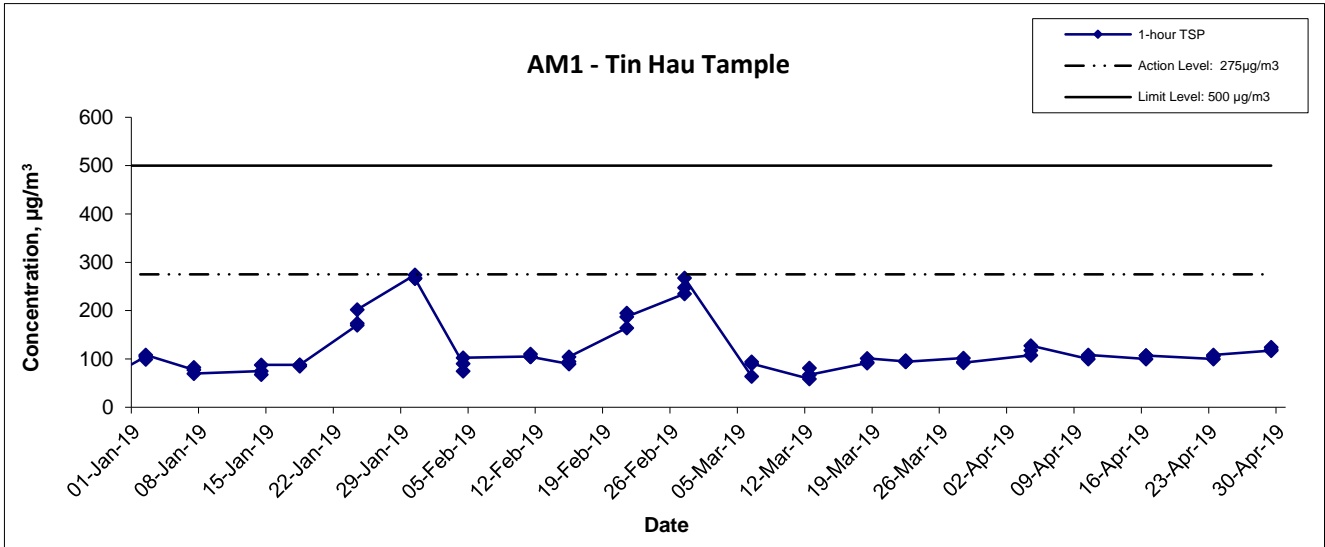
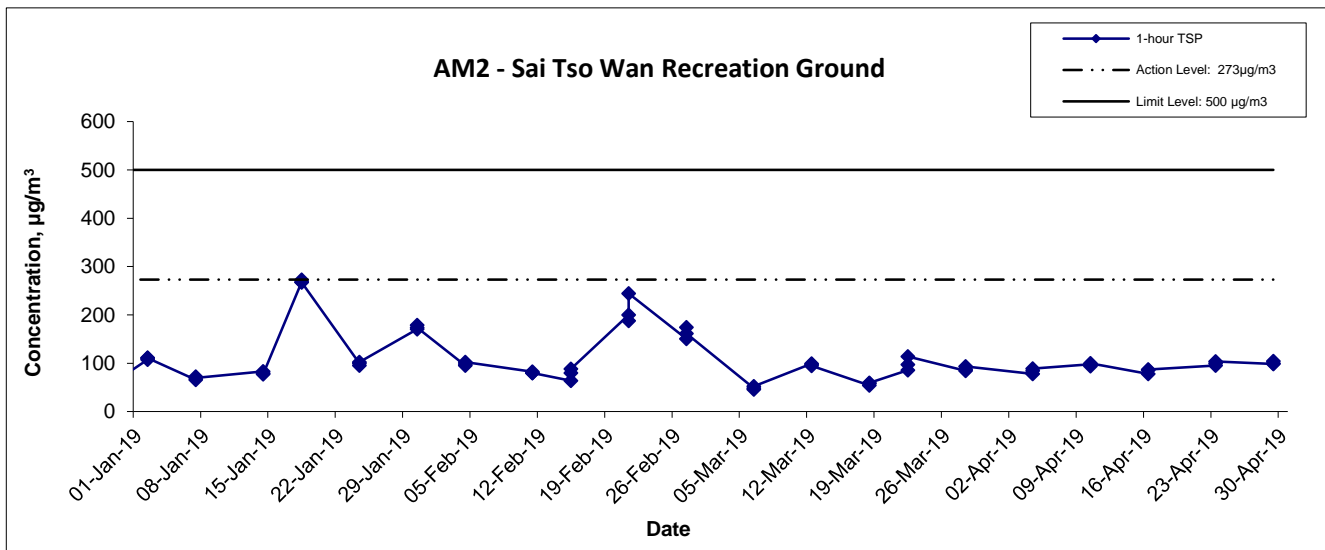
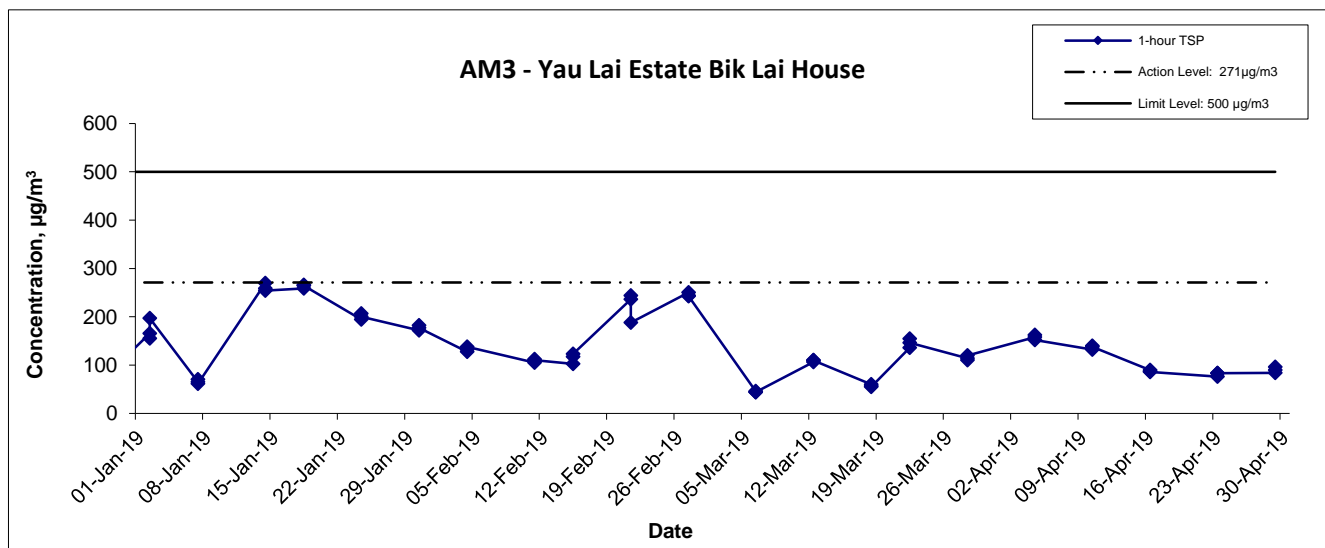
### 1-hr TSP Concentration Levels

Title	Agreement No. CE/59/2015 (EP)	Scale	Project	CINOTECH
	Environmental Team for Tseung Kwan O - Lam Tin Tunnel - Design and Construction	N.T.S	No. MA16034	
Graphical Presentation of 1-hour TSP Monitoring Results		Date	Appendix	
		Apr-19	C

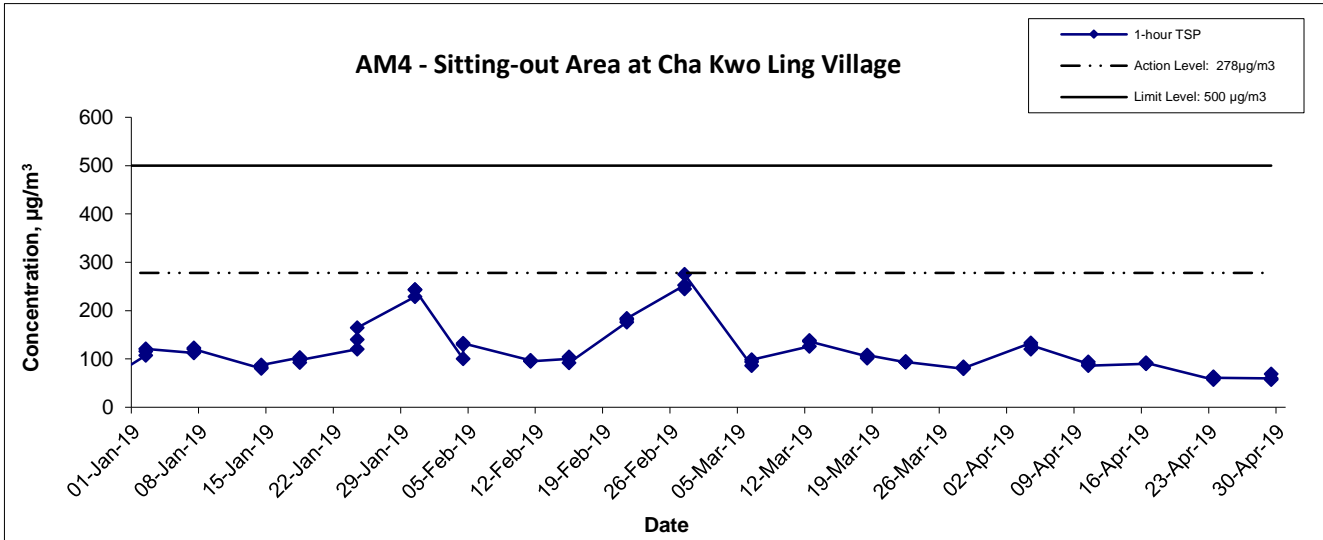
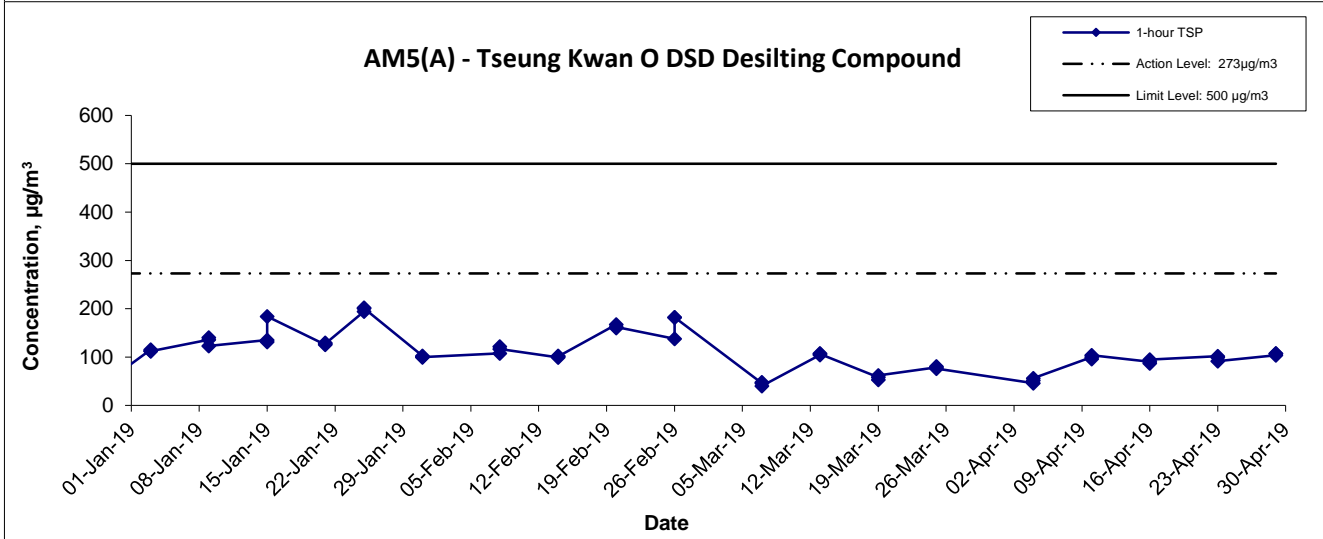
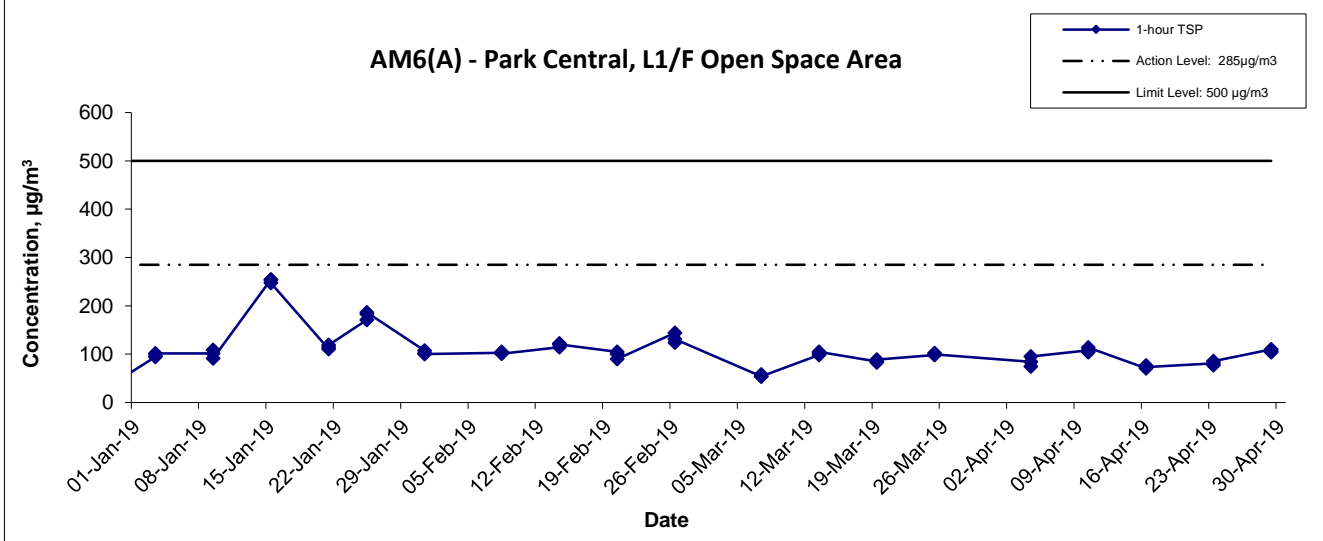
### 1-hr TSP Concentration Levels

Title Agreement No. CE/59/2015 (EP) Environmental Team for Tseung Kwan O - Lam Tin Tunnel - Design and Construction  Graphical Presentation of 1-hour TSP Monitoring Results	Scale N.T.S	Project No. MA16034	CINOTECH
	Date Apr-19	Appendix C

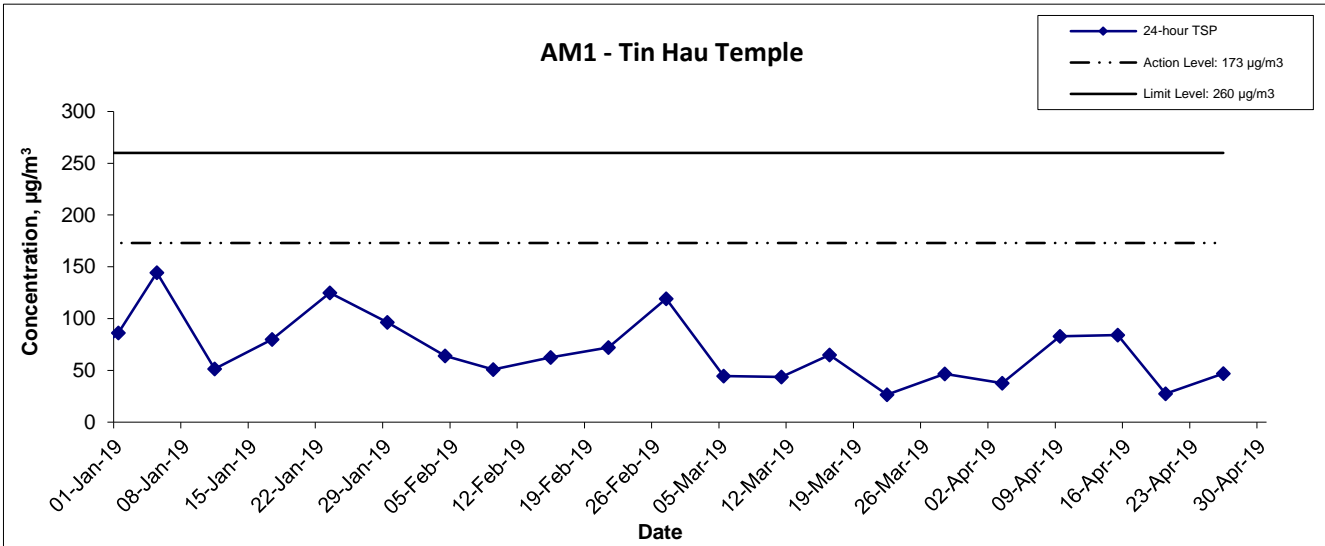
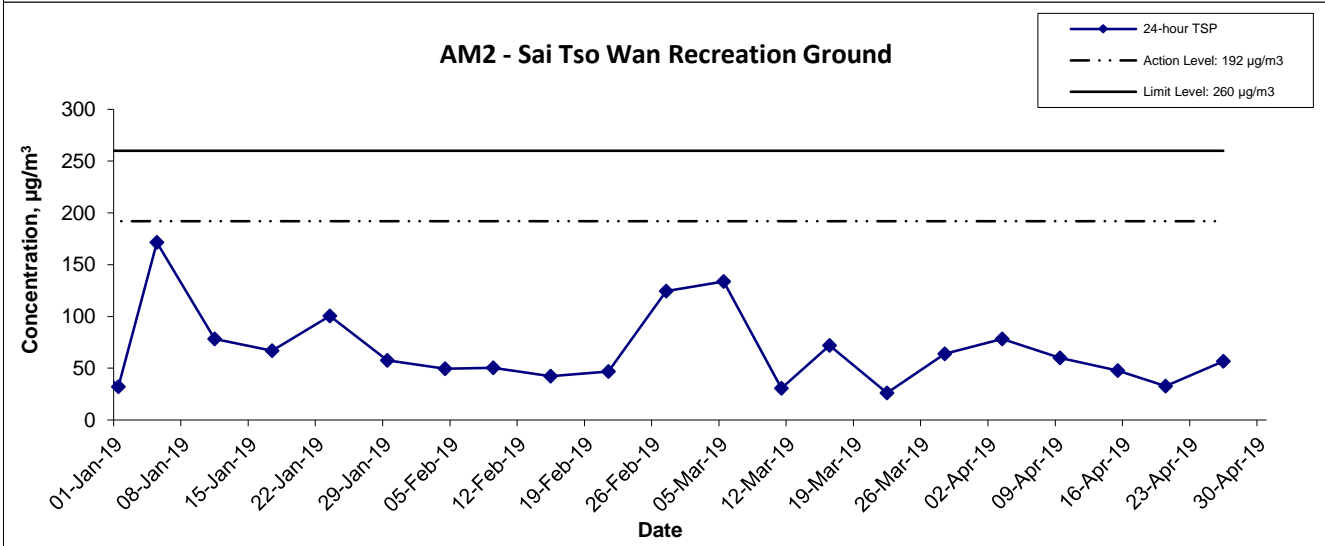
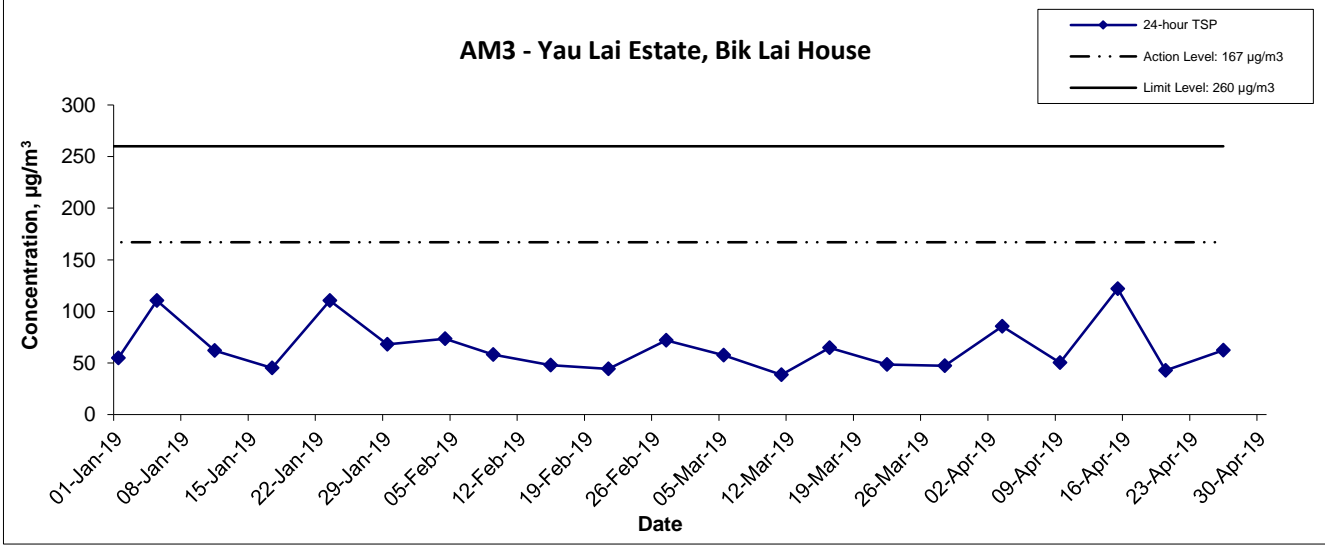
### 24-hr TSP Concentration Levels

Title	Agreement No. CE/59/2015 (EP)	Scale	Project No.	CINOTECH
	Environmental Team for Tseung Kwan O - Lam Tin Tunnel - Design and Construction	N.T.S	MA16034	
Graphical Presentation of 24-hour TSP Monitoring Results		Date	Appendix	
		Apr-19	C

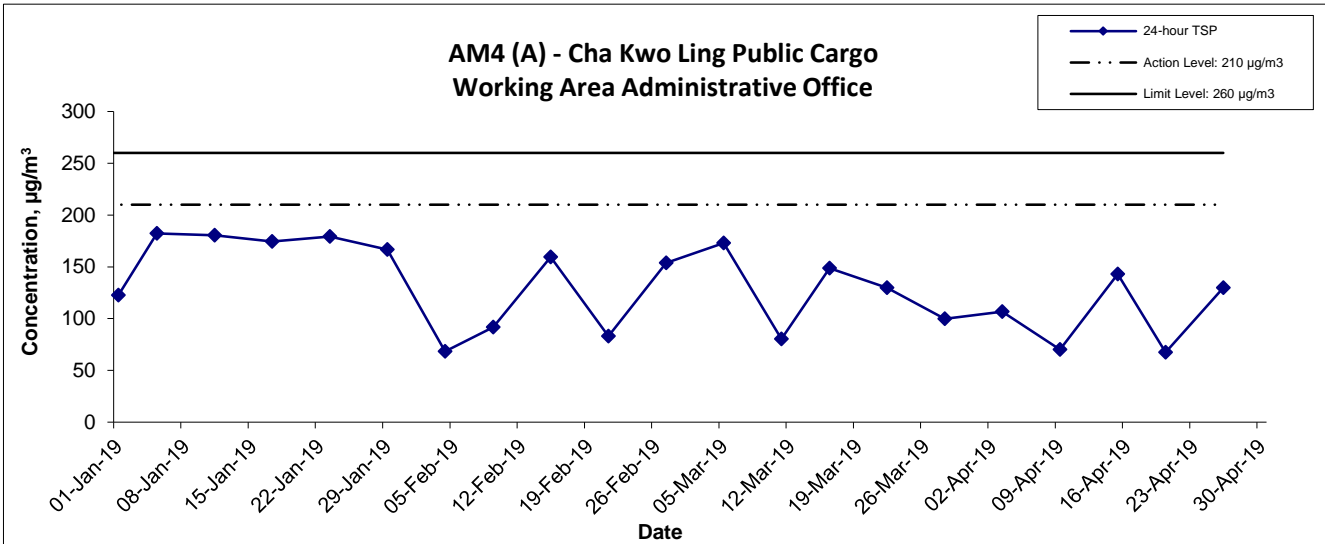
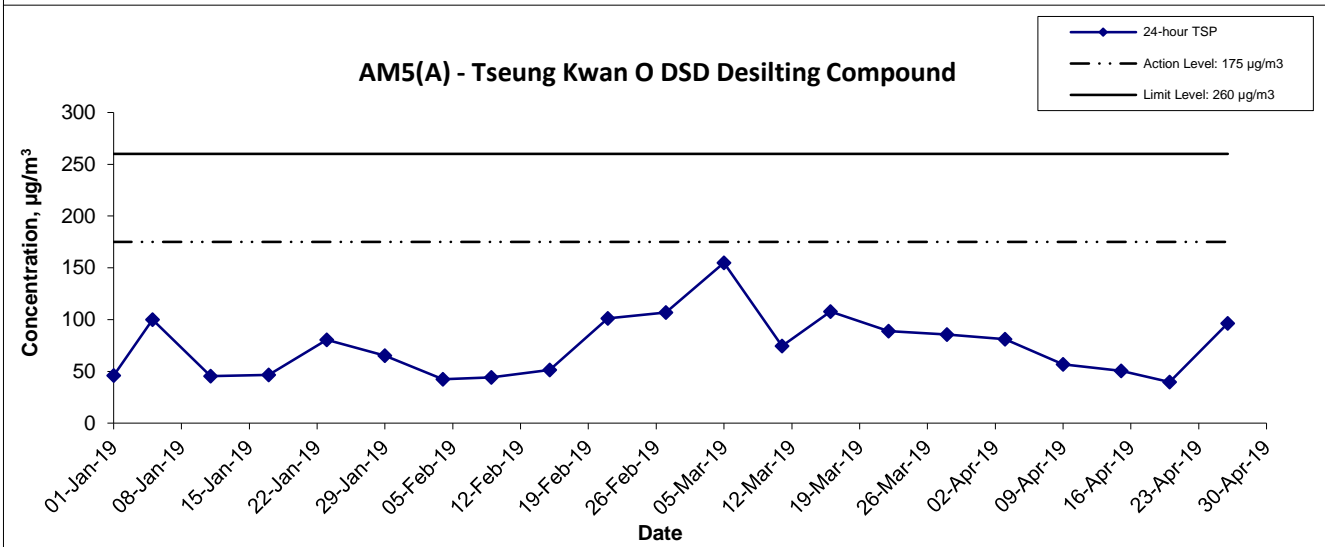
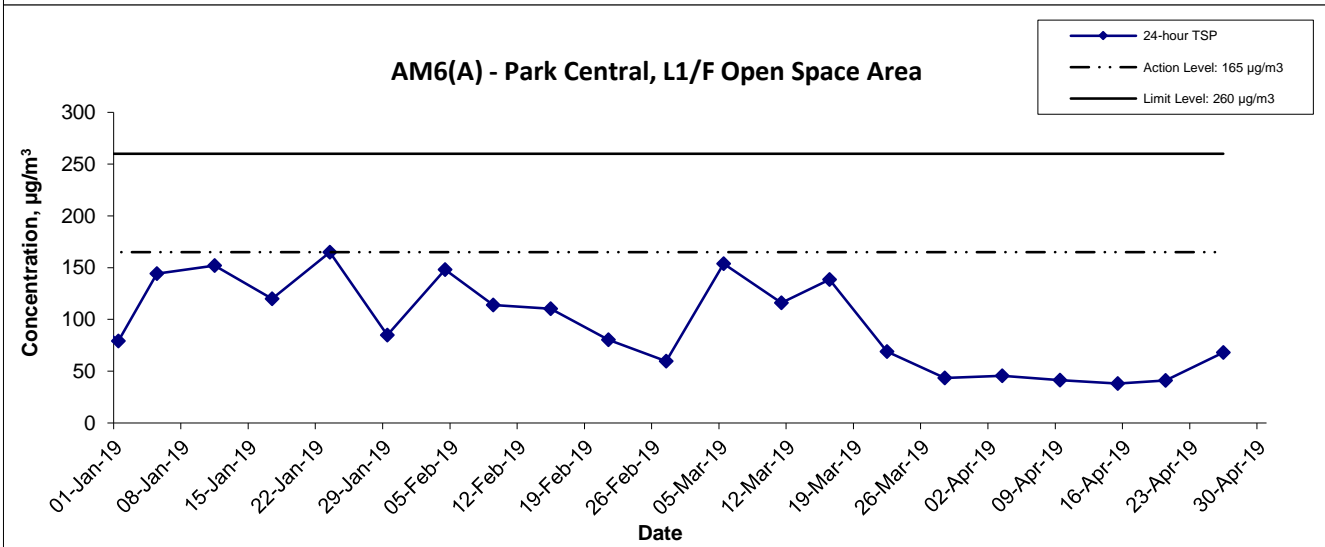
### 24-hr TSP Concentration Levels

Title	Agreement No. CE/59/2015 (EP)		Scale	N.T.S	Project No.	MA16034	CINOTECH
	Environmental Team for Tseung Kwan O - Lam Tin Tunnel - Design and Construction			Date		Apr-19	
Graphical Presentation of 24-hour TSP Monitoring Results

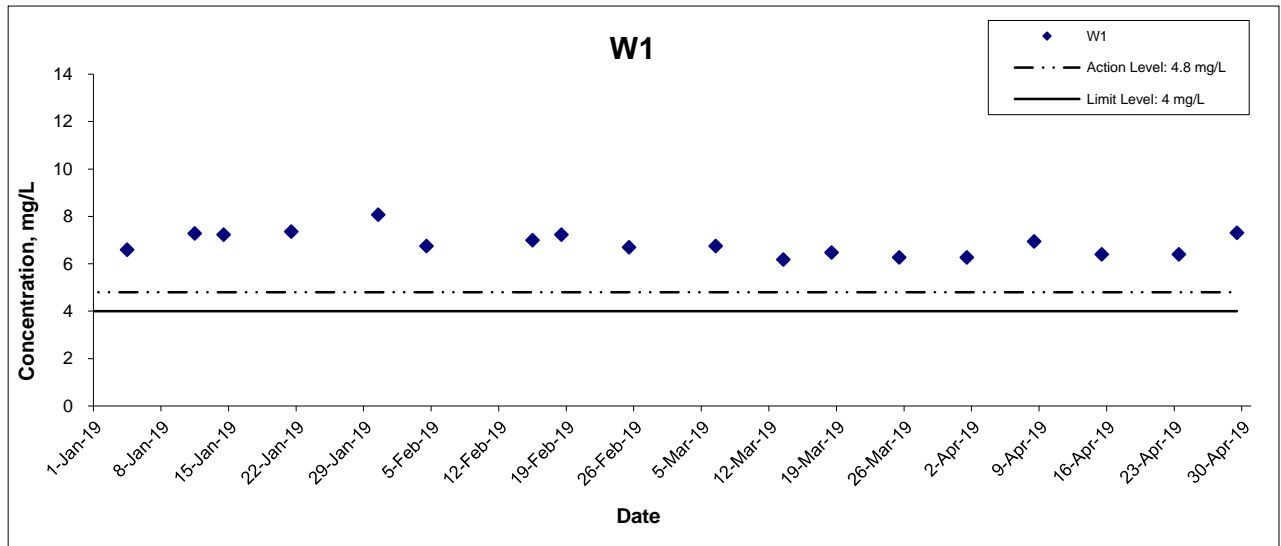
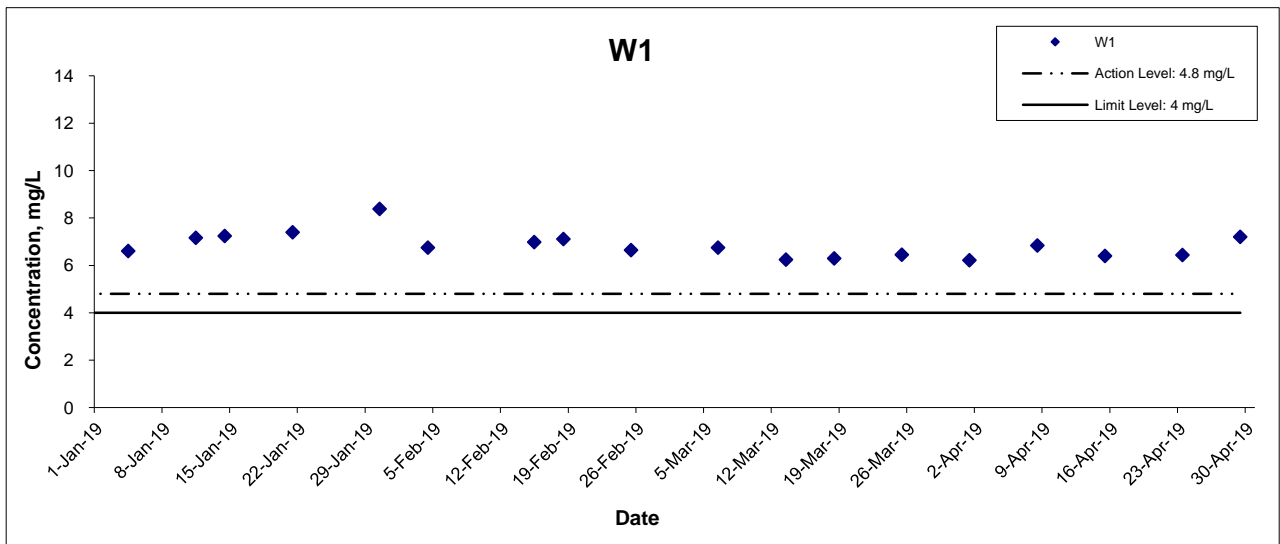
### Dissolved Oxygen (Depth-Averaged) at Mid-Ebb Tide

### Dissolved Oxygen (Depth-Averaged) at Mid-Flood Tide

Title Agreement No. CE 59/2015(EP) Environmental Team for Tseung Kwan O - Lam Tin Tunnel Design and Construction  Graphical Presentation of Additional Water Quality Monitoring Results	Scale N.T.S	Project No. MA16034	
	Date Apr-19	Appendix F

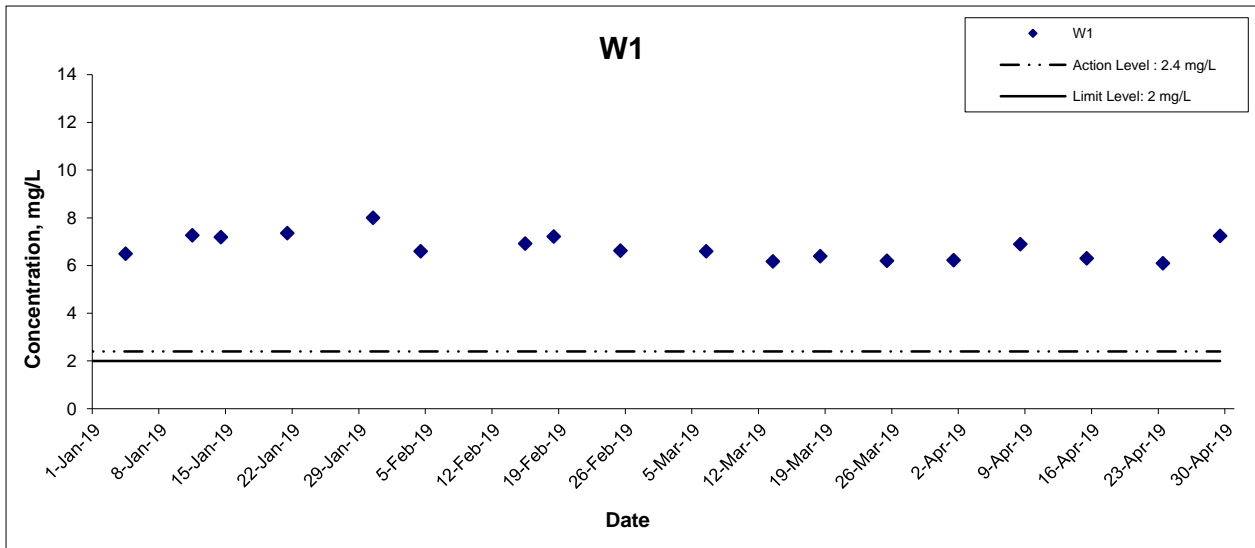
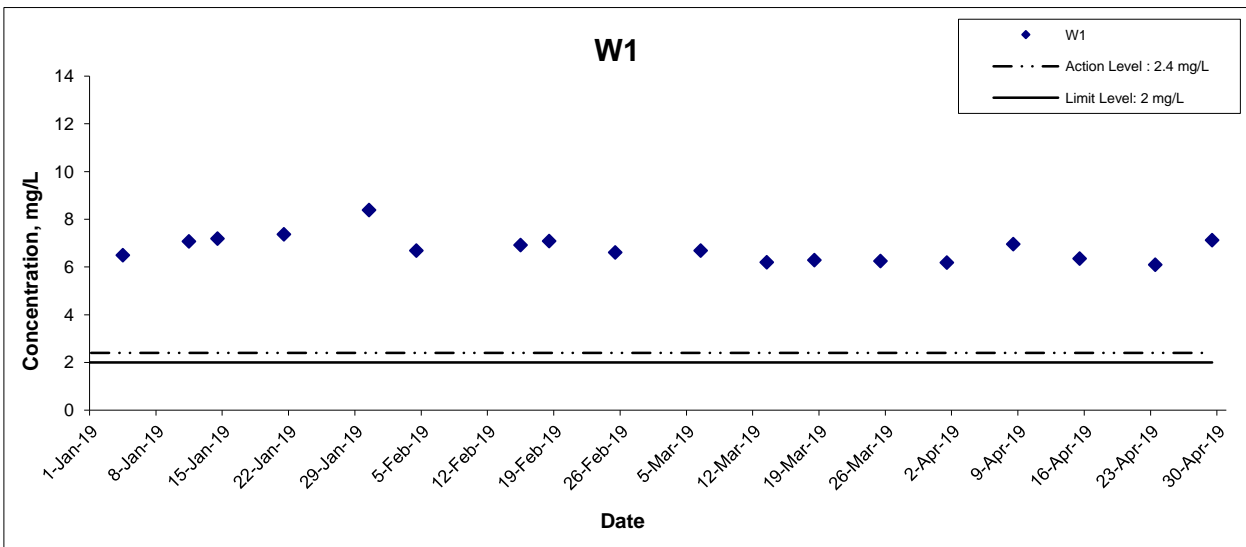
### Dissolved Oxygen (Bottom) at Mid-Ebb Tide

### Dissolved Oxygen (Bottom) at Mid-Flood Tide

Title Agreement No. CE 59/2015(EP) Environmental Team for Tseung Kwan O - Lam Tin Tunnel Design and Construction  Graphical Presentation of Additional Water Quality Monitoring Results	Scale N.T.S	Project No. MA16034	
	Date Apr-19	Appendix F

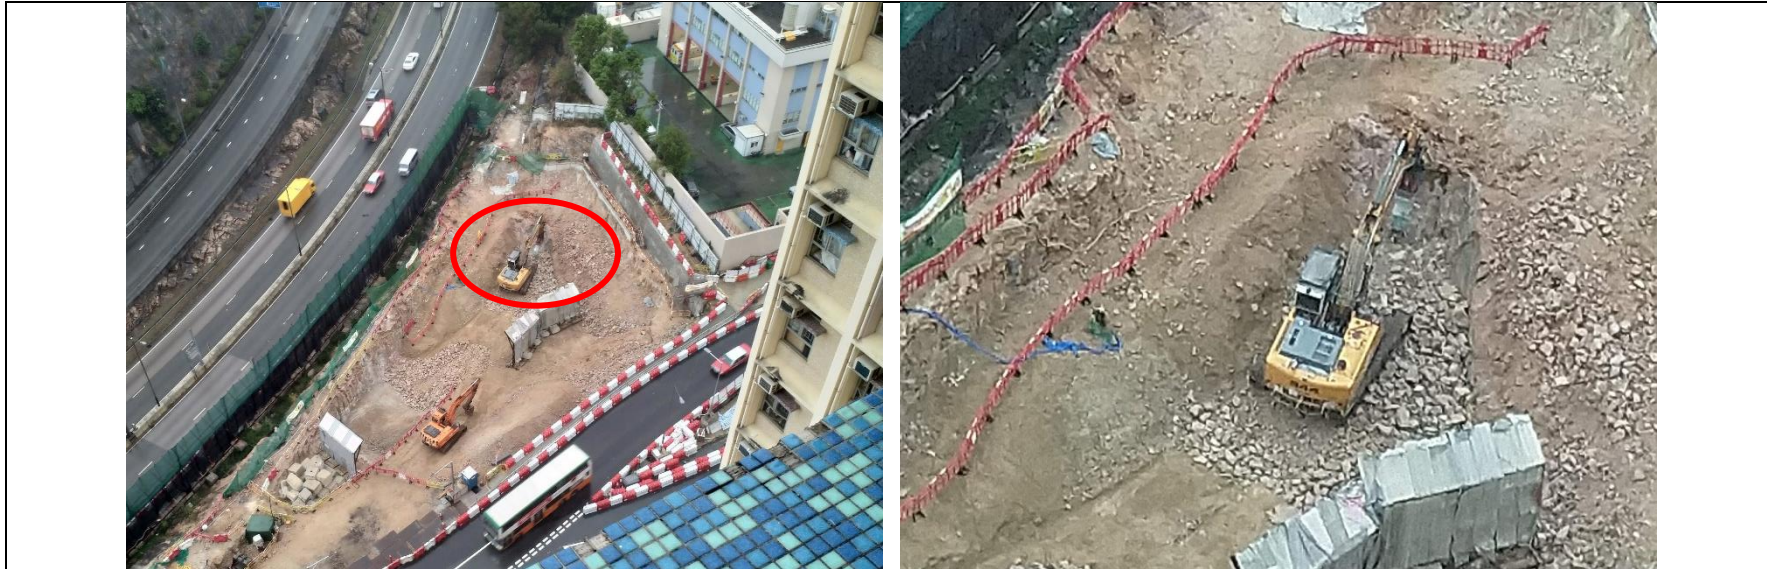
Photo 1 and Photo 2

1. Construction activities under this Project at Site Portion IVC:  
According to the observation of our monitoring staff, a breaker was in operation at site Portion IVC near the ambulance depot in the first 30-minute noise measurement (photo 1 and photo 2). It was stopped whilst the second 30-minute noise measurement was carrying out.
2. Our staff also reported that some movable noise barriers have been erected but unable to block the direct view from the monitoring station to the breaker.
3. Road Traffic Noise at slips roads approaching Eastern Harbour Crossing Tunnel.

Breaker operation in Portion IVC near the ambulance depot

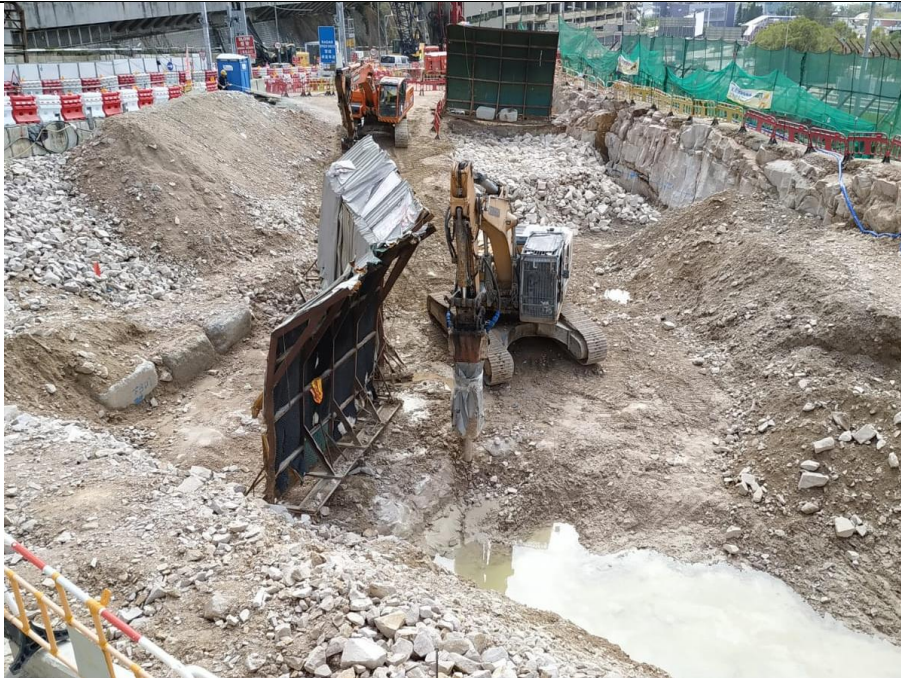
Photo 3

1. The contractor demonstrated a proper setup of cantilevered noise barrier to screen the breaker head inside Portion IVC (photo 3).
2. The contractor reported the progress of deploying additional noise mitigation measures for Portion IVC near Yau Lai Estate. A semi-enclosure with sound proofing canvases will be setup in early March 2019.

Demonstration of cantilevered noise barrier for breaking works in Portion IVC

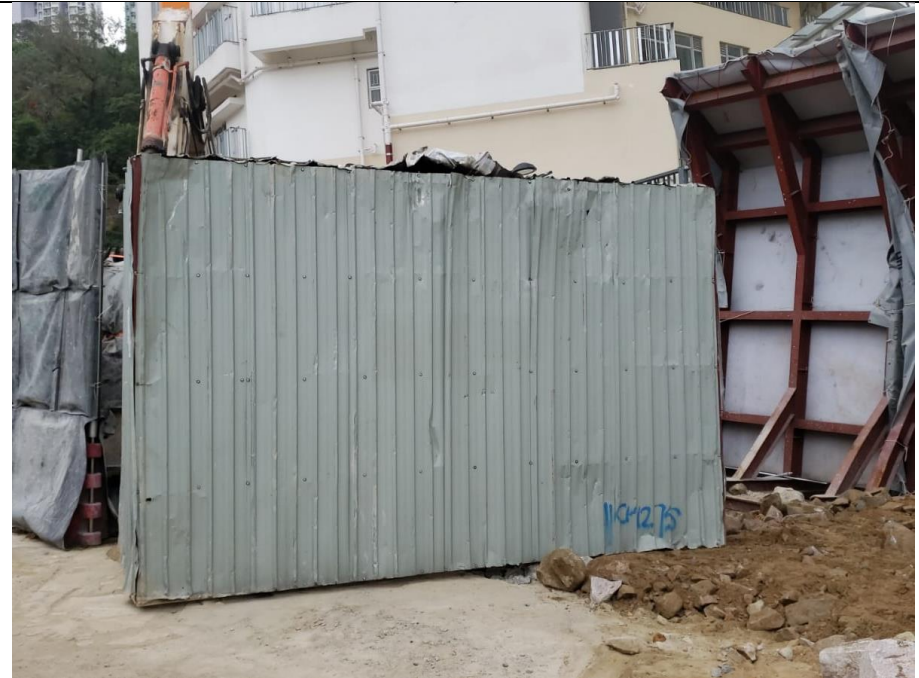
Photo 4

Current cantilevered noise barriers and SilentUP noise barriers at Portion IVC adjacent to Yau Lai Estate
