Civil Engineering and Development Department

**Agreement No. CE 59/2015 (EP)
Environmental Team for
Tseung Kwan O – Lam Tin Tunnel
Design and Construction**

**Quarterly Environmental
Monitoring and Audit Report –
November 2019 – January 2020**

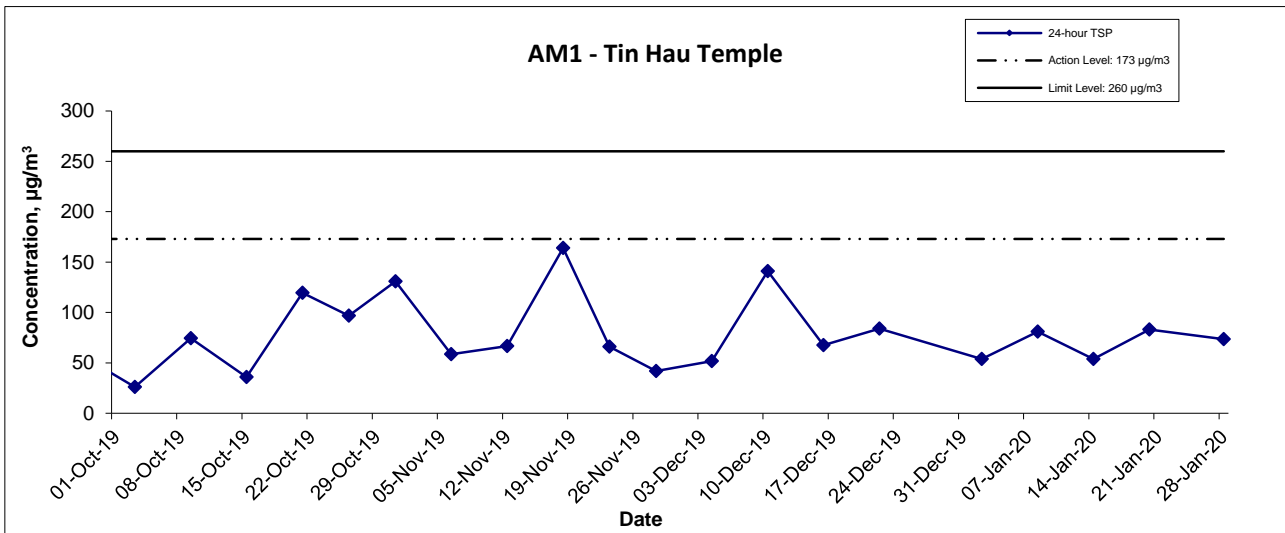
24-hr TSP Concentration Levels

Agreement No. CE/59/2015 (EP) Environmental Team for Tseung Kwan O - Lam Tin Tunnel - Design and Construction	Scale	Project	
		N.T.S	
Graphical Presentation of 24-hour TSP Monitoring Results	Date	Appendix	
		Jan-20	C

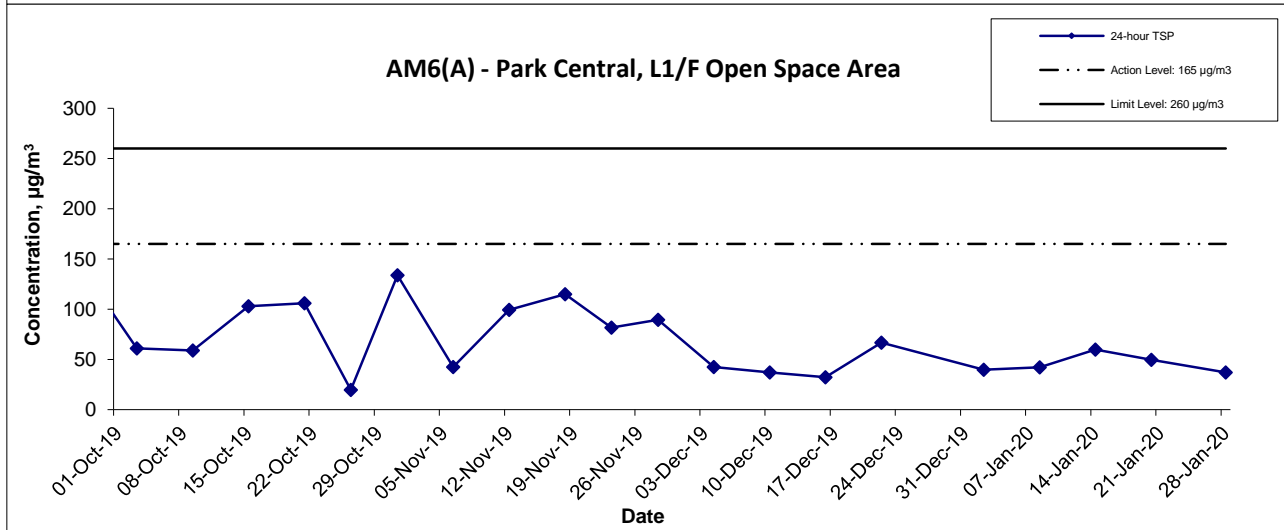
24-hr TSP Concentration Levels

Agreement No. CE/59/2015 (EP) Environmental Team for Tseung Kwan O - Lam Tin Tunnel - Design and Construction Graphical Presentation of 24-hour TSP Monitoring Results	Scale	Project

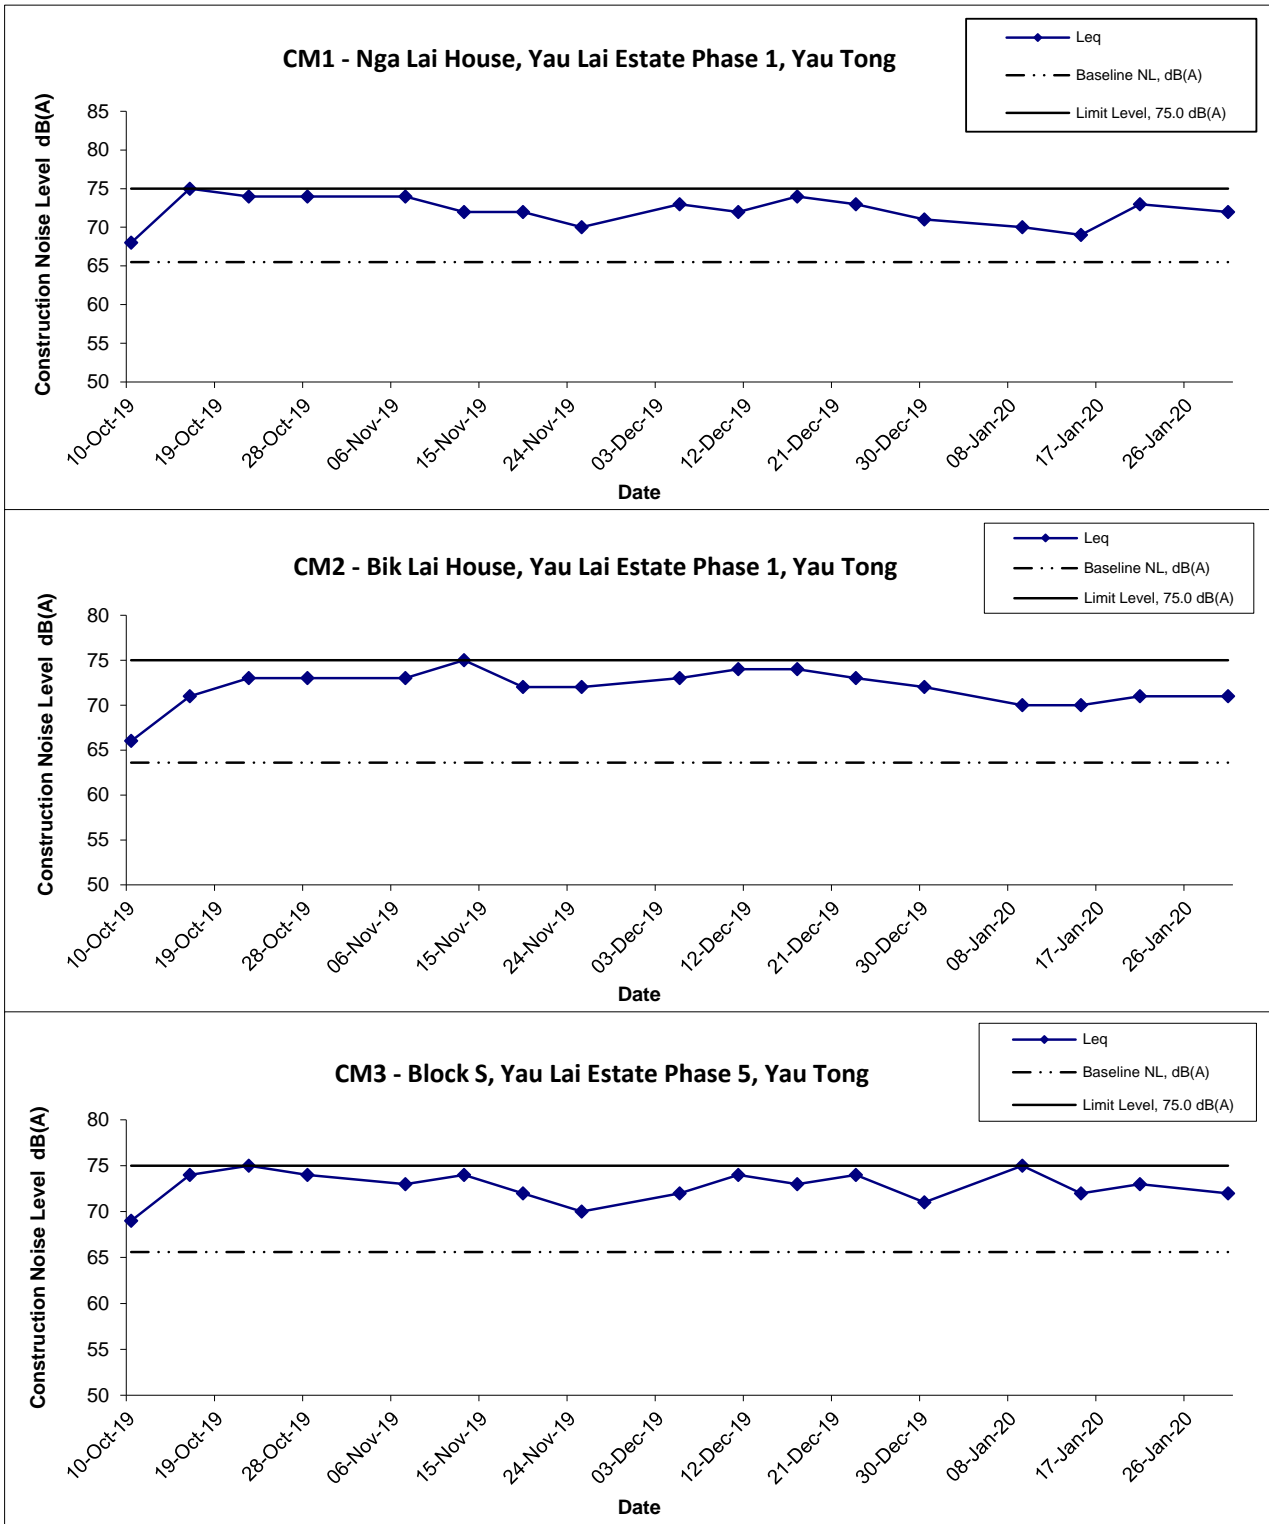
Title Agreement No. CE/59/2015 (EP) Environmental Team for Tseung Kwan O - Lam Tin Tunnel - Design and Construction Graphical Presentation of Construction Noise Monitoring Results	Scale	Project	CINOTECH
	N.T.S	No. MA16034	
	Date	Appendix	
	Jan 20	D

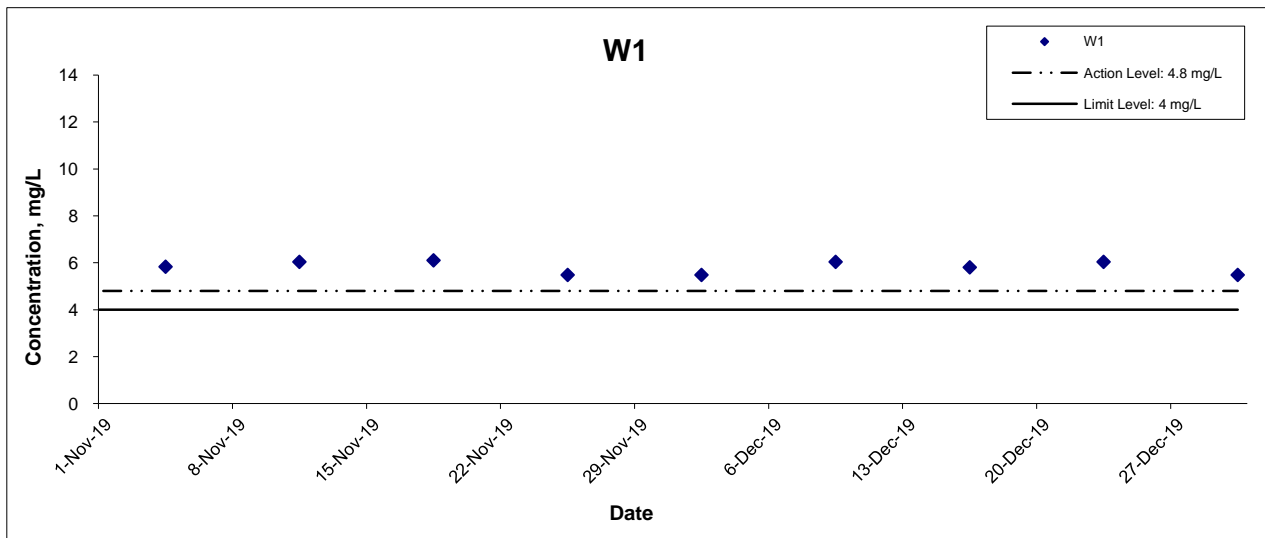
Dissolved Oxygen (Depth-Averaged) at Mid-Flood Tide

Title Agreement No. CE 59/2015(EP) Environmental Team for Tseung Kwan O - Lam Tin Tunnel Design and Construction Graphical Presentation of Additional Water Quality Monitoring Results	Scale N.T.S	Project No. MA16034	
	Date Dec-19	Appendix F
