# Civil Engineering and Development Department

**Agreement No. CE 59/2015 (EP)  
Environmental Team for  
Tseung Kwan O – Lam Tin Tunnel  
Design and Construction**

**Quarterly Environmental  
Monitoring and Audit Report –  
May 2020 – July 2020**

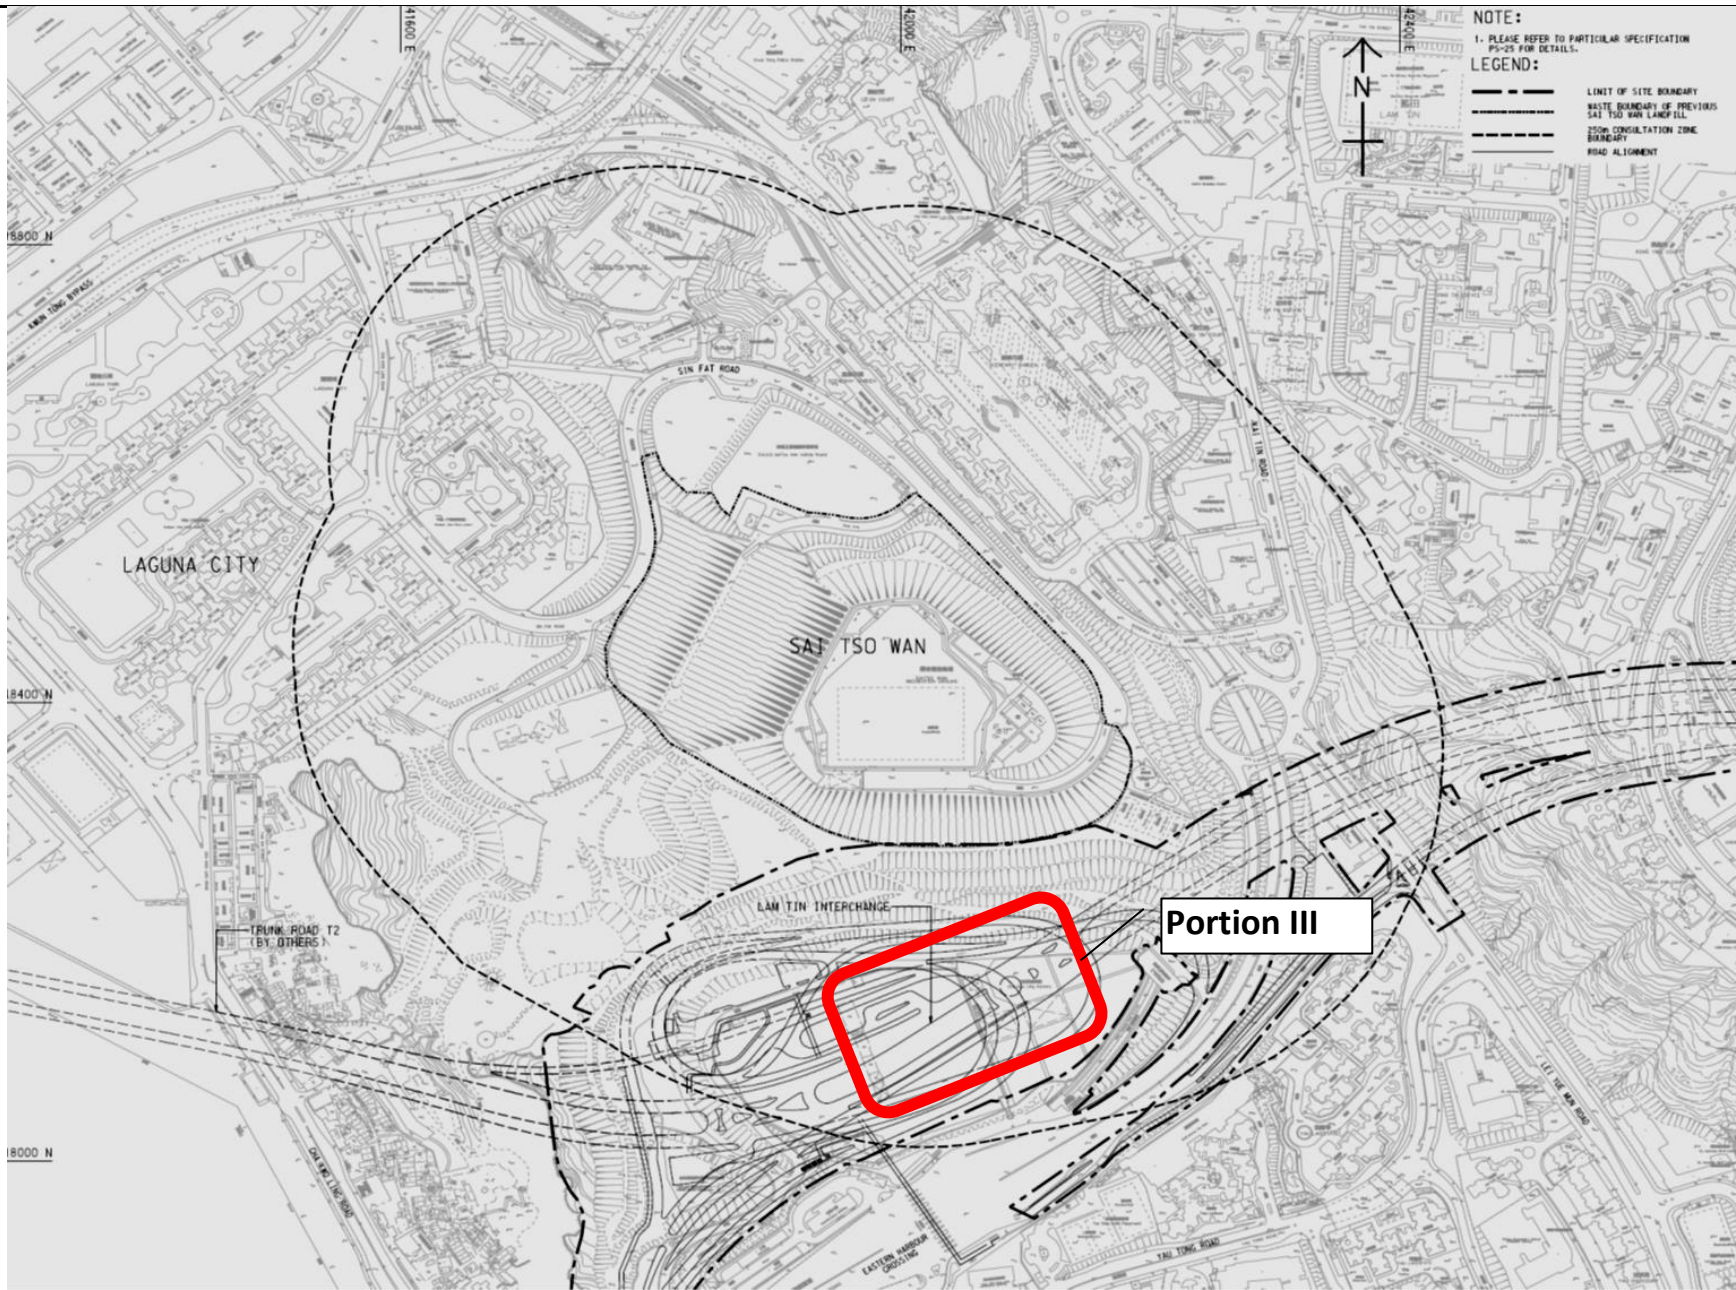
Title Agreement No. CE/59/2015 (EP)  
 Environmental Team for Tseung Kwan O - Lam Tin Tunnel - Design and Construction  
 Locations of Landfill Gas Monitoring
