# Civil Engineering and Development Department

**Agreement No. CE 59/2015 (EP)  
Environmental Team for  
Tseung Kwan O – Lam Tin Tunnel  
Design and Construction**

**Monthly Environmental Monitoring and  
Audit Report for  
March 2022  
(version 1.0)**

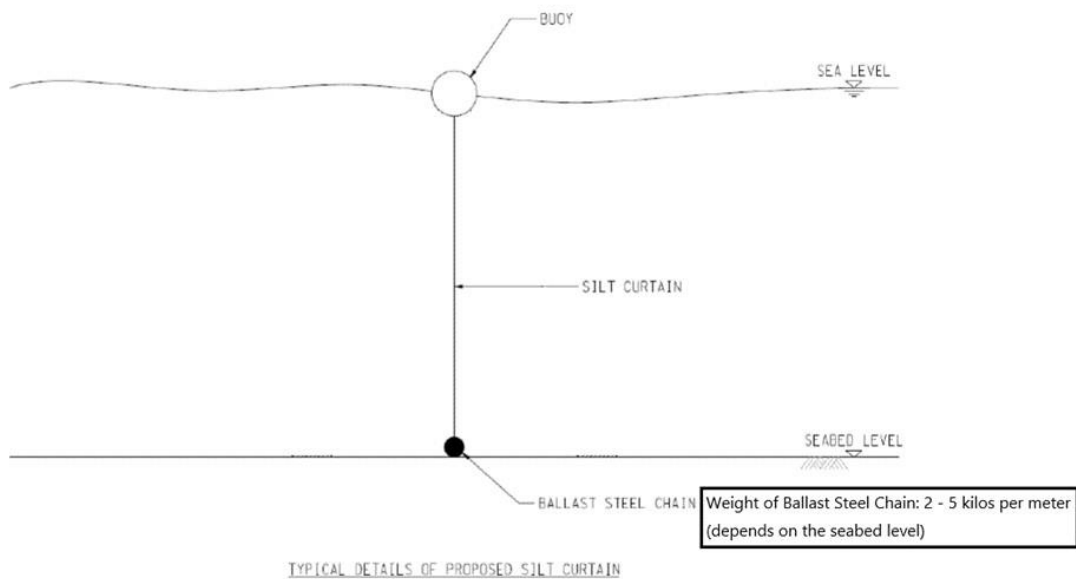
Figure 1 Typical details of proposed silt curtain

Sufficient spare geotextile will be kept on site for replacing of damaged silt curtains. The spare geotextile shall be kept in place to avoid direct contact with water and sunlight.

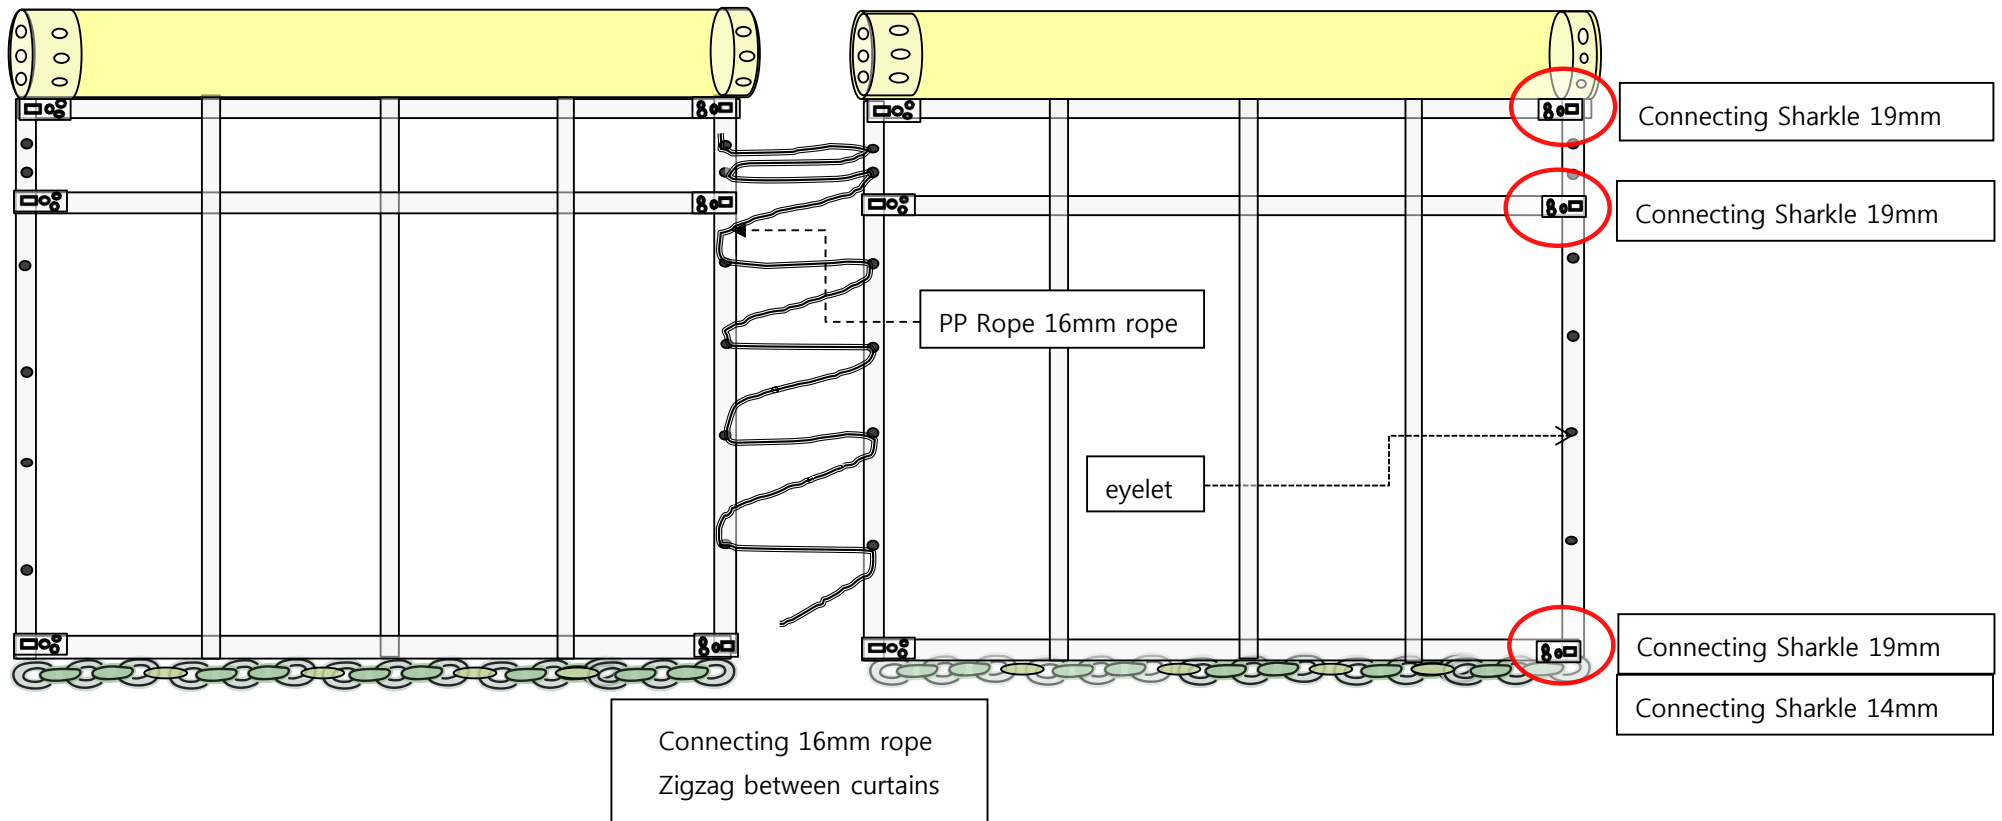
## Installation Guide (Connecting curtain and curtain)

\* Number of connections(between curtain and curtain)

19mm sharkle	No. of eyelet
2m height of curtain	3	6
3m height of curtain	4	9
4m height of curtain	4	12
5m height of curtain	5	15
6m height of curtain	5	18

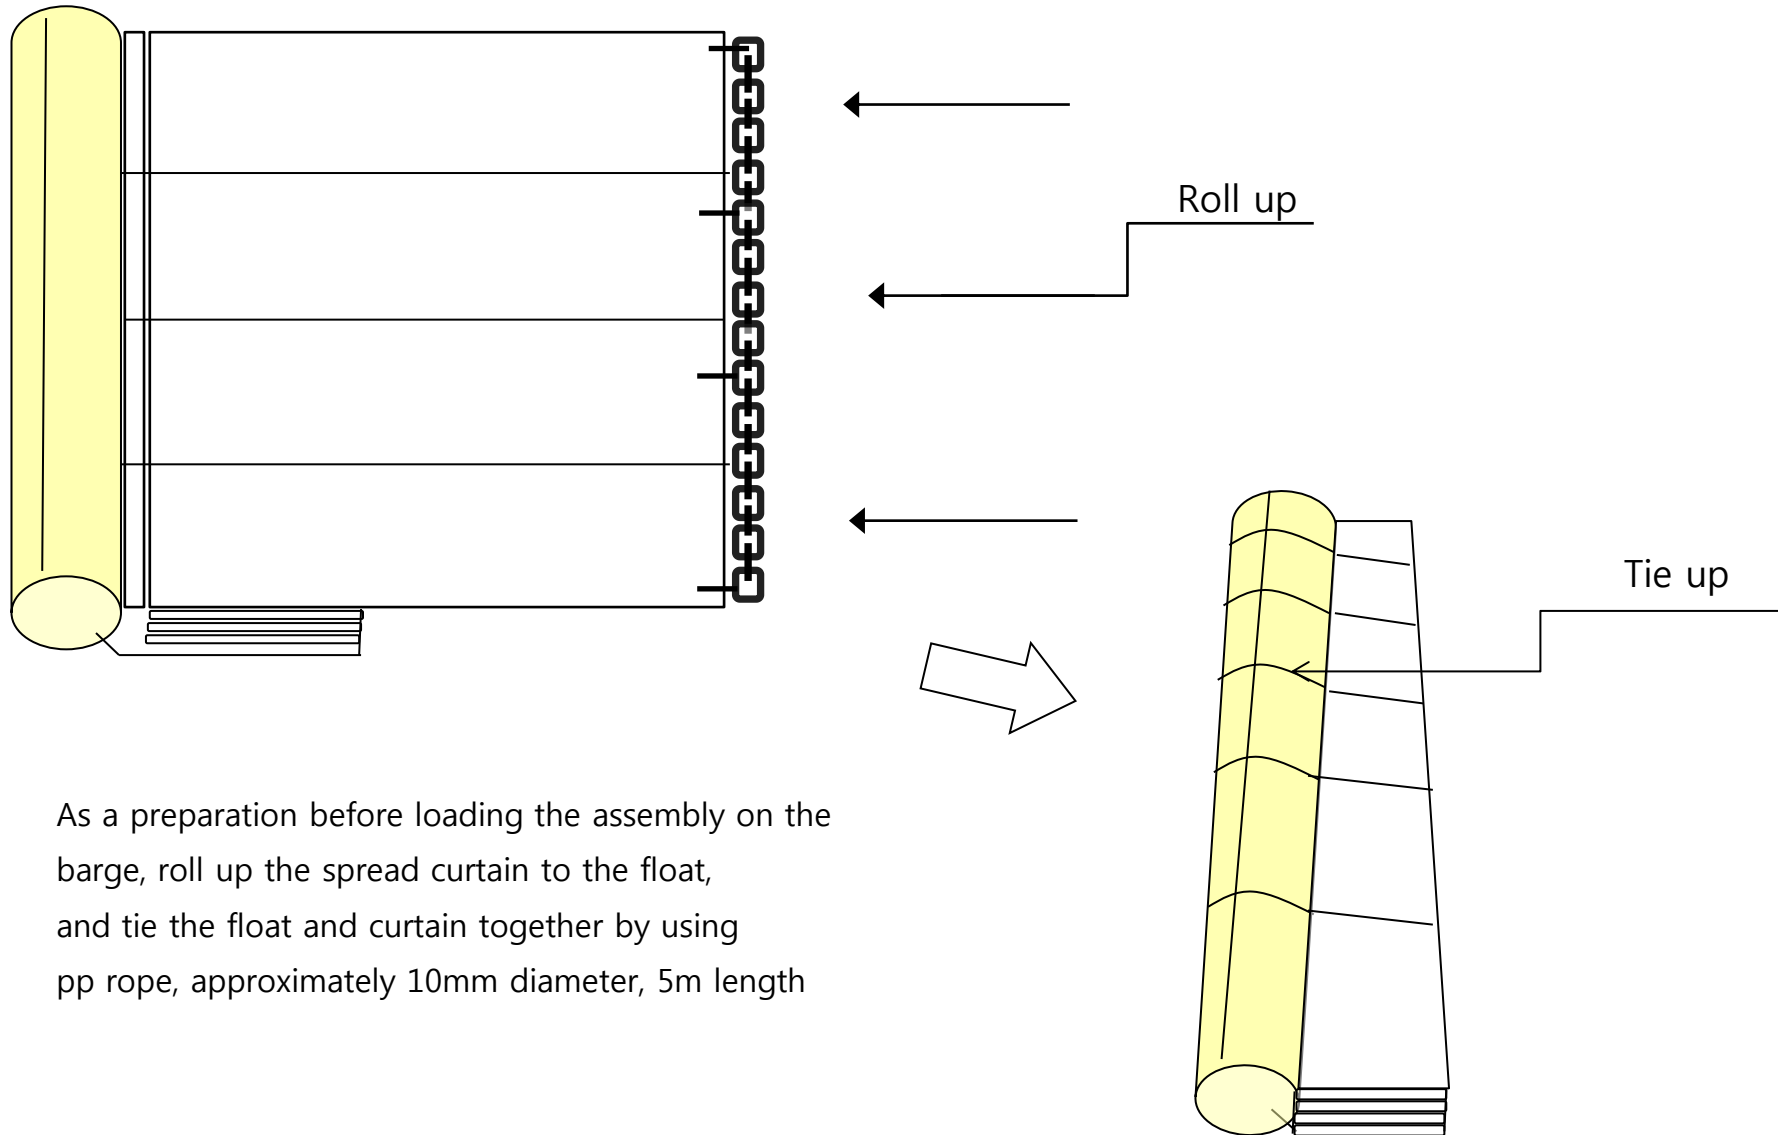
## Installation Guide (Temporary tying curtains)

As a preparation before loading the assembly on the barge, roll up the spread curtain to the float, and tie the float and curtain together by using pp rope, approximately 10mm diameter, 5m length

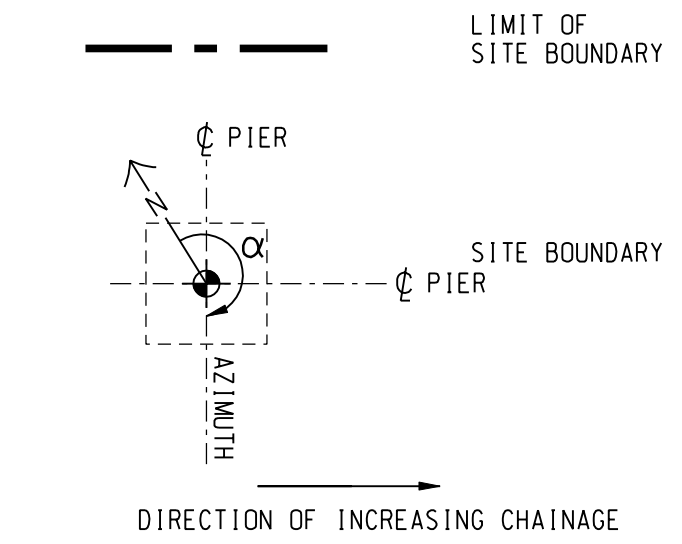
Location of Silt Curtain

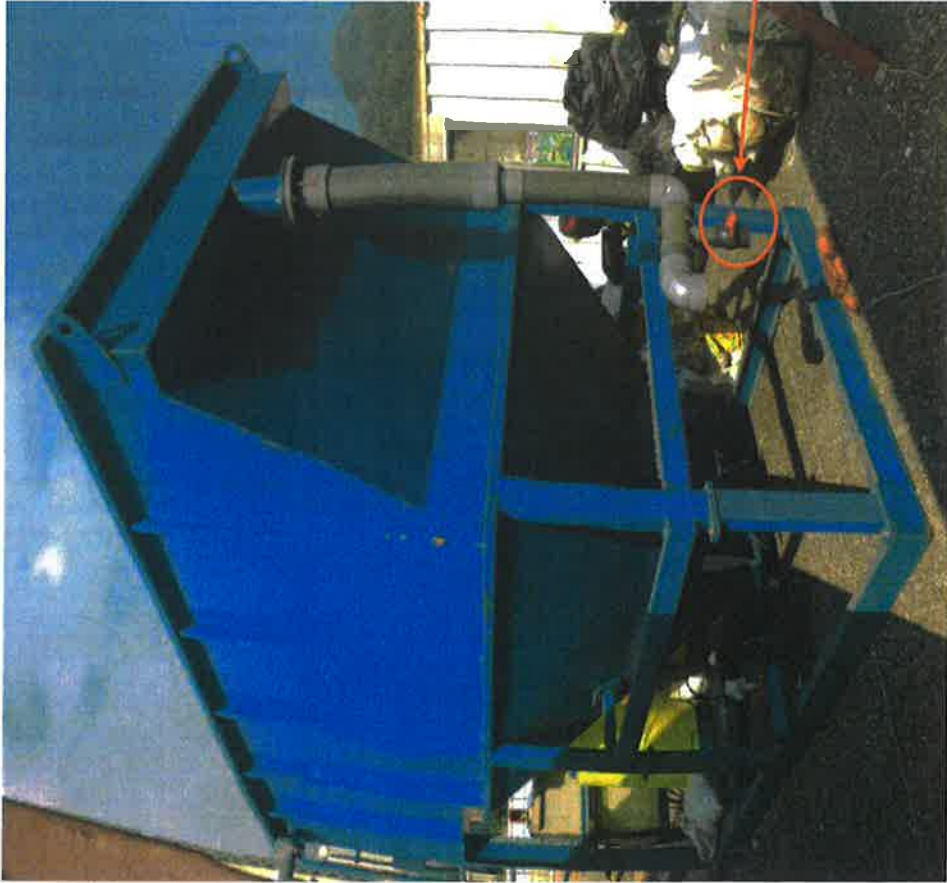
Sampling Point 1 (S.P.1) at sampling valve of the discharge outlet of Wastewater Treatment Facility (A)  
取樣點 (S.P.1) 位於廢水處理設施 (A) 出水口的取樣閥

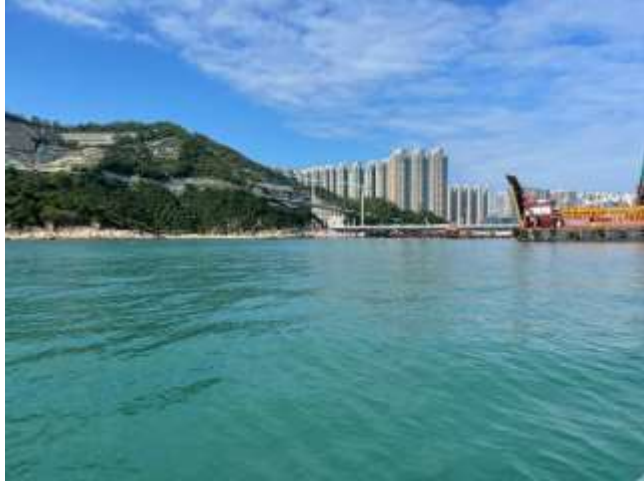
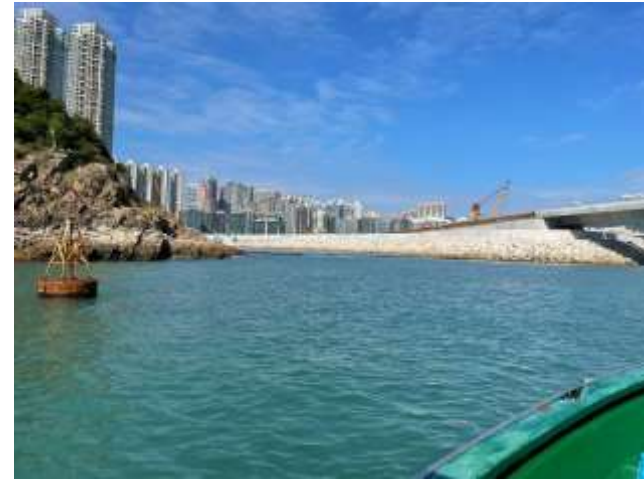
Photo 5 (Recorded on 25 March 2022)

During regular water quality monitoring, the sea appears to be clear in general (Photo 5 to 6). However, it is observed that natural occurring algal bloom happened in mid-March 2022 which may contribute to the exceedance (Photo 7 to 8).

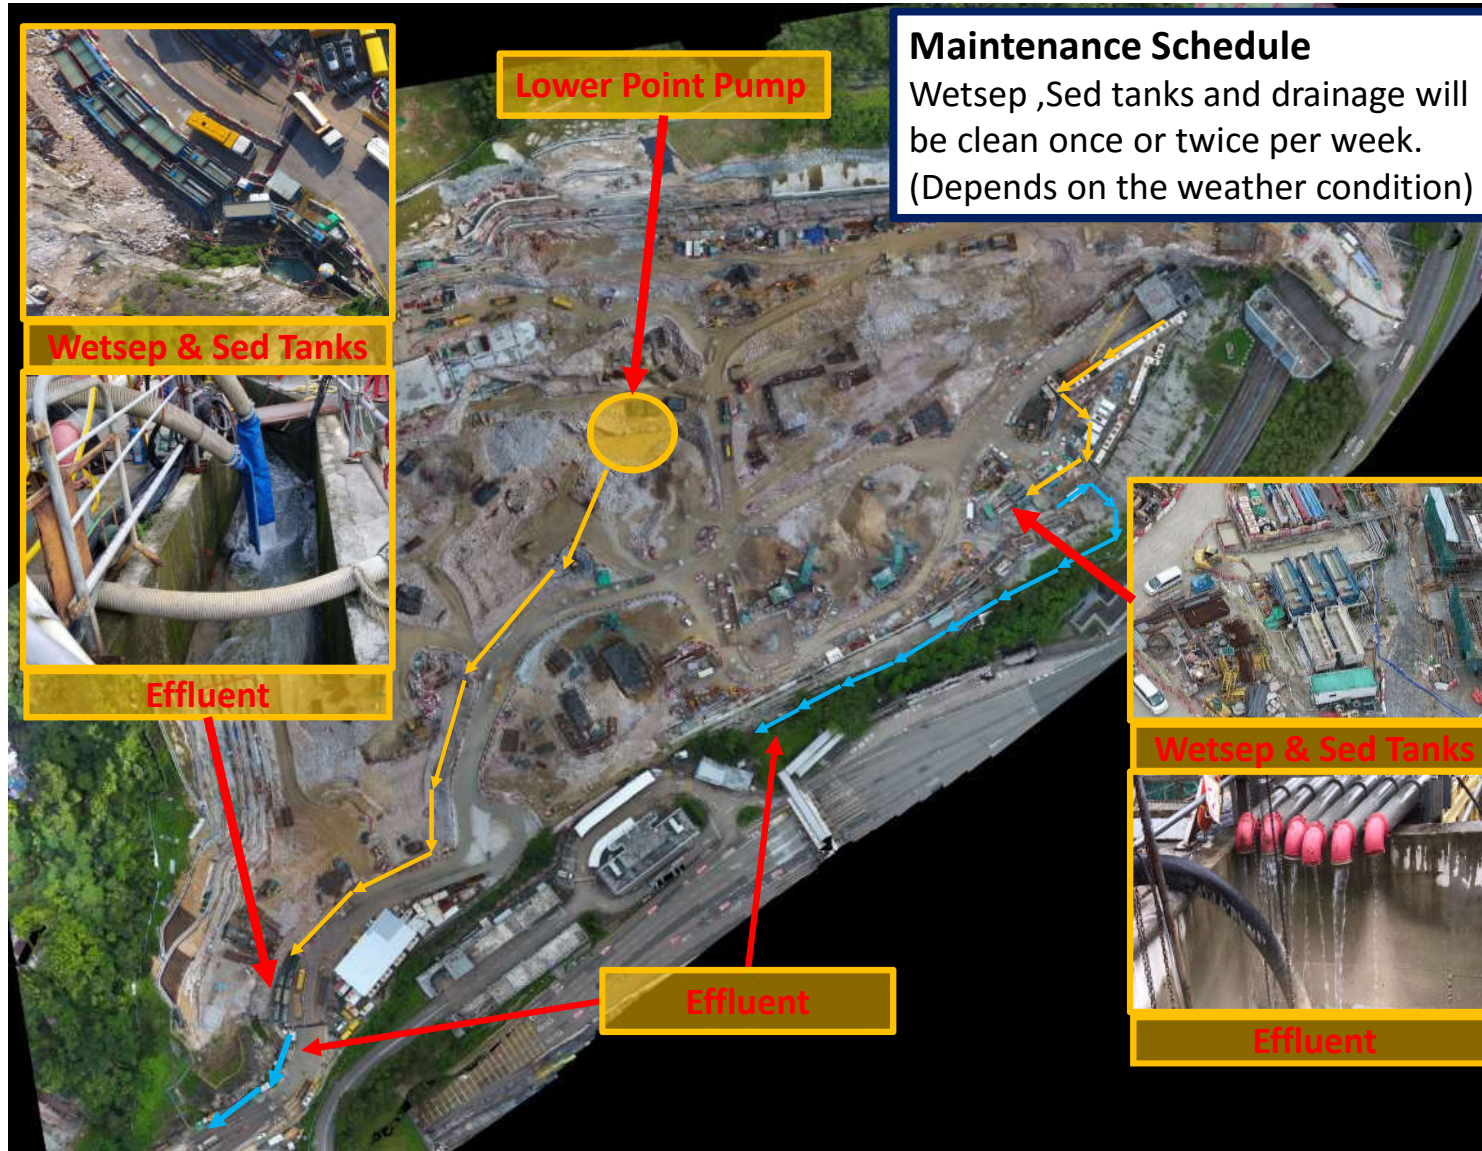
**Maintenance Schedule**  
Wetsep ,Sed tanks and drainage will be clean once or twice per week.  
(Depends on the weather condition)

- 5.44 Regular cleaning depending on site conditions are provided for the WetSep at Area A and Z; and the storage tanks and sedimentation tanks at Area A. The water treated by the sedimentation tank and the wetsep shall be discharged towards the designated discharge point. Quality of the effluent are also monitored regularly.

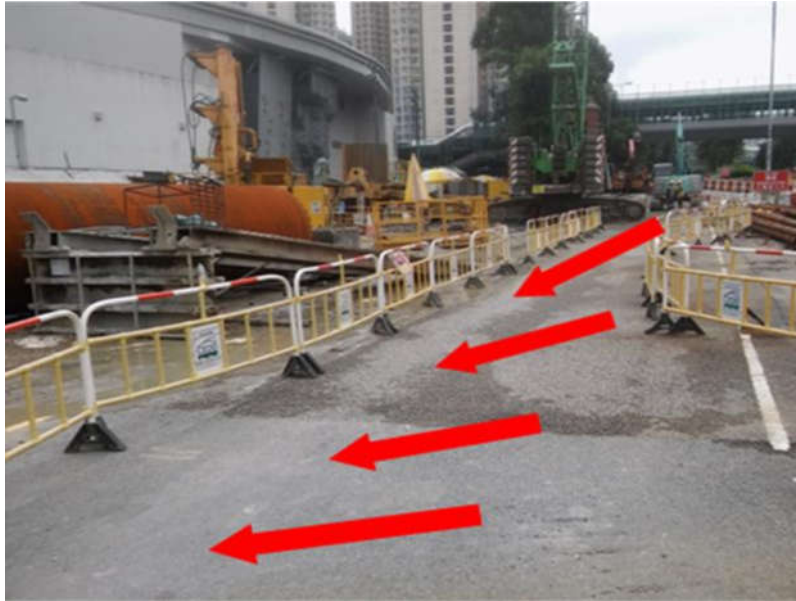
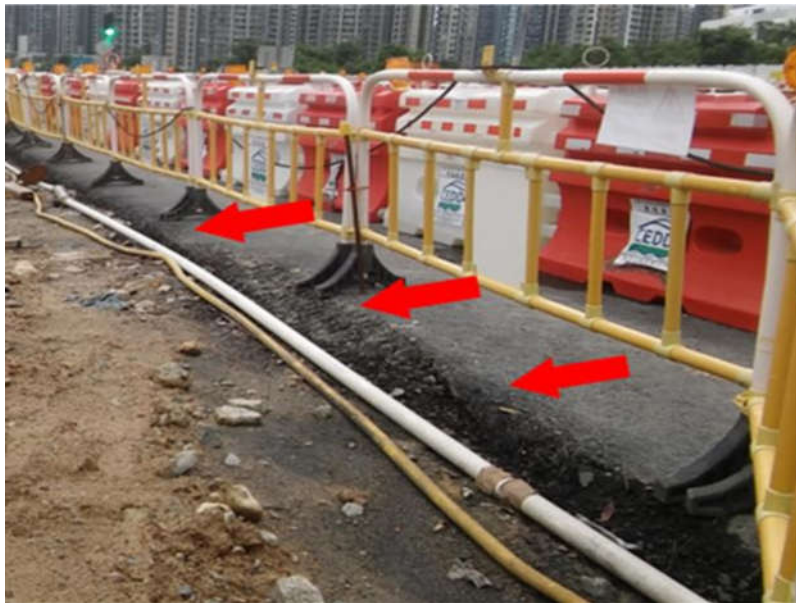
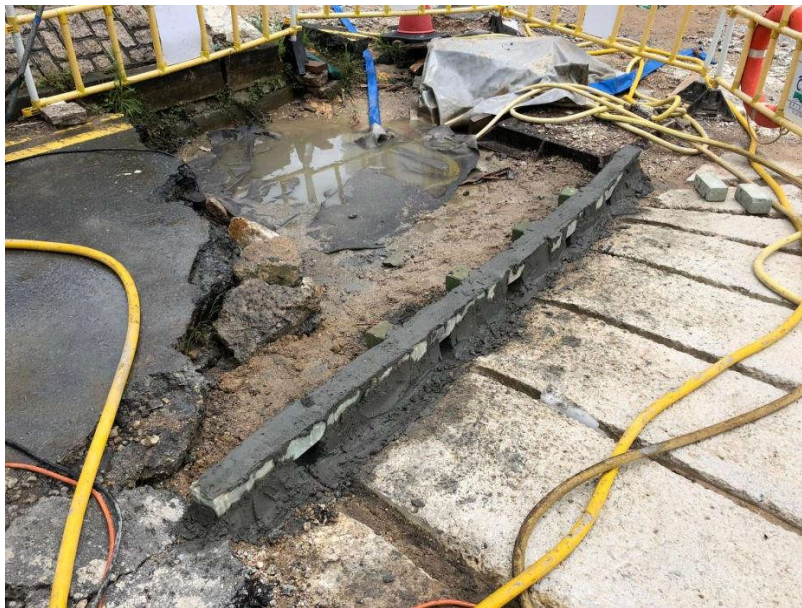
### Surface runoff collection

**Height difference between the road and site area to form a natural flow. Sump pit was provided for wastewater collection.**

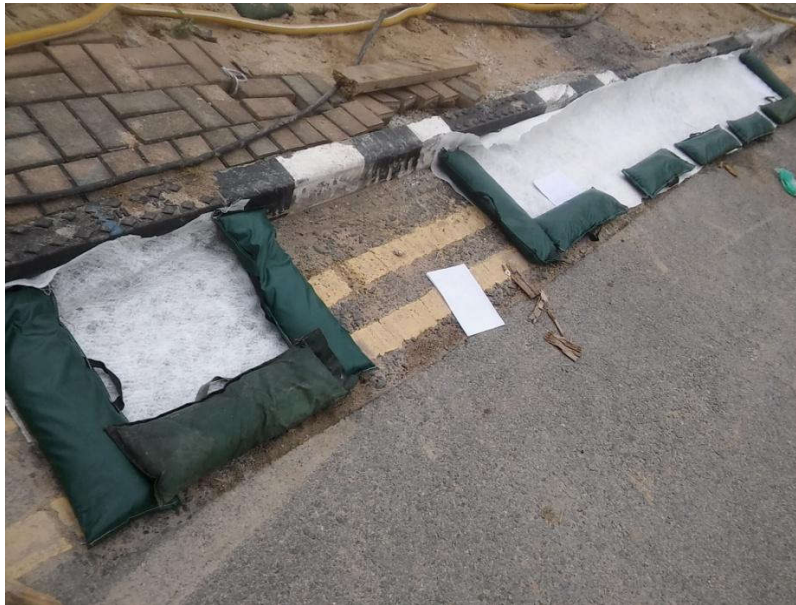
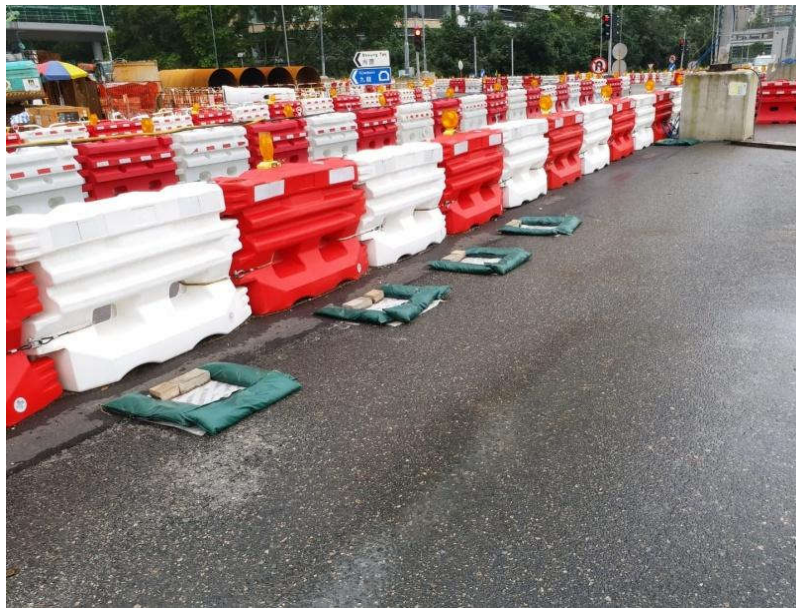
### Gully Protection

**Gully were protected and covered by geotextile.**

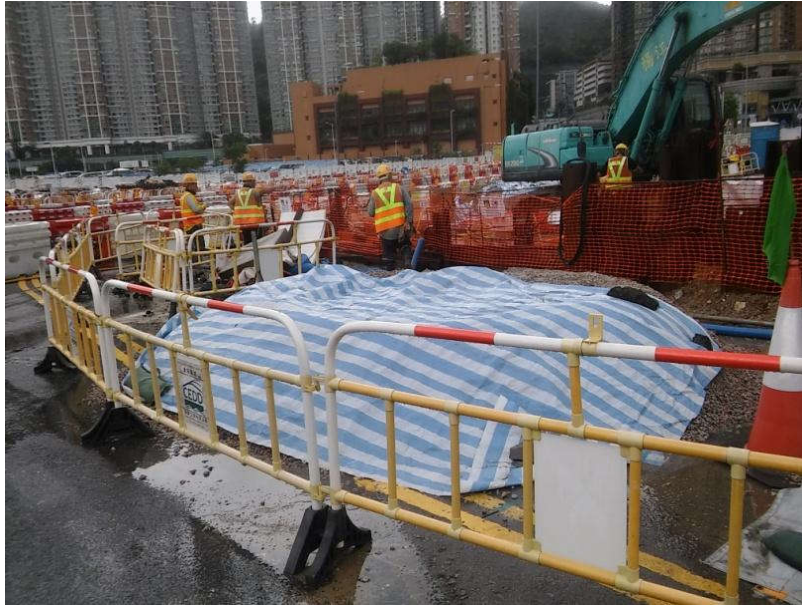
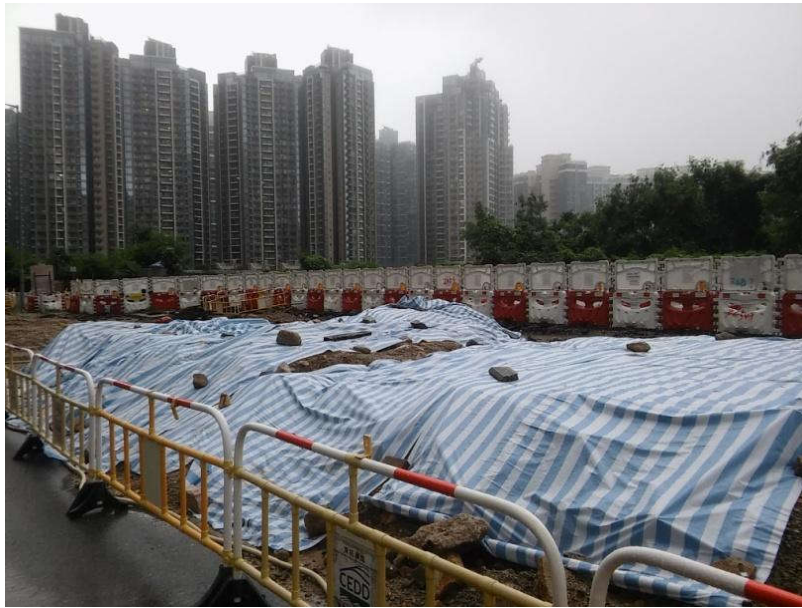
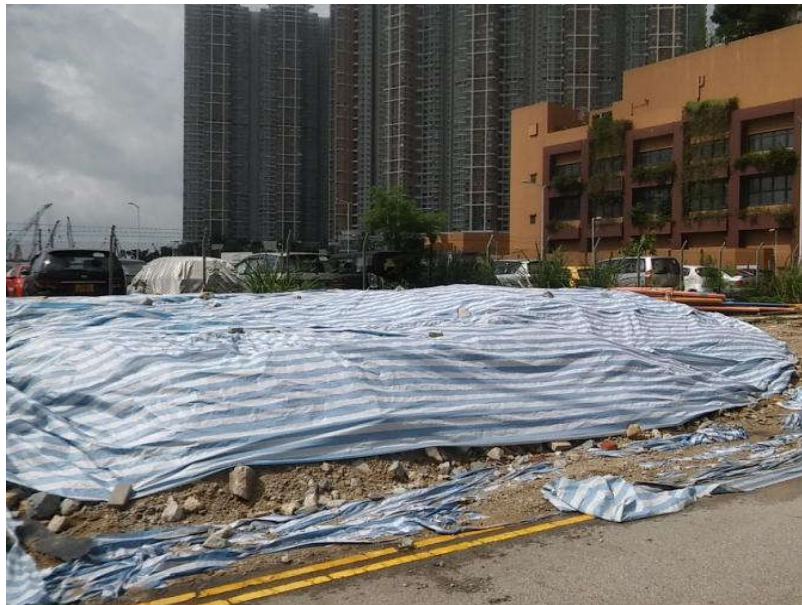
### Stockpile Cover

**Stockpile Should be proper cover with tarpaulin.**

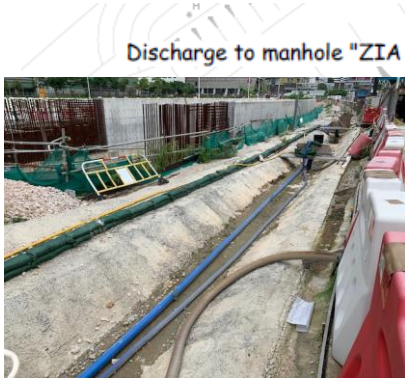
Temp. Channel

Discharge to manhole "ZIA 4004921"

- ← channel / surface water flow direction
- ← water pump direction
- sump pit
- sedimentation tank

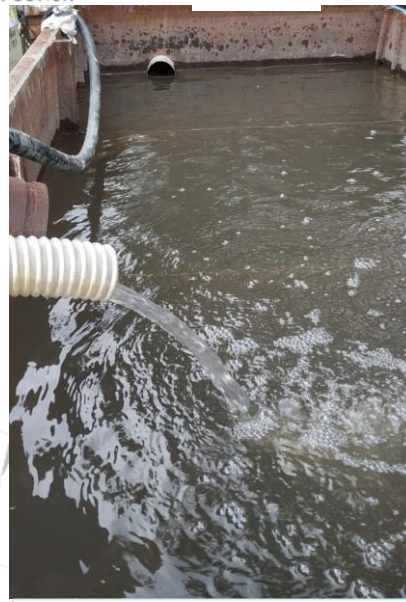
Sedimentation Tank

Temp. drainage system at the site office area
