**Agreement No. CE 59/2015 (EP)
Environmental Team for
Tseung Kwan O – Lam Tin Tunnel
Design and Construction**

**Monthly Environmental Monitoring and
Audit Report for
May 2022
(Version 2.0)**

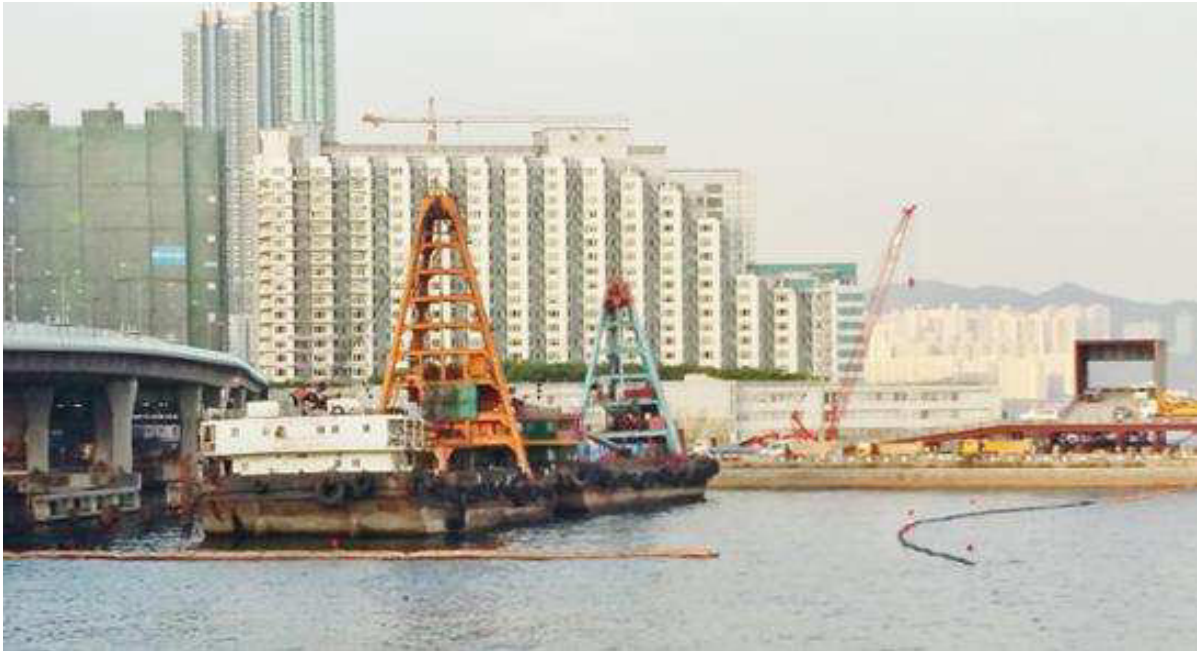
Date	Jan 2015
Project	Contract No. SCL1121 Shatin to Central Link - NSL Cross Harbour Tunnel
Client	MTRC
Consultant	AECOM Asia Co. Ltd
Main Contractor	Penta Ocean - China State JV
Works	Silt Curtain
Material	Woven Geotextile Bontec SG110/110
Quantity	8,400 sqm

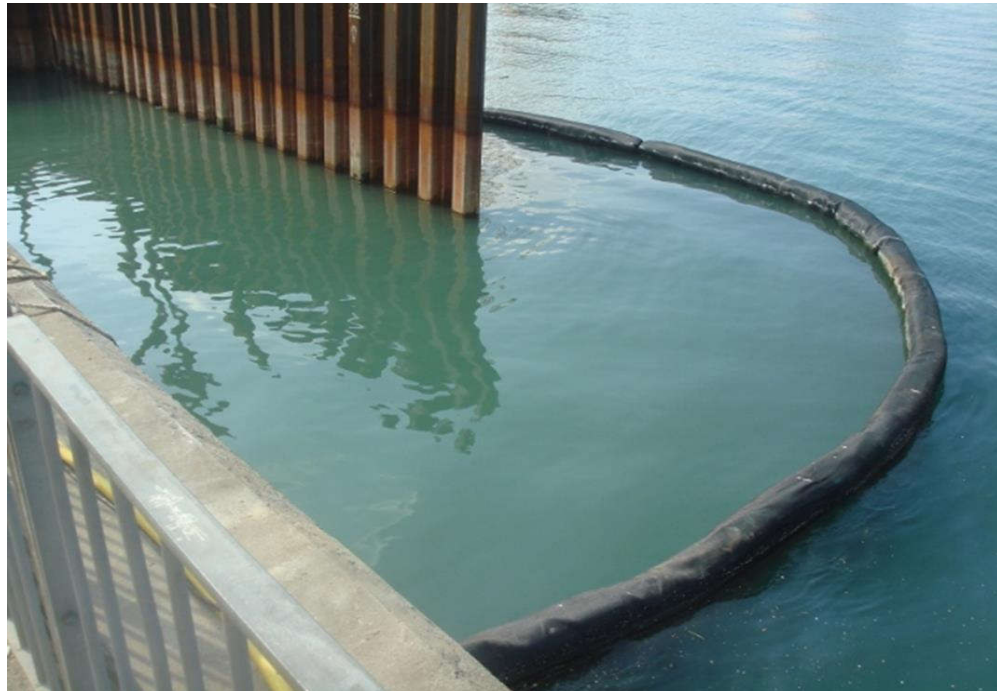
Date	Nov 2014
Project	Contract No. HY/2010/08 Central-Wanchai Bypass - Tunnel (Slip Road 8 Section)
Client	Highway Department
Consultant	AECOM Asia Co Ltd
Main Contractor	China State Construction Engineering (HK) Ltd
Works	Silt Curtain
Material	Woven Geotextile Bontec SG110/110
Quantity	1,575 sqm

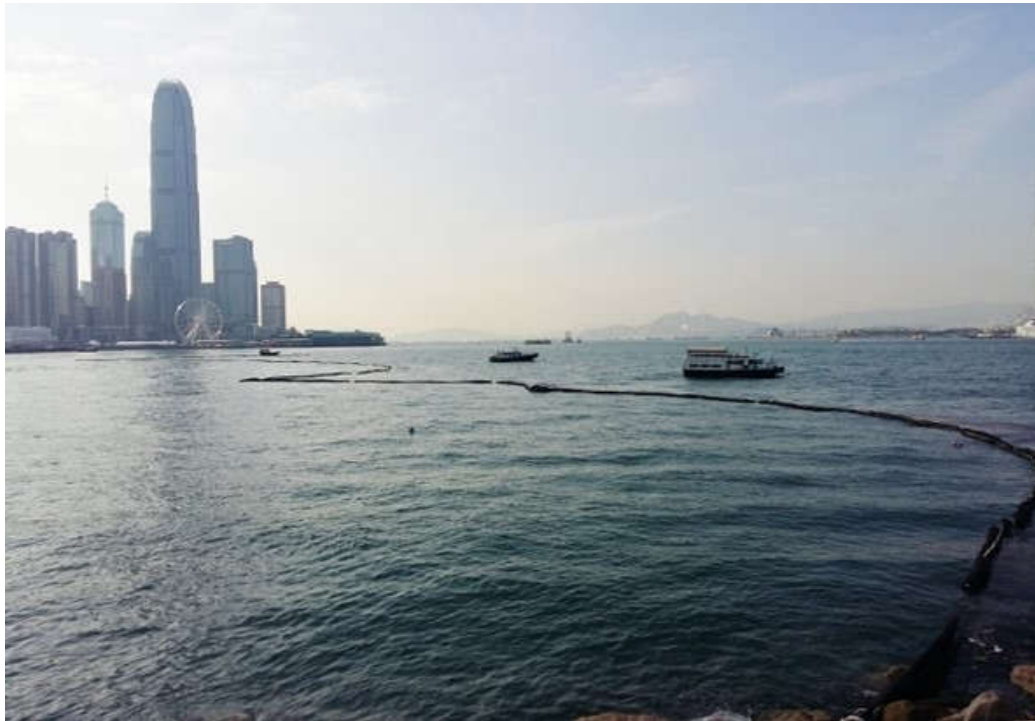
Date	May 2013
Project	Contract No. HK/2012/08 Wan Chai Development Phase II - Central Wan Chai Bypass at Wan Chai West
Client	CEDD
Consultant	AECOM Asia Co. Ltd
Main Contractor	China State Construction Engineering Co. Ltd
Works	Silt Curtain
Material	Woven Geotextile SG110/110
Quantity	42,000 sqm

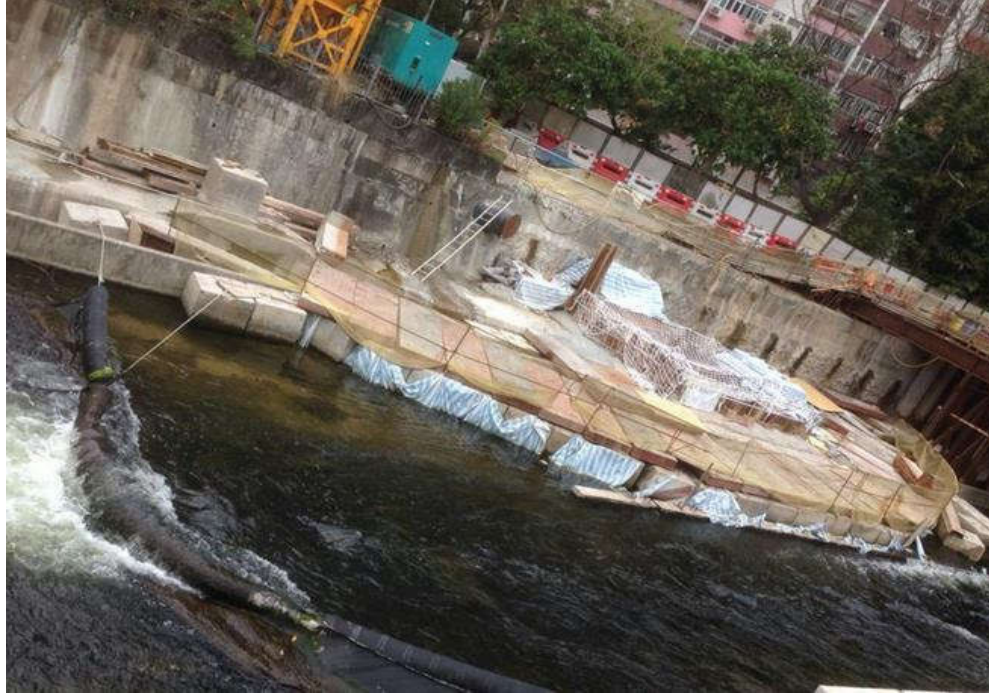
Date	Feb 2014
Project	Contract No. DC/2011/04 Reconstruction, improvement and rehabilitation of Kai Tak River from Wong Tai Sin Police Station to Tung Tau II Estate
Client	Drainage Service Department
Consultant	Scott Wilson Limited
Main Contractor	Leader - Sunnic JV
Works	Silt Curtain to Kai Tak Nullah
Material	Woven Geotextile Bontec SG110/110
Quantity	525 sqm

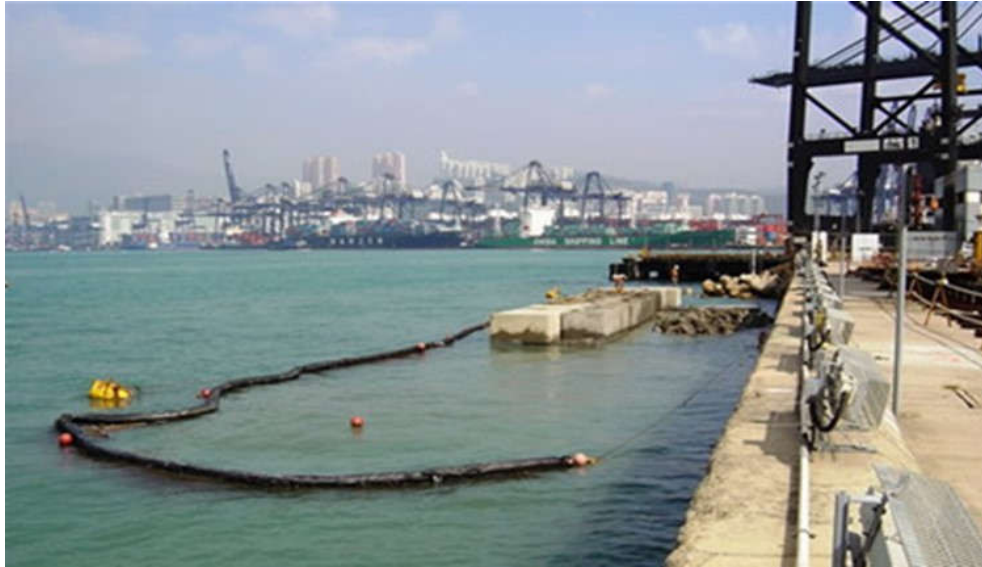
Date	November 2005
Project	Contract No. HY/2002/26 Stonecutters Bridge
Client	Highway Department
Consultant	Ove Arup and Partners HK Ltd
Main Contractor	Hong Kong River Engineering Co Ltd Maeda - Hitachi - Yokogawa - Hsing Chong Joint Venture
Material	Woven geotextile Bontec SG110/110
Works	Tailor-made Silt Curtain
Size	1,050 sqm

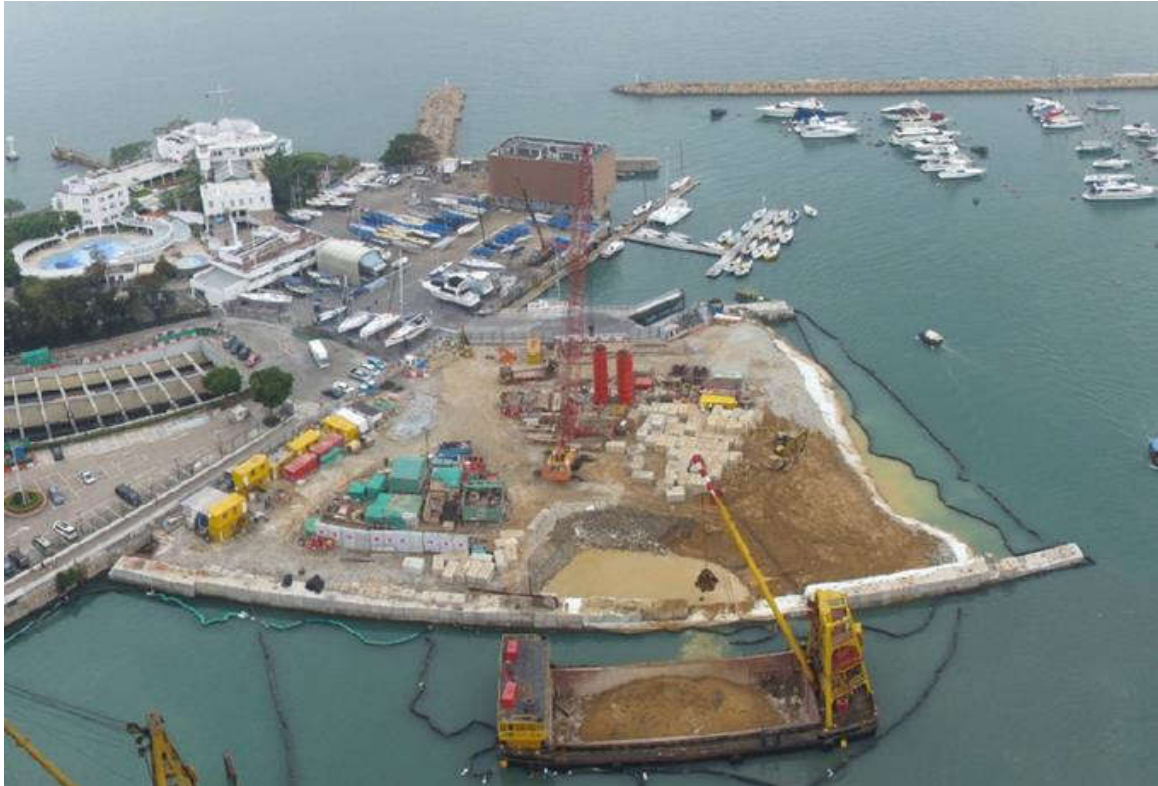
Date	June 2013
Project	Contract No. HY/2009/15 Central-Wanchai Bypass-Tunnel (Causeway Bay Typhoon Shelter Section)
Client	Highway Department
Consultant	AECOM Asia Co. Ltd
Main Contractor	China State Construction Engineering (HK) Limited
Works	Tailor-made Silt Curtain
Material	Woven Geotextile Bontec SG110/110

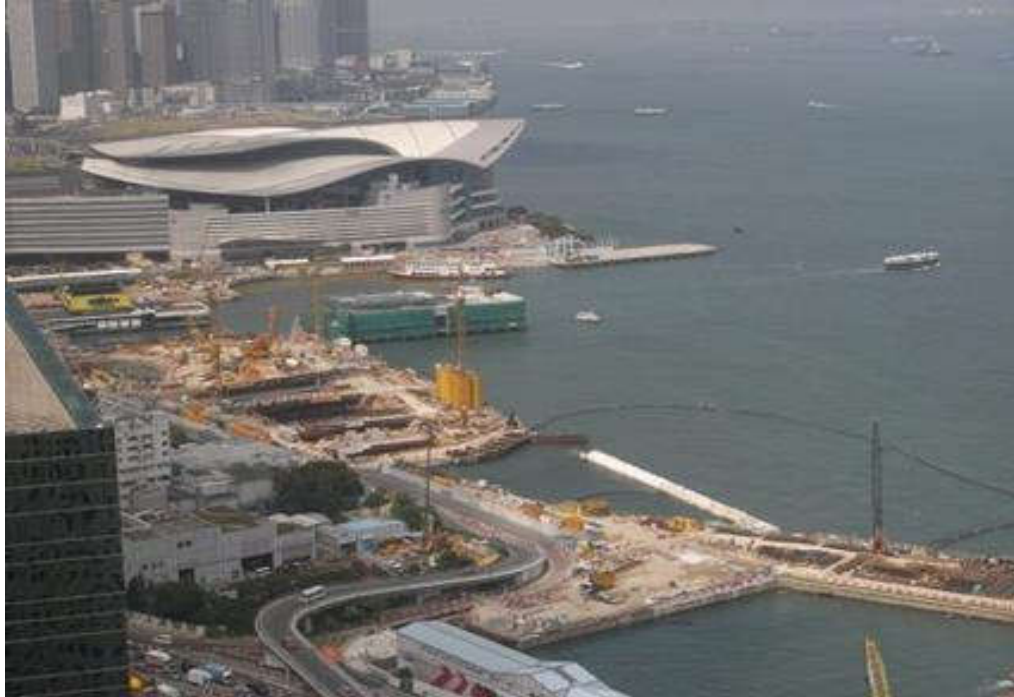
Date	March 2010
Project	Contract No. HK/2009/01 Wan Chai Development Phase II -Central - Wanchai Bypass at Hong Kong Convention and Exhibition Centre
Client	Civil Engineering and Development Department
Consultant	AECOM Asia Co. Ltd
Main Contractor	Chun Wo - Leader Joint Venture
Works	Intake Silt Curtain
Materials	Woven Geotextile SG110/110
Size	34,125 sqm

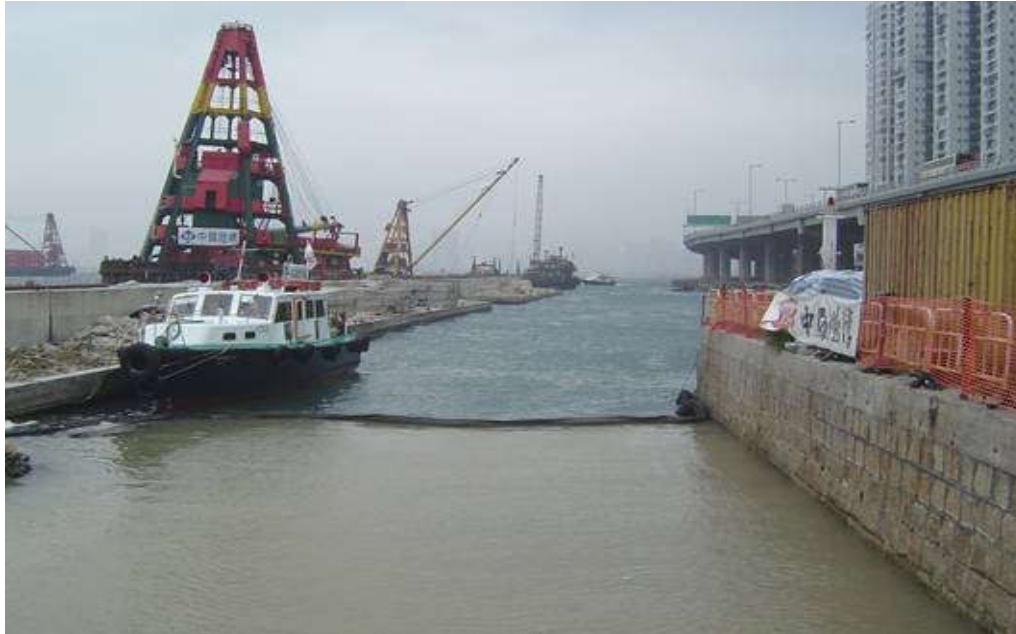
Date	April 2011
Project	Contract No. HY/2009/11 Central - Wanchai Bypass - North Point Reclamation
Client	Highways Department
Consultant	AECOM Asia Ltd
Main Contractor	China Harbour Engineering Company
Works	Tailor-made Silt Curtain
Materials	Woven Geotextile SG110/110
Quantity	22,066 sqm

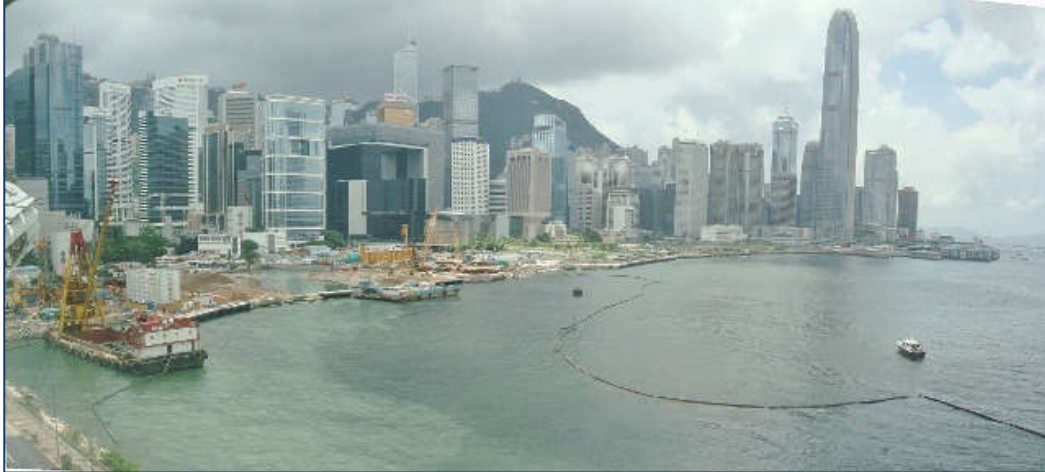
Central – Wan Chai Bypass - seawall separation using heavy non-woven geotextile Bontec SNW120

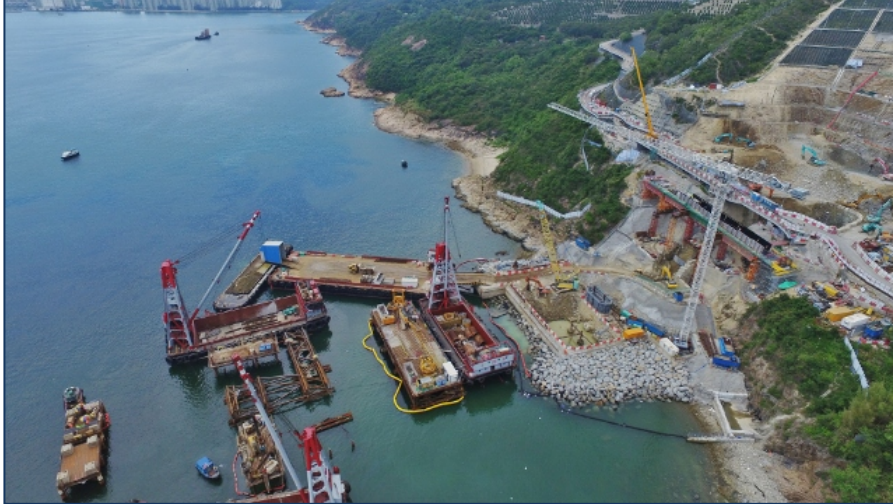
TKO - Lam Tin Tunnel - Main tunnel and associated works using DSP silt curtain

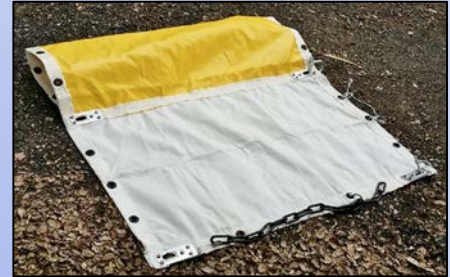
Typical proto-type

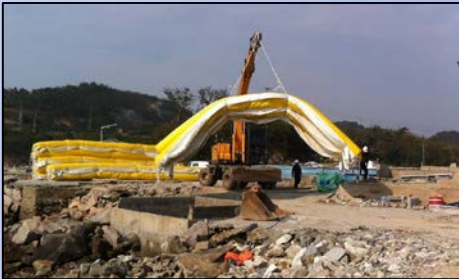
Handling of the silt curtain

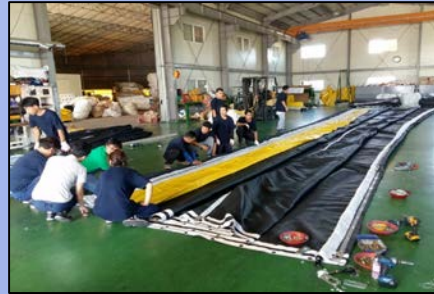
Fabrication of silt curtain

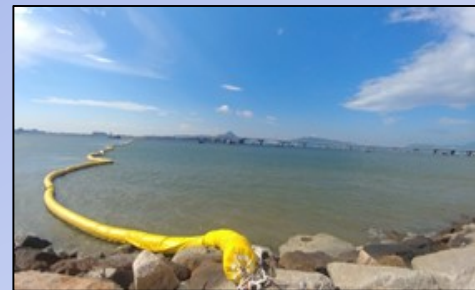
Hanging type

- **Hanging type** - typical floating system to enclosed work area
- **Standing type** - suspended in mid water to allow marine traffic
- **Barge type** – for attachment to vessel or marine structure
- **Cover head type** - for coastal calm area
- **Frame type** - for enclosure of grab bucket
- **Double chain type** – a waving skirt to accommodate tidal change

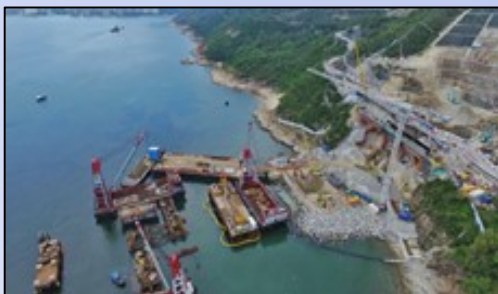
Hanging type - Woven PP geotextile

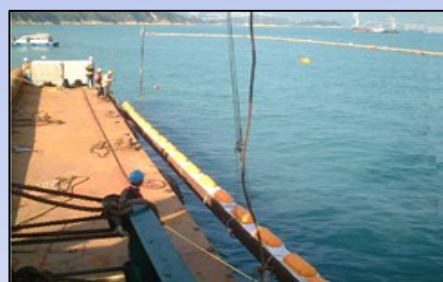
Standing type

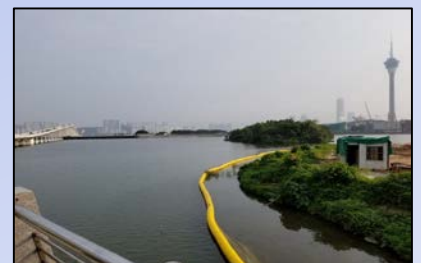
Double chain type

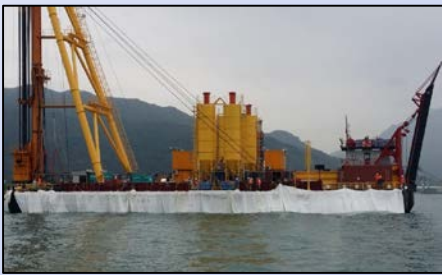
Barge type

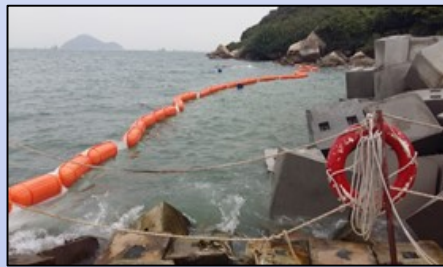
Cover head type

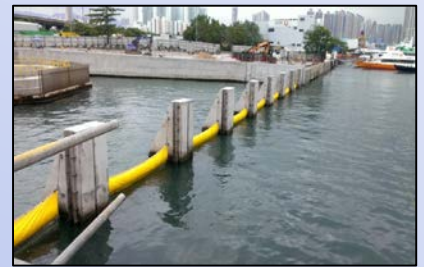
Small span type

There are various sizes of float (buoyancy necessity), different grades of geotextile (strength requirement), a variety of steel plates (connection integrity), reinforcement belt (stiffening the curtain body) and several bottom chain (adequate ballast weight) to configurate the most appropriate system.

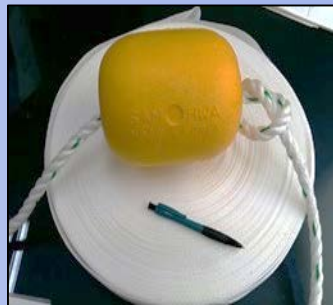
Marker buoy

Optional accessories include sub-float to counter balance wave action, marker buoy to identify anchor position, marker light to signal alignment, fluke & ton bag anchor to replace anchor block as well as PP rope, shackle and anchor wire.

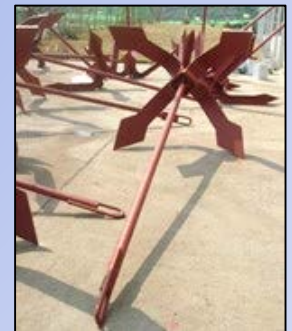
Fluke anchor

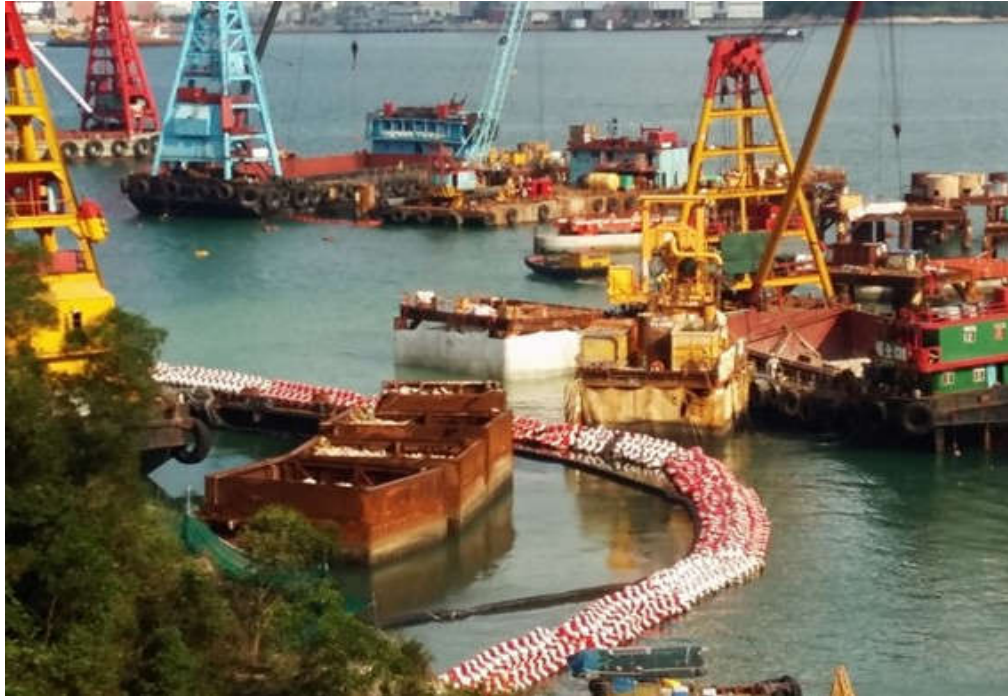
Date	April 2018
Project	Contract No. NE/2017/01 TKO - Lam Tin Tunnel Road - TKO Interchange and Associated Works
Client	Civil Engineering and Development Department
Consultant	AECOM Asia Co Ltd
Main Contractor	Chun Wo - STEC - CMGC JV Sam Woo Bore Pile Foundation Ltd
Works	Piling Rig Silt Curtain
Material	DSP15 Skirt Type Silt Curtain
Quantity	214 spans

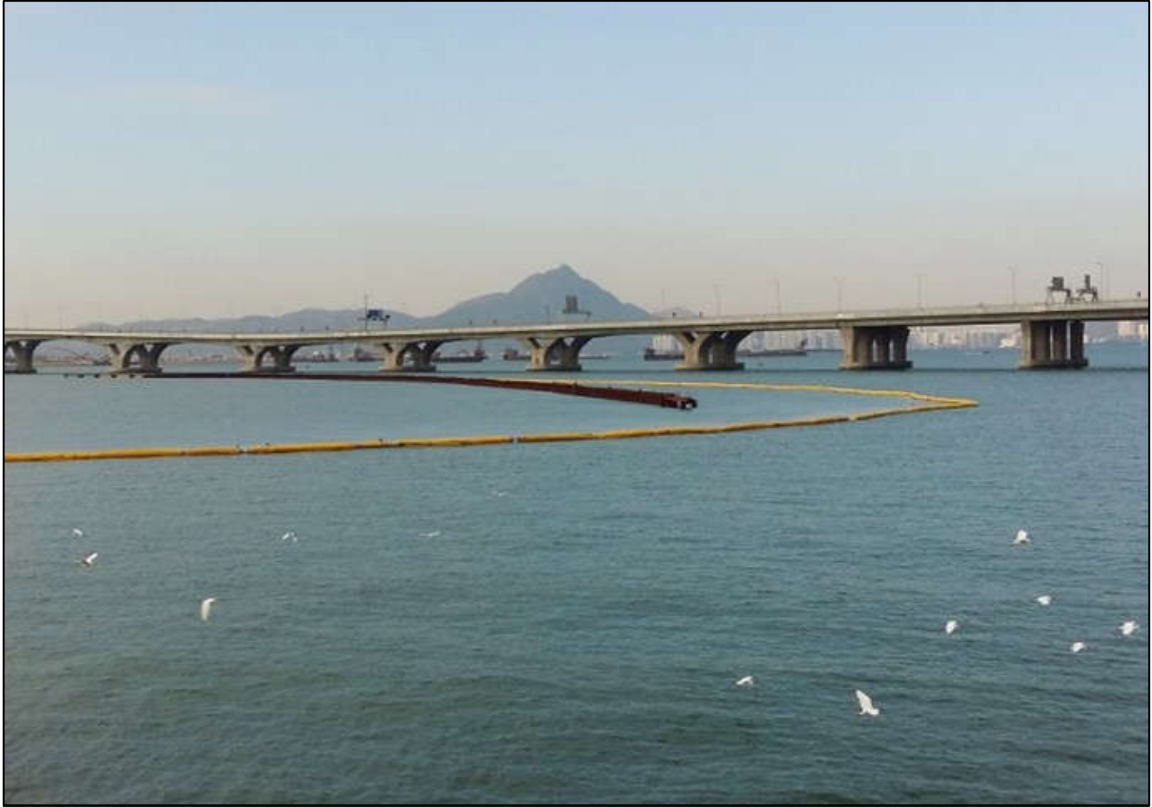
Date	April 2018
Project	Contract No. NL/2017/03 Tung Chung New Town Extension - Reclamation and Advance Works
Client	Civil Engineering Development Department
Consultant	AECOM Asia Co Ltd
Main Contractor	Build King - Samsung C & T JV
Works	Marine Water Turbidity Control
Material	DSP15 Tube Type Silt Curtain
Quantity	514 spans, 10.28 km long

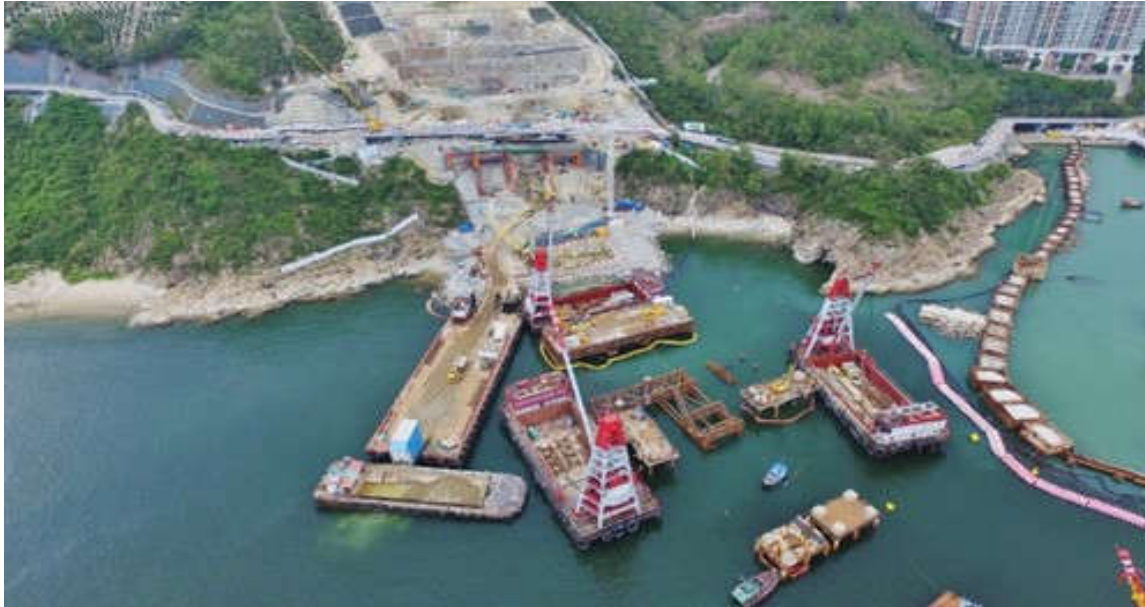
Date	April 2018
Project	Contract No. NE/2017/01 TKO - Lam Tin Tunnel Road - TKO Interchange and Associated Works
Client	Civil Engineering and Development Department
Consultant	AECOM Asia Co Ltd
Main Contractor	Chun Wo - STEC - CMGC JV Sam Woo Bore Pile Foundation Ltd
Works	Piling Rig Silt Curtain
Material	DSP15 Barge Type Silt Curtain
Quantity	182 spans - 500 m length

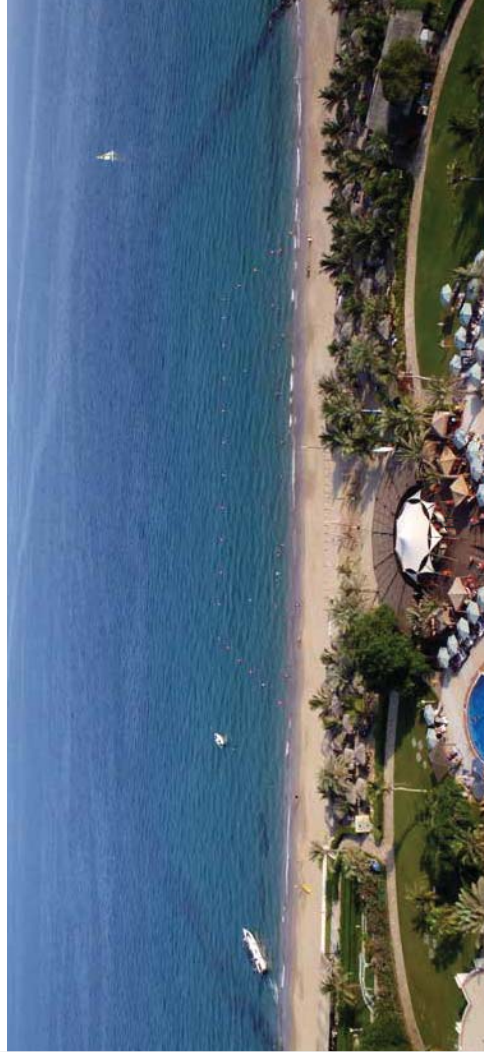
REFERENCE 2

For embankment filling, the ACETube® geotextile tube forms the core structure of the embankment to increase the dredging capacity. **Stones laid outside of the embankment protect and improve the service life of the structure.** The height of a single geotextile tube can be up to 4.0 m or more. After double stacking the ACETube®, and adding the riprap cover, the levee height reached almost 9.0 m.

The ACETube® geotextile tube skillfully uses the dredged sand source as the sand embankment material to simultaneously reduce the cost of dredging and construction materials and lower the carbon emissions of the total project to achieve effects of safety, environmental friendliness and cost-effectiveness. The giant sand containment system manufactured with high-strength geotextiles can significantly increase the allowable fill volume in a single session, which greatly reduces the material and construction cost.

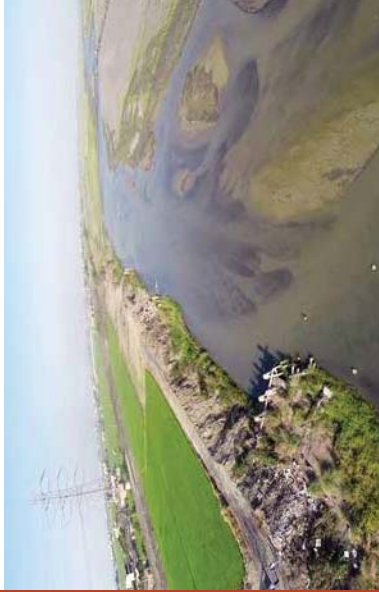
The ACETube® geotextile tubes were used to shelter the foundation of the PC spur dam. First, a layer of polypropylene ACETube® paved both sides of the dam's foundation to retard base subsidence. The ACETube® were then filled to different heights or stacked together to stabilize the foundation, and to reduce the effects of scour and improve the effectiveness of siltation at the pier heads. Also, at the most severe erosion sites, gabions overspread the ACETube® and gaps were filled with local sand to amplify the overall erosion resistance of the structure.

Zhuoshui River often encounters the problems of flood plain shrinkage. A spur dam was installed to serve as the river bank protection; however, due to long-term erosion along the foundation at the spur head, soil loss and local settlement of the structure occurred resulting in the destruction of the gabion shield and exposure of the pier head.

This project has canvassed more than 1,100 m of the Zhuoshui River bank for the protection of flood plain slopes and several spur dams along the river. Instead of solely using gabions, the combination of gabions with ACETube® geotextile tubes can save around 30-40% of the overall costs, and furthermore reduce approximately 88% of carbon emissions. The shoreline has extended and direct erosion of the flood plain has reduced, successfully improving the safety of the embankment and well exerting its functions.

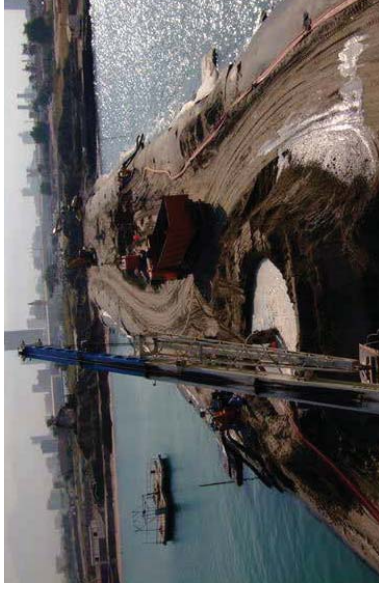
This project applied various types of ACETube® as the perimeter barrier structure which contained and trapped in-situ sand to forming the core of the breakwater. The construction was carried out from bottom to top with the usage of 286 ACETube® geotextile tubes. Externally, ACETube® was covered with an under-layer of aggregates and further protected by a layer of armor rocks. The final look was similar to a rubble-mound type breakwater.

This project was at a coast in Ras Al Khaimah, where there was a groyne for the protection of the navigation channel. The local authority planned to build a fishing port right there where the groyne was and decided to make use of it as a part of the port.

The innovative application of ACETube® for breakwater construction significantly reduced the cost and minimized environmental disturbance. The project even won 2013 International Achievement Award from IFAI for its outstanding performance.

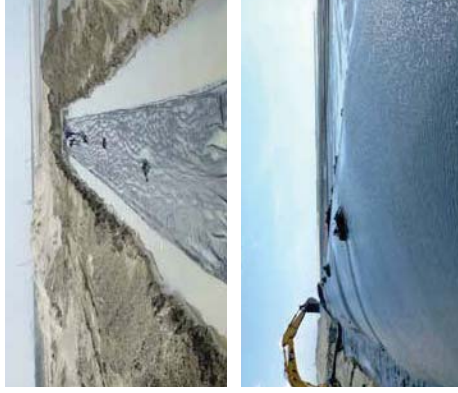
In this case, the existing sea sand is filled into the giant ACETube® geotextile tube. The geotextile tube forms a gravity structure to meet the needs for stability of the cofferdam, and has the functions of energy dissipation and wave breaking, and thus it can dredge the silt and fill the land.

Using the existing sea sand to backfill the giant ACETube® geotextile tube can reduce the amount of concrete and reduce the damage of the project to the coastal ecological environment. Compared with the wave block of equal weight, it can reduce at least 2500T-CO₂ emissions. Compared with riprap of equal weight, it can reduce engineering costs by 50% and truly achieve the green goals of safety, economy, ecological protection and carbon reduction.

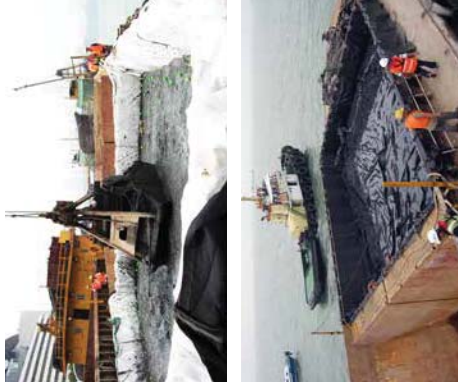
For sludge dredging and treatment, the designer manages to deploy the ACEContainer™ sandbags in the second phase of the Victoria Harbor Development Project. The ACEContainer™ is sized and installed according to the opening space of the open-bottom vessel (hopper barge). After being filled with silt and sealed, it can be directly transported to the intended location by the open-bottom vessel (hopper barge) for throwing operations.

The use of ACEContainer™ is a faster and more effective solution than conventional dredging techniques. As ACEContainer™ has excellent tensile and stitching strength, water permeability and filtration properties, it can properly encapsulate sludge during the casting process to avoid environmental pollution.

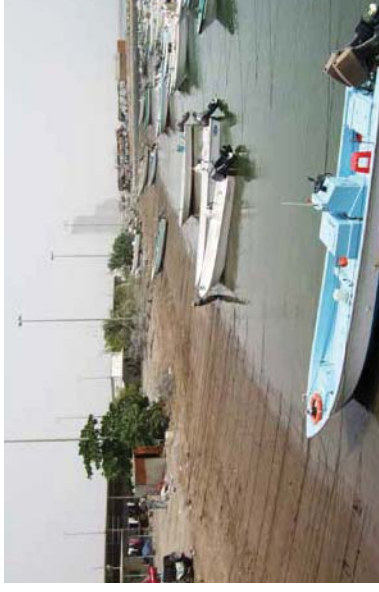
The designer proposed building a 3 m high reinforced earth quay wall. The wall face was built with stacked precast concrete blocks, each 70 cm high. These blocks then were with ACEGrid® geogrid. To avoid the reduction of soil strength caused by the sea, as well as the possible structure settlement, the foundation of the retaining wall below water level was backfilled with graded aggregate. The upper part above water level was backfilled with sand.

The quay wall and marina have been attacked by tropical cyclones from the Gulf of Oman, these structures remain steady. The capacity and convenience of the fish port has been significantly enhanced by the construction of the quay wall.

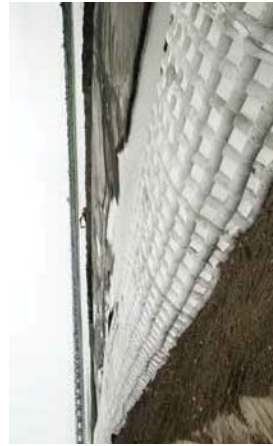
The reinforced soil structure is a gravity retaining structure composed of a panel system, stiffening materials, and rammed backfill soil. The reinforcement material is buried between the soils, and the tensile strength and shear strength of the original soil are increased by the strength of the material. Its application not only can greatly reduce construction costs, shorten the construction period, achieve earthwork balance, and allow large deformation of structures caused by earthquakes or other external forces, but also increases its aesthetics upon completion.

When the reinforced soil structure is used as the embankment, the geogrid has good hydrolysis resistance and will not be damaged by the water soaking, and the soil sand surrounded by the stiffening grid will not be lost, so the overall stability can be maintained.

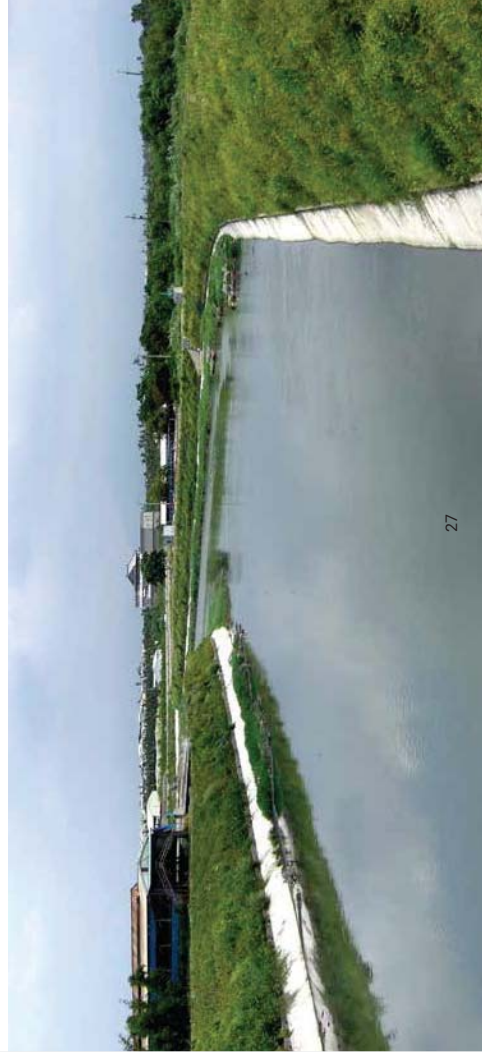
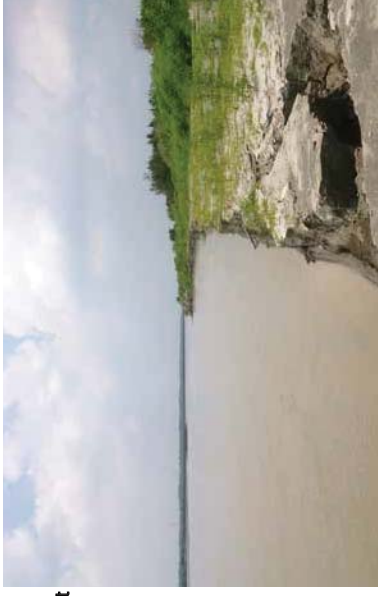
REFERENCE 2

The foundation of the project uses the pre-cast concrete blocks. The existing dredged soil is used to construct the ACEGrid® Reinforced Revetment above the flood level.

The flooding of upstream villages and farmland can be improved to reduce the flooded area by about 300 hectares. The reinforced wall surface can be planted and greened. Upon completion, the planting and greening effect is remarkable, and it has the advantages of porosity, rough surface and self-purification ability to restore water quality. In-situ backfilling with local dredged earth and stone can reduce transportation costs and carbon emissions.

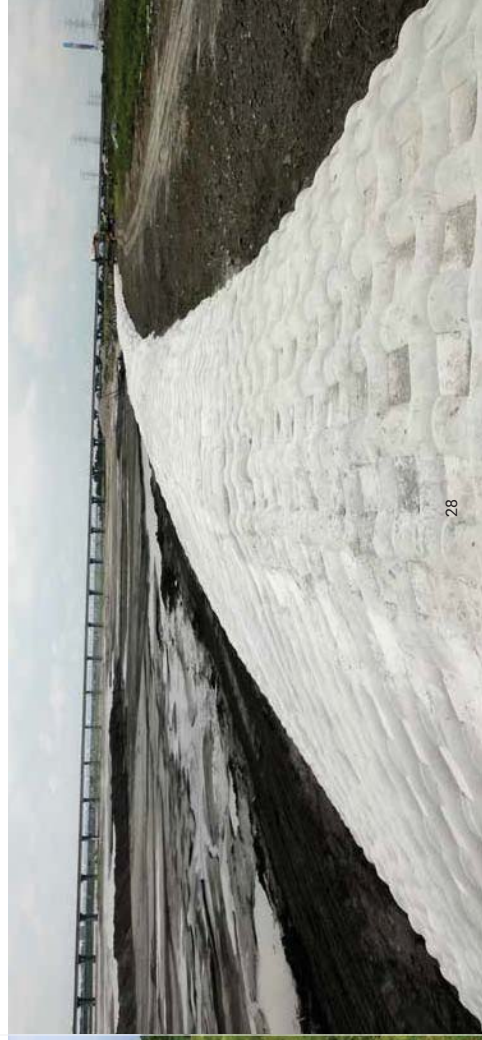
The ACETube® geotextile tube is filled with the existing river silt near the site, and the surface layer is laid with the ACEFormer™ geotextile mattress filled with cement mortar to strengthen the slope strength and protect the high riverbank from loss.

After the remediation, the bank line extends outward, prevents the river from directly scouring the high riverbank, and improves the safety of the riverbank and the dike. Compared with the gabion, it saves the cost by about 30%~40% and reduces the carbon dioxide emissions by 88%. And it is also conducive to the river environment due to in-situ backfilling with the use of existing silt.

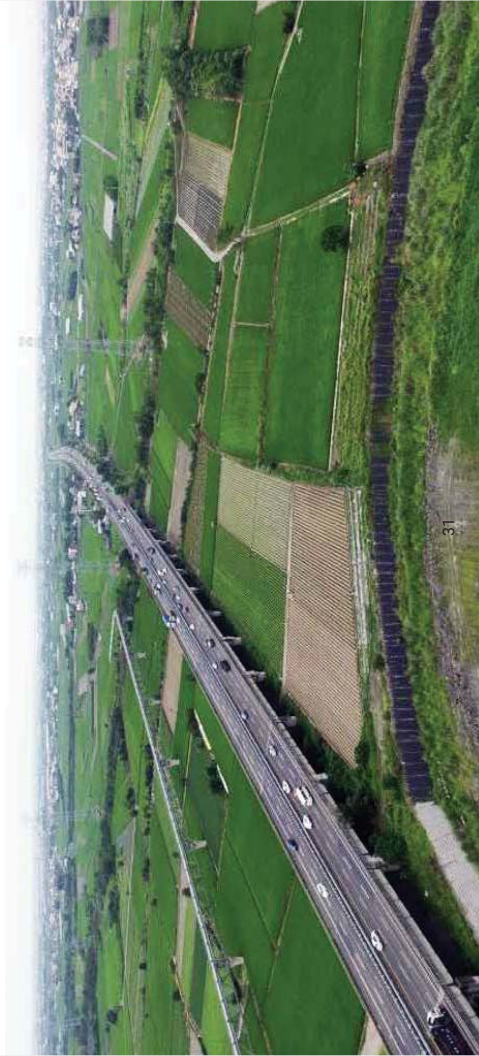
Adopt the scouring protection system composed of the ACETube® geotextile tube and ACEFormer™ geotextile mattress.

A significant amount of cost of using expensive concrete materials can be saved. The flexible nature of the material allows it to adapt to different topography and local conditions, which not only makes engineering easier, but also helps the structure to adapt to the environment.

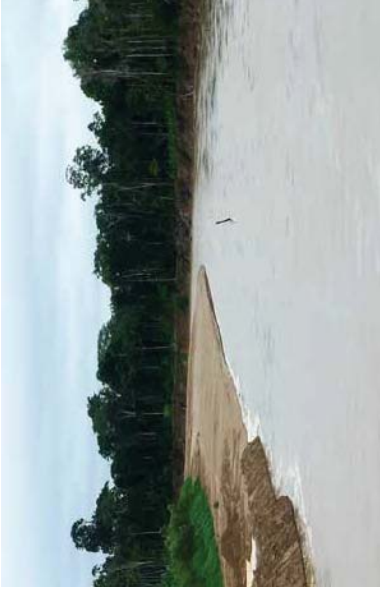
The long-term lateral erosion of the riverbank causes the slope to collapse continuously and the side slope on the bank to be nearly vertical, and as the vegetation cannot grow, it poses a threat to the stability of the riverside roads and the bridge along the river bank.

The ACETube® geotextile tubes in different sizes are stacked on the bank slope and around the pier to form a revetment, and the ACETube® geotextile tubes are stacked on the upper part of the river bank to form several layers that increase the revetment height. A total of 2,050 geotextile tubes in three sizes are mainly used.

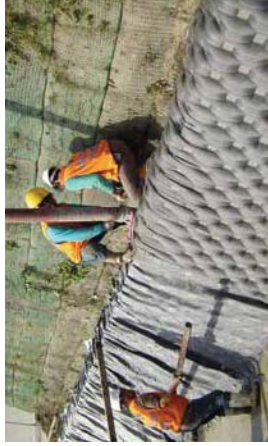
In order to prevent the erosion of the slope and the loss of soil, using the ACEFormer™ as the revetment is a very effective solution. ACEFormer™ are two-layer and high-strength geotextile mattresses grouted with cement mortar or concrete. The geotextiles are able to accommodate different landforms, and provide a formwork to construct a surface protection structure. With the filling material, the ACEFormer™ system provides an

effective shield and medium against erosion, and to reduce the wave energy and flow velocity on the applied surface.

ACEFormer™ is very different from the traditional steel formwork. It contains the interconnected bag space for filling cement mortar. When the mortar is solidified, a rigid panel is formed for protection. As it is not like the general formwork that needs to be removed after grouting, it can save working hours.

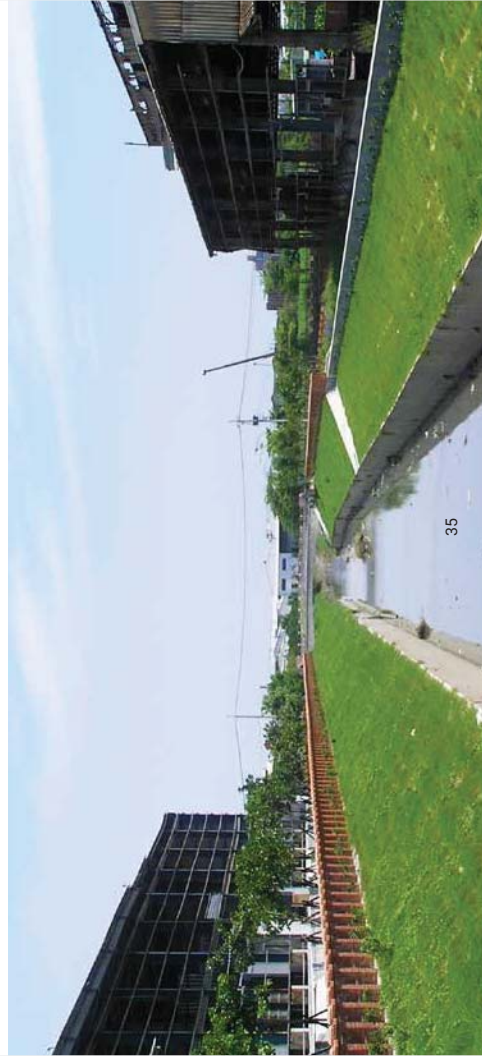
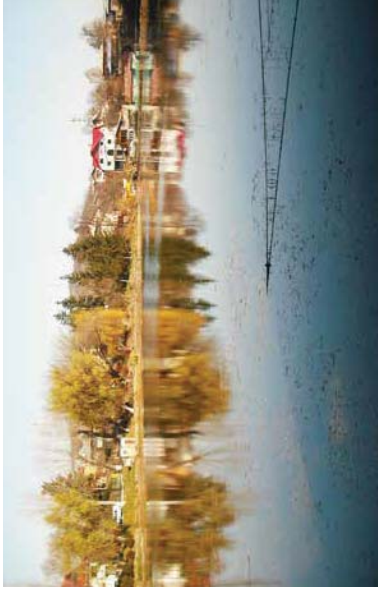
REFERENCE 2

Pursuing the objectives of the project, the designer came up with a good idea of using ACE Revetment Composite System to meet all the requirements in one solution. To overcome the scouring, reinforced concrete (RC) revetment was used for the area below the water level. The revetment was then backfilled with engineered fill, sloped upward and backward to the pavement grade. To prevent the erosion of surface run-off and to minimize the possible harsh destruction due to overflow or flooding, ACEFormer™ Vegetation Type (V Type) geotextile mattress was placed on the backfilled surface. Different from traditional concrete structure, ACEFormer™ not only provides a durable surface for scouring resistance, but also offers spaces for vegetation to grow.

The initial palish gray surface of the ACEFormer™ has been changing to rich fresh green and a variety of local species have been observed on site. Although the site has experienced several challenges of strong typhoons and torrential rainfalls, the canal stays stable and the flooding damages have ceased completely.

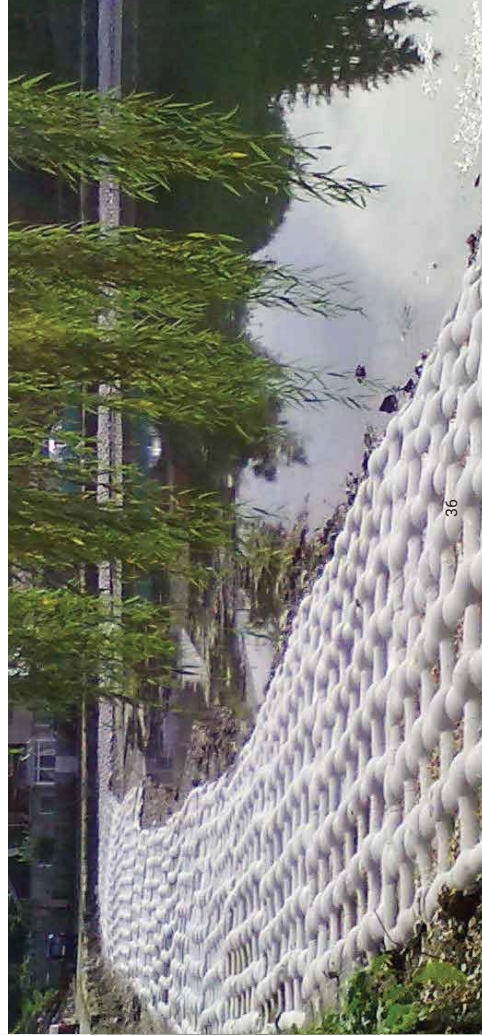
The best solution was to construct the revetment with ACEFormer™ Vegetation Type geotextile mattresses. This easy and quick method could shorten the construction time after the water in lake was drained out.

The ACEFormer™ act as a strong cover layer on the eroded area, and counteracts attacks from water to prevent landslides. The special design of ACEFormer™ Vegetation Type would also crop landscaping plants to avoid the wanton growth of weeds.

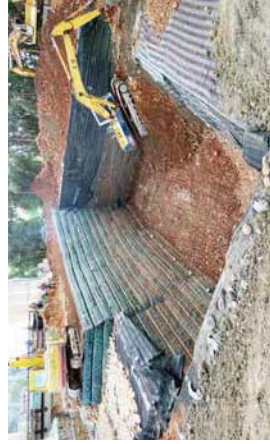
The mechanical effect provided by the geogrid is a stable "apparent cohesion", which is also the main stabilization mechanism of the soil reinforced structure. The geogrid will not

be damaged by water soaking, and the soil that is surrounded by the geogrid will not be lost, so the reinforced structure can maintain stability.

The geogrid has the function of strengthening the soil, which can make up for the insufficient shear strength or tensile strength in the soil. The layered configuration can increase the friction between the material and the soil layer to strengthen the soil. Therefore, the reinforced retaining wall can have a larger slope degree than the natural slope, and increase the flooding capacity of the flood retention pond.

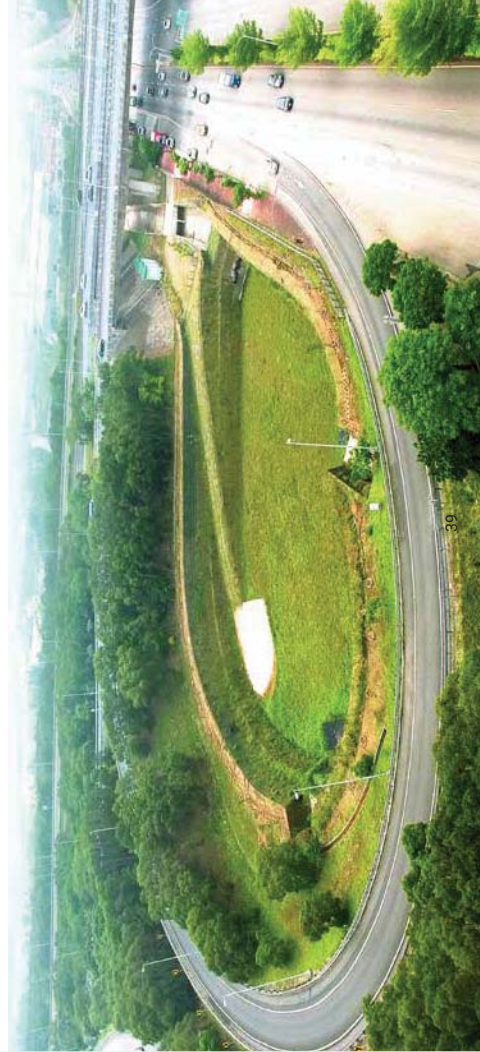
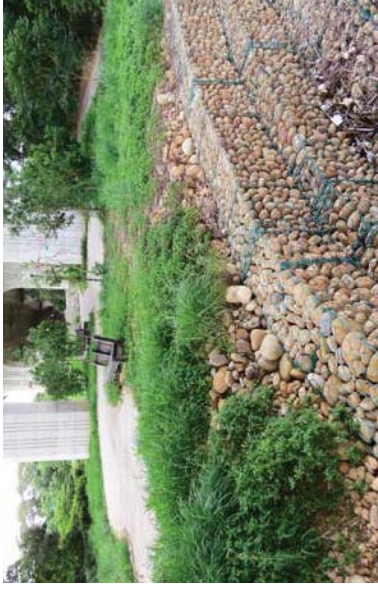
REFERENCE 2

The green space in the northern upper circle of the National freeway's Shalu Interchange is used to dig and construct a detention pond in the stable gravel layer. The pond wall is reinforced with the ACEGrid® geogrid and the ACESandbag™ erosion control bag to hold the local earth and stones.

It is a wrapped-around reinforced structure constructed by using a large amount of excavated earth and stones. In addition to being equipped with the flood detention function, it can also effectively reduce the costs. We set up disaster prevention facilities in idle spaces to effectively address the threat of regional flooding. The stiffend slope has a good vegetative effect, so that the space can still retain the original green landscape.

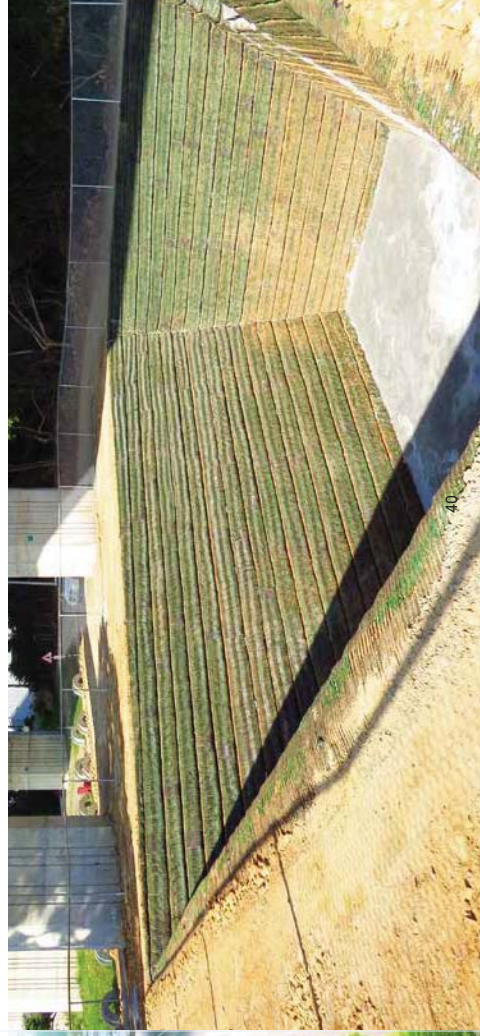
The construction utilized local materials, natural granular backfill to form mechanically stabilized earth (MSE) wall as the wall structure around the detention pond. The bottom of detention pond uses RC raft foundation. Every 4 m vertical height of the MSE wall lays out light gravel drainage layer with horizontal and vertical ACEDrain™ geocomposite drainage panels of 2 m spacing, so that the seepage water in the soil layer behind the slope is diverted into the pond to release the water pressure and to maintain the long-term stability of the reinforced slope. Moreover, the reinforced slope uses durable erosion control bags which are filled with in-situ selected soils and staked on the slope with ACEGrid® GG geogrids wrapping around, allowing the slope to have stable foundation for vegetation and to reach the effects of greening and ecological friendliness.

The detention pond allows surface runoff to be stored temporarily within it and thus achieves the effect of flood storage; moreover, it is able to reduce flood peak flow produced by rainstorm or delay the arriving time of peak flow, and then decrease flooding condition of low-lying district downstream during rainy seasons. Using mechanically stabilized earth (MSE) on this construction not only fulfills the basic demand of security and economy in civil engineering but also conforms to the current trends of carbon reduction and ecological sustainability pursued by the engineering industry.
