**Agreement No. CE 59/2015 (EP)
Environmental Team for
Tseung Kwan O – Lam Tin Tunnel
Design and Construction**

**Monthly Environmental Monitoring and
Audit Report for
May 2022
(Version 2.0)**

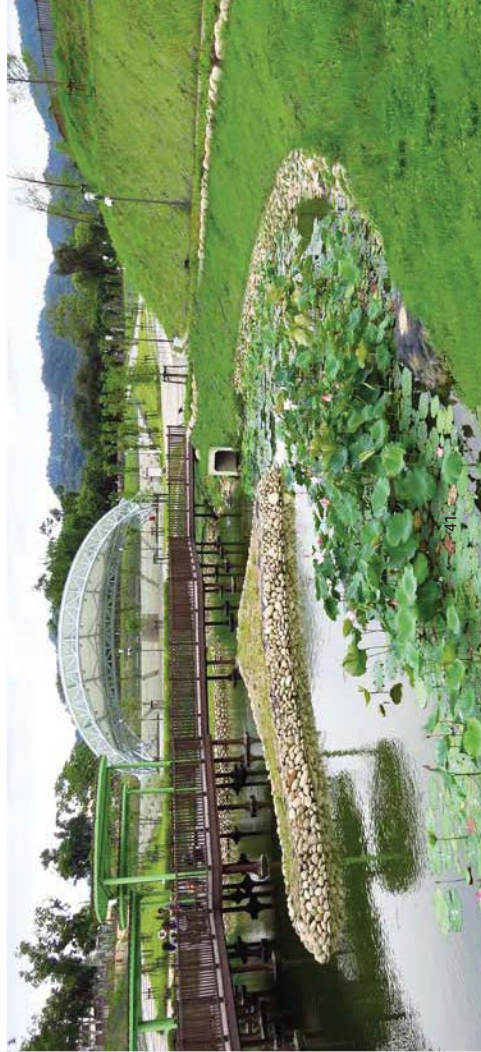
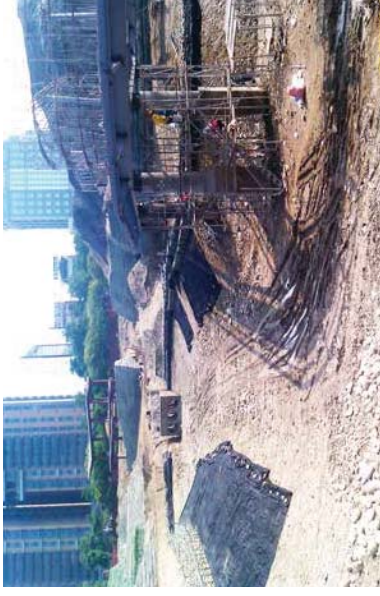
REFERENCE 4

ACEText[®] geotextiles and geosynthetic clay liners are laid under the flood detention pond, pile up pebbles at the bottom and the lower half of the slope, and stack the upper half of the slope with the ACESandbag[™] Erosion Control Bags. Also, we use the ACEMat[™] Turf Reinforcement Mats to carry out erosion protection and planting on the slope of the park.

The occurrence of flooding is greatly reduced, and the recreational and sightseeing space is created to enhance the quality of nearby living environment. The park can adjust the microclimate of the adjacent area, reduce the heat island effect, improve air pollution, and improve the overall quality of life of the local people.

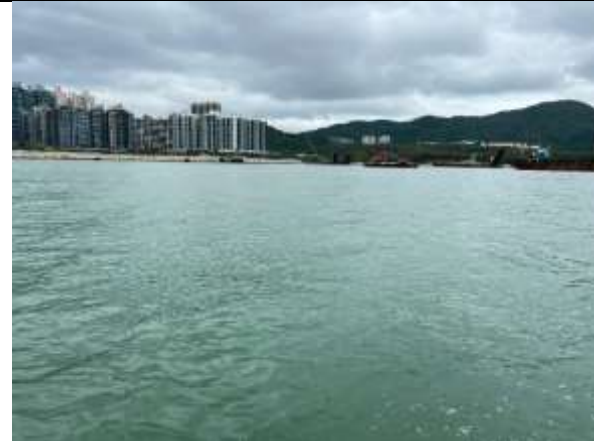
Photo 4 (Recorded on 13 May 2022)

During regular water quality monitoring, the sea appears to be clear in general (Photo 4 to 6). No obvious muddy water was observed during the monitoring.

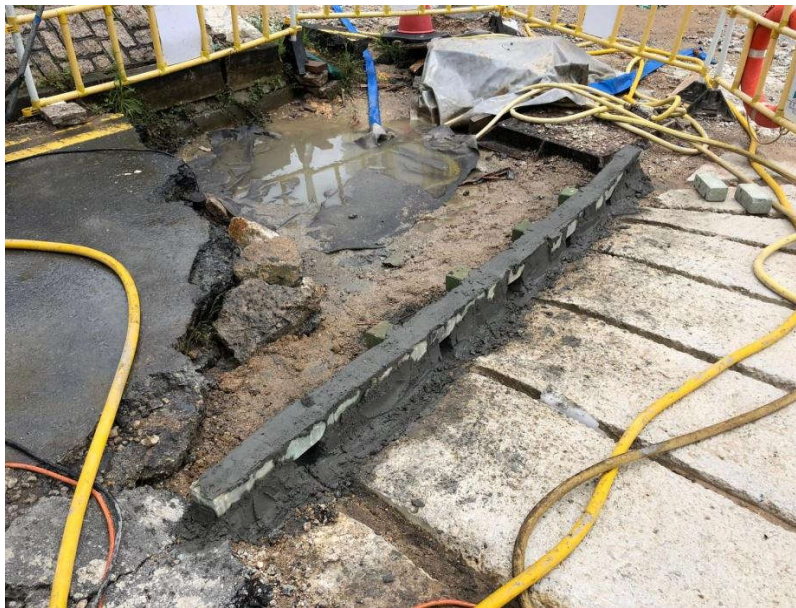
Surface runoff collection

Height difference between the road and site area to form a natural flow. Sump pit was provided for wastewater collection.

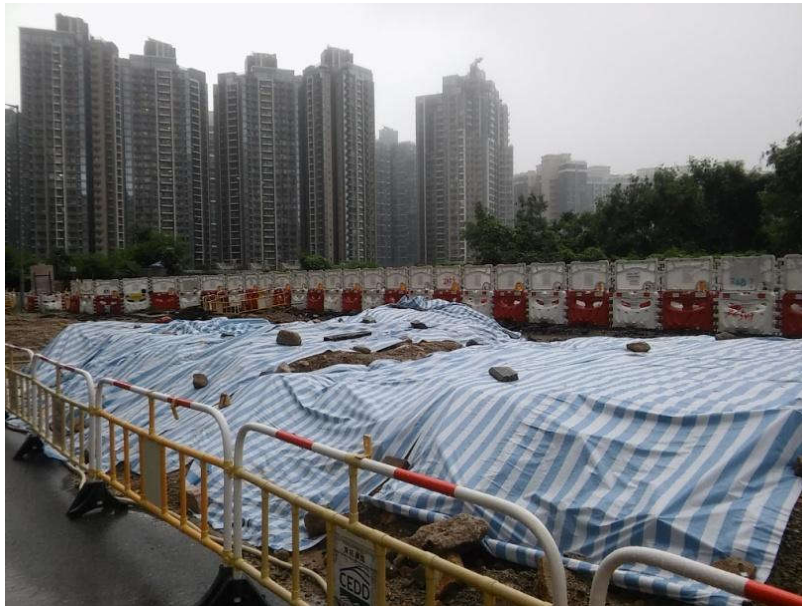
Stockpile Cover

Stockpile Should be proper cover with tarpaulin.
