# **Proposed Comprehensive Development at Wo Shang Wai, Yuen Long**

Monthly EM&A Report for July 2023

**Document reference:** 370161 | 05|01 | A

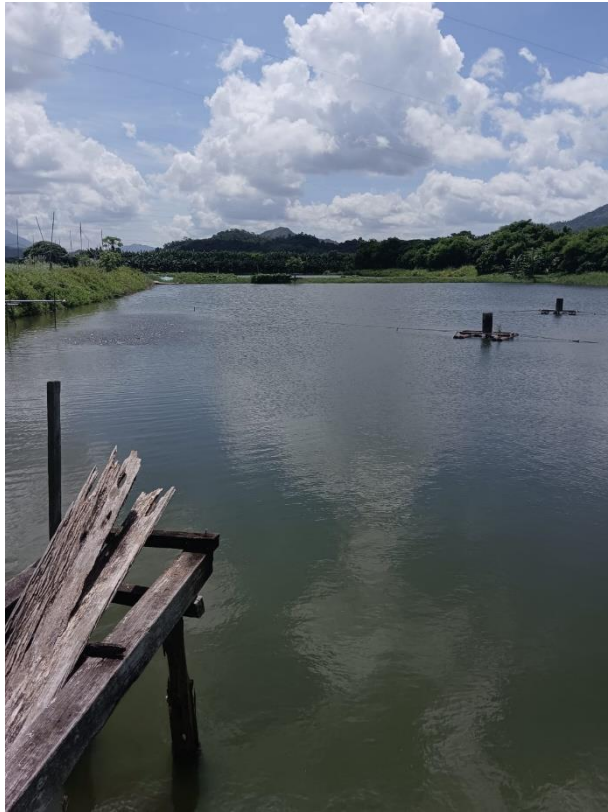
**Photo 3**                    **Appearance of the water body at MP3 on 5 July 2023**

Exceedances of the Action Level of pH were observed on 10, 21, 26 and 31 July 2023, exceedance of the Limit Level of DO was observed on 5, 7, 10, 12, 14, 19, 21 and 28 July 2023 at MP3.

Mitigation measures for water quality protection, including the provision of wastewater treatment facilities (with sedimentation tank and AquaSed) and proper drainage system that separates from the WRA, have been implemented (see Photo 1 & 2). No adverse impact on the fish pond near the site was observed, including on the days with exceedance of water quality parameters.

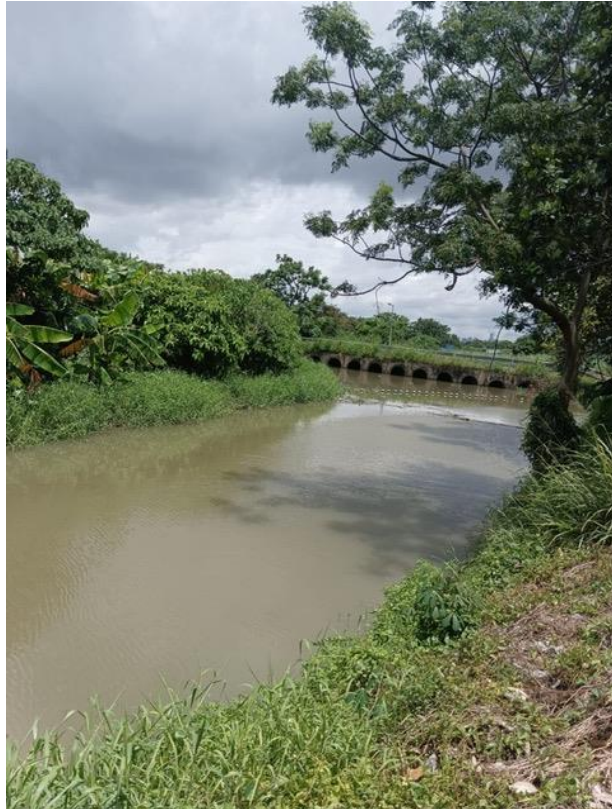
**Photo 13**      **Appearance of the water body at MP4 on 3 July 2023**

On 3 July 2023, the day of DO exceedance at MP4, MP5 and MP6, the water body appeared to be slightly muddy and some reed growth was observed along the ditch (see Photos 13, 21 and 26). Excessive growth of algae and its degradation may have led to a decrease in the DO level in the water. As presented in the weekly site inspections checklists, no observation regarding discharge of muddy water was recorded in July 2023.

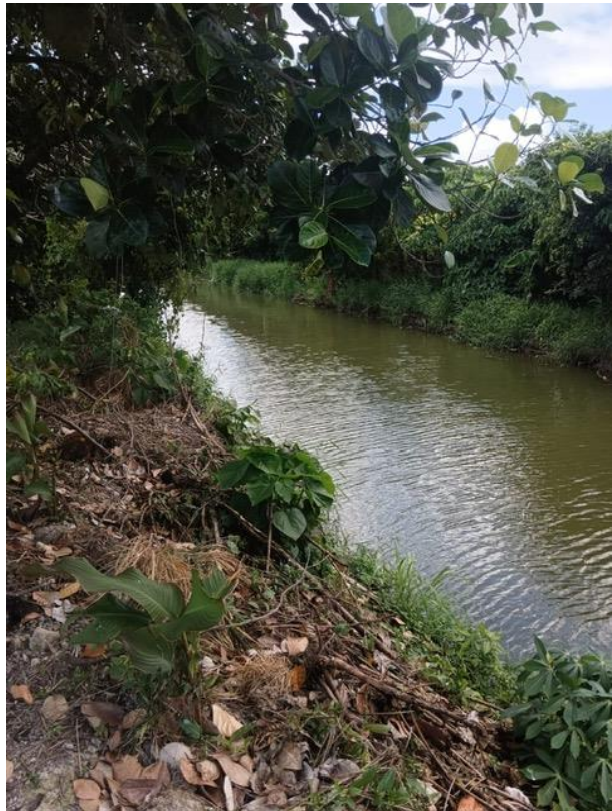
**Photo 14**      **Appearance of the water body at MP4 on 10 July 2023**

Exceedances of the Limit Level of SS were observed on 21 and 24 July 2023 at MP4. Exceedances of the Limit Level of DO were observed on 3 July 2023 at MP4, MP5 and MP6. Exceedances of the Action Level of pH were observed on 10, 12, 14, 28 and 31 July 2023 at MP4; 10, 12, 14 and 26 July 2023 at MP5; and 12, 14 and 26 July 2023 at MP6.

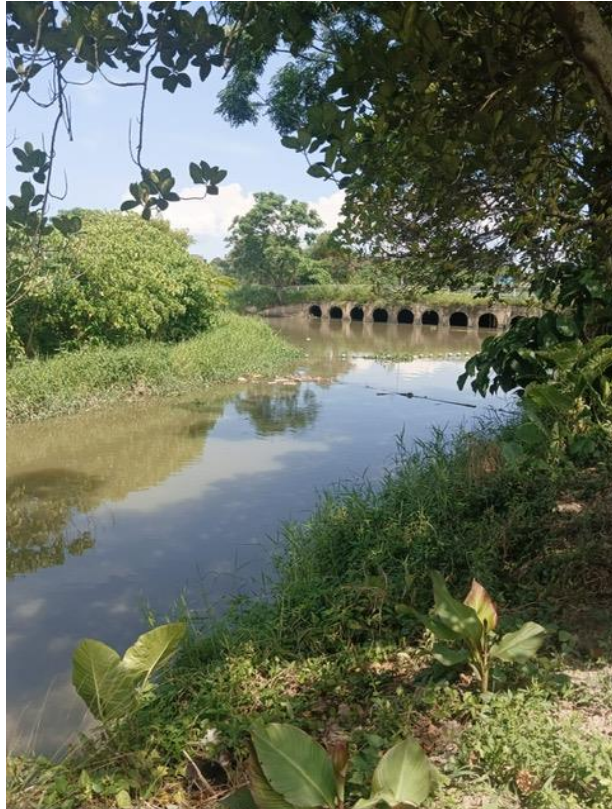
**Photo 17**      **Appearance of the water body at MP4 on 21 July 2023**

Some growth of water plant, fallen leaves and debris was observed at MP4 on the days of SS exceedance (see Photos 17 and 18). It is possible that these items may have impeded the normal flow of ditch water resulting in localised accumulations of SS.
