# **Proposed Comprehensive Development at Wo Shang Wai, Yuen Long**

Monthly EM&A Report for October 2023

10 November 2023

This is the 162<sup>nd</sup> EM&A report submitted under the Condition 4.5 of Environmental Permit No. EP-311/2008/E. This report summarises the findings on EM&A during the period from 1 to 31 October 2023.

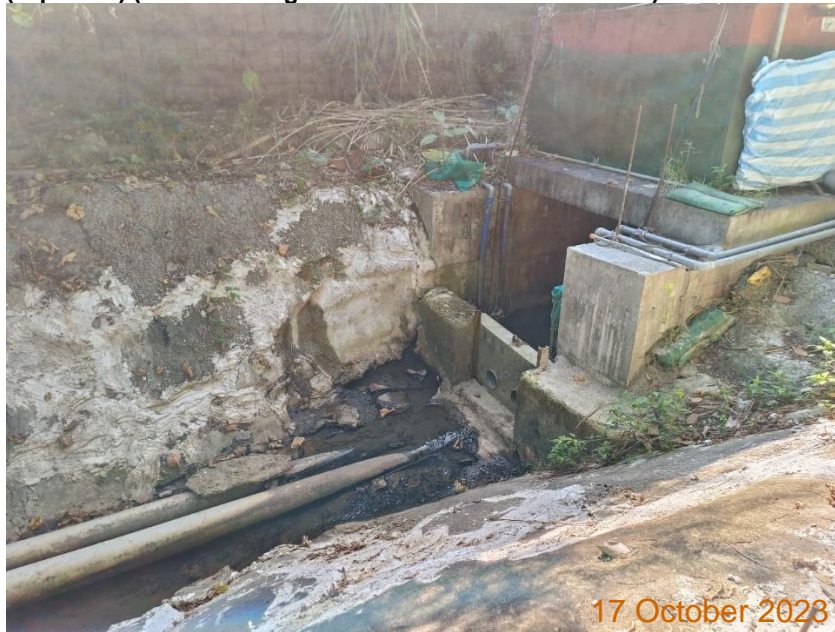
**Photo 1** Installation of barrier at the drainage channel to intercept site runoff and pump the wastewater to the sedimentation tanks prior to wastewater treatment facilities (AquaSed) (near discharge outlet to the northern ditches)

Mitigation measures for water quality protection, including the provision of wastewater treatment facilities (with sedimentation tank and AquaSed) and proper drainage system that separates from the WRA, have been implemented (see Photo 1 & 2). No adverse impact on the fish pond near the site was observed, including on the days with exceedance of water quality parameters.

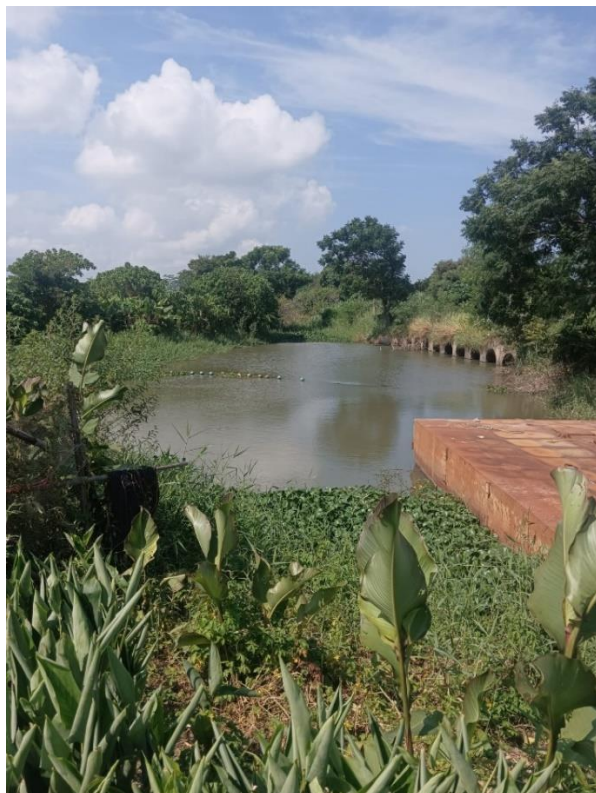
**Photo 16**      **Appearance of the water body at MP4 on 3 October 2023**

A fair amount of water plant growth and some floating vegetation was observed at MP4 on the days of SS exceedances (see Photos 16, 18, 19, 20 and 21). It is possible that excessive growth of vegetation and fallen leaves may have impeded the normal flow of ditch water resulting in localised accumulations of SS.

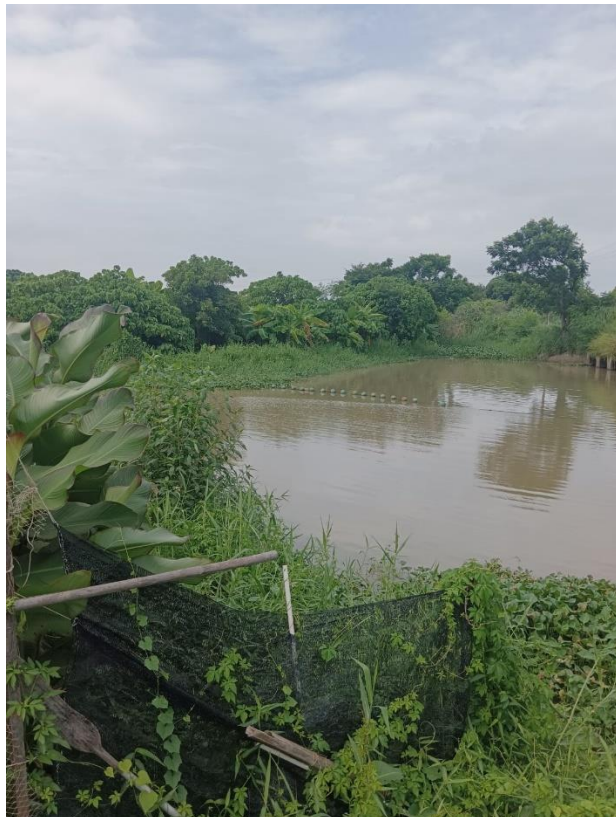
**Photo 20**      **Appearance of the water body at MP4 on 18 October 2023**

It is believed that the SS exceedances at MP4 as well as pH exceedances at MP4, MP5 and MP6 were probably due to localised natural variations, water plant growth and its degradation.

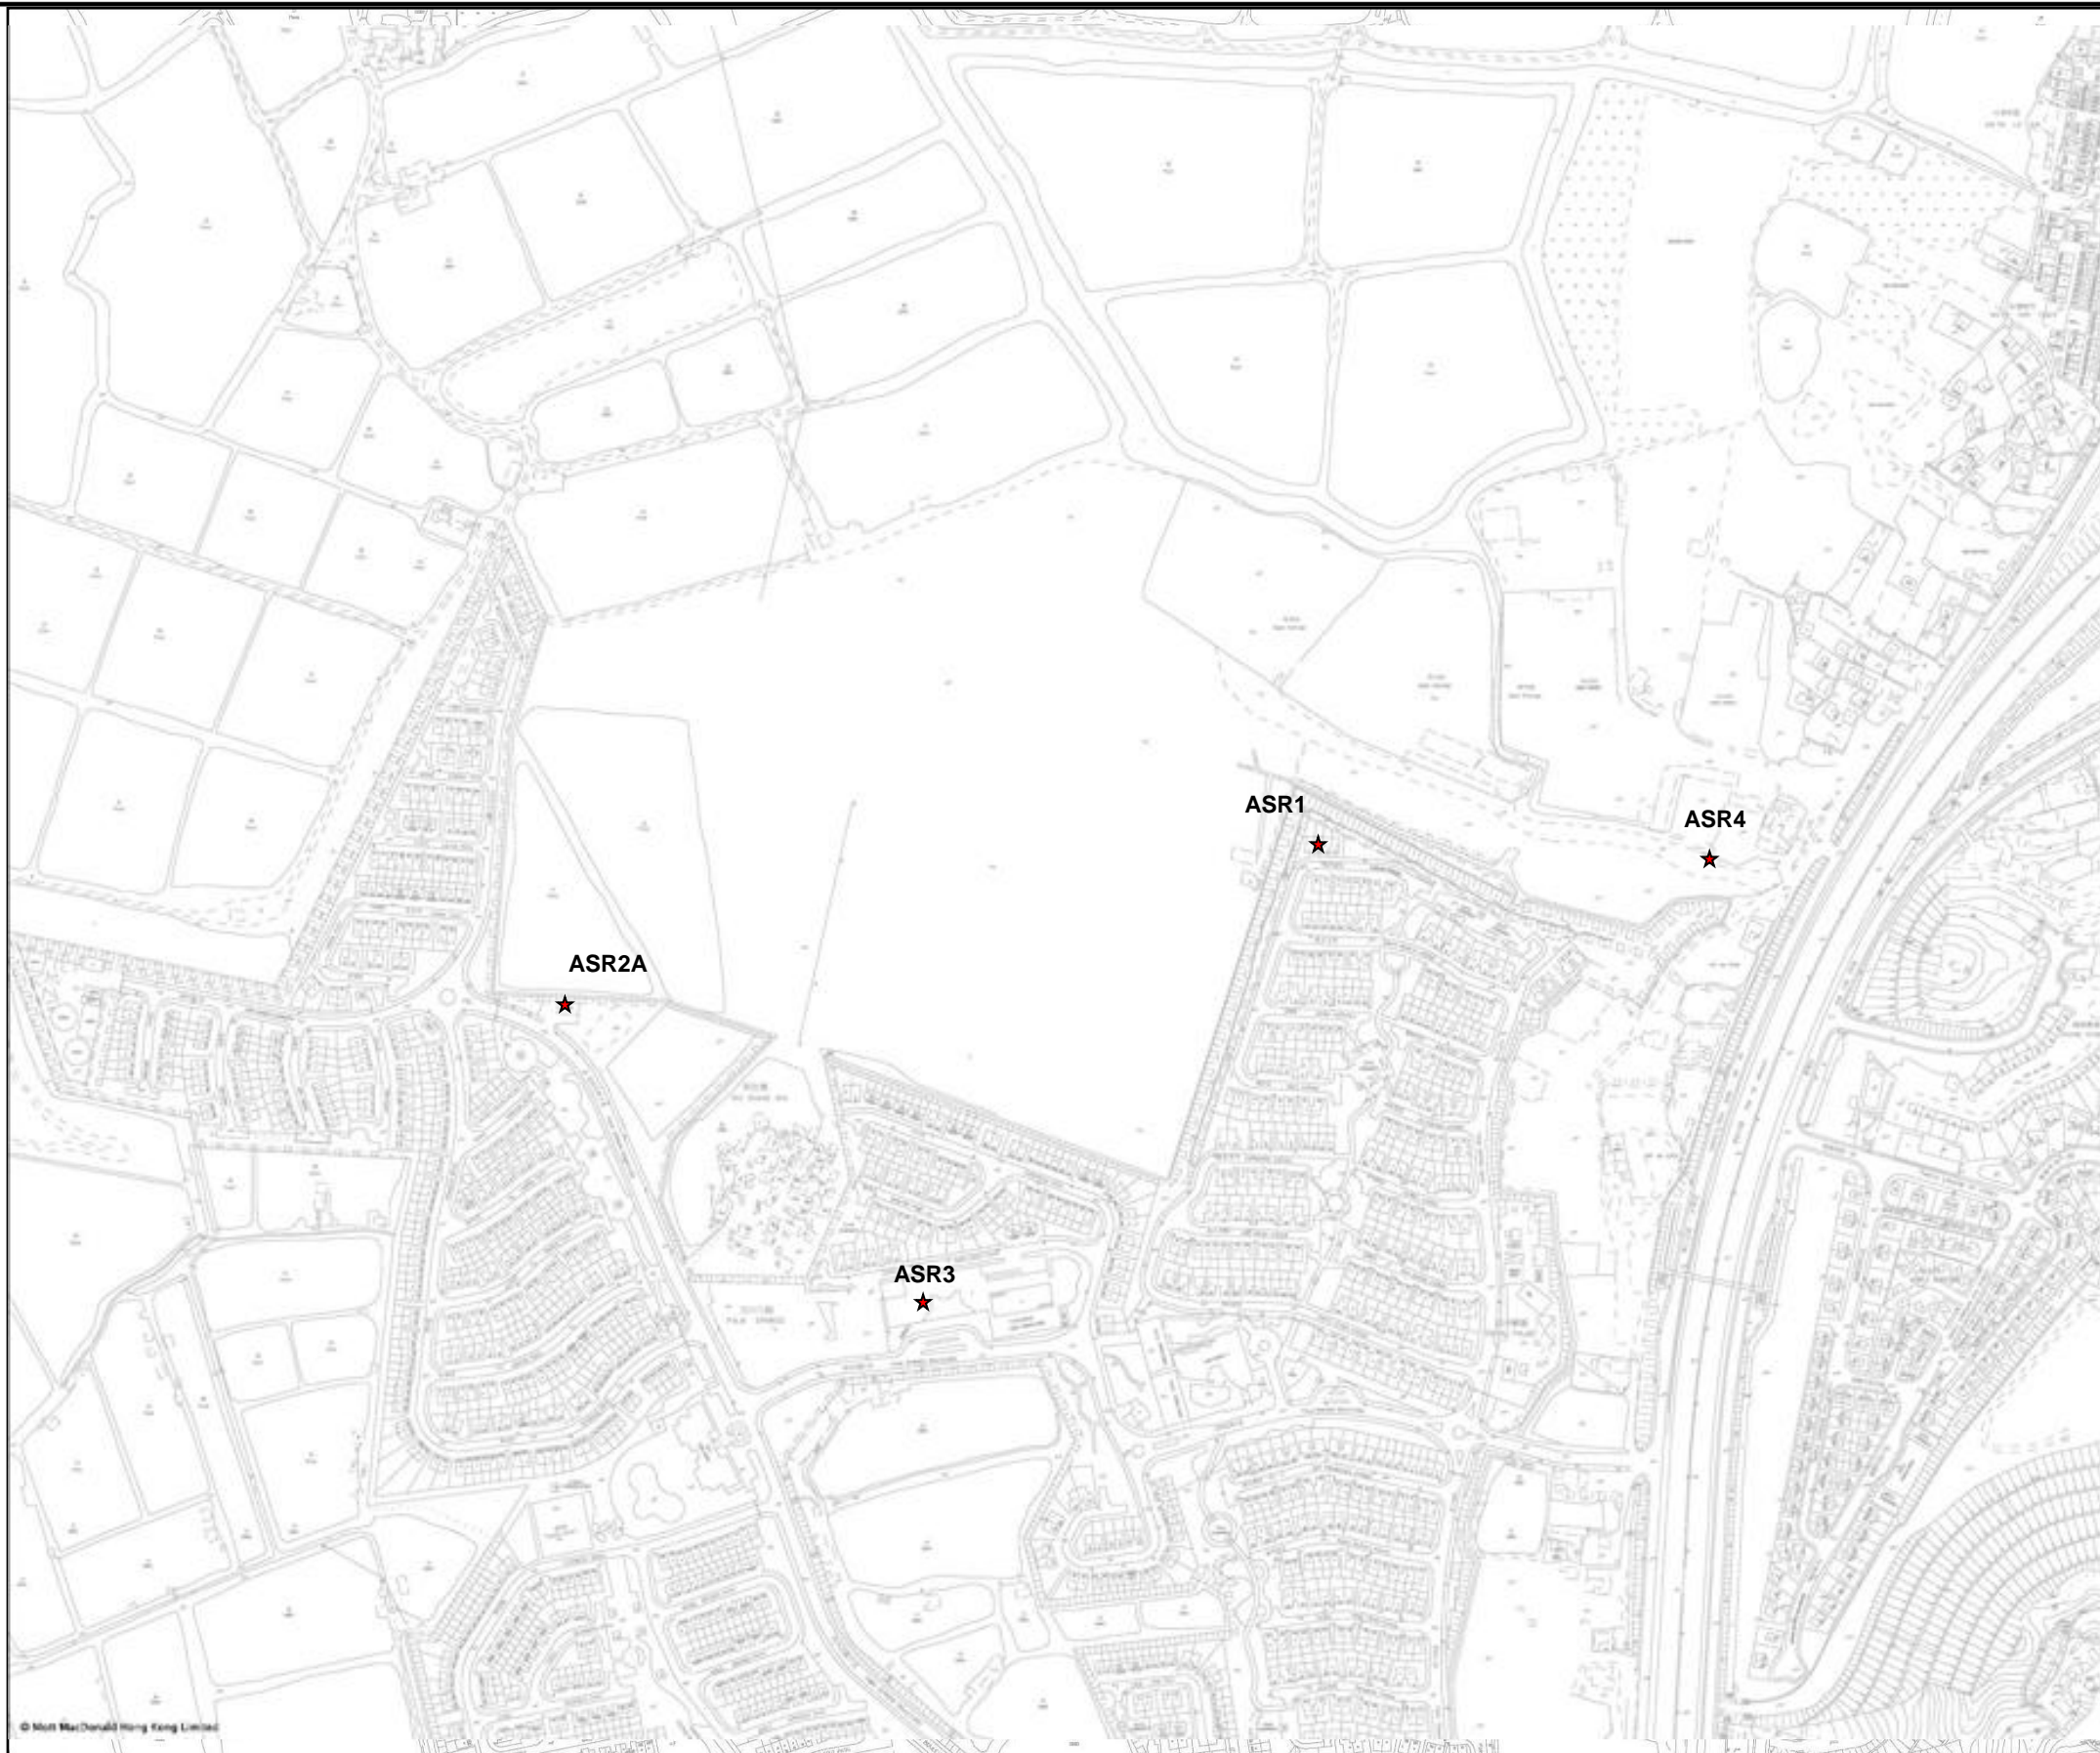
Notes					
<p>★ Construction Phase Air Quality Monitoring Locations</p>					
Reference drawings					
Rev	Date	Drawn	Description	Ch'k'd	App'd
			<p><b>M</b> <b>MOTT</b> <b>MACDONALD</b></p> <p>3/F Manulife Place 348 Kwun Tong Road Kwun Tong, Kowloon Hong Kong T +852 2828 5757 F +852 2827 1823 W mottmac.com</p>		
Client					
PROFIT POINT ENTERPRISES LIMITED					
Project					
PROPOSED COMPREHENSIVE DEVELOPMENT AT WO SHANG WAI, YUEN LONG					
Title					
Locations of Air Quality Monitoring Stations					
Designed			Eng check		
Drawn			Coordination		
Dwg check			Approved		
Scale at A1		Status		Rev	
Drawing Number			Figure 2.1

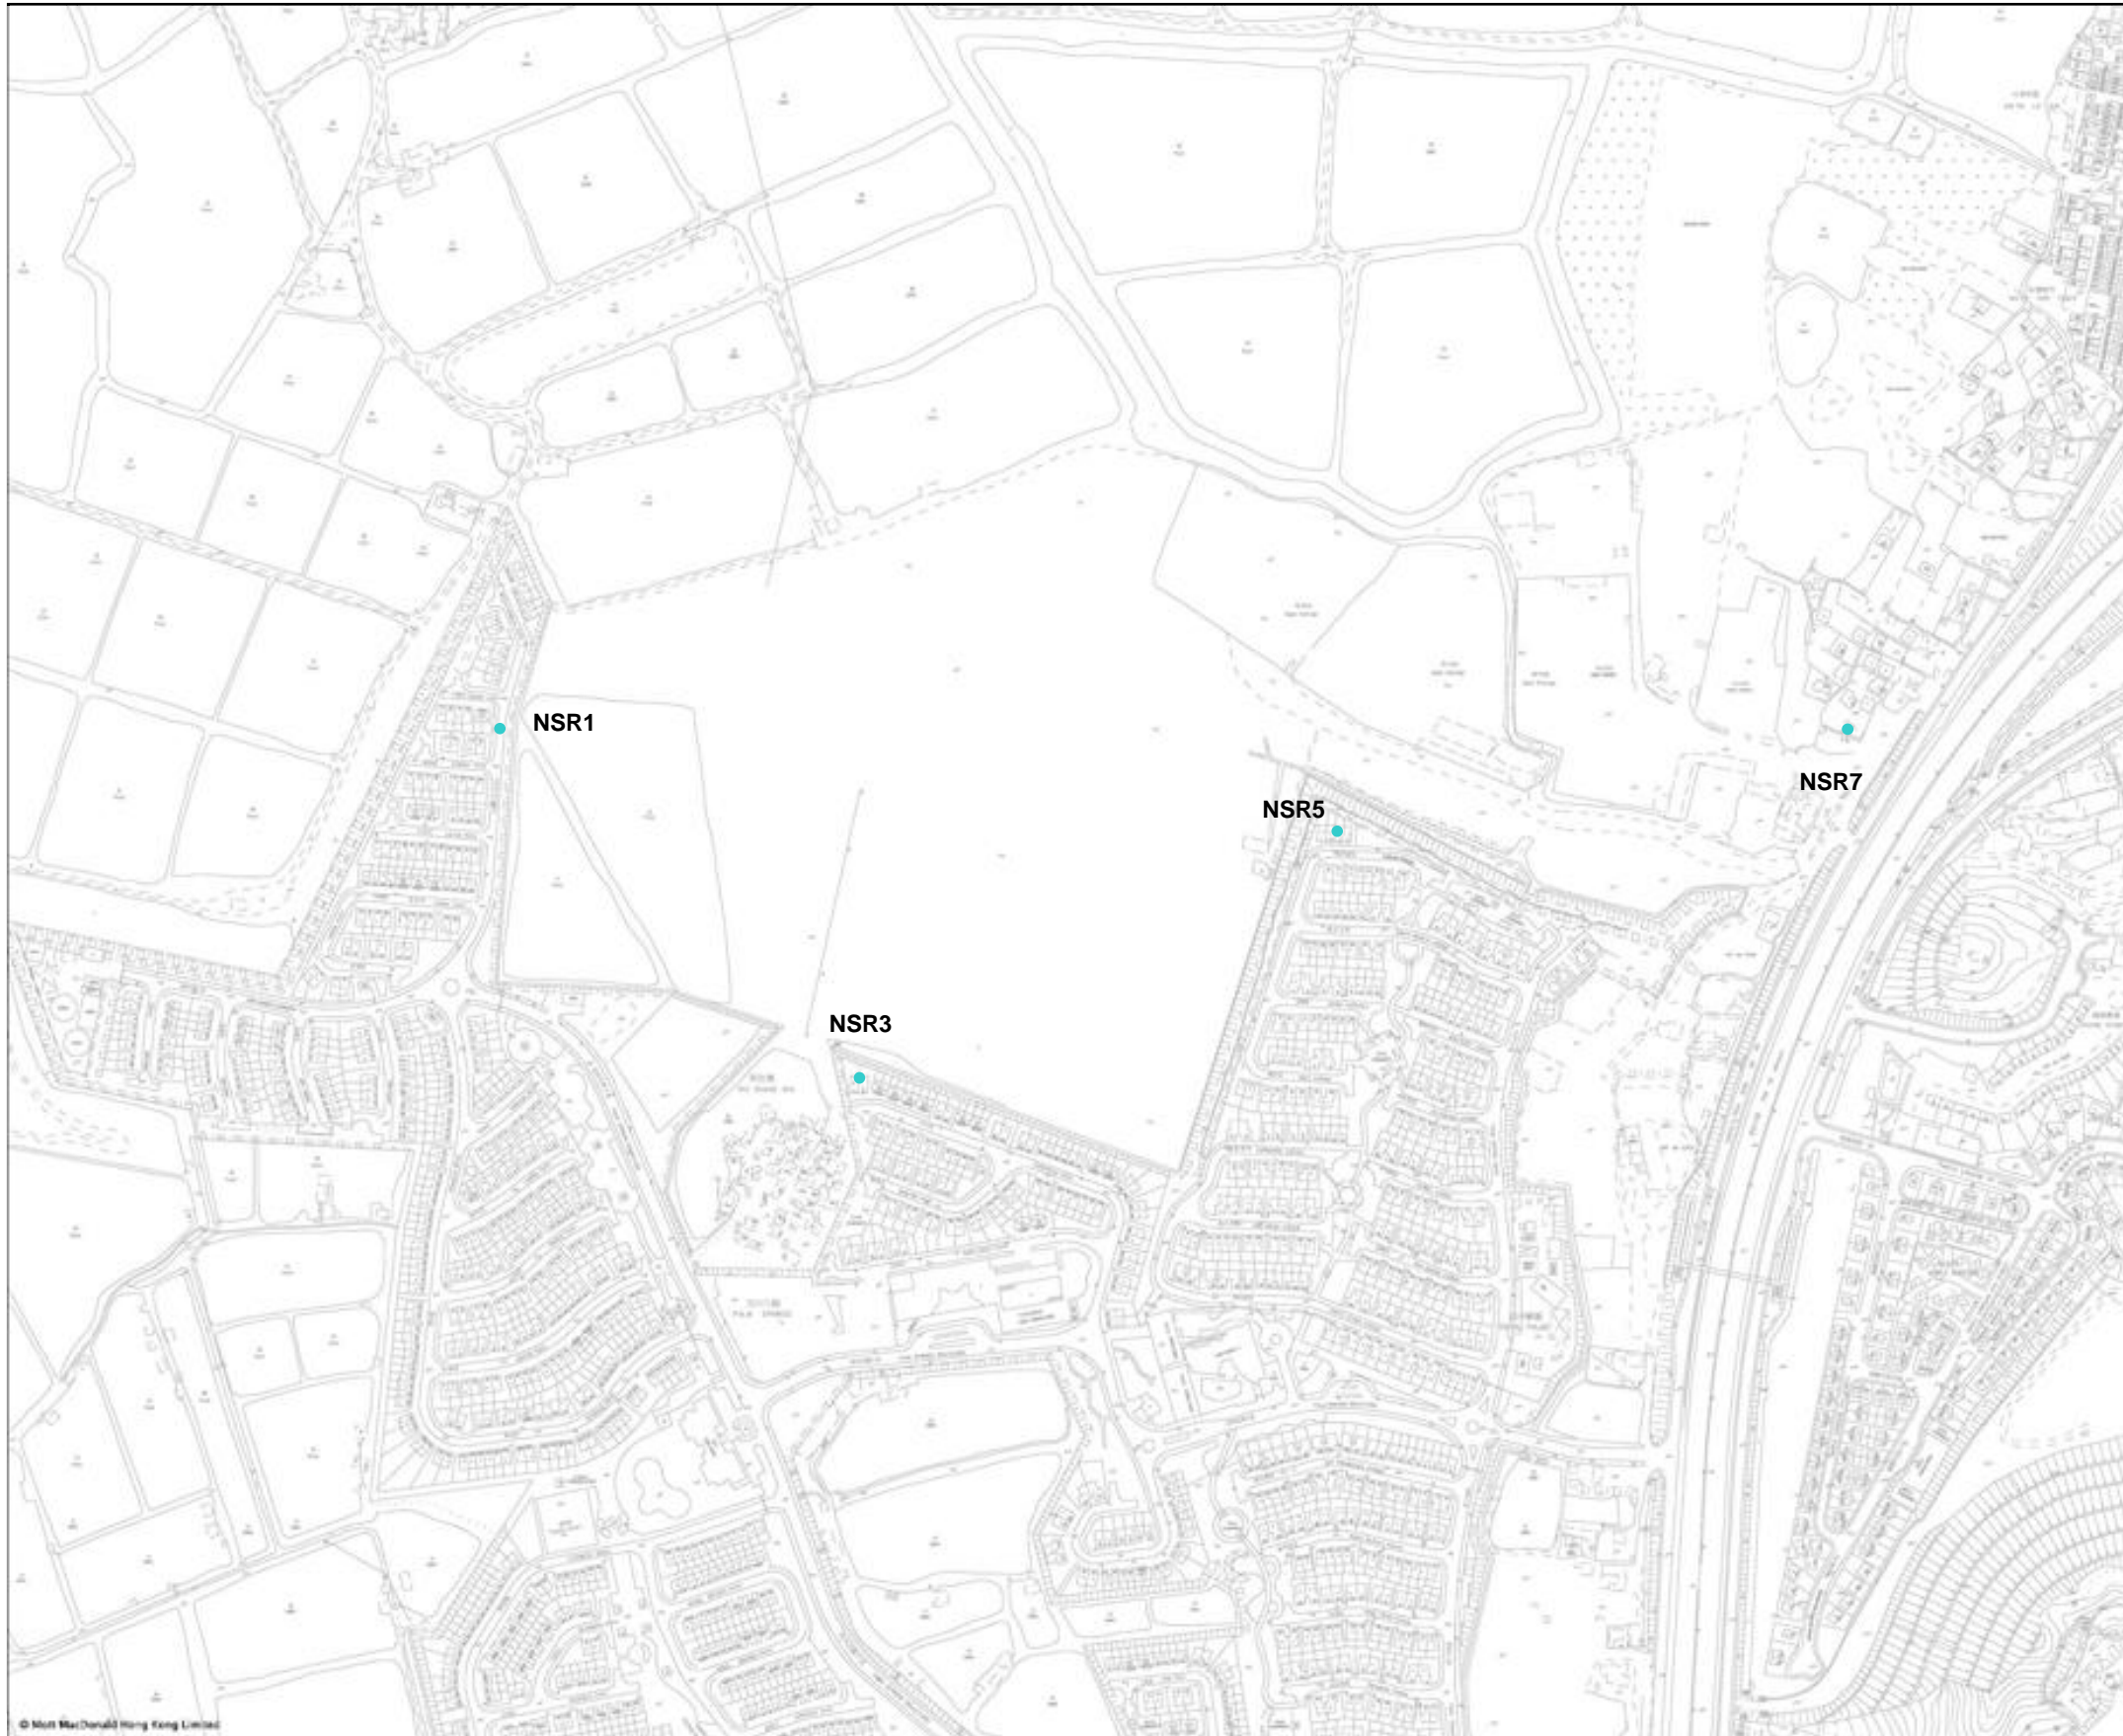
Notes					
Key to symbols <span style="color: blue;">●</span> Construction Phase Noise Monitoring Stations					
Reference drawings					
Rev	Date	Drawn	Description	Ch'k'd	App'd
			<b>M</b> <b>MOTT</b> <b>MACDONALD</b>		
			3/F Manulife Place 348 Kwun Tong Road Kwun Tong, Kowloon Hong Kong T +852 2828 5757 F +852 2827 1823 W mottmac.com		
Client					
PROFIT POINT ENTERPRISES LIMITED					
Project					
PROPOSED COMPREHENSIVE DEVELOPMENT AT WO SHANG WAI, YUEN LONG					
Title					
<b>Locations of Noise          Monitoring Stations</b>					
Designed			Eng check		
Drawn			Coordination		
Dwg check			Approved		
Scale at A1		Status		Rev	
Drawing Number			Figure 2.2
