# **Proposed Comprehensive Development at Wo Shang Wai, Yuen Long**

Quarterly EM&A Summary Report for November  
2022 – January 2023(Rev A)

4 April 2023

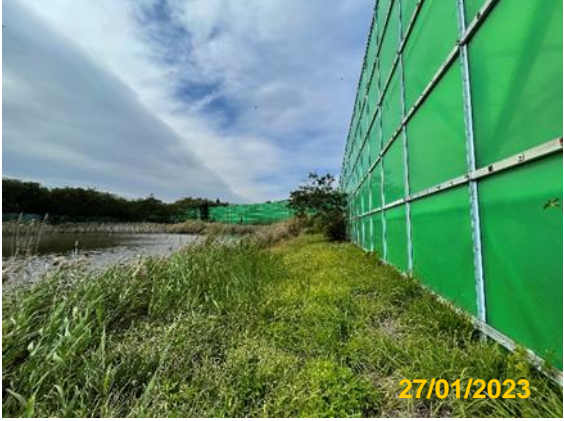
<p>Photo 1: The Construction works have been screened by hoarding / noise barriers. (CM2)</p>	<p>Photo 2: The wetland areas have been established and the ponds are seasonally filled with rainwater (OM4)</p>

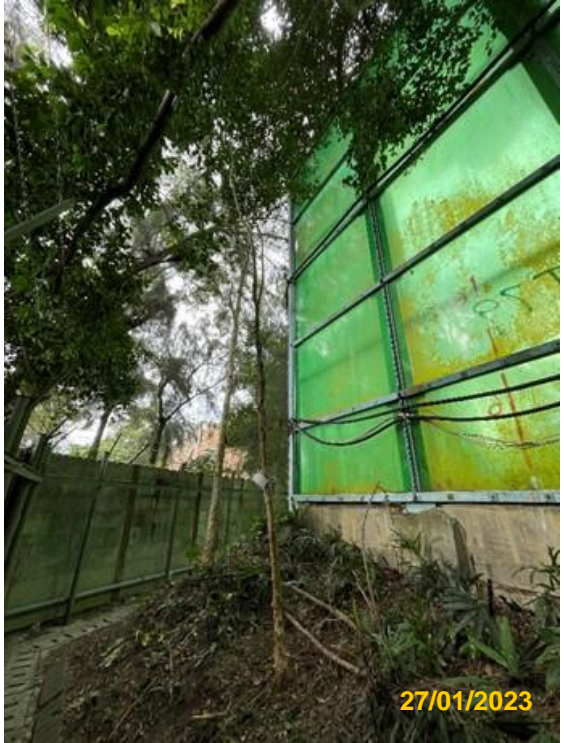
<p>Photo 3: Advance screen planting of noise barrier has been undertaken (CM6, OM2)</p>
