Proposed Comprehensive Development at Wo Shang Wai, Yuen Long

Quarterly EM&A Summary Report for Aug 2023 –
Oct 2023 (Rev A)

21 November 2023

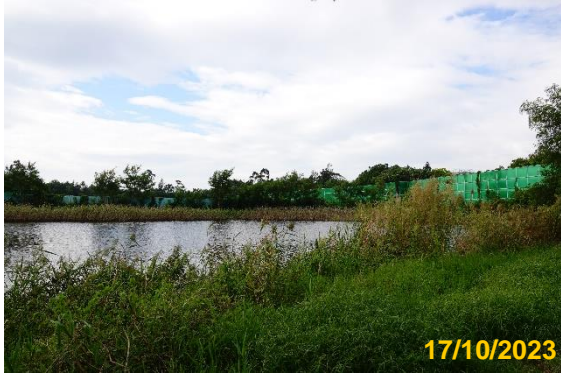
<p>Photo 1: The Construction works have been screened by hoarding / noise barriers. (CM2)</p>	<p>Photo 2: The wetland areas have been established and the ponds are seasonally filled with rainwater (OM4)</p>

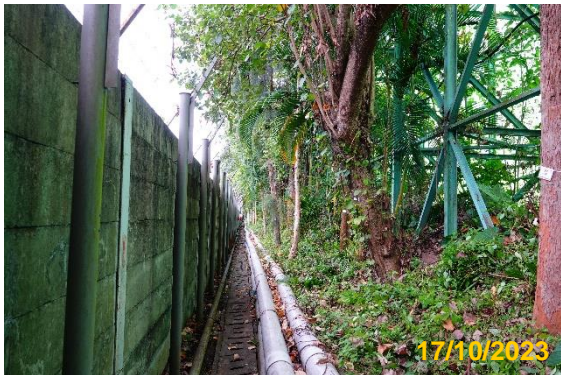
<p>Photo 3: Advance screen planting of noise barrier has been undertaken (CM6, OM2)</p>
