# **Ocean Park Tai Shue Wan Water World Project**

Final EM&A Review Report

September 2021

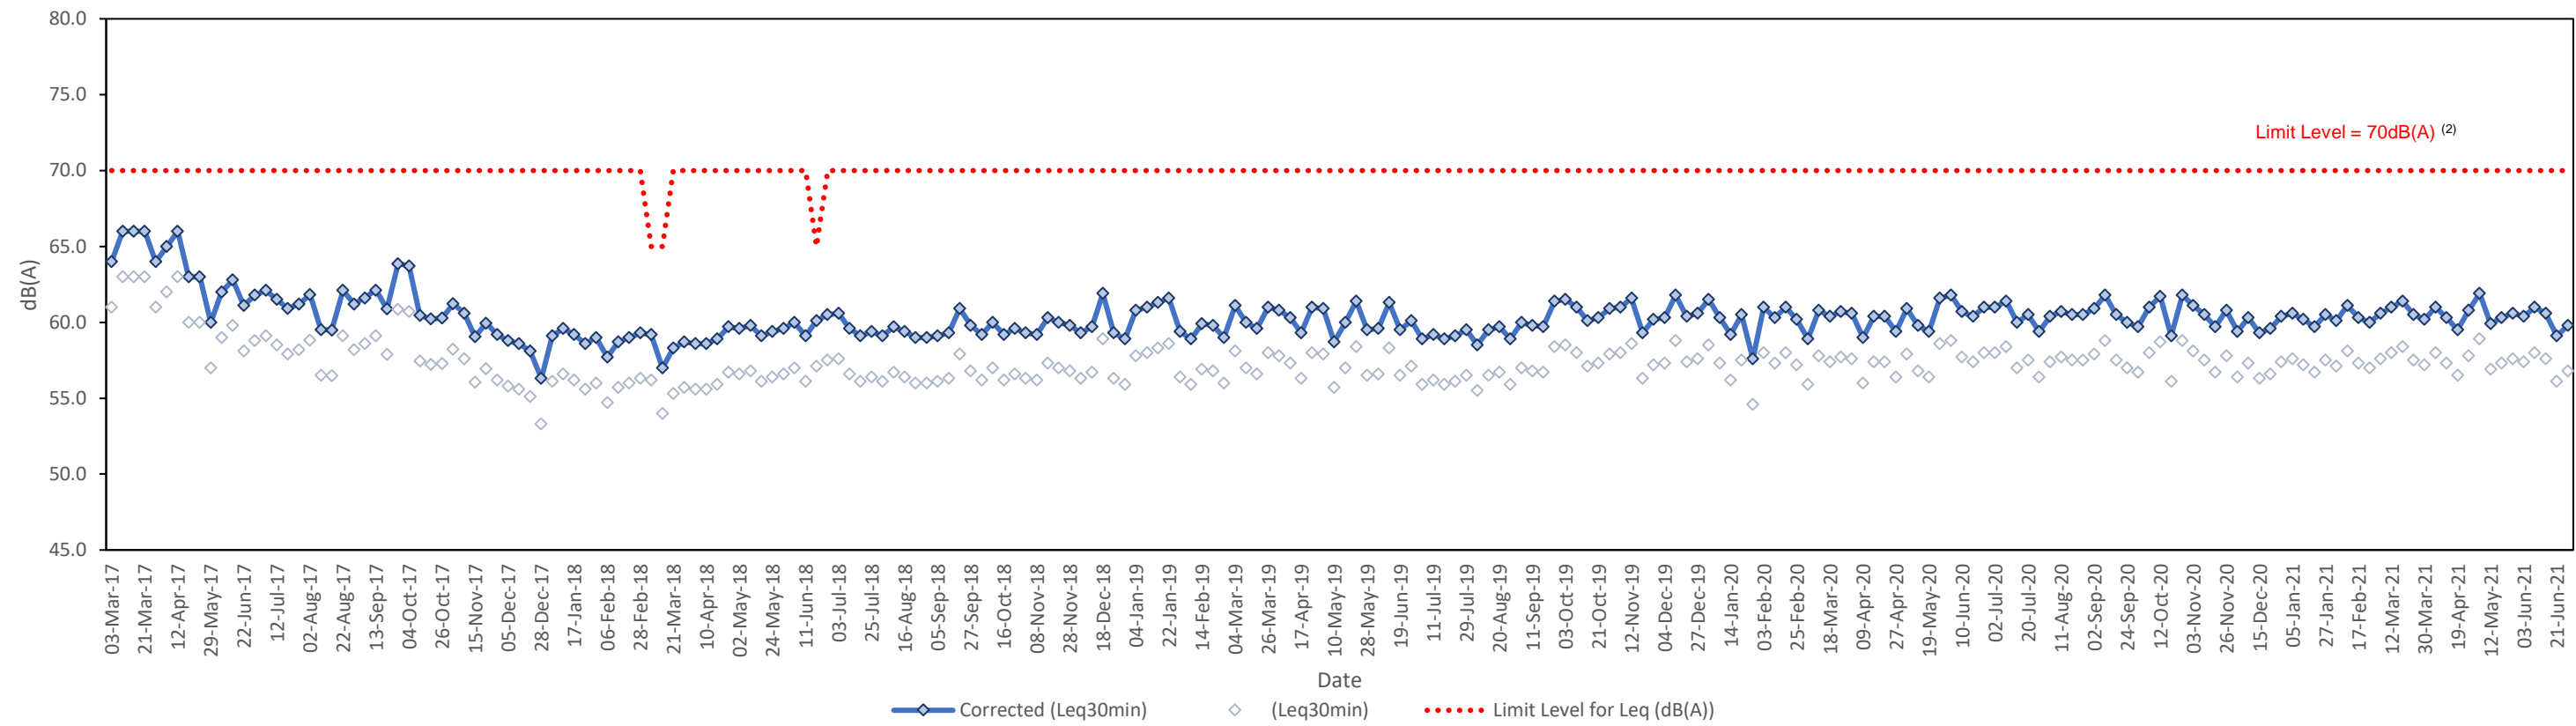
### Noise Level for 30 min, dB(A), at NM1A <sup>(1)</sup>

Monitoring for noise levels due to construction work was undertaken in compliance with the EM&A manual during the construction period. The results of the noise monitoring measurement were below the Limit Level of 70 dB(A). Table 4.1 summarises the construction noise monitoring results in comparison of the Limit Level and baseline condition as reported in the Baseline Monitoring Report. Graphical plots of the construction noise monitoring data are presented in **Appendix F**. No exceedance of Action or Limit Levels for construction noise was recorded during the construction period.

1. A correction of +3 dB(A) was made to the free field measurement at monitoring station NM1A.
2. Acceptable Noise Levels for school should be reduced to 65 dB(A) during examination period.
3. The construction activities being carried out during the monitoring period refers to Section 2.2.

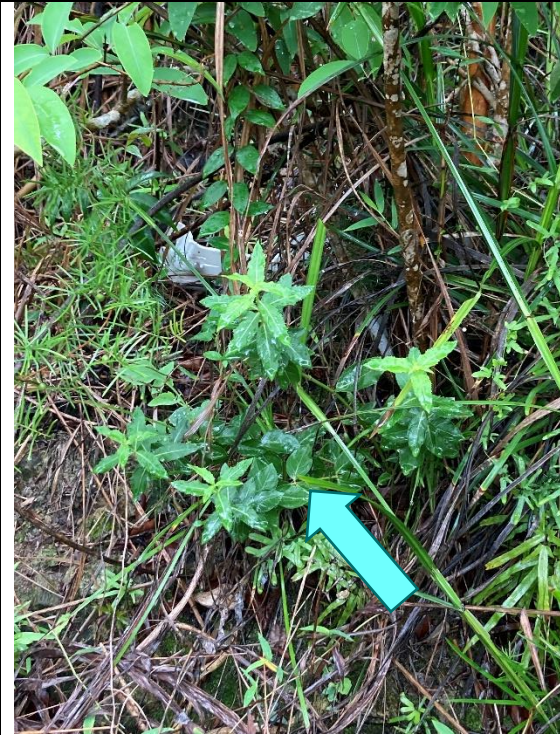
Photo 1 – Group 2 of *Platycodon Grandiflorus*  
(As of June 2021)

As recorded during the last ecological inspection event in June 2021, it was observed that Group 2 of *Platycodon grandiflorus* was found to be vigorous and was in good health condition. However, Group 1 of *Platycodon grandiflorus* could not be found within the fenced area due to natural life cycle of this perennial herbaceous species, and new shoots would be expected to emerge from the underground part in the next growing season. The latest photo of the *Platycodon grandiflorus* is shown in **Appendix H**.

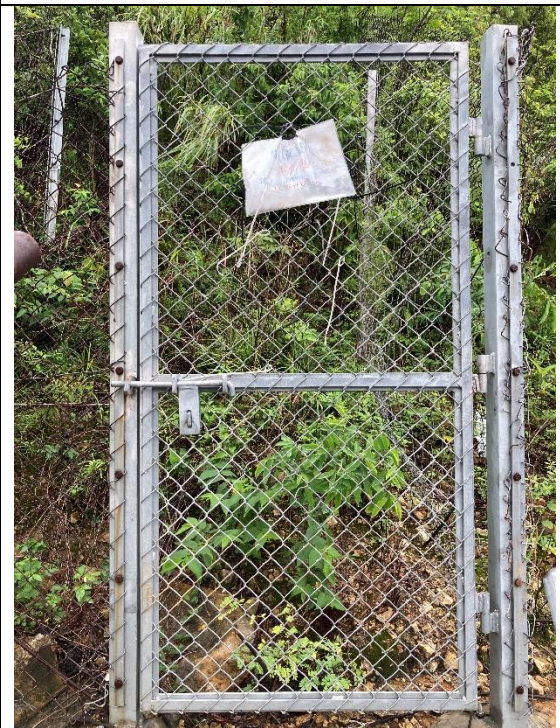
Photo 2 – Fencing and warning sign  
(As of June 2021)

During the construction period, the preventive mitigation measures, i.e., erecting of temporary protective fencing and sign post, were found to be effectively implemented to protect the *Platycodon grandiflorus* from human disturbance, and there was no signs or evidence (e.g. dust coating of plant) suggesting the on-going construction activities within the Project Area has affected the health condition of the *Platycodon grandiflorus*. In general, the *Platycodon grandiflorus* was in good health condition and has been growing according to the natural life cycle. Table 4.3 summarised the special observations on the growth of *Platycodon grandiflorus* related to typhoon events during the construction period.
