# **Ocean Park Tai Shue Wan Water World Project**

Operation Phase Monthly EM&A Report  
October 2022

November 2022

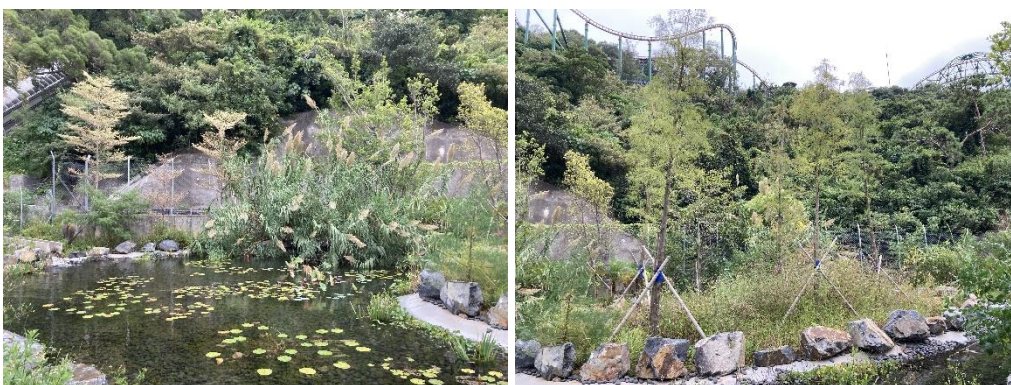
Monitoring of the EEA was undertaken on 17 October 2022. The condition of vegetation in the EEA was generally well-maintained, while the pond was also maintained with suitable water level and continuous water inflow (see **Figure 2.1**). The EEA was inspected, but no ardeids or day roost of Black-crowned Night Heron were found in the EEA. Few individuals of Black Kite (*Milvus migrans*) were observed soaring over the area. Other bird species observed in the EEA include Chinese Bulbul (*Pycnonotus sinensis*), Red-whiskered Bulbul (*Pycnonotus jocosus*) and Swinhoe's White-eye (*Zosterops simplex*). Butterfly species Plain Tiger (*Danaus chrysippus*), Common Tiger (*Danaus genutia*) and Blue Tiger (*Tirumala limniace*) were recorded within the EEA (see **Figure 2.2**). Apart from that, a group of Short-nosed Fruit Bat (*Cynopterus sphinx*), which is a species listed as “Near Threatened” in Red List of China's Vertebrates (Jiang *et al.*, 2016)<sup>1</sup>, was observed roosting under Chinese Fan-palms within the EEA (see **Figure 2.3**), which echoes the findings of the Short-nosed Fruit Bat Inspection Report submitted prior the construction phase.

**Figure 2.1** General view of the freshwater pond and vegetation in the EEA

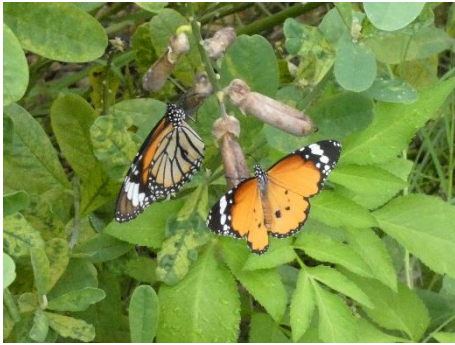
**Figure 2.2** Butterfly species Plain Tiger (*Danaus chrysippus*) and Common Tiger (*Danaus genutia*)

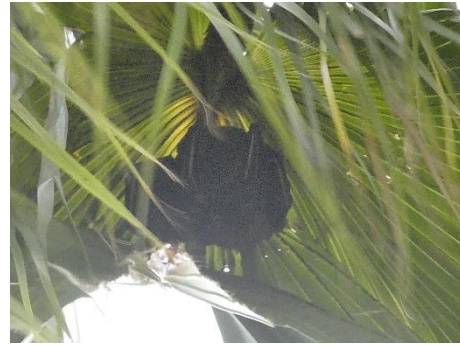
**Figure 2.3** Short-nosed Fruit Bat roosting on frond of Chinese Fan-palm

In this month of monitoring of the EEA, survey was conducted on 17 October 2022 covering the period from one hour before sunset until nightfall. No ardeids were noted roosting in the EEA, while a species of conservation importance, Short-nosed Fruit Bat, was observed within the EEA.
