Contract No. 13/WSD/16

Mainlaying in Tseung Kwan O

**Annual EM&A Review Report No.4
(September 2021 – August 2022)**

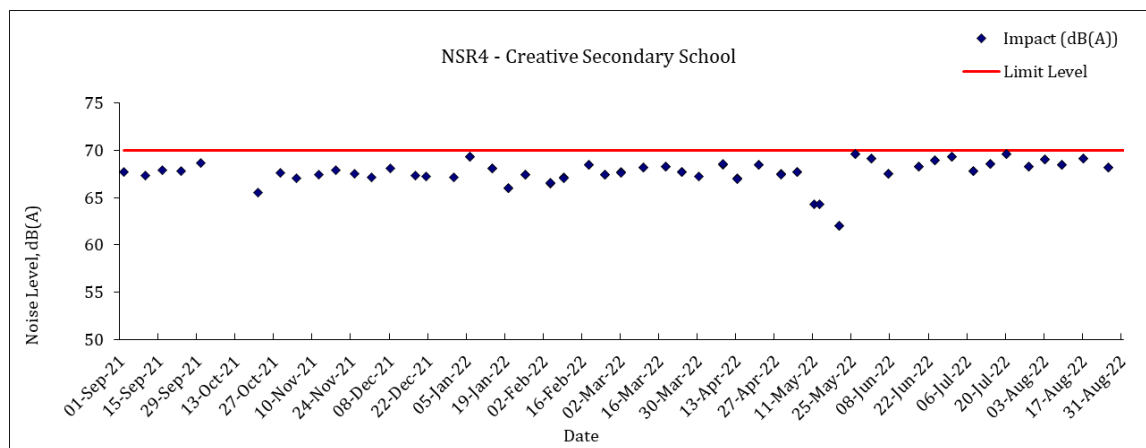
2.10. The graphical presentation of construction noise monitoring results was presented below.

2.12. No action or limit level exceedance was recorded for construction noise monitoring during the reporting month.
