**Monthly EM&A Report
(June 2021)**

Contract Name : Environmental Team for Drainage
Improvement Works at Ngong Ping
(Contract No. DC/2019/06)

Report No. : 0118/20/ED/0360A

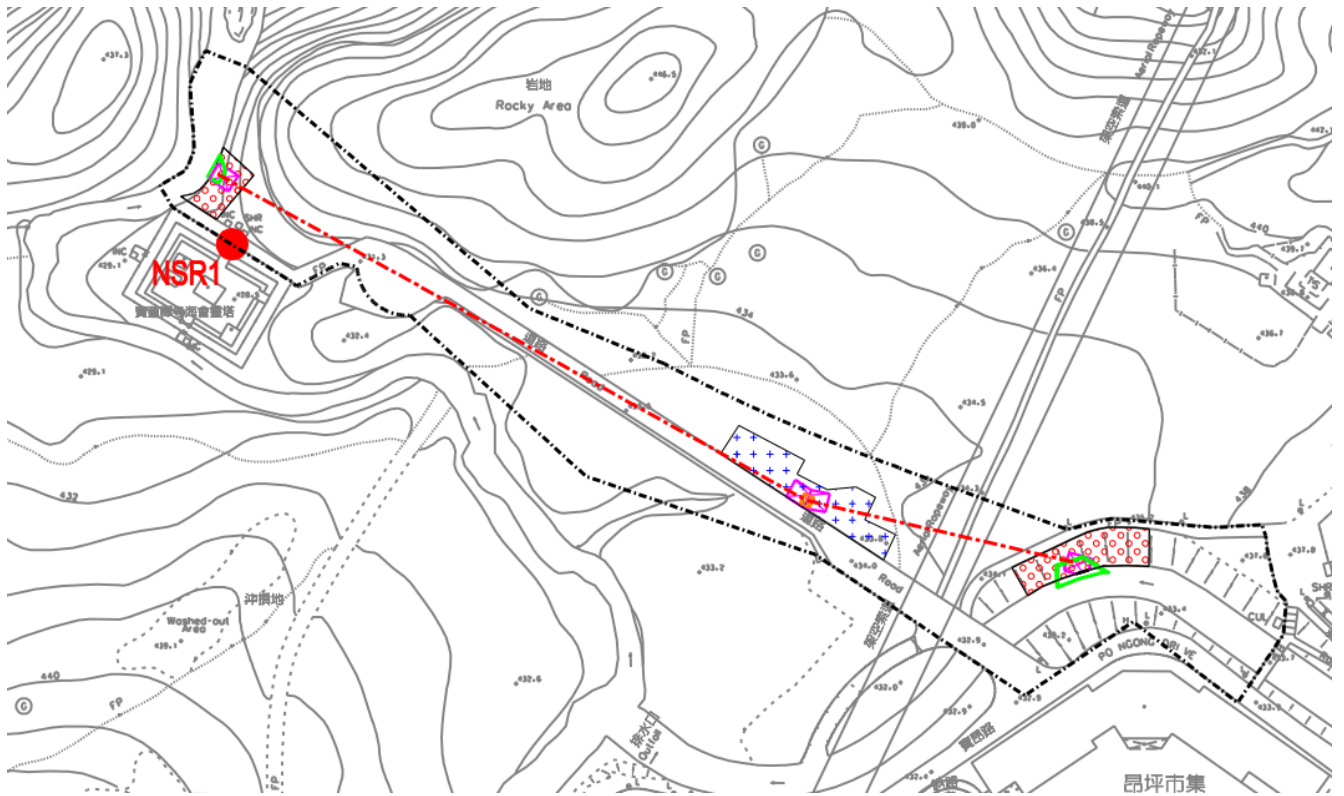
Figure 2a Noise Monitoring Locations (Part 1)

NSRs*	Monitoring Location	Type of Measurement#
NSR1	Columbarium of Po Lin Monastery	Free-field
NSR5	Village House No. 49A	Free-field
NSR8	Village House No. 34	Façade

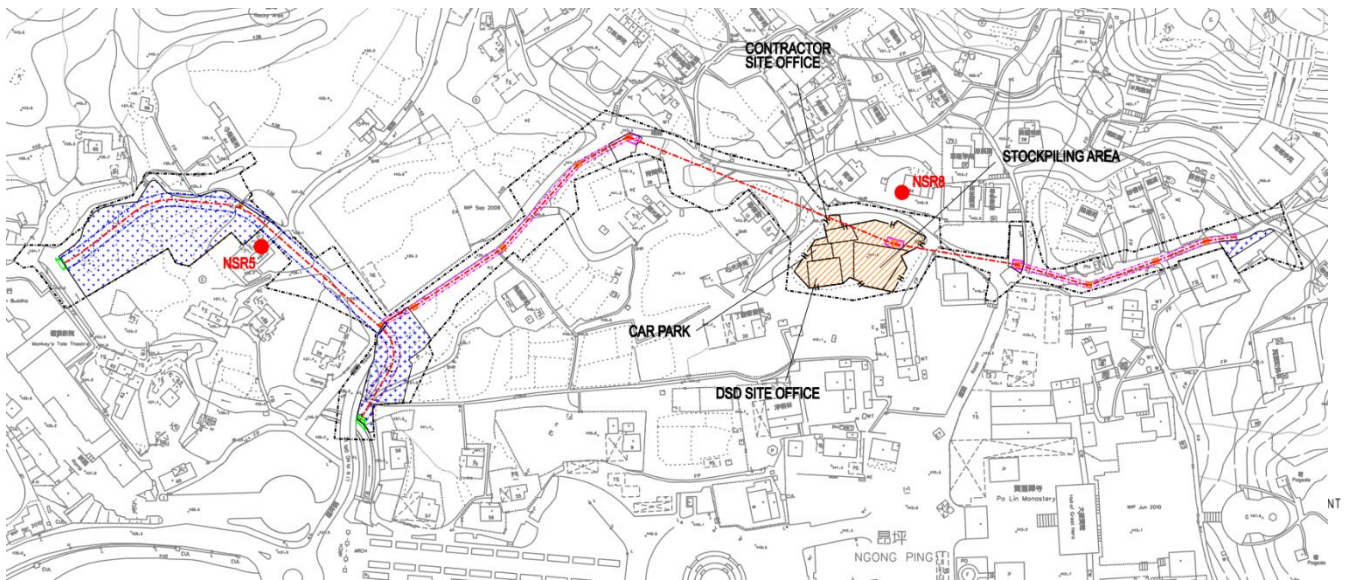
Figure 2b Noise Monitoring Locations (Part 2)

For Free-field measurement, +3dB(A) should be added to the measured results.

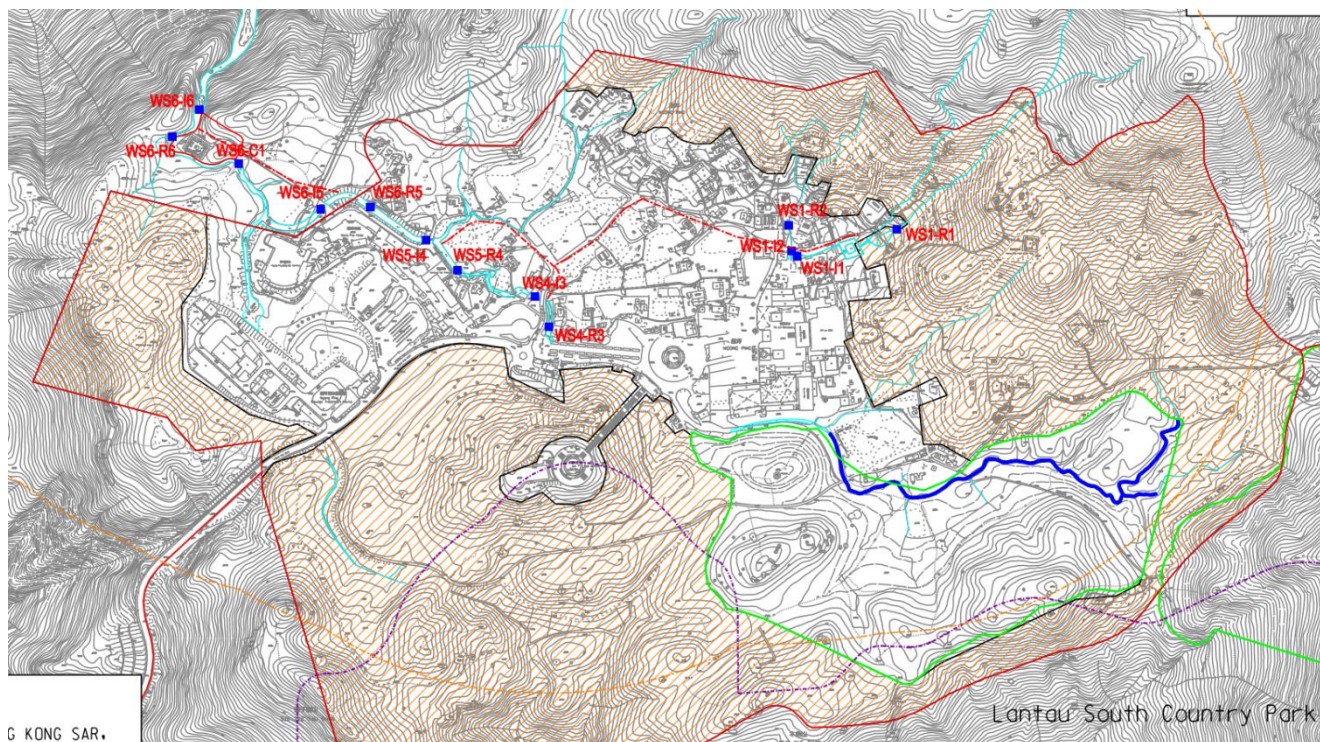
Figure 2c Water Quality Monitoring Locations

Station	Type
WS1-R1	Upstream reference
WS1-I1	Downstream impact
WS1-R2	Upstream reference
WS1-I2	Downstream impact
WS4-R3	Upstream reference
WS4-I3	Downstream impact
WS5-R4	Upstream reference
WS5-I4	Downstream impact
WS6-R5	Upstream reference
WS6-I5	Downstream impact
WS6-C1	Intermediate Control
WS6-R6	Upstream reference
WS6-I6	Downstream impact

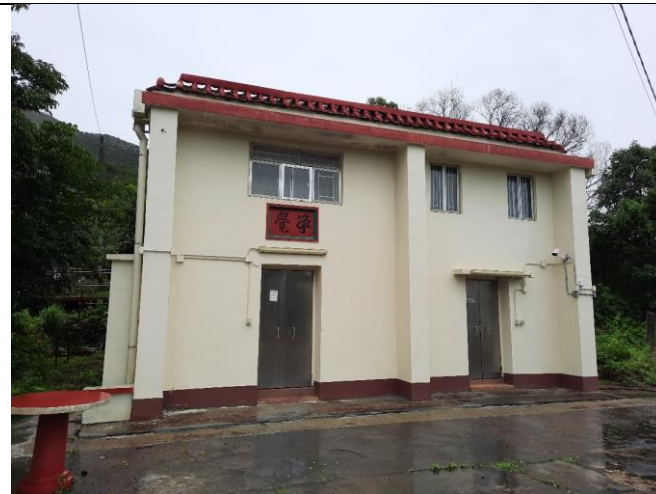
(2) No crack monitoring device was installed in accordance to the approved condition survey reports of NP-10, NP-11 & NP-19. (Photos 4&7) Please obtain consent from the owner/occupier for installation of monitoring devices.

Photo 4: No crack monitoring devices were found at locations as recommended in the approved survey report of NP-10.

(1) Provide up-to-date monitoring data a week before the next site audit; (2) Install crack monitoring devices unless rejected by owners/occupiers (please inform ET in case of refusal by owners/occupiers); (3) follow the monitoring & precautionary measures in the approved condition survey reports; (&) provide latest works programme if there is any update.

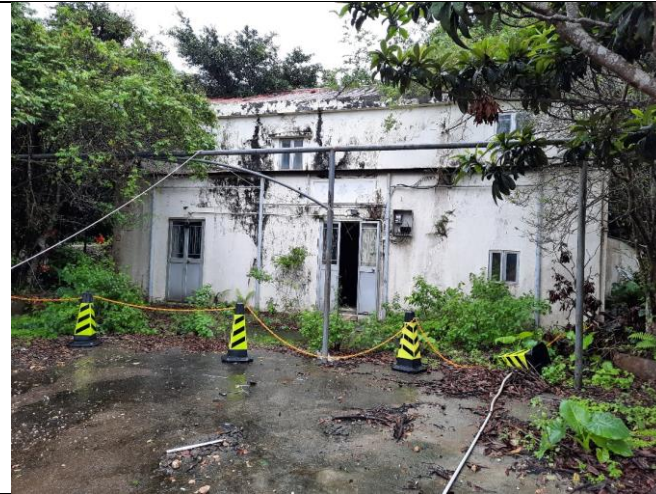
Photo 7: No crack monitoring devices were found at locations as recommended in the approved survey report of NP-11.

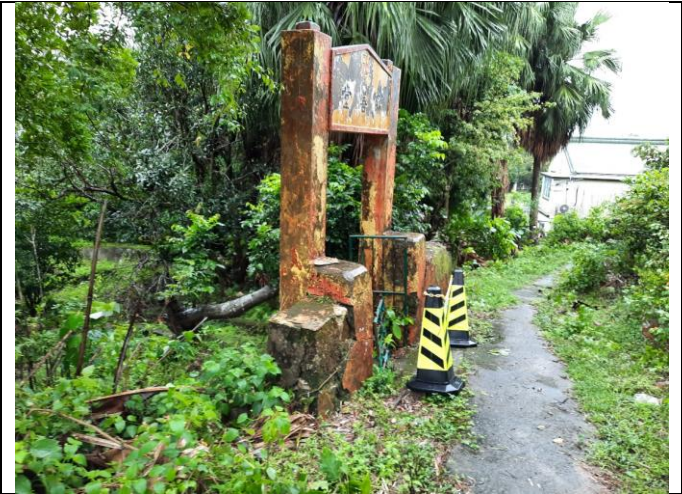
Photo 8: NP-19 has been fenced off in accordance to EM&A Manual.

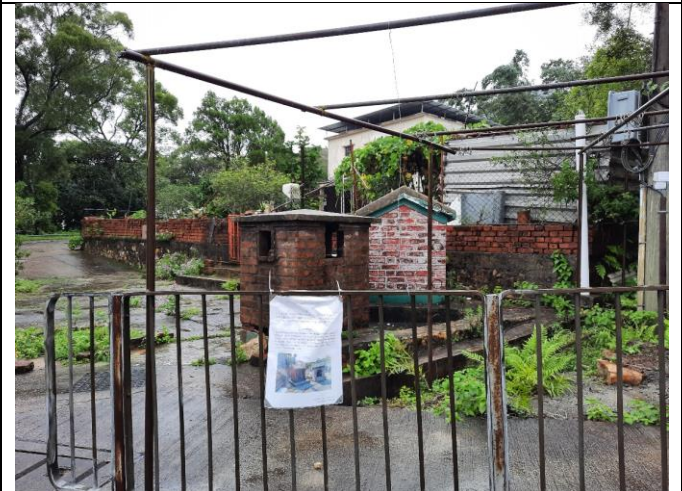
Photo 11: No temporary fence has been erected around NP-26 in mutual agreement with the villagers.

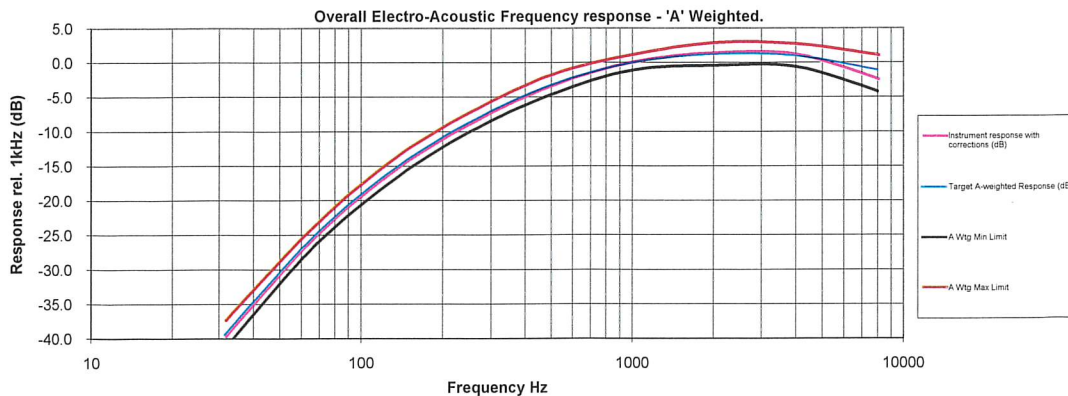
Combined Electro-Acoustic Frequency Response - A Weighted (IEC 61672-3:2006)

The following A-Weighted frequency response graph shows this instruments overall frequency response based upon the application of multi-frequency pressure field calibrations. The microphones Pressure to Free field correction coefficients are applied to pressure response. Reference level taken at 1kHz.
