**Monthly EM&A Report
(July 2021)**

Contract Name : Environmental Team for Drainage
Improvement Works at Ngong Ping
(Contract No. DC/2019/06)

Report No. : 0118/20/ED/0370A

Project Title	Drainage Improvement Works at Ngong Ping
Document Title	Monthly EM&A Report (July 2021)
Fugro Project No.	0118/20
Fugro Document No.	0118/20/ED/0370A
Issue Number	01

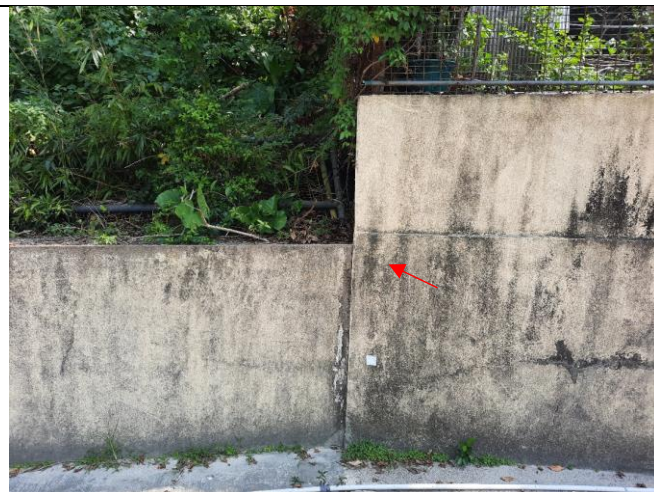
(1) one reflective target on the fence wall of NP-10 is missing, compared to May 2021. (Photo 2) Please ensure the targets being securely fixed at the monitoring position.

Photo 2: Reflective target for settlement monitoring was installed on the fence wall at NP-10 (missing one reflective target compared to May 2021).

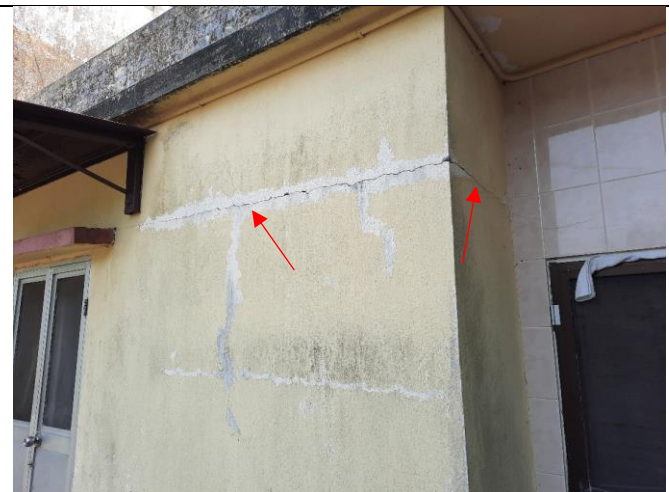
(2) No crack monitoring device was installed at the moment. However, the devices shall be installed at the agreed locations by ET and the contractor within a week (NP-10: photos 3-5; NP-11: photo 8)

Photo 3: NP-10 (D18): Locations for installation of tell-tales (2nos.: 1no. on each side of the wall) agreed by ET and Contractor during site audit.

(1) Owner of NP-10 & NP-11 agreed to install crack monitoring devices. The devices shall be installed at the agreed locations by ET and the Contractor during the site audit. (NP-10: D18(x2nos.), D64(x/no.), D92(x/no.); NP-11: D30).

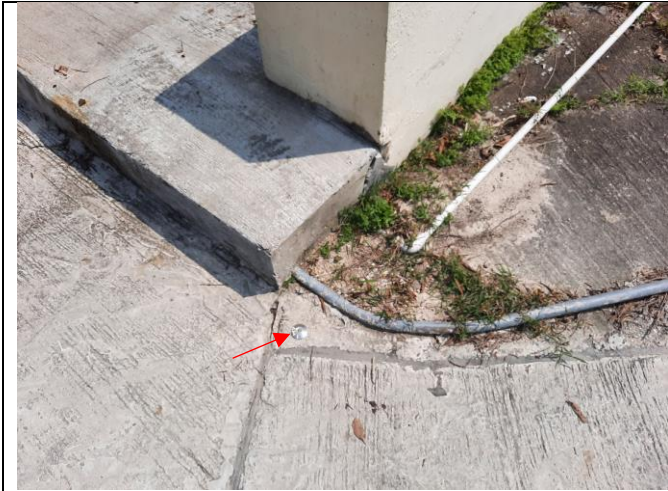
Photo 7: Ground settlement marker for settlement monitoring was installed at the entrance of NP-11.

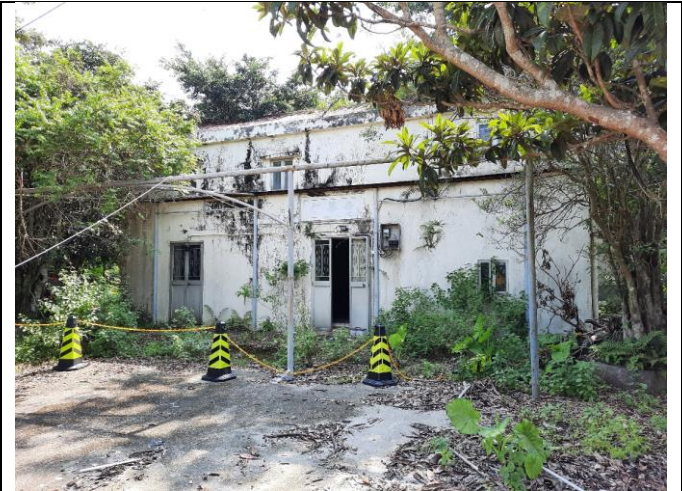
Photo 9: NP-19 has been fenced off in accordance to EM&A Manual.

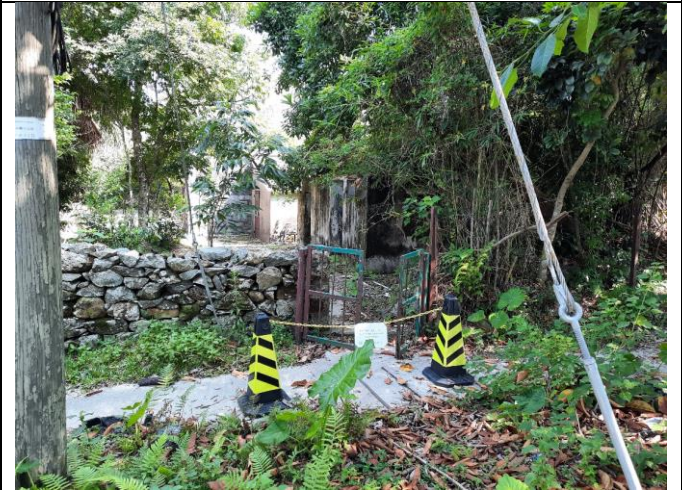
Photo 12: Access to NP-20 & NP-21 has been fenced off in accordance to EM&A Manual.

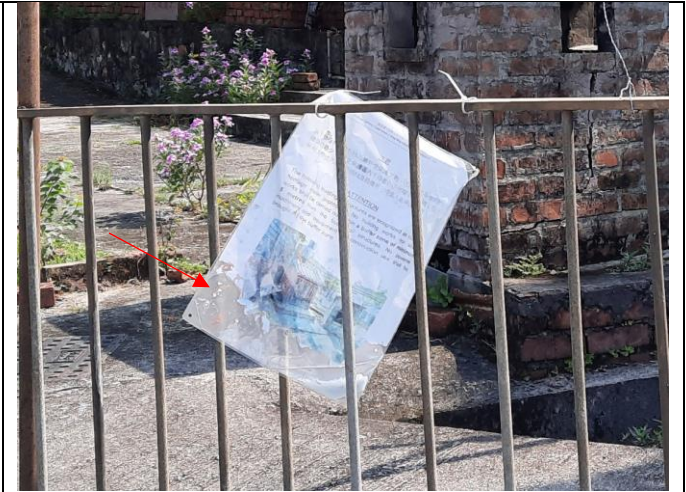
(3) The notice posted near NP-26 was found defective. (photo 15). Replacement is needed.

Photo 15: The notice at NP-26 was found defective. Replacement is required.
