Floral Protection Plan

Contract No. DPW 01/2020 Environmental Team for Drainage Improvement Works at Ngong Ping

0118/20/ED/0228j 10 | 30 March 2021

Drainage Services Department

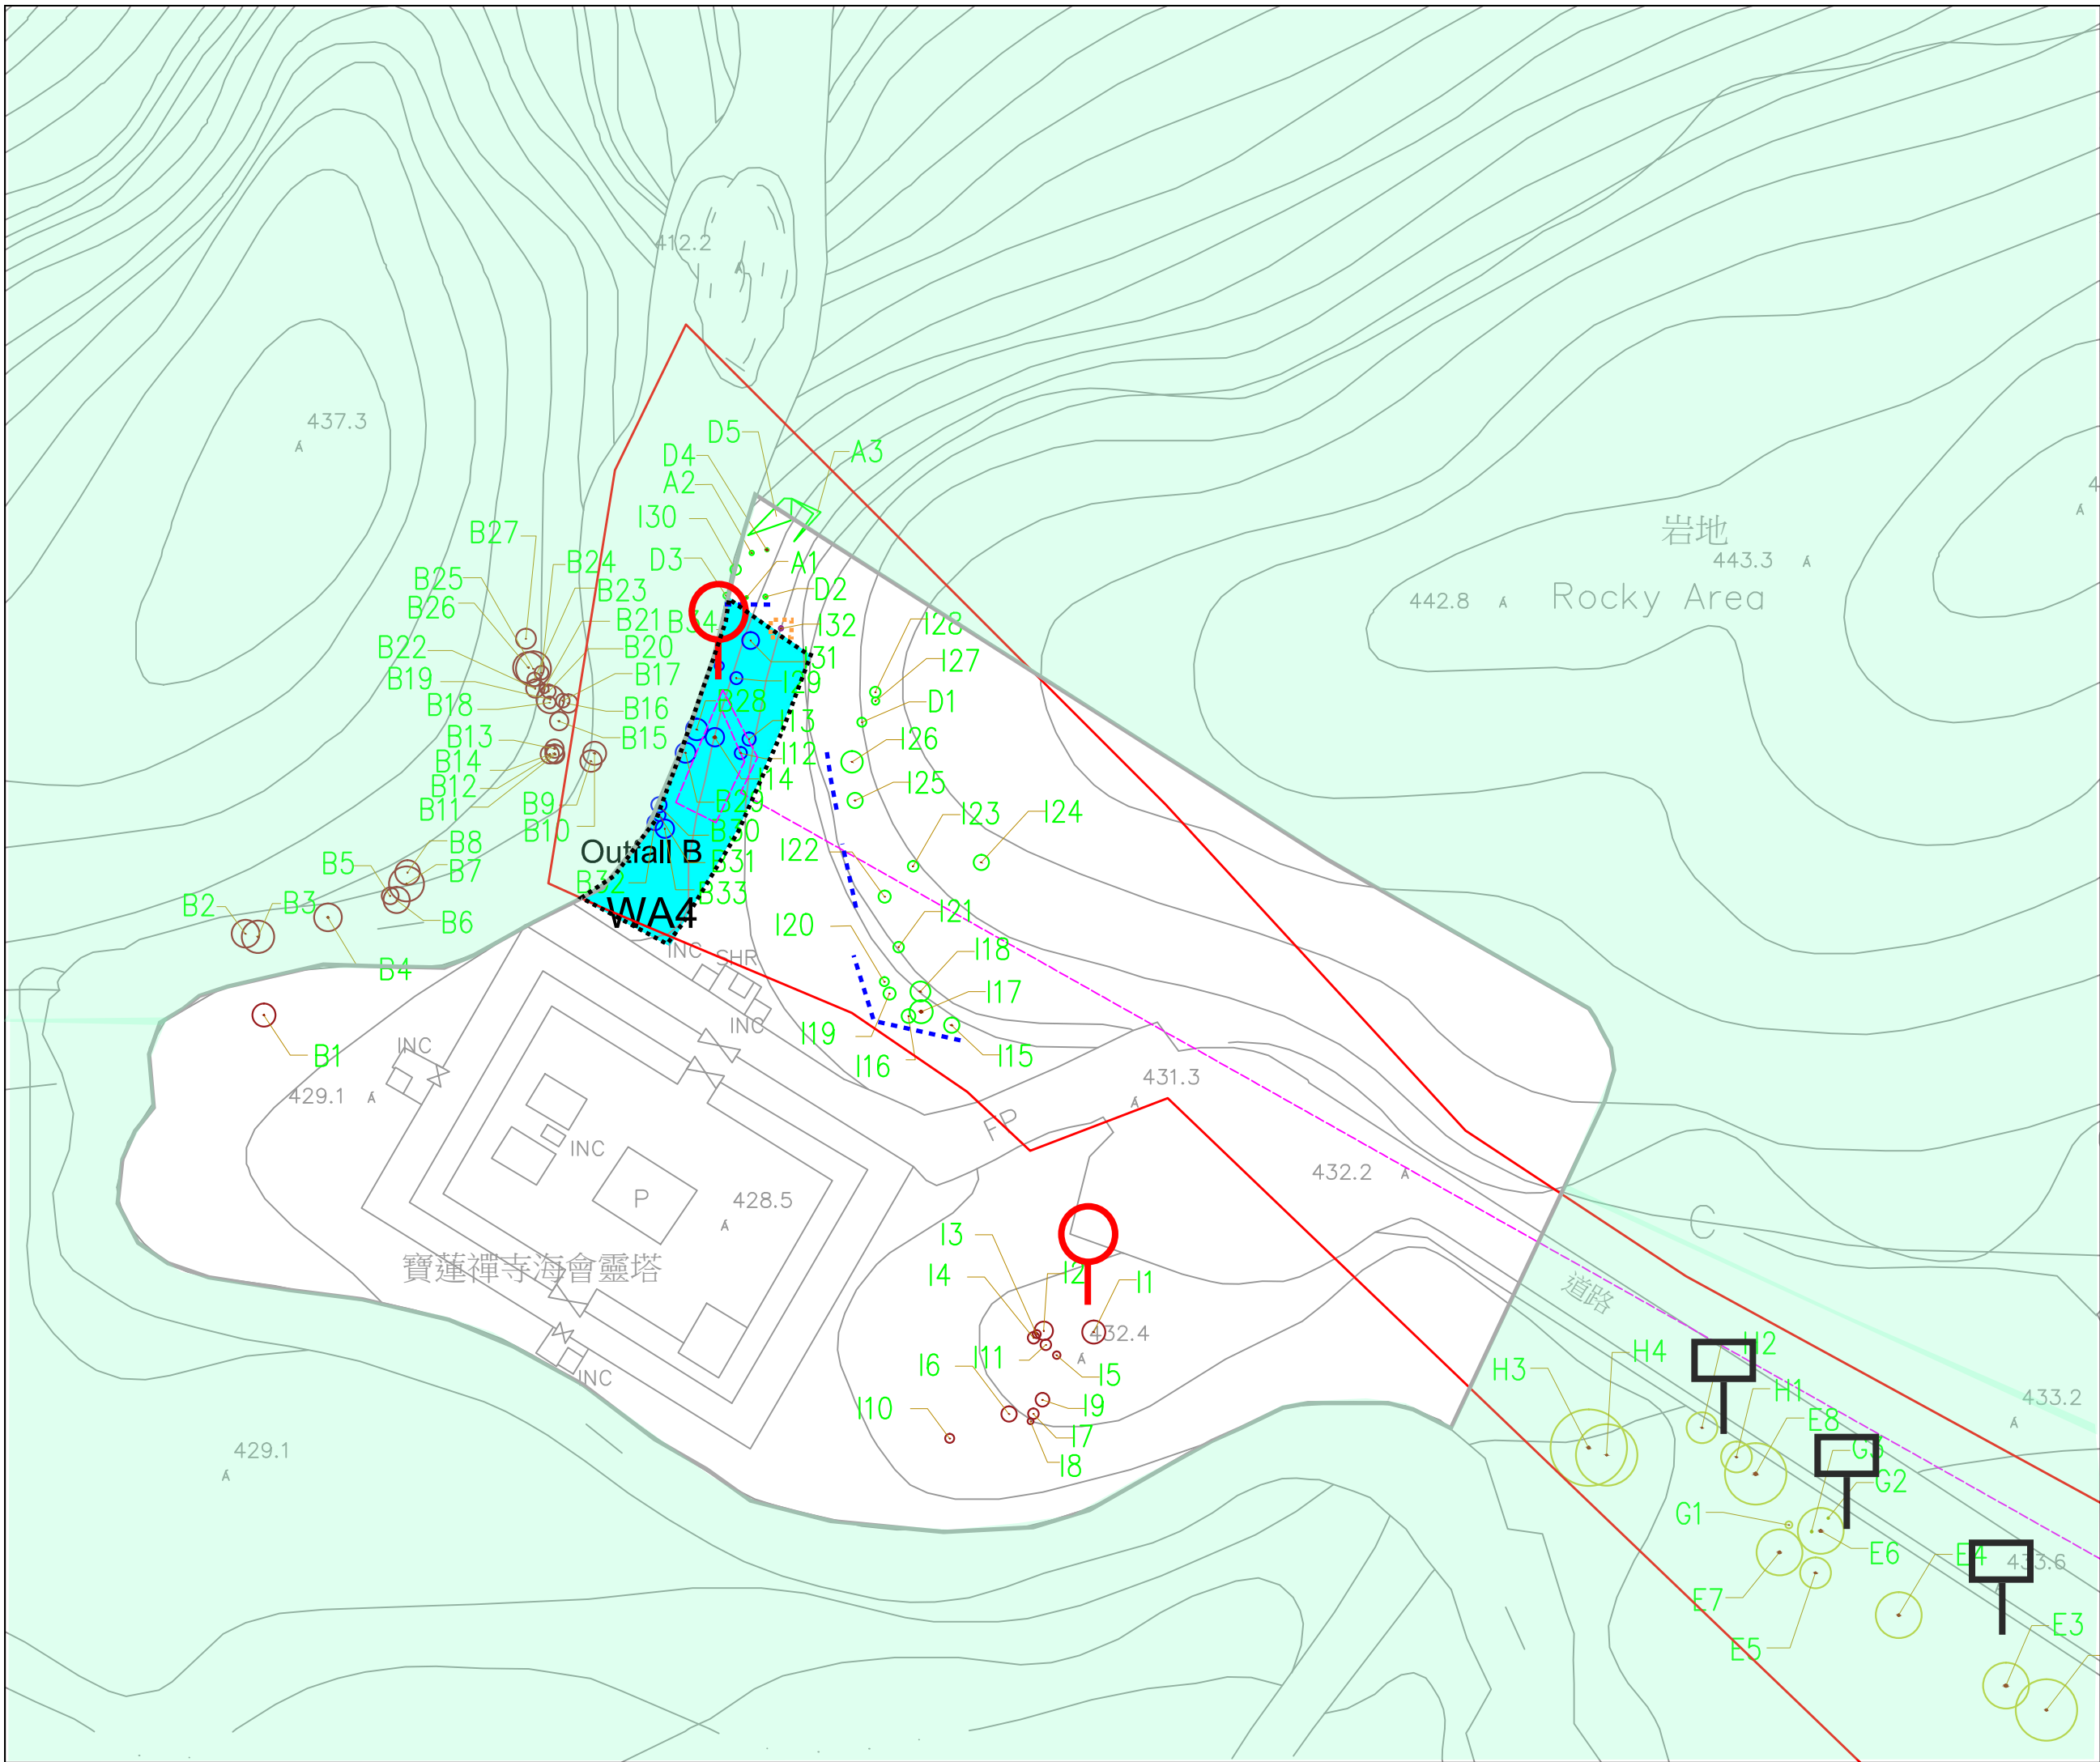
FIGURE NUMBER 1.a	REVISION 2
----------------------	---------------

A.3 Location of each Protection Measure

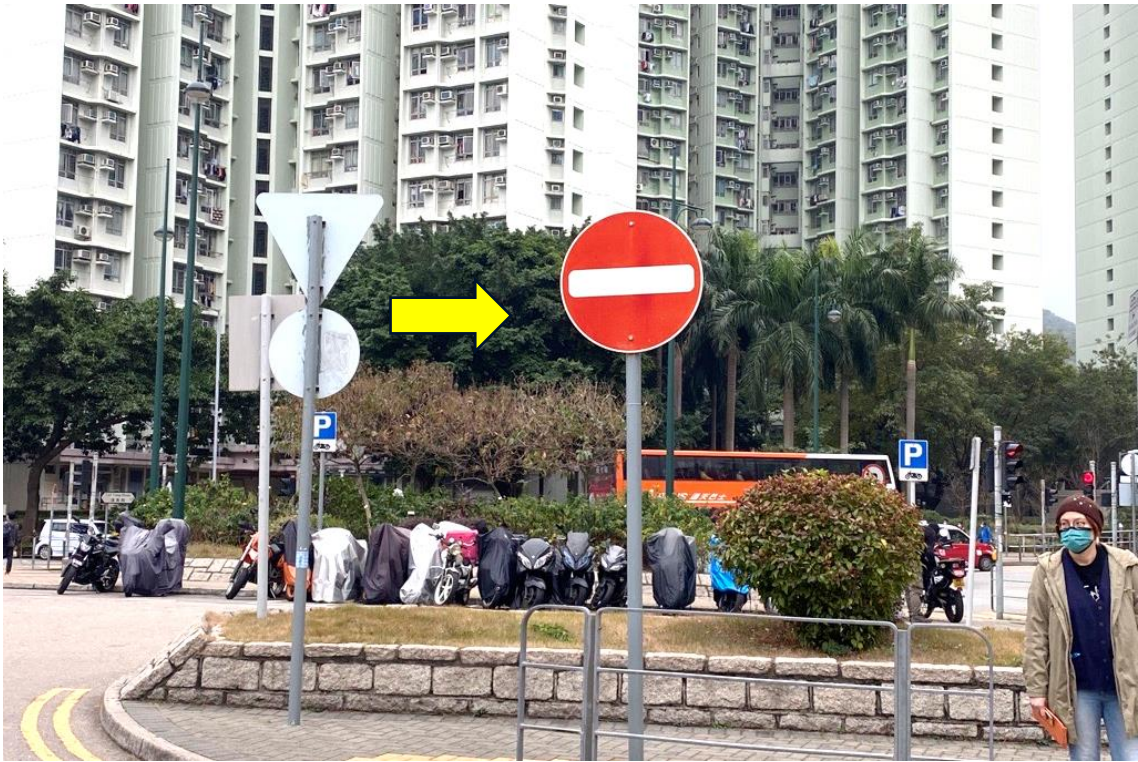
Appendix A.4.1: Sample Post Indicating Prohibition of Access

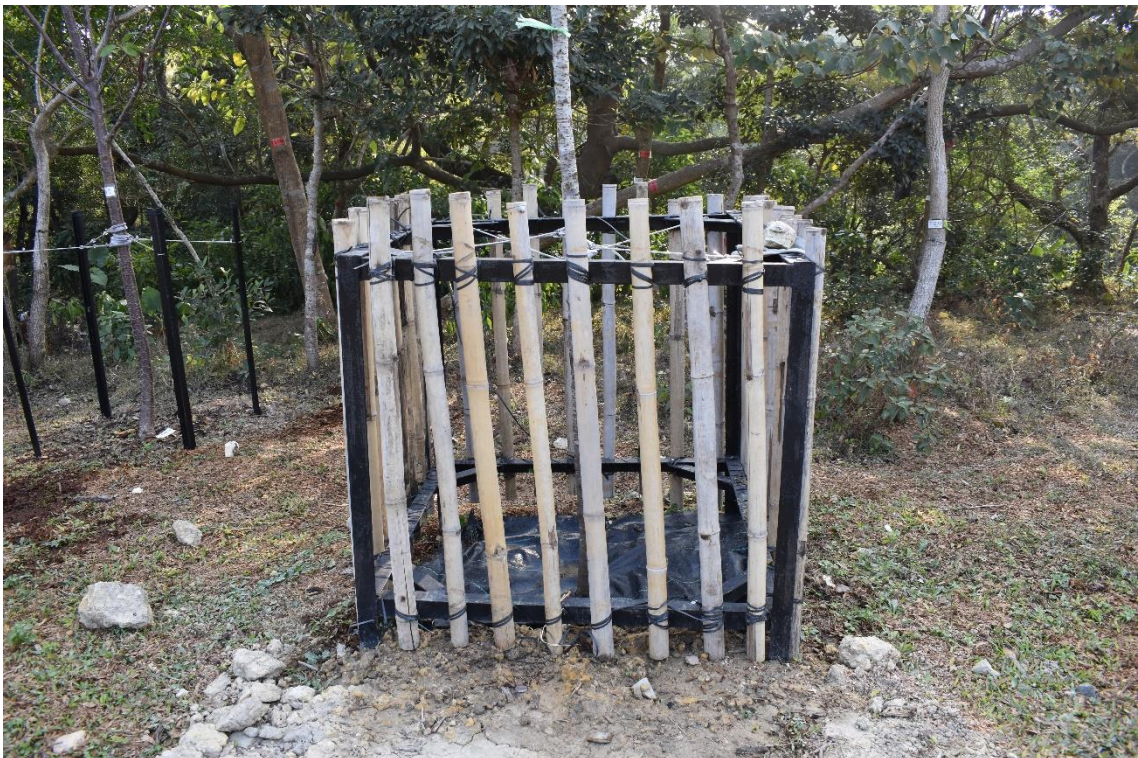
Appendix A.4.2: Sample Photo for Erection of Solid Fencing Around Plant Species

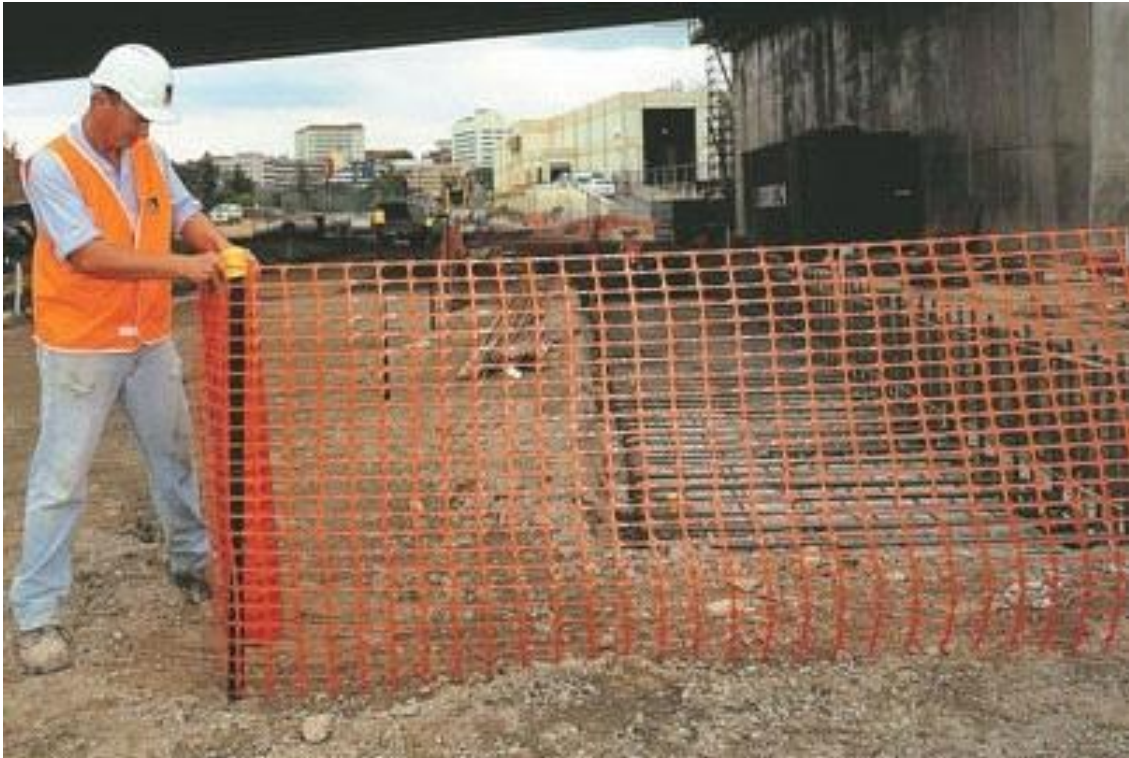
Appendix A.4.3 Sample Solid Fences that can be placed in the Access Entrance (source: https://upload.ecvv.com/upload/Product/201011/China_orange_barrier_fencing_mesh20101121447373.jpg)

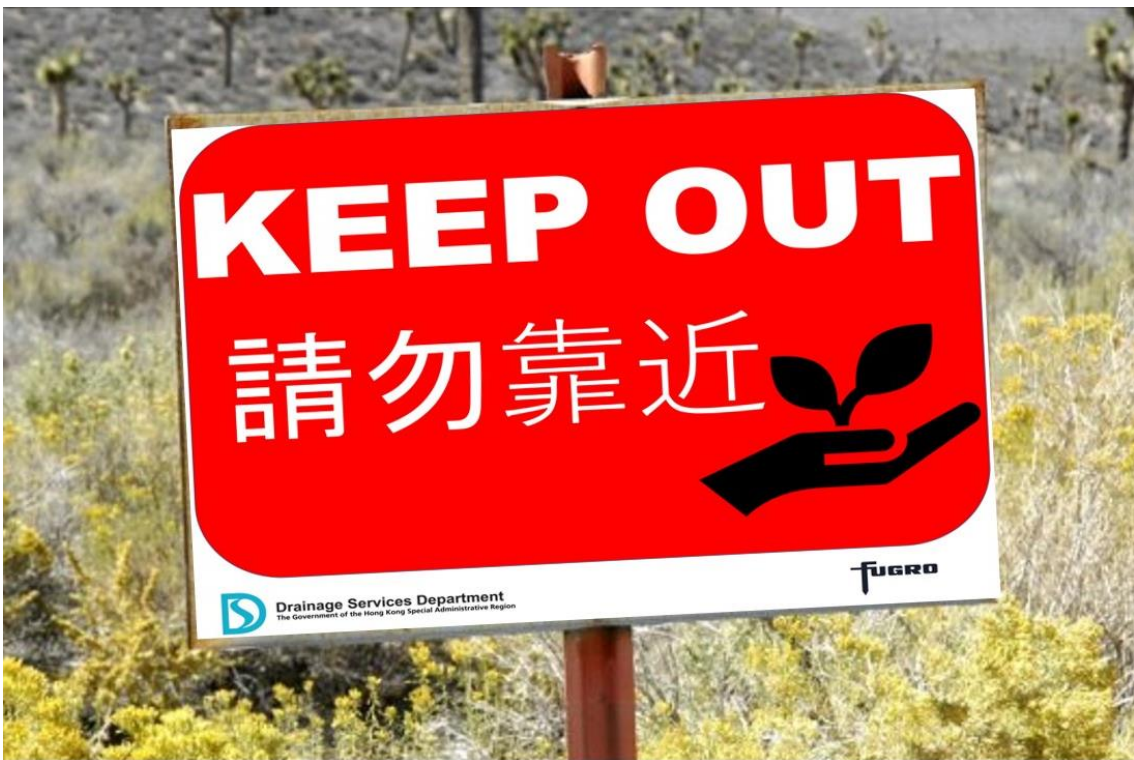
Appendix A.4.4: Sample Warning Sign Posts/Label for the Floral Species of Conservation Interest

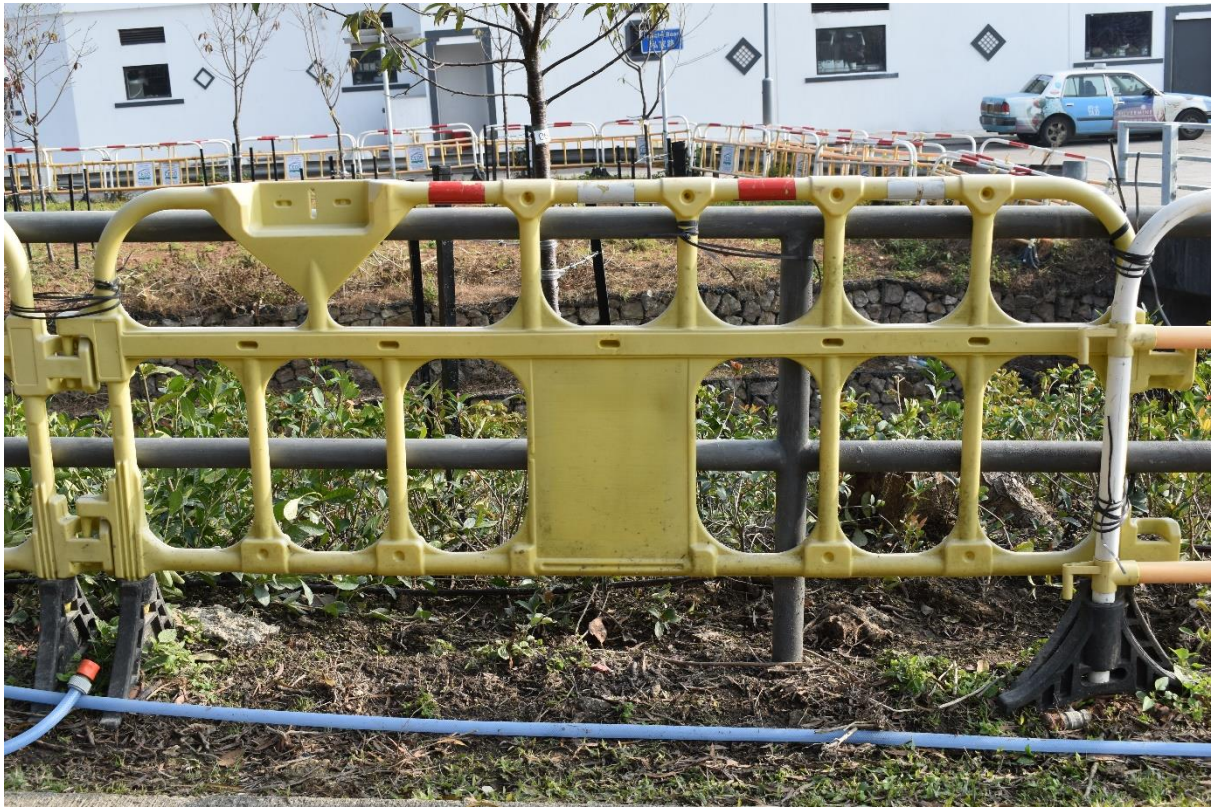
Appendix A.4.5: Sample Solid/Rigid Fence Enclosing Work and Stockpiling Areas
