Environmethal Team Services for Contract No. SS H504 Design and Construction of Chai Wan Government Complex and Vehicle Depot

17th Monthly EM&A Report (March 2023)

Contract No. SS H504
Design and
Construction of Chai
Wan Government
Complex and Vehicle
Depot

17th Monthly EM&A Report

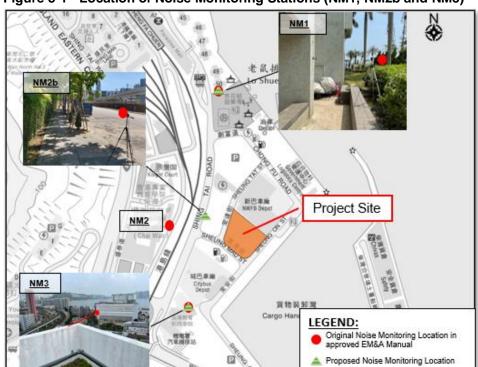
Figure 3-1 Location of Noise Monitoring Stations (NM1, NM2b and NM3)

Due to the adjustment of the location of NM2a to NM2b, the measured noise level at NM2b would represent the noise levels at NM2.
