**Contract No. DC/2018/08**  
**Inter-reservoirs Transfer Scheme –**  
**Water Tunnel between Kowloon Byewash Reservoir and Lower Shing Mun Reservoir**  
**Monthly Environmental Monitoring and Audit (EM&A) Report**  
**(November 2021)**

**29th Monthly EM&A Report (Rev. 2)**

- E2. This is the 29<sup>th</sup> Monthly Environmental Monitoring and Audit (EM&A) Report presents EM&A works undertaken in the period from 1 to 30 November 2021. EM&A works were performed in accordance with the approved EM&A Manual and conditions stipulated in the amended Environmental Permit EP-345/2009/A.

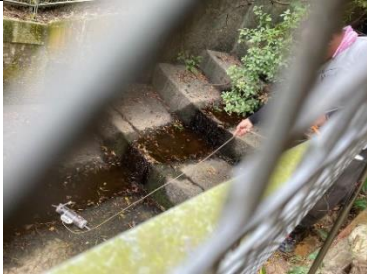
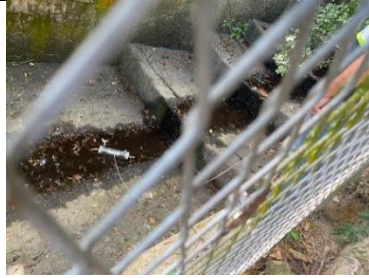
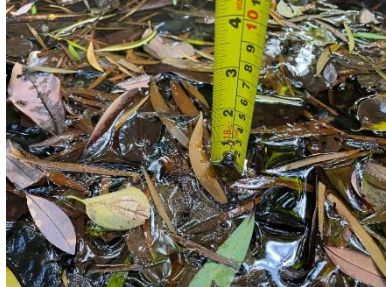
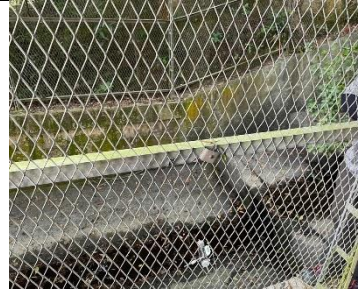
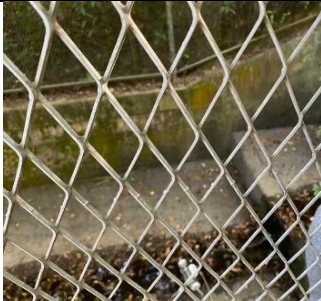
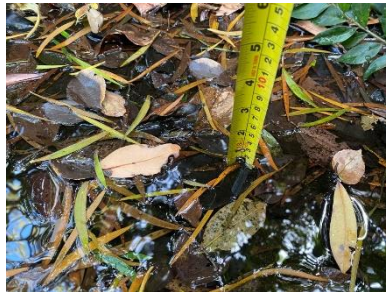
**C1b on Days with Insufficient Water Available for Water Sampler**

Note 1: Period without data implied that water in location C1b was dried up, insufficient water was available for sample collection

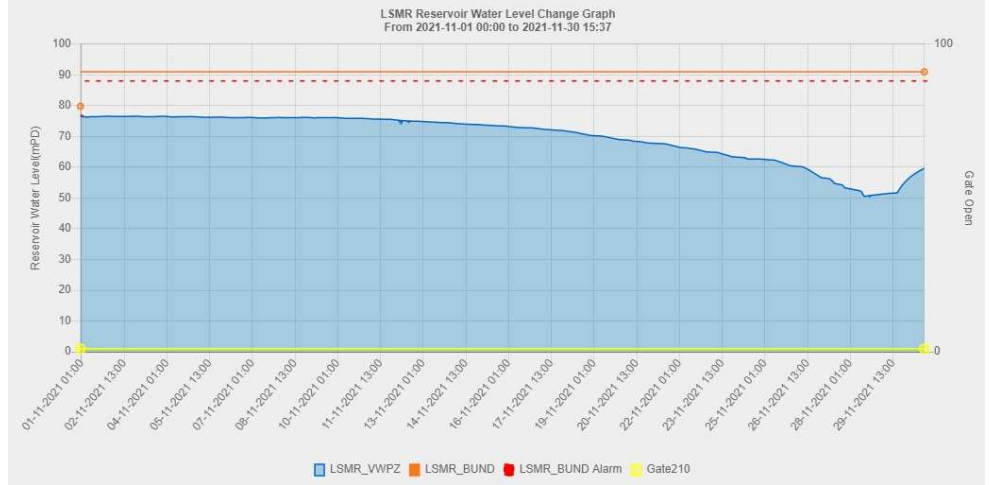
Figure 1 – Graph of Water level at LSMR

<p>The exceedance is considered not related to the construction works of IRTS. No further action is required.</p>	Monitoring Date	Turbidity at D2a	29/11/2021	190 NTU	30/11/2021	5.7 NTU
Monitoring Date	Turbidity at D2a						
29/11/2021	190 NTU						
30/11/2021	5.7 NTU

**Remark** The exceedance is considered project unrelated. The exceedance was recorded on 29 November 2021. The repeat in-situ measurement was conducted on 30 November 2021.

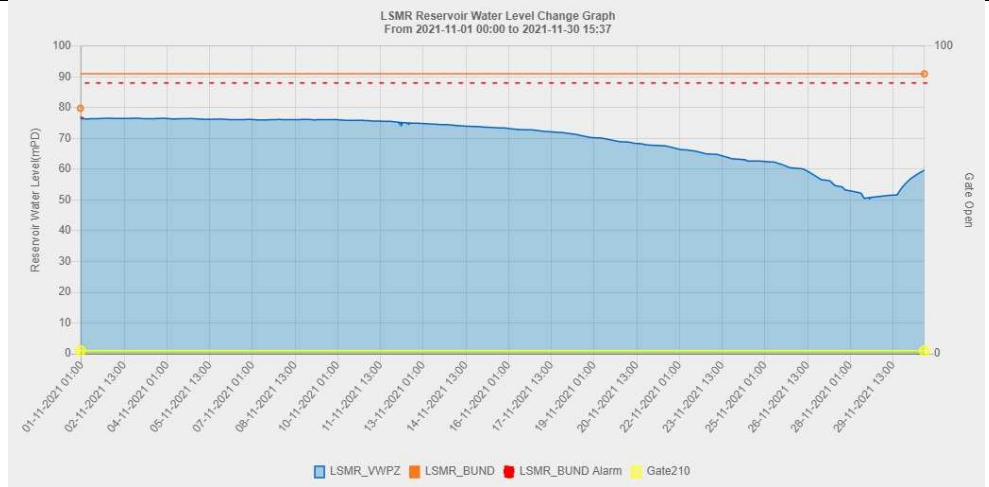
Figure 1 – Graph of Water level at LSMR

<p>The exceedance is considered not related to the construction works of IRTS. No further action is required.</p>	Monitoring Date	SS at D2a	29/11/2021	94 mg/L	30/11/2021	4.1 mg/L
Monitoring Date	SS at D2a						
29/11/2021	94 mg/L						
30/11/2021	4.1 mg/L

<b>Remark</b>	The exceedance is considered project unrelated. The exceedance was recorded on 29 November 2021. The repeat water quality measurement was conducted on 30 November 2021.
---------------	--
